Preliminary Geotechnical Assessment Report

Ruakākā Energy Park Solar Farm

Prepared for Meridian Energy Ltd

Prepared by Beca Limited

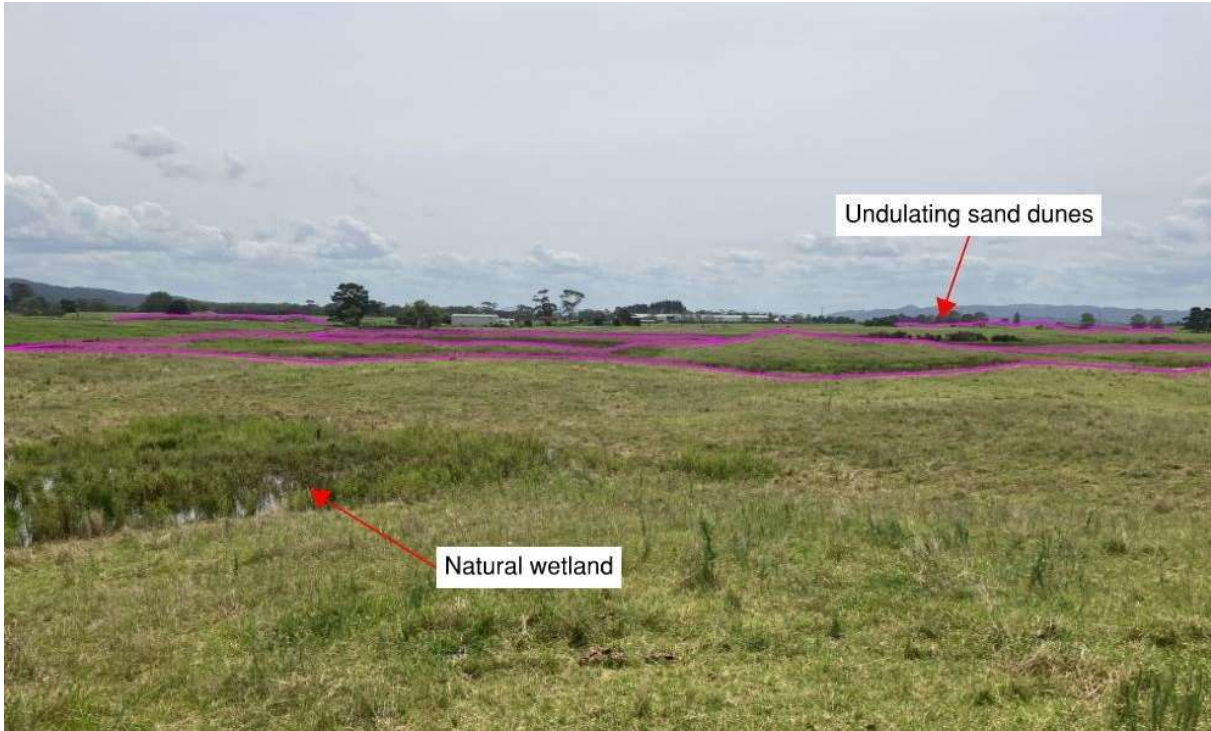
Figure 4-1: Photo of Site 1 undulating topography.

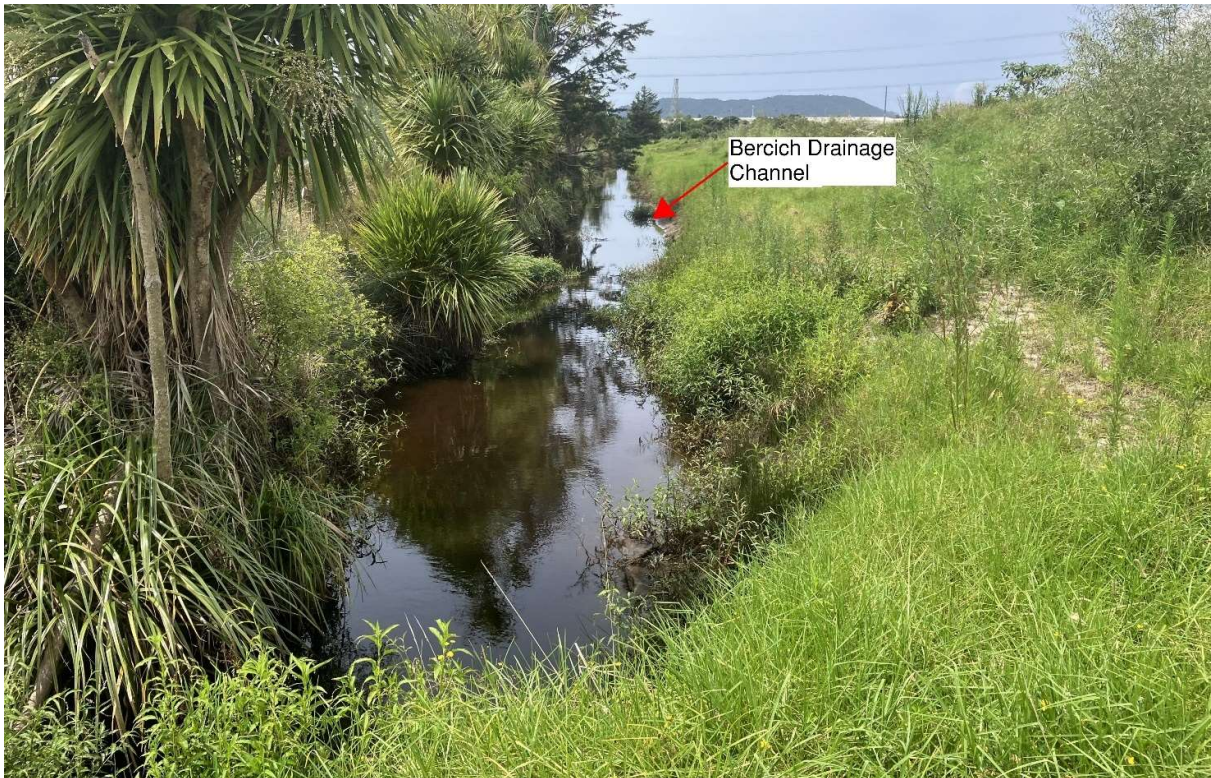
Figure 4-2: Bercich Drain running through the centre of Site 1.

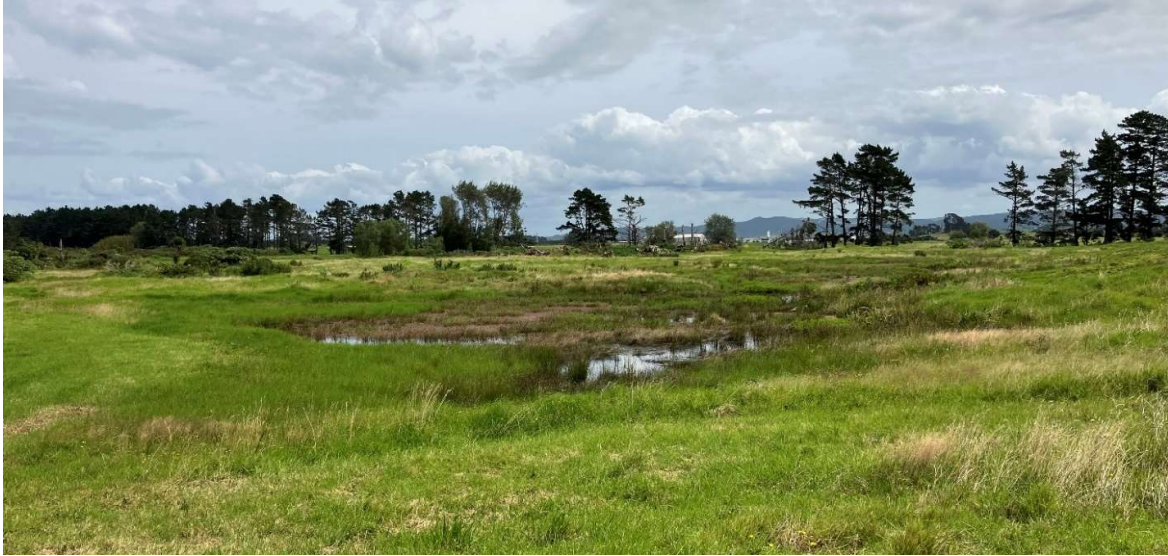
Figure 4-3: Natural wetlands within Site 1.

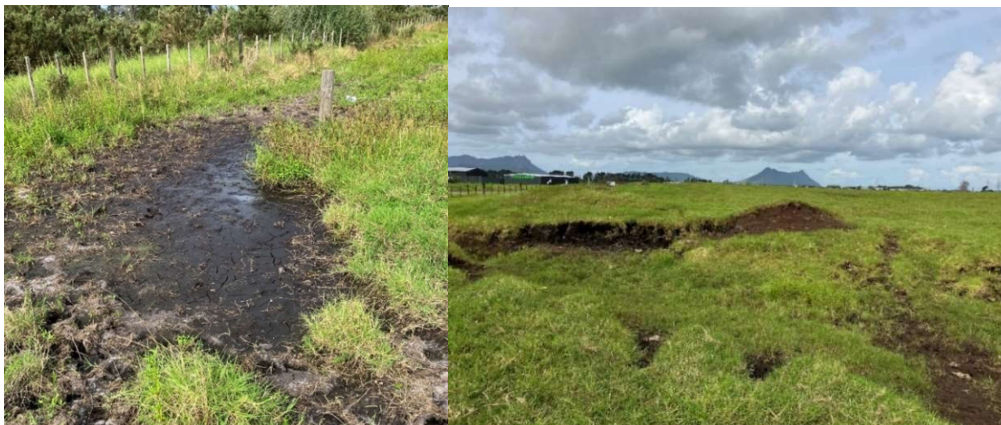
Figure 4-4: Soft peaty soils visible along access tracks

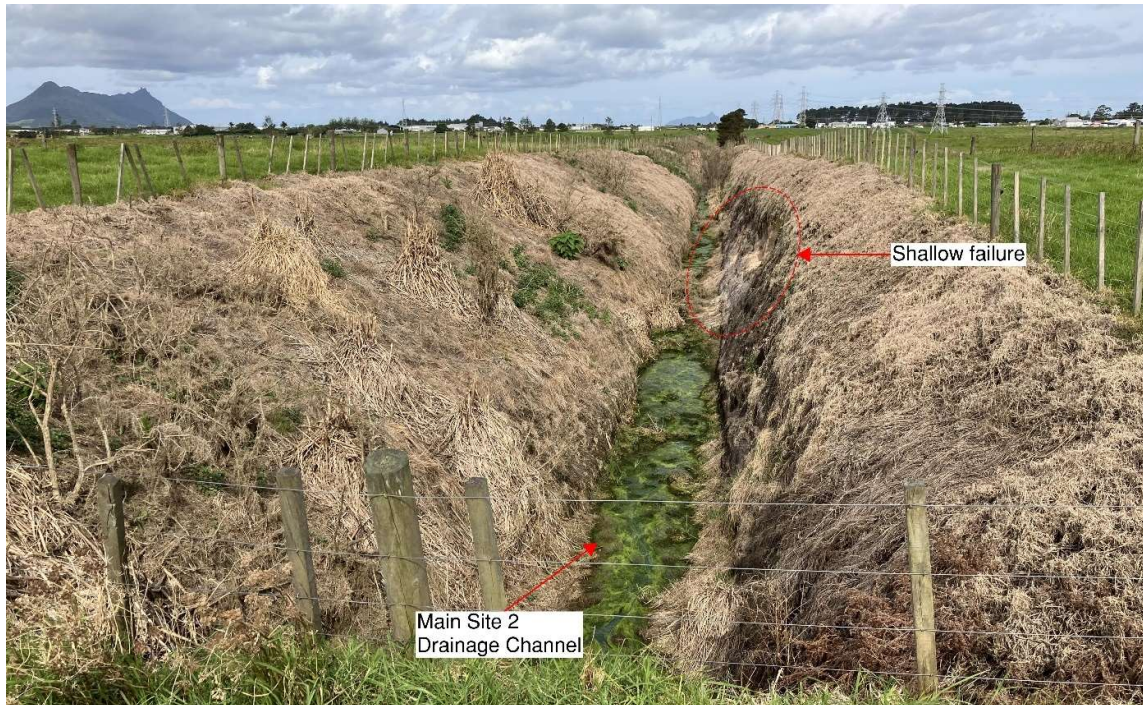
Figure 4-5: Main 4m deep drainage channel running through Site 2

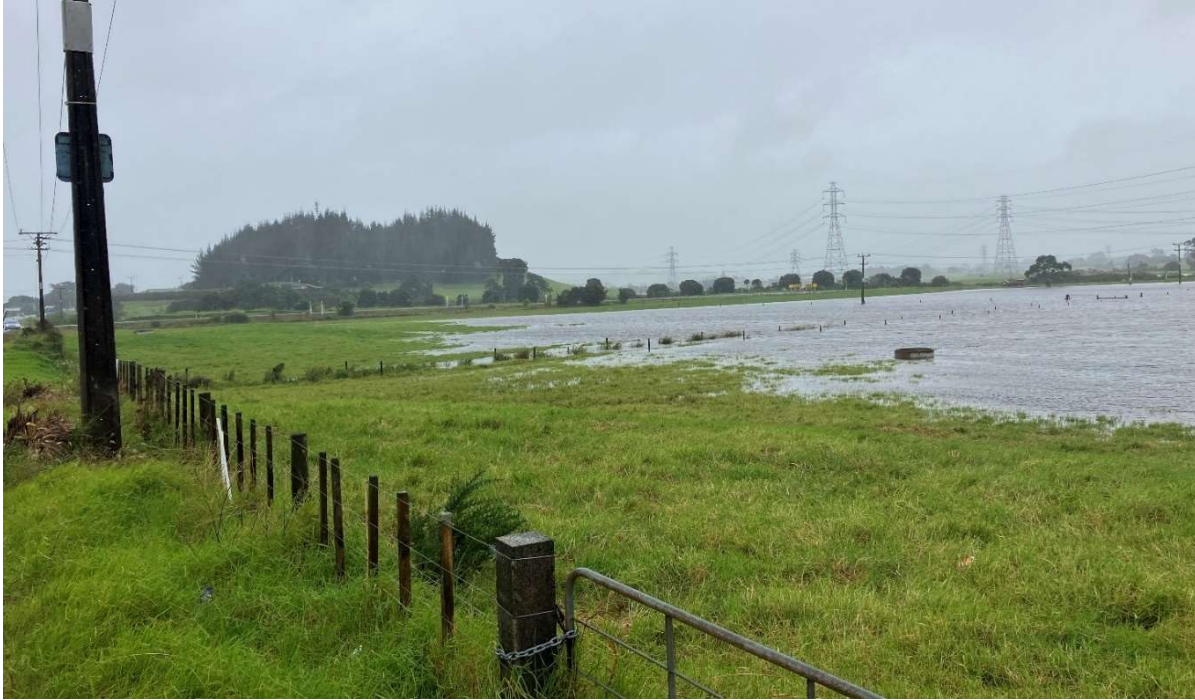
Figure 4-6: Low lying estuarine flood plain on Site 3 during heavy rainfall
