DUNE RESTORATION STRATEGY FOR THE OMAPERE-OPONONI SHORELINE

A strategy for the restoration of the Omapere-Opononi shoreline and dunes as a means of mitigating the effects of coastal erosion on property and infrastructure and enhancing the amenity and biodiversity of the shoreline.

Hokianga Harbour Foreshore Restoration Society

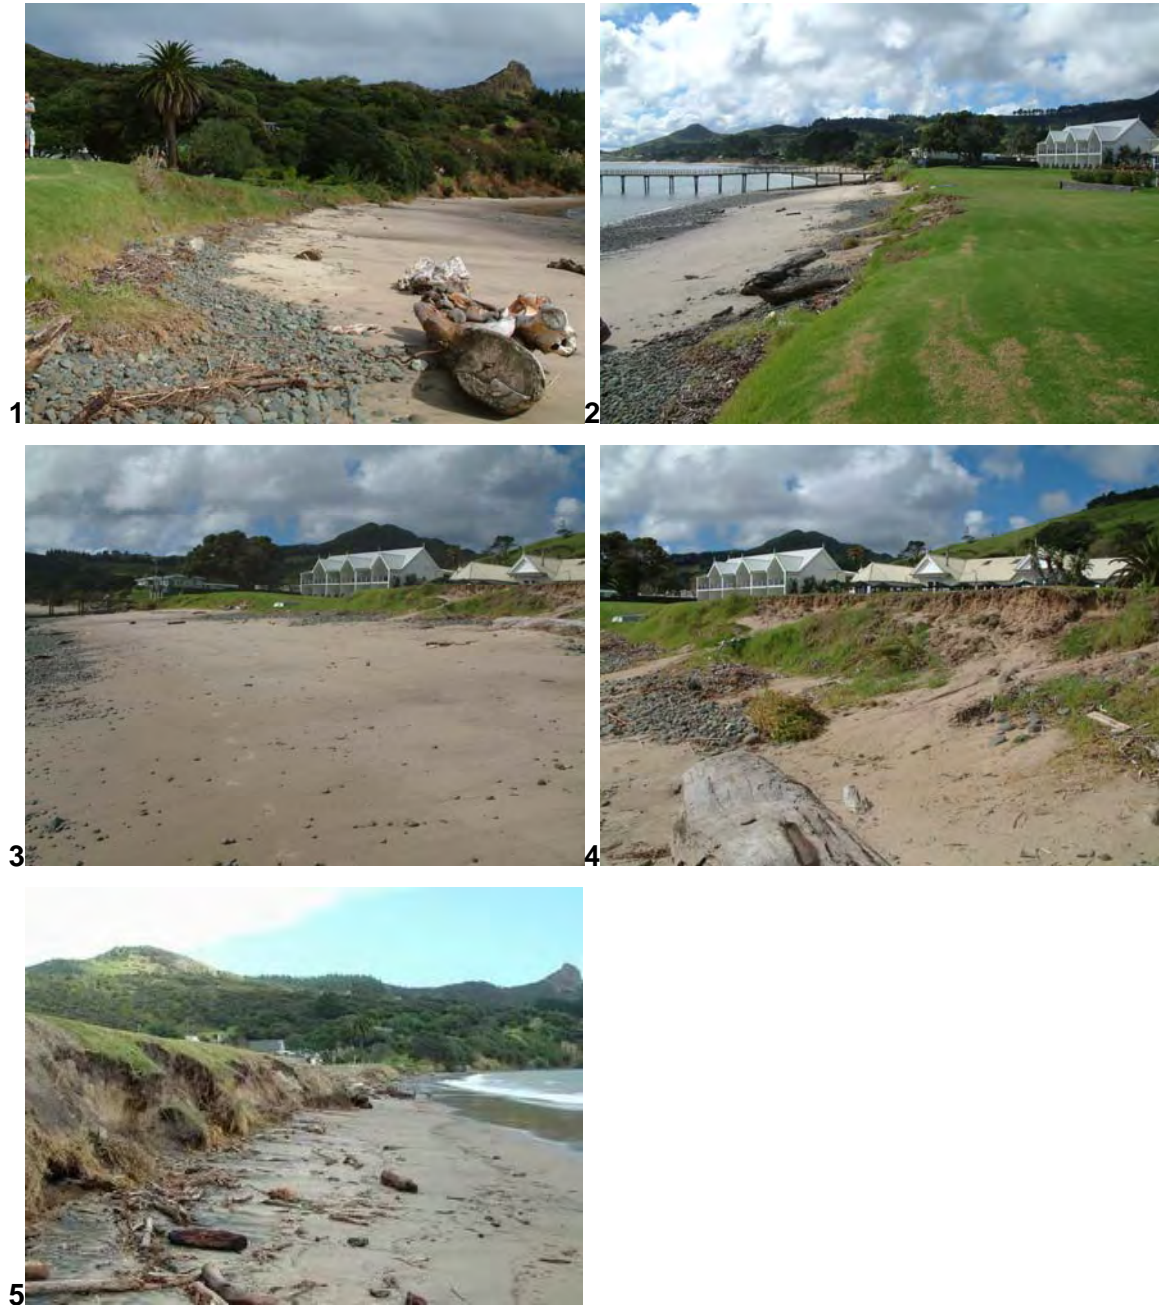
<i>Priority ranking</i>	3 rd priority as restoration of this bank will stabilise foreshore reserve in front of Copthorne. Stabilisation of foreshore in this area will enable any future management of the Wharf Road boat ramp to be done in a manner that has less impact on this site (to reduce the extent of sediment bypassing in the lee of the structure).
<i>Shoreline length and area for restoration</i>	160 metres (from pohutakawa trees to Wharf Road boat ramp) & 1200 m ² .
<i>Minimum shoreline setback from development</i>	15 metres from Copthorne chalets.
<i>Recommended restoration</i>	Retire a minimum of 7 metres of foreshore reserve/land for dune vegetation to provide a sufficient erosion buffer. Remove non-sand material and non-native plants. Reshape first 1 – 3 metres of shoreline bank to bring slope of dune face back to 25 – 30 degrees. Plant first 7 metres of reshaped area with spinifex/pingao mix. Low growing shrubs/trees can be planted landward of fenced off area if desired.

Site 1 photographs: Image 1 – 4 circa April 2008. Image 5 circa September 2005 following significant storm event.

<i>Provision of public access</i>	Provision of two access structures within restored area and one step type structure at the Wharf Road boat ramp end.
<i>Fencing</i>	Temporary fencing (post & wire) to enclose plants and restored area.
<i>Cost estimates (note assumes volunteer labour costs for planting, fencing and construction of access structures)</i>	Access structures ~ \$3,000. Fence ~ \$1,600. Plants ~ \$13,800. Machinery ~ \$3,000. Other miscellaneous ~ \$500. Sum of costs ~ \$21,900.
<i>Land ownership</i>	Predominantly FNDC reserve, although some private title near the Copthorne.
<i>Notes</i>	Need to assess suitability of existing dune/bank sediment/geology for reshaping, particularly in the south area as there appears to be an extensive uncemented cobble conglomerate in the southern extent of this site. Recommend that the approach is staged in either two or three individual stages. This will mitigate risk of failure from extreme storm events and will allow success to be monitored before committing to full restoration.

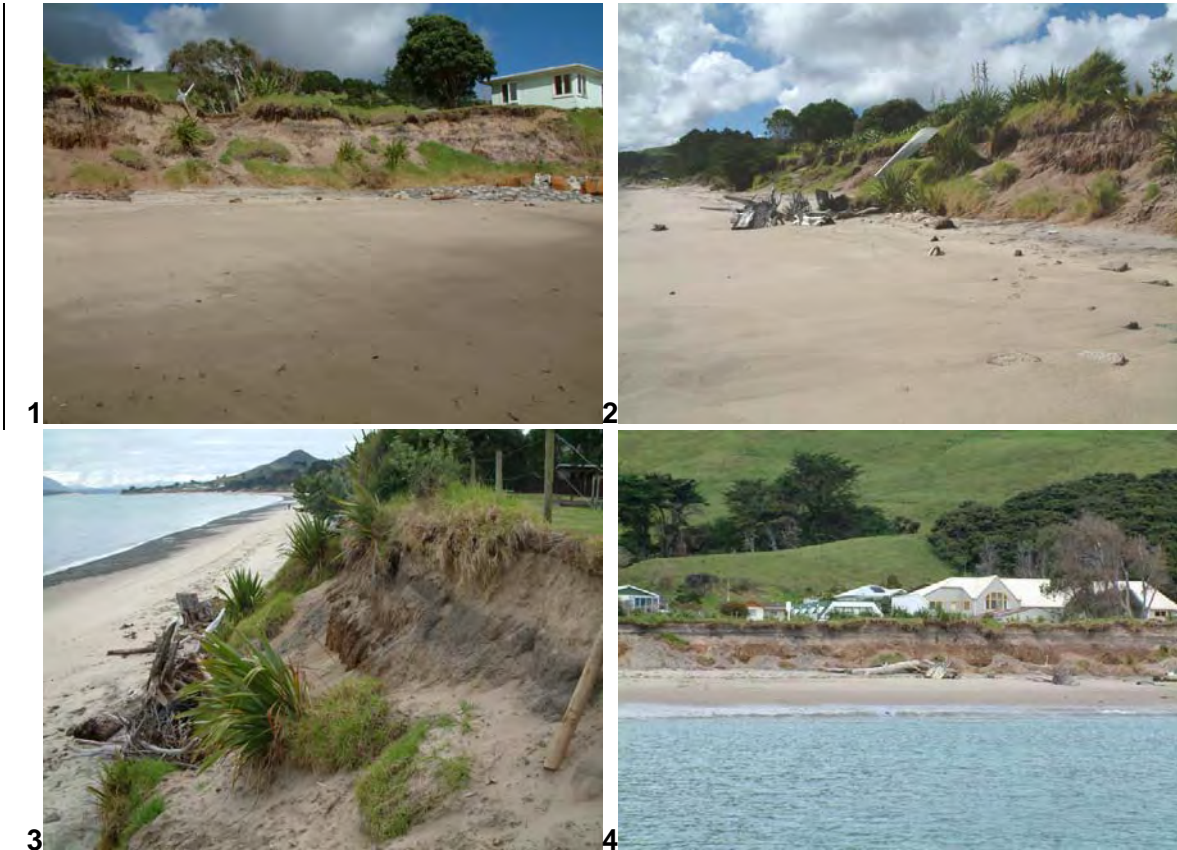
<i>Priority ranking</i>	2 nd priority. Restoration of this bank will aid in stabilisation of foreshore reserve by reducing failure of over steep bank face. Public access will also be enhanced through Freese Park to the beach. Management of potential erosion adjacent to the seawall will also be enhanced.
<i>Shoreline length and area for restoration</i>	72 metres (from seawall to end of park) & 620 m ² .
<i>Minimum shoreline setback from development</i>	27 metres from public toilets, 12 metres from playground
<i>Recommended restoration</i>	Retire a minimum 10 metre margin of foreshore reserve for dune vegetation to provide a sufficient buffer. Reshape the first 6 – 8 metres of bank to bring slope of dune face back to 26 – 33 degrees. Reshaping should focus on the upper profile whilst leaving a toe buttress of the cemented sandstone to resist toe erosion. Care should be taken during any reshaping to minimise disturbance of the lowest 2 metres of bank. Plant first 10 metres of reshaped area with spinifex/pingao mix. Low growing shrubs/trees can be planted landward of fenced off area if desired.

Site 2 photographs: Image 1 – 3 circa April/June 2008. Image 4 circa October 2005.

<i>Provision of public access</i>	Provision of one sand ladder access structure adjacent to playground.
<i>Fencing</i>	Temporary fencing (post & wire) to enclose plants and restored area.
<i>Cost estimates (note assumes volunteer labour costs for planting, fencing and construction of access structures)</i>	Access structure ~ \$1,000 Fence ~ \$720 Plants ~ \$7,130 Machinery ~ \$1,500 Other miscellaneous ~ \$500 Sum of costs ~ \$10, 850
<i>Land ownership</i>	FNDC reserve
<i>Notes</i>	Cemented sandstone will need to be crushed (track rolled) during reshaping. As little disturbance as possible should be undertaken at the toe of the bank to try and preserve a sandstone buttress which will be more resistant to toe erosion. Profile data show height of erosion scarp is 4 metres from toe of bank to crest, with 2 – 4 metres horizontal setback between toe to crest – indicate a slope face of 45 – 63 degrees which is maintained by the cemented sandstone geology. To achieve a slope face of 26 – 33 degrees it is necessary to achieve a horizontal setback from toe to crest of 6 – 8 metres from current toe (whilst maintaining a 4 metre vertical elevation from bank crest to toe).

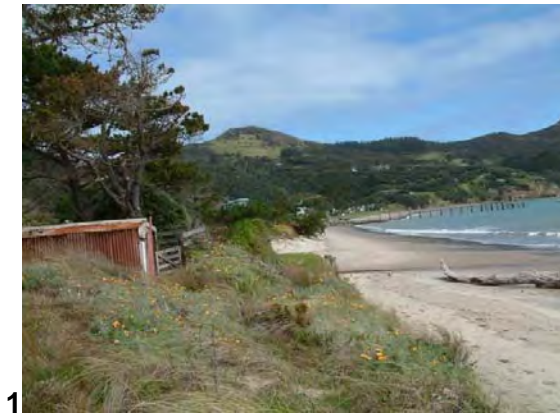
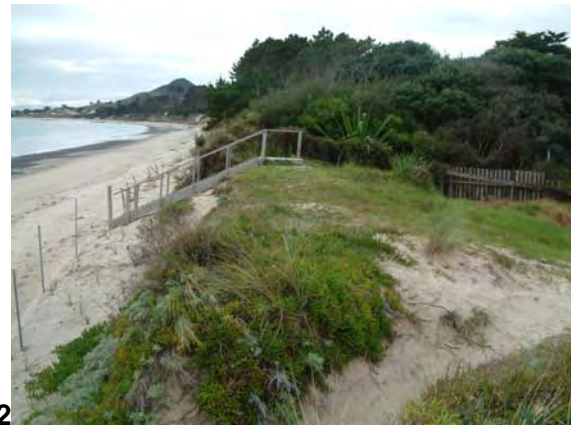
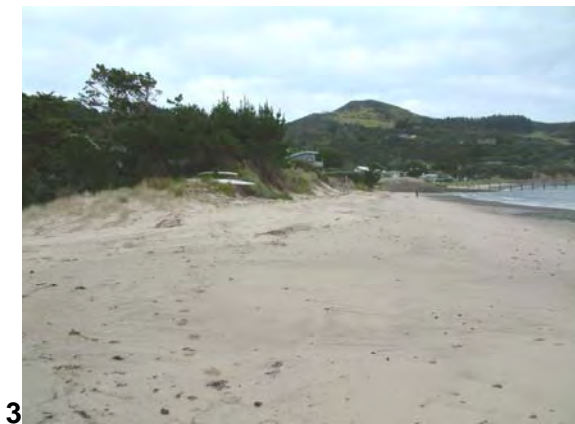
<i>Priority ranking</i>	5th priority. Restoration of this bank will stabilise foreshore and allow for continuation of restoration works. Public access will also be enhanced.
<i>Shoreline length and area for restoration</i>	85 metres & 550 m ² .
<i>Minimum shoreline setback from development</i>	4 - 10 metres from garden sheds.
<i>Recommended restoration</i>	Reshape first 3 - 5 metres of bank to bring slope of dune face back to 26 – 33 degrees & smooth out the contour of dune profile. Remove non-native vegetation including pine trees. Plant first 5 metres of reshaped area with spinifex/pingao mix. Care should be taken to minimise disturbance of areas of dune already vegetated with spinifex & pingao.
<i>Provision of public access</i>	Provision of one sand ladder access structure adjacent to the existing foreshore access point.
<i>Fencing</i>	Temporary fencing (post & wire) at the base of restored area only (foot traffic should not be too heavy through private property) and along access point.

Site 4 photographs: Image 1 – 3 circa April/June 2008.

<i>Cost estimates (note assumes volunteer labour costs for planting, fencing and construction of access structures)</i>	Access structure ~ \$1,000 Fence ~ \$425 Plants ~ \$6,325 Machinery ~ \$1,500 Other miscellaneous ~ \$500 Sum of costs \$9,750
<i>Land ownership</i>	Private title.
<i>Notes</i>	The area contains some spinifex and pingao that should be maintained.

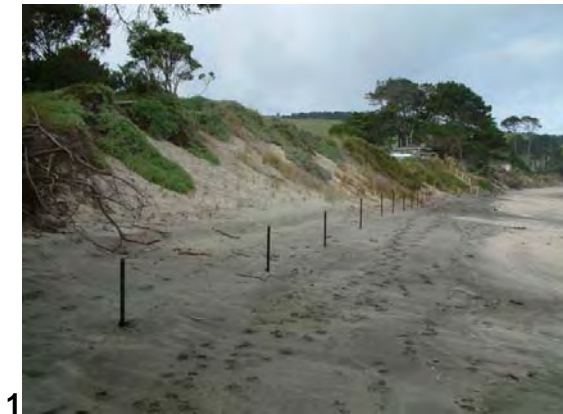
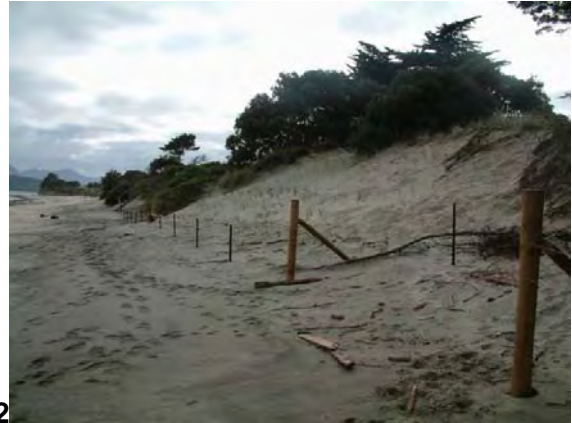
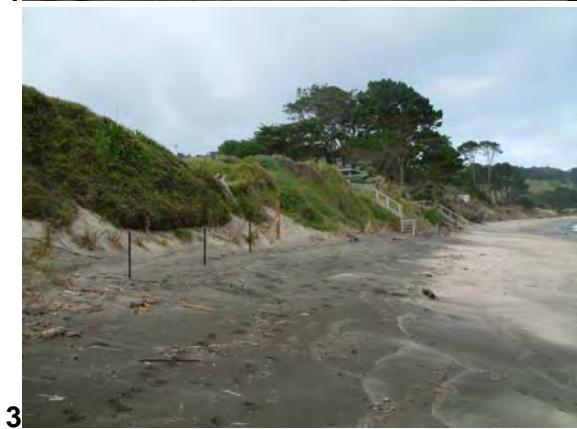
<i>Priority ranking</i>	1st priority. Restoration of this bank will stabilise foreshore. The restoration will enable any erosion adjacent to the seawall to be managed.
<i>Shoreline length and area for restoration</i>	160 metres (from seawall to end of park) & 1000 m ² .
<i>Minimum shoreline setback from development</i>	10 metres from closest dwelling.
<i>Recommended restoration</i>	Reshape first 2- 4 metres of bank to bring slope of dune face back to 26 – 33 degrees & smooth contour of dune profile. This is not required in some parts where existing profile slope is sufficient. Plant first 10 metres of reshaped area with spinifex/pingao mix. Care should be taken to minimise disturbance of areas of dune already vegetated with spinifex & pingao.
<i>Provision of public access</i>	Provision of two sand ladder access structures adjacent to existing foreshore access point for access to private properties. The location of these needs to be determined by the residents at this is mostly private title with no public access.

Site 8 photographs: Image 1 – 3 June 2008.

<i>Fencing</i>	Temporary fencing (post & wire) at the base of restored area only (foot traffic should not be too heavy through private property) and along access point.
<i>Cost estimates (note assumes volunteer labour costs for planting, fencing and construction of access structures) Costs will be lower as work has begun on this project.</i>	Access structures ~ \$1,500 Fence ~ \$800 Plants ~ \$5,000 Machinery ~ \$2,000 Other miscellaneous ~ \$500 Sum of costs ~ \$9,800
<i>Land ownership</i>	Private title with one part FNDC reserve.
<i>Notes</i>	The area contains some spinifex and pingao that should be maintained. Work has already begun on this project: <ul style="list-style-type: none"> • Post and wire fence erected along the toe of the dune along a portion of this area (see photos 1-3 below). • Spinifex and pingao planted on areas of the dune suitable for planting without reshaping.

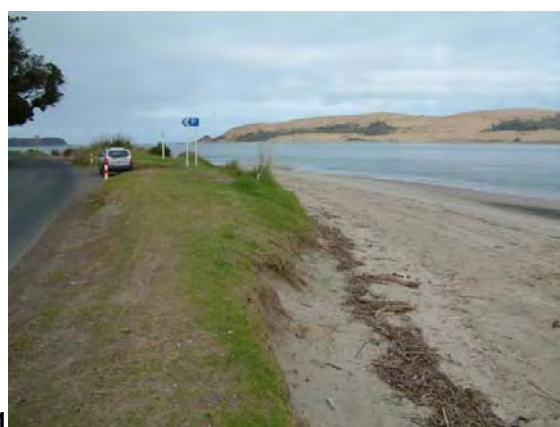
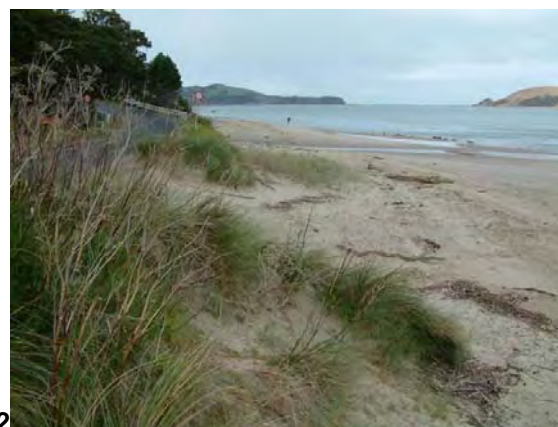
<i>Priority ranking</i>	4th priority. Restoration of this bank will stabilise foreshore and minimise risk of erosion to the road and the need for future protection works.
<i>Shoreline length and area for restoration</i>	110 metres (from seawall to end of park) & 600 m ² .
<i>Minimum shoreline setback from development</i>	2 – 5 metres from road.
<i>Recommended restoration</i>	Reshape first 2- 3 metres of bank to bring slope of dune face back to 26 – 33 degrees & smooth contour of dune profile. Remove existing marram grass and other non-native vegetation. Plant reshaped area with spinifex/pingao mix.
<i>Provision of public access</i>	Provision of one access structure to enable access through fenced area. This should be placed opposite the new carpark/shopping centre area to enable/encourage use of the access structure. It is critical that public access through these proposed restoration areas is provided in a manner that enables clear and easy access through to the beach.

1 Site 12a photographs: Image 1 – 2 June 2008.

<i>Fencing</i>	Temporary fencing (post & wire) to enclose restored area. Note the need to enable public access in a clear and easy manner. Possibly consider a series of small fenced off sections as to enable easy access.
<i>Cost estimates (note assumes volunteer labour costs for planting, fencing and construction of access structures)</i>	Access structure ~ \$1,000 Fence ~ \$600 Plants ~ \$6,900 Machinery ~ \$1,000 Other miscellaneous ~ \$500 Sum of costs ~ \$10,000
<i>Land ownership</i>	Road reserve.
<i>Notes</i>	Some care will need to be taken in any reshaping that is taken in close proximity to the road so as to minimise the risk of destabilising the dune/bank.

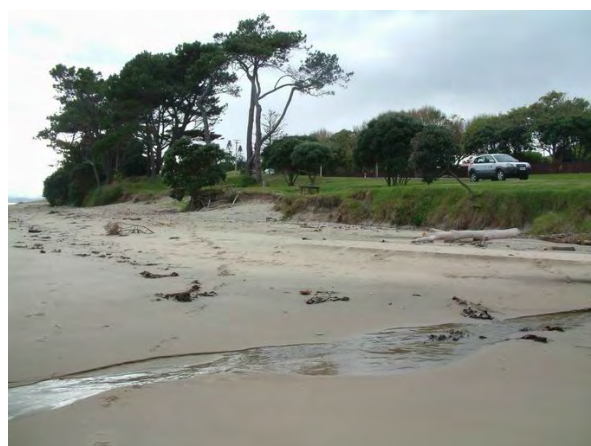
<i>Priority ranking</i>	6th priority. Restoration of this bank will stabilise foreshore and minimise risk of erosion to the reserve and the need for future protection works. This is seen as a good site for establishment of successful planting in a high public use area and will provide a model for further work that might involve similar bank reshaping and boardwalk accessways.
<i>Shoreline length and area for restoration</i>	65 metres (from storm water outlet north to pine trees) & 350 m ² .
<i>Minimum shoreline setback from development</i>	14 – 28 metres from road. FNDC plan to relocate picnic table.
<i>Recommended restoration</i>	Reshape front edge of bank to bring slope of dune face back to 26 – 33 degrees & smooth contour of dune profile. Remove non-native vegetation. Plant reshaped area with spinifex/pingao mix.
<i>Provision of public access</i>	Provision of one boardwalk access structure to enable access through fenced area. This should be placed opposite the new car-park/shopping centre area to enable/ encourage use of the access structure.

Site 12b photograph: Image June 2008.

<i>Fencing</i>	Temporary fencing (post & wire) to enclose restored area.
<i>Cost estimates (note assumes volunteer labour costs for planting, fencing and construction of access structures)</i>	Access structure ~ \$1,000 Fence ~ \$900 Plants ~ \$2,300 Machinery ~ \$2,000 Other miscellaneous ~ Sum of costs ~ \$6,200
<i>Land ownership</i>	FNDC
<i>Notes</i>

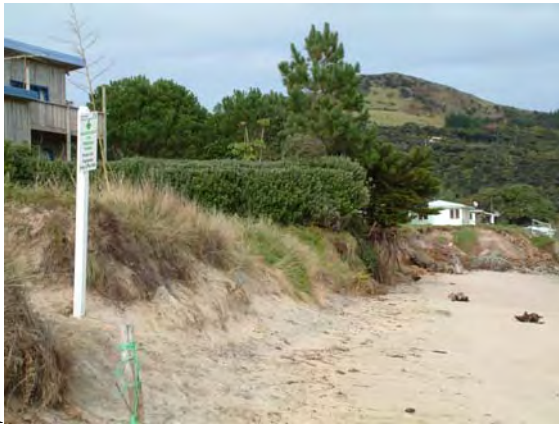
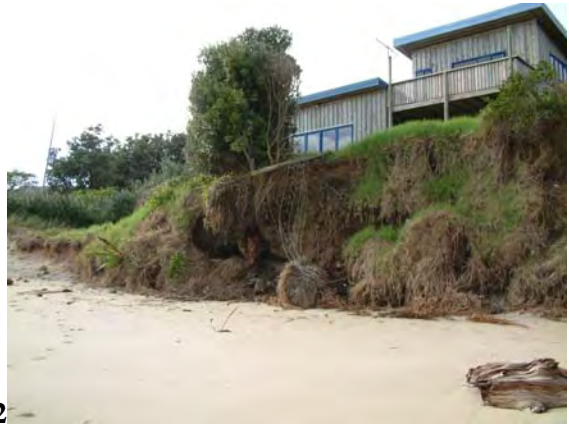
This area is located immediately north of Freese Park. There is insufficient setback from the dwelling to the shoreline to enable restoration of the dune. The dune also contains soil fill that would require removal.

1 2
Site 3 photographs: Images 1 – 2 June 2008.

Alternative management options should be considered for this site which may involve protection works (require consent and would likely be problematic when placed in isolation on the foreshore) or landward relocation of the dwelling, which, unless the garage was removed from the property, appears unlikely given space restrictions.

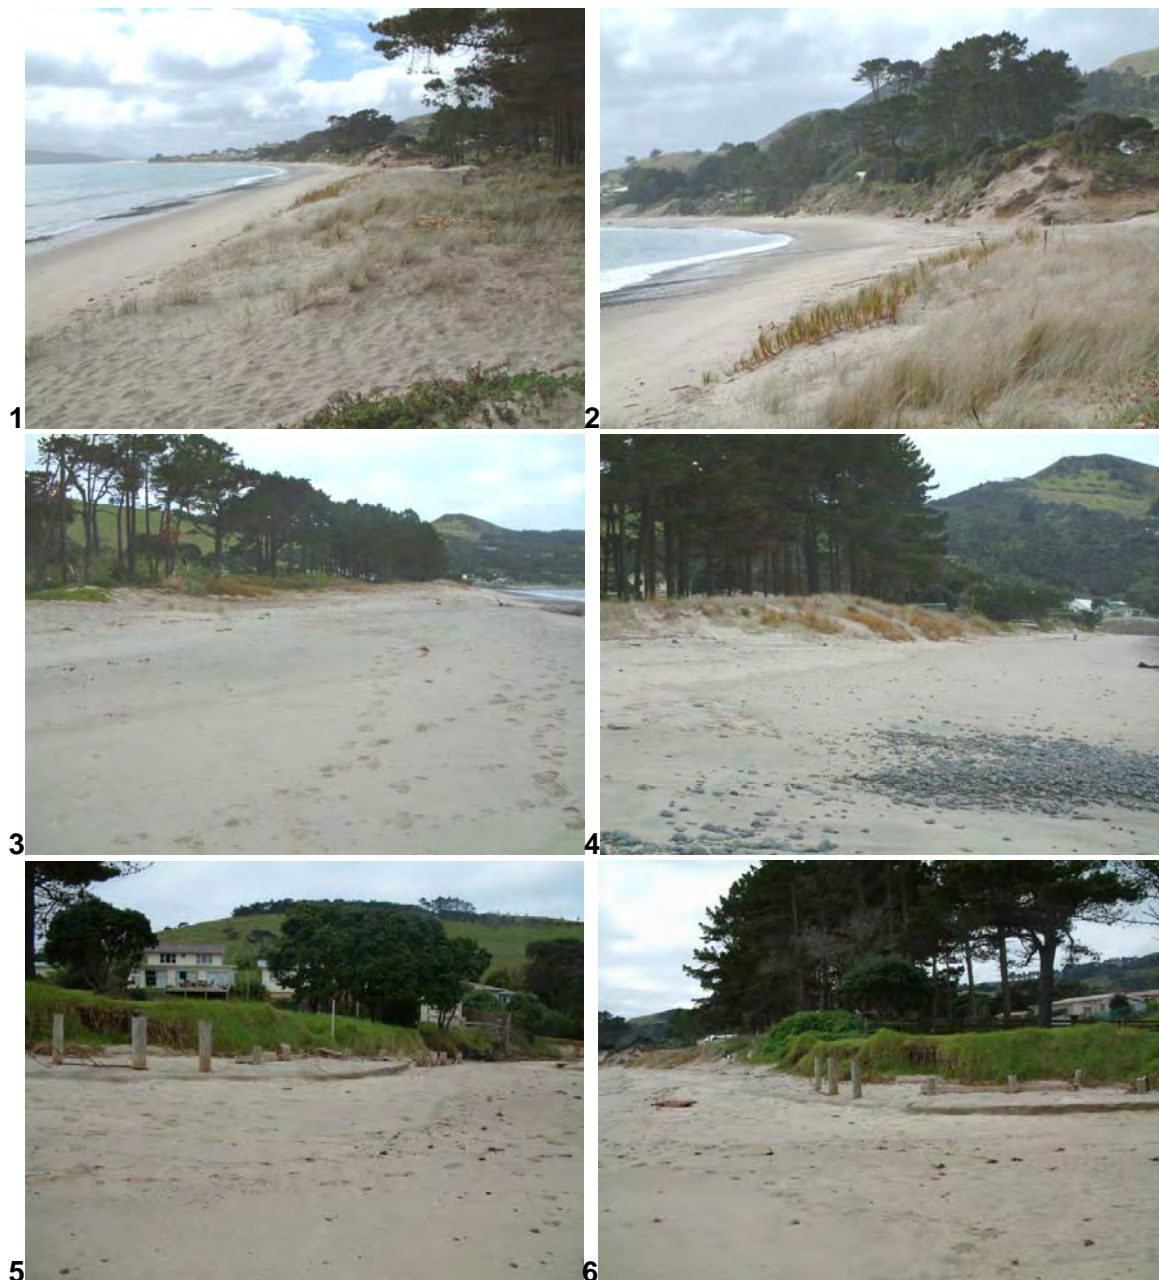
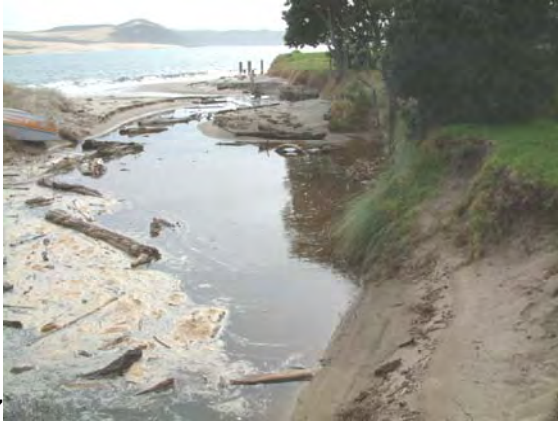
Whilst restoration would benefit this site, this is considered a low priority as there is sufficient setback of dwellings from the shoreline to buffer effects of erosion. Furthermore, the dune in this area appears healthy and well accreted, not requiring any intervention in the form of reshaping, replanting or fencing. As such, restoration in this area is not recommended. However, this area would benefit from some occasional maintenance (weeding and fertilising of spinifex/pingao) to encourage strong growth of the dune.

The south extent of this section could benefit from some reshaping and restoration, which would aid in the continuity of the dune complex at this site. This is in the area immediately north of the first stream. In this area the dune complex has been removed and capped with soil to create a gently sloping lawn. This land is slowly eroding, due to the combined effects of the stream outlet migration and coastal erosion. Removal of the soil and existing non-native vegetation and replanting with spinifex and pingao would aid in the stability of this area. This would only be necessary in a small section that is approximately 20 metres in length (refer to Site 5 photos 5 & 6). This subsection of Site 5 could be afforded priority status for restoration, particularly if done in conjunction with other works to stabilise the right bank of the stream (as discussed below).

Erosion of the right (north) stream bank at this site is of concern to at least one adjacent property owner. This bank has eroded due to combined coastal and river processes cutting into the toe of the bank causing this to erode. Dune restoration is not recommended at this stream bank, due to the river processes and lack of sediment supply to the right bank. However, a small rock revetment seawall structure (designed in accordance with professional engineering standards) could be implemented to address erosion of the stream bank. This will likely only have minor adverse effects on coastal processes, the main being potential for increased erosion where the structure terminates. This activity would require a coastal permit, obtained prior to commencing work.

7
Site 5 photographs: Images 1 – 7 June 2008.

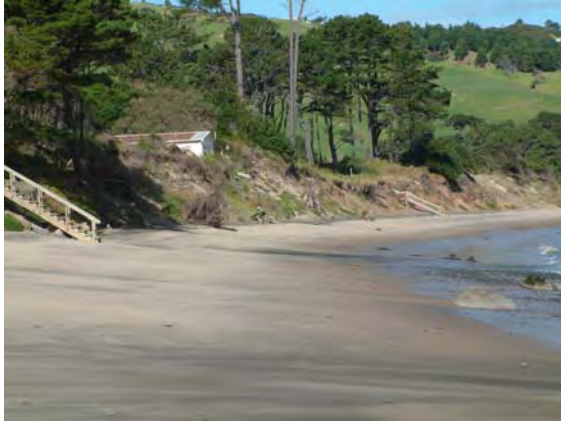
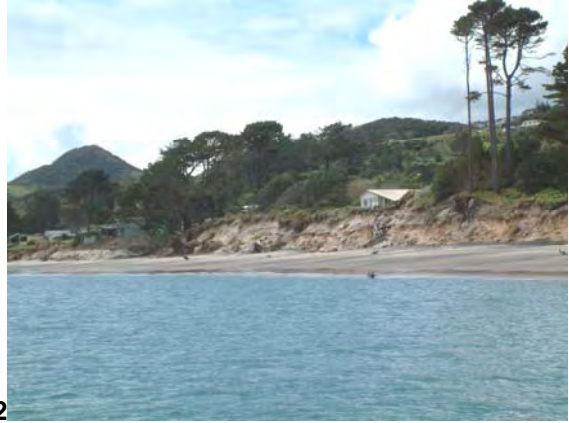
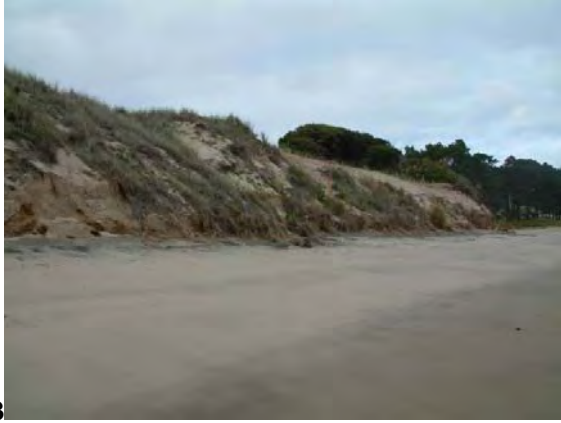
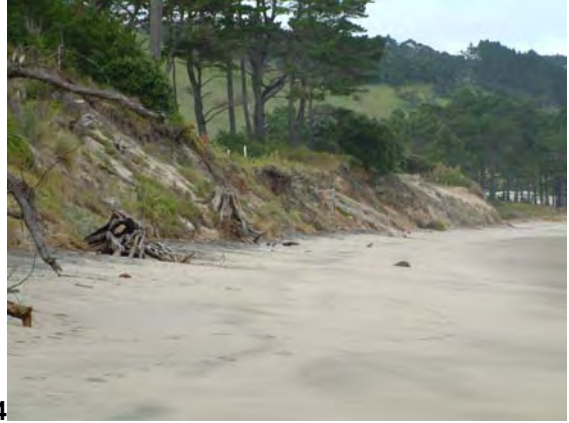
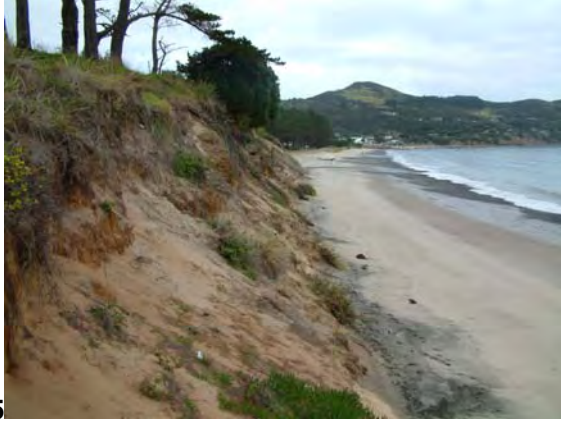
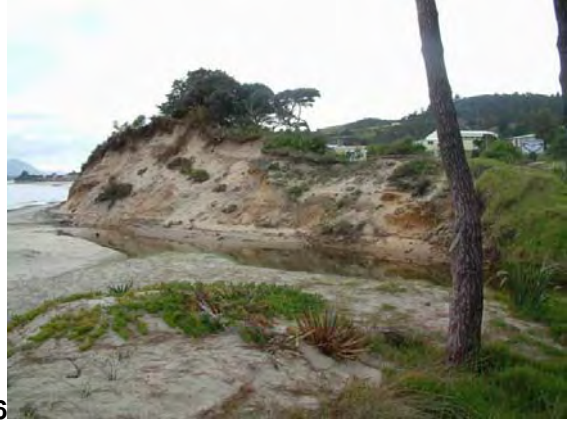
Some vegetation removal and minor reshaping could be undertaken near the top of the bank profile in parts of this site, to enable a clear area and gentle slope for planting with pingao and spinifex. In any case, the sandstone of the lower 2 – 3 metres of the bank profile should not be disturbed as this offers some resistance to erosion in areas where spinifex and pingao establishment is difficult.

Wholesale reshaping of the bank/dune is not recommended for the majority of this site, given the high elevation of the bank (approx 5 – 6 metres from toe to crest) and steep face (greater than 50 degrees). To sufficiently correct the over steep profile, some 9 – 12 metres of bank, extending from the shoreline landwards, would need to be reshaped to bring the profile face back towards 26 – 33 degrees.

Whilst replanting with spinifex and pingao is to be encouraged by property owners, as this will reduce the rate of erosion in this area, the over steep profile and steep face will continue to erode as the toe of the bank is undercut and the upper profile slumps and fails. However, spinifex and pingao establishment will aid in retention of sand at the toe of the bank and will aid in mitigating the rate of undercutting and failure and should be undertaken where this is a concern.

To the south of this site the stream is causing substantial erosion to the right (north) stream bank/dune complex (Refer Site 6 photo 6). The stream bank/dune complex is comprised of cemented sandstone and the eroded face has a slope over 50 degrees and an elevation of approximately 6 metres. This bank/dune complex will continue to erode as the stream discharge undercuts the toe and causes the over steep profile to collapse.

Site 6 photographs: Images 1 – 6 June 2008.

Realignment of the stream outlet to a location approximately 40 metres south of the existing outlet would mitigate this erosion. To achieve this, a new outlet, which could be done in the place of an old channel, could be cut through the dune/berm with a hydraulic excavator and excavated sand placed against the bank/dune complex and used to infill the old outlet. The adverse environmental effects of this realignment would likely be minor, although this could result in some impoundment of the stream waters as the flow is unlikely to be sufficient to keep the new outlet open under all flow conditions. However, this effect currently occurs at the existing outlet location and should not be too great a concern.

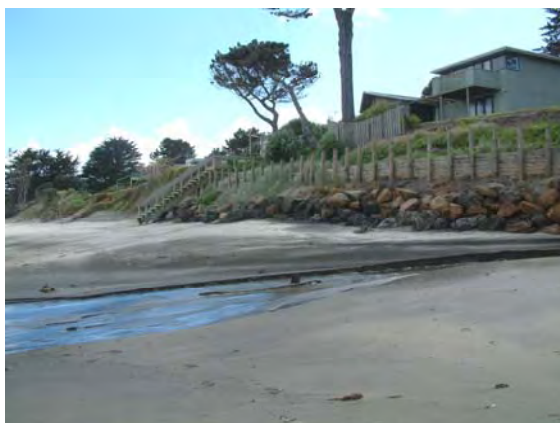
This site is protected with a seawall, hence there is no requirement for dune restoration.

1
Site 6 photograph: Images 1 June 2008.

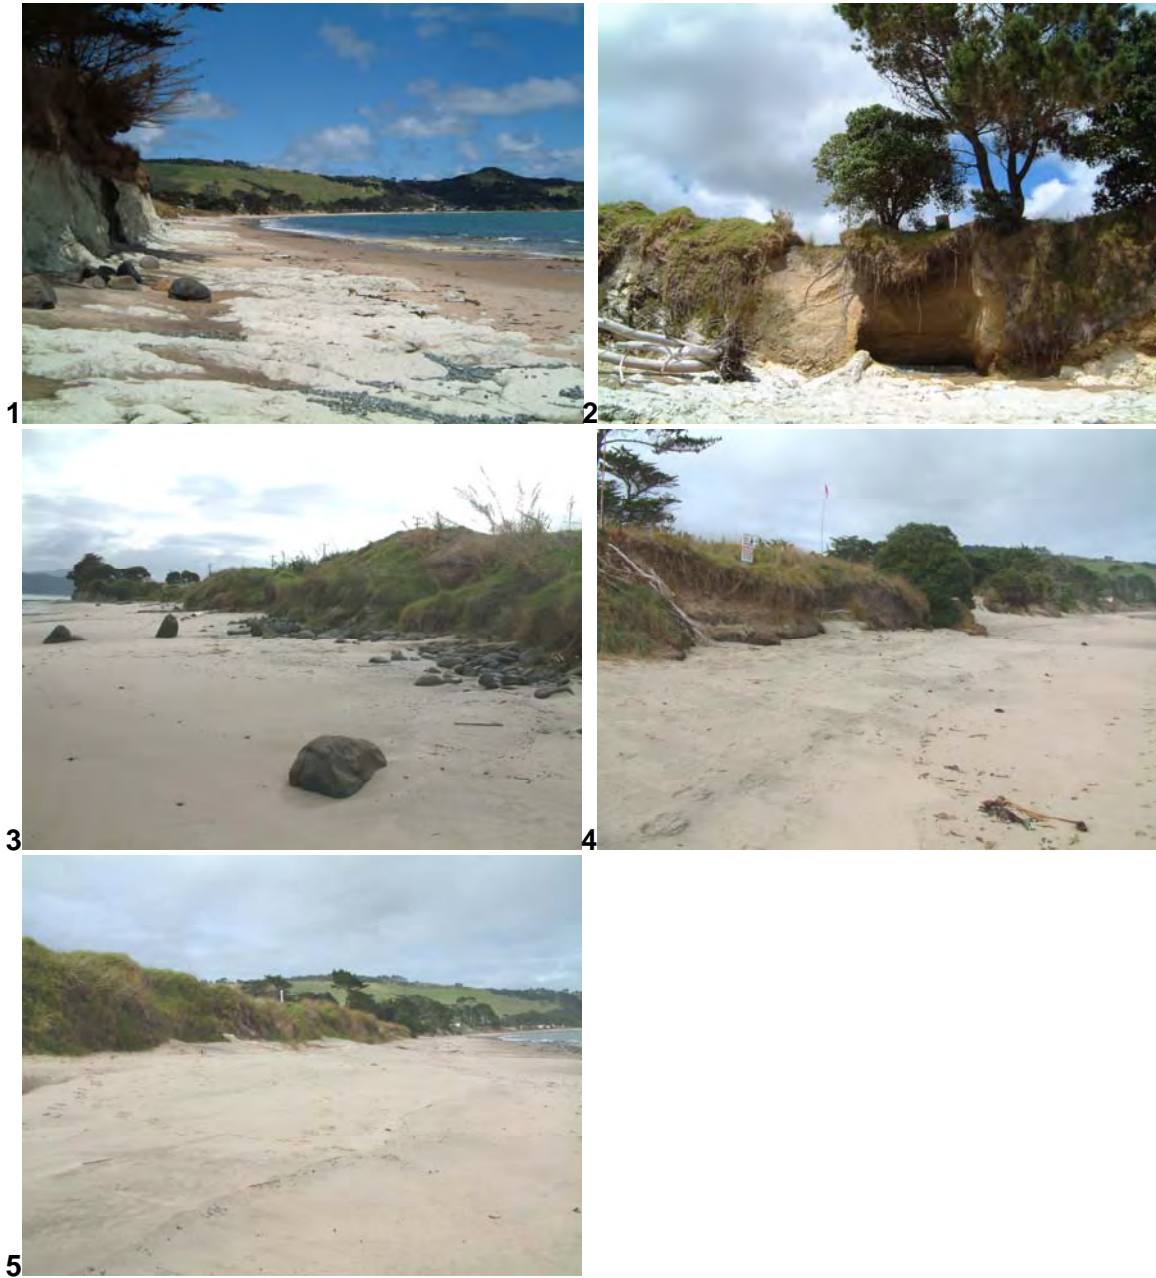
This area of foreshore is comprised of three distinct geomorphologies. The northern half of the site is comprised of mudstone cliffs and a shore platform that with a transient sand veneer, no restoration works are feasible in this part (Refer Site 9 images 1-2). Parts of the area are also protected with seawalls.

The next quarter south of this features a friable mudstone and weakly cemented sandstone layer overlain by relict dune sands (Refer Site 9 images 3-4). Restoration in this part is compromised by the underlying mudstone and the close proximity of shoreline to road, and restoration is therefore not recommended.

The southern quarter of this site appears to be mostly comprised of dune sands, however patches of mudstone were apparent which would need to be investigated further prior to proceeding with any restoration in this area (Refer Site 9 image 5). Nevertheless, restoration of this southern area could be undertaken in the form of reshaping and planting with pingao and spinifex and should be considered in the future to enable continuation of the dune restoration recommended for site 8.

Site 9 photographs: Images 1-5 circa 2004 and June 2008.

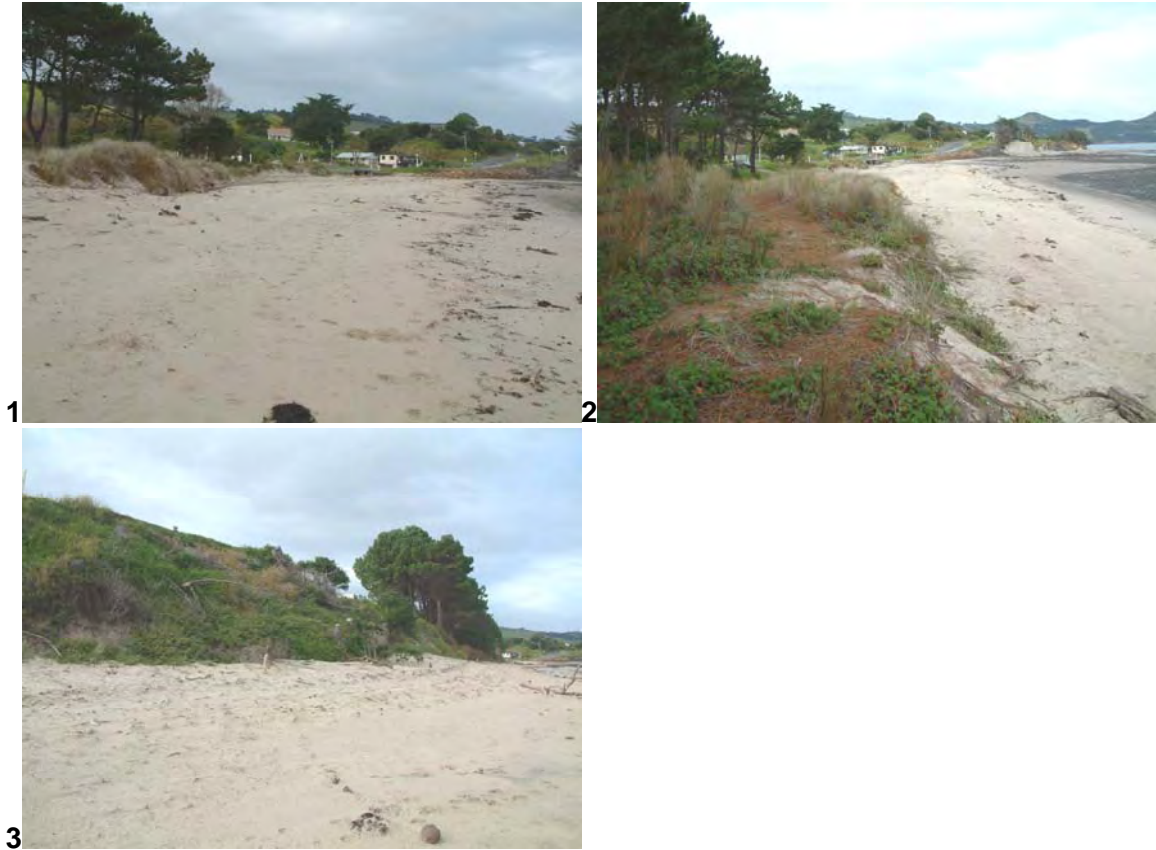
The stability of the foreshore in the south half of this site is predominantly influenced by the Waiarohia Stream outlet, which meanders northwards on occasions causing erosion of the shoreline and dune and impacting on sediment supply to the north half of the site. Restoration is not recommended in the south half of this site due to the influence of the Waiarohia Stream and the fact that no dwellings or infrastructure are at immediate risk if the area erodes. However, removal of the pine trees and enhancement of the back dune area by replanting with spinifex and pingao would aid in enabling dune recovery following episodes of erosion.

In the north half of this site the foreshore is comprised of a large transient sand berm which banks onto a steep dune relict. The heavy vegetation on the dune face in this area indicates that this area has been stable in recent times, however the steep profile indicates substantial past erosion events. Reshaping of the bank in this area is not recommended due to the height of the bank (< 6 metres) and steep bank face, meaning that any reshaping would encroach upon the location of the dwellings that are located close to the top of the bank. Nevertheless, successful vegetation of the transient berm fronting the bank would aid in stabilising the bank toe and may enable formation of an incipient dune if the pingao and spinifex were to successfully establish over a period of several years if only minor erosion episodes occur.

Site 10 photographs: Images 1-3 June 2008.

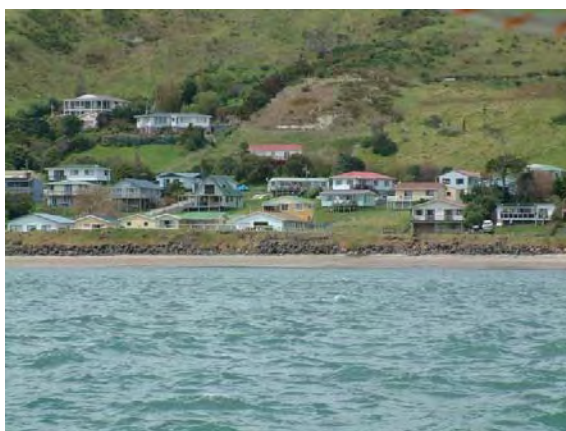
The shoreline in this site is located in close proximity to the road, and is for the most part protected with rock sea walls. No restoration works are recommended for this area of shoreline.

Site 11 photograph: Image 1 October 2005.

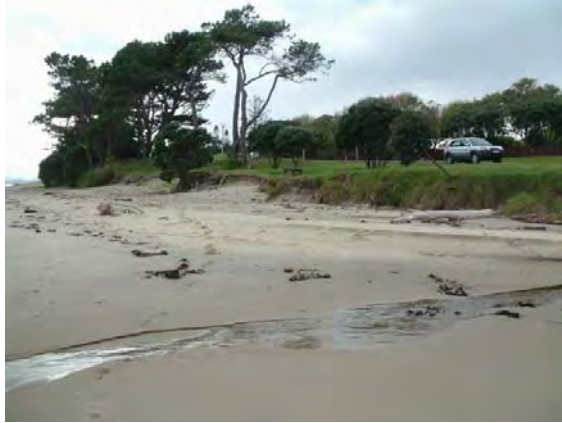
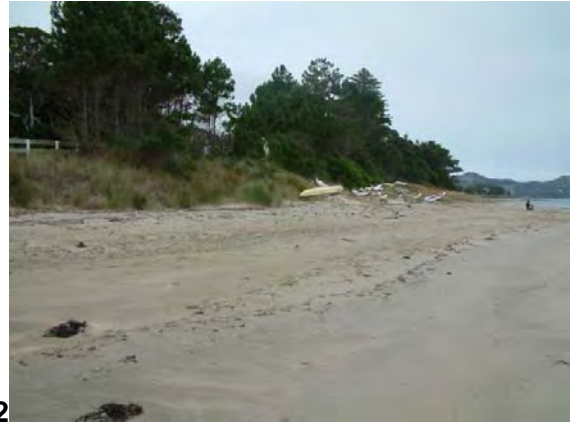
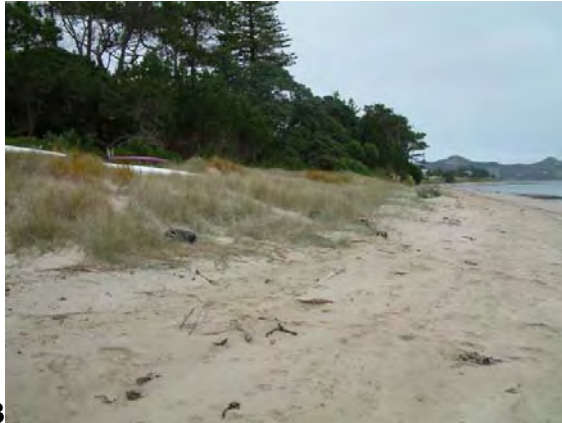
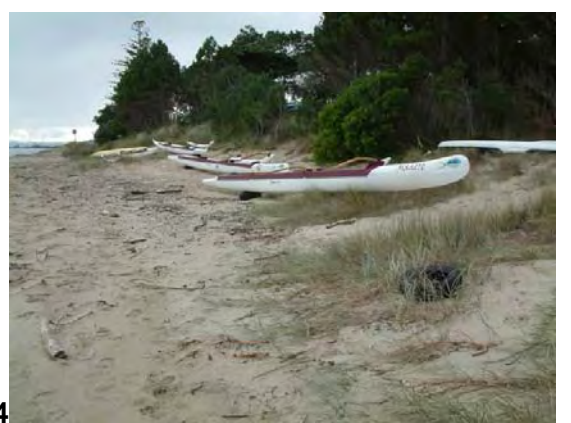
The mid-south extent of this site features a well vegetated incipient dune and no restoration is recommended in this part of the site. Restoration could be undertaken at the very southern extent of this site and would require reshaping of the eroded bank and revegetation of the first 2 – 4 metres of the bank with pingao and spinifex. However, as no infrastructure or dwellings are immediately at risk from erosion in this area, this is not seen as an immediate priority for restoration.

Site 12 photographs: Images 1-4 June 2008.

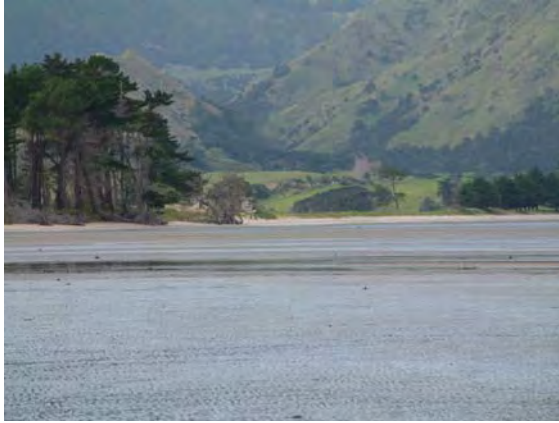
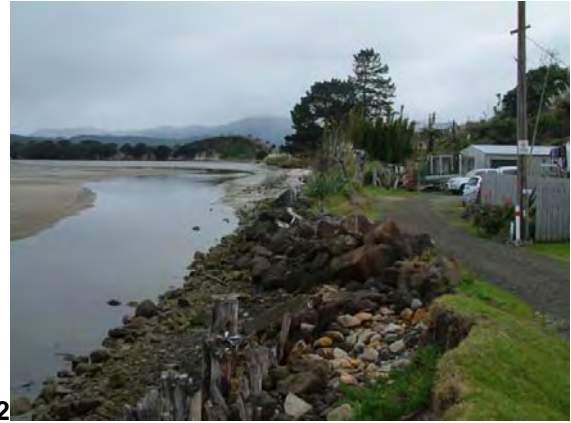
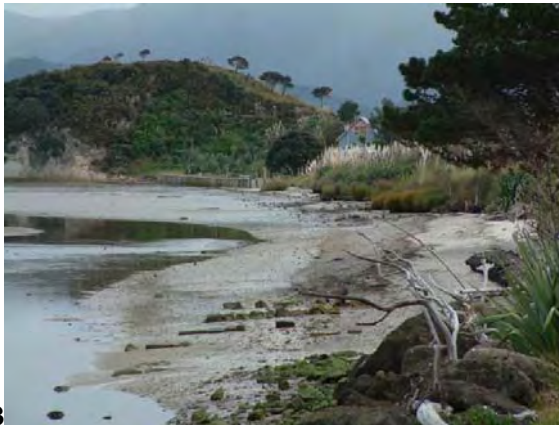
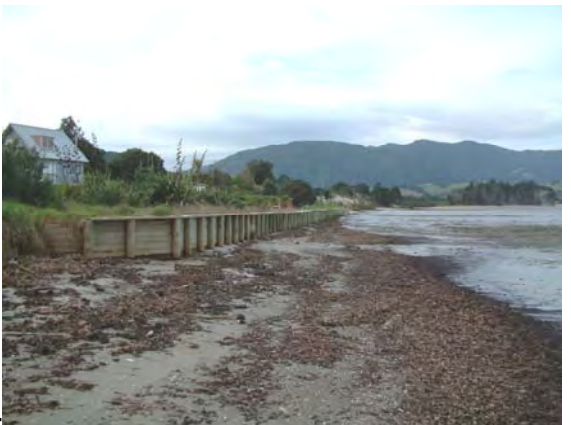
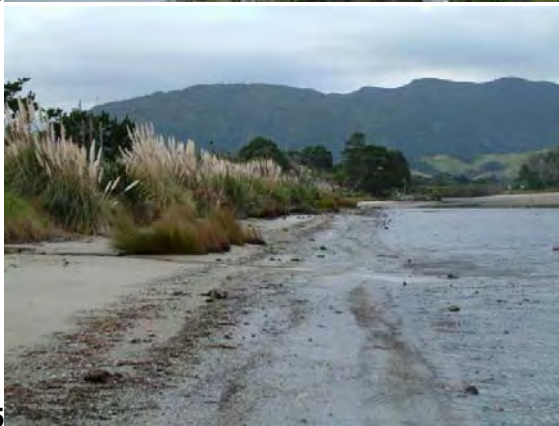
The Koutu shoreline is comprised of two distinct geomorphologies. In the area north of the Koutu estuary the shoreline is comprised of a weakly cemented mudstone or soil backed by mixed vegetation. No restoration is recommended in this area as there is insufficient sand or suitable dune relict. The area within the estuary is similar in character and a derelict seawall is located between the road and the dwellings. The estuary spit is comprised of sand, and whilst restoration may be feasible in this location, it is not recommended as the area is currently grazed by cattle and there appears to be little risk, if any, to dwellings (although one dwelling appears to be located close to the shoreline).

Site 13 photographs: Images 1-5 June 2008.
