# Poplar windthrow following Cyclone Gabrielle

Date: 1 April 2023 Author: John Ballinger, Dean Satchell, Simon Webb

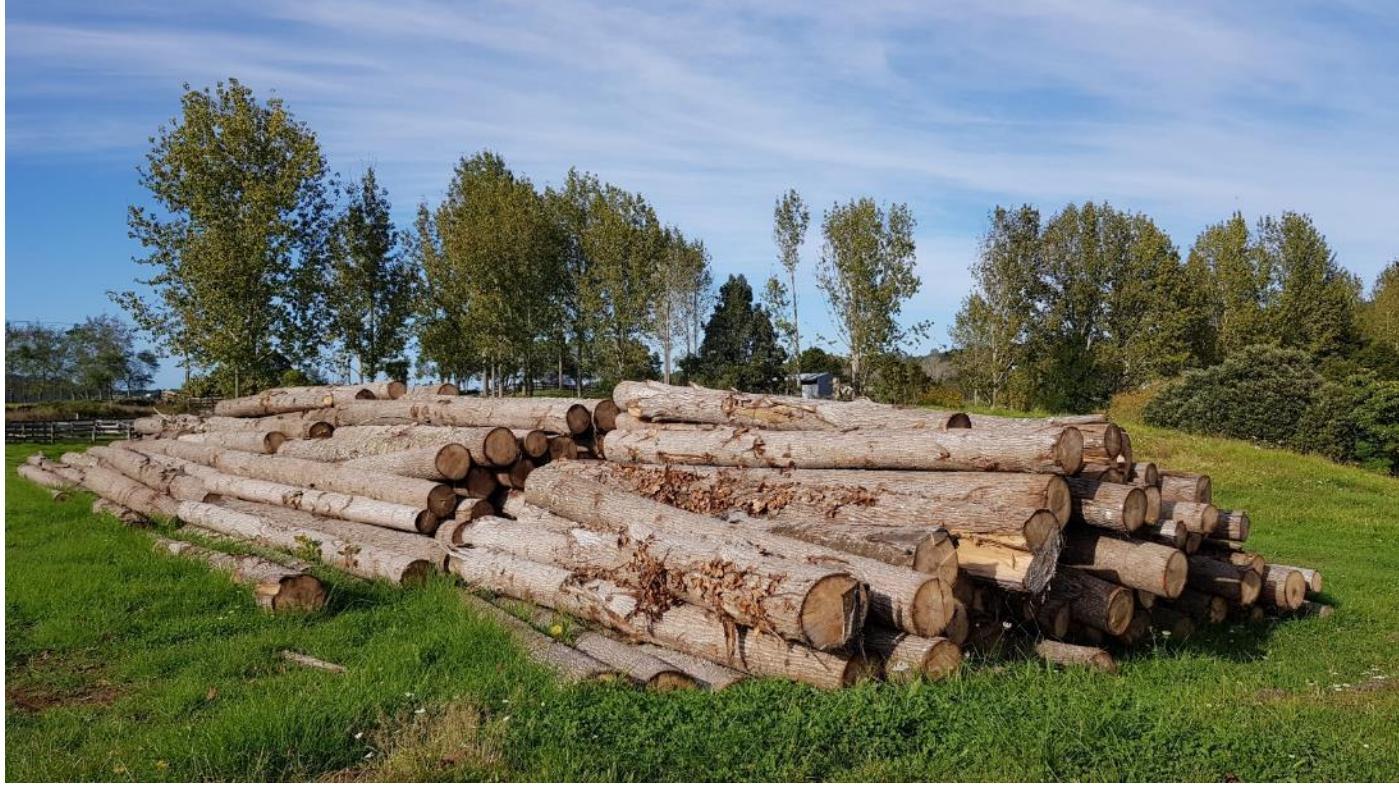
This Kawa poplar plantation suffered extensive toppling with 180 of the 220 planted blowing over (82% loss). The initial SE wind toppled 12 trees, then when it switched to the SW the rest of the trees came down. Even though the soil type is well drained, it was saturated during the cyclone. It was noted that poplars with poor form and of unknown parentage growing on the same soil on a neighbouring property did not suffer from windthrow. However, this could be a result of variations in wind tumbling/turbulence rather than a difference between clones.

Kawa logs from toppled trees.

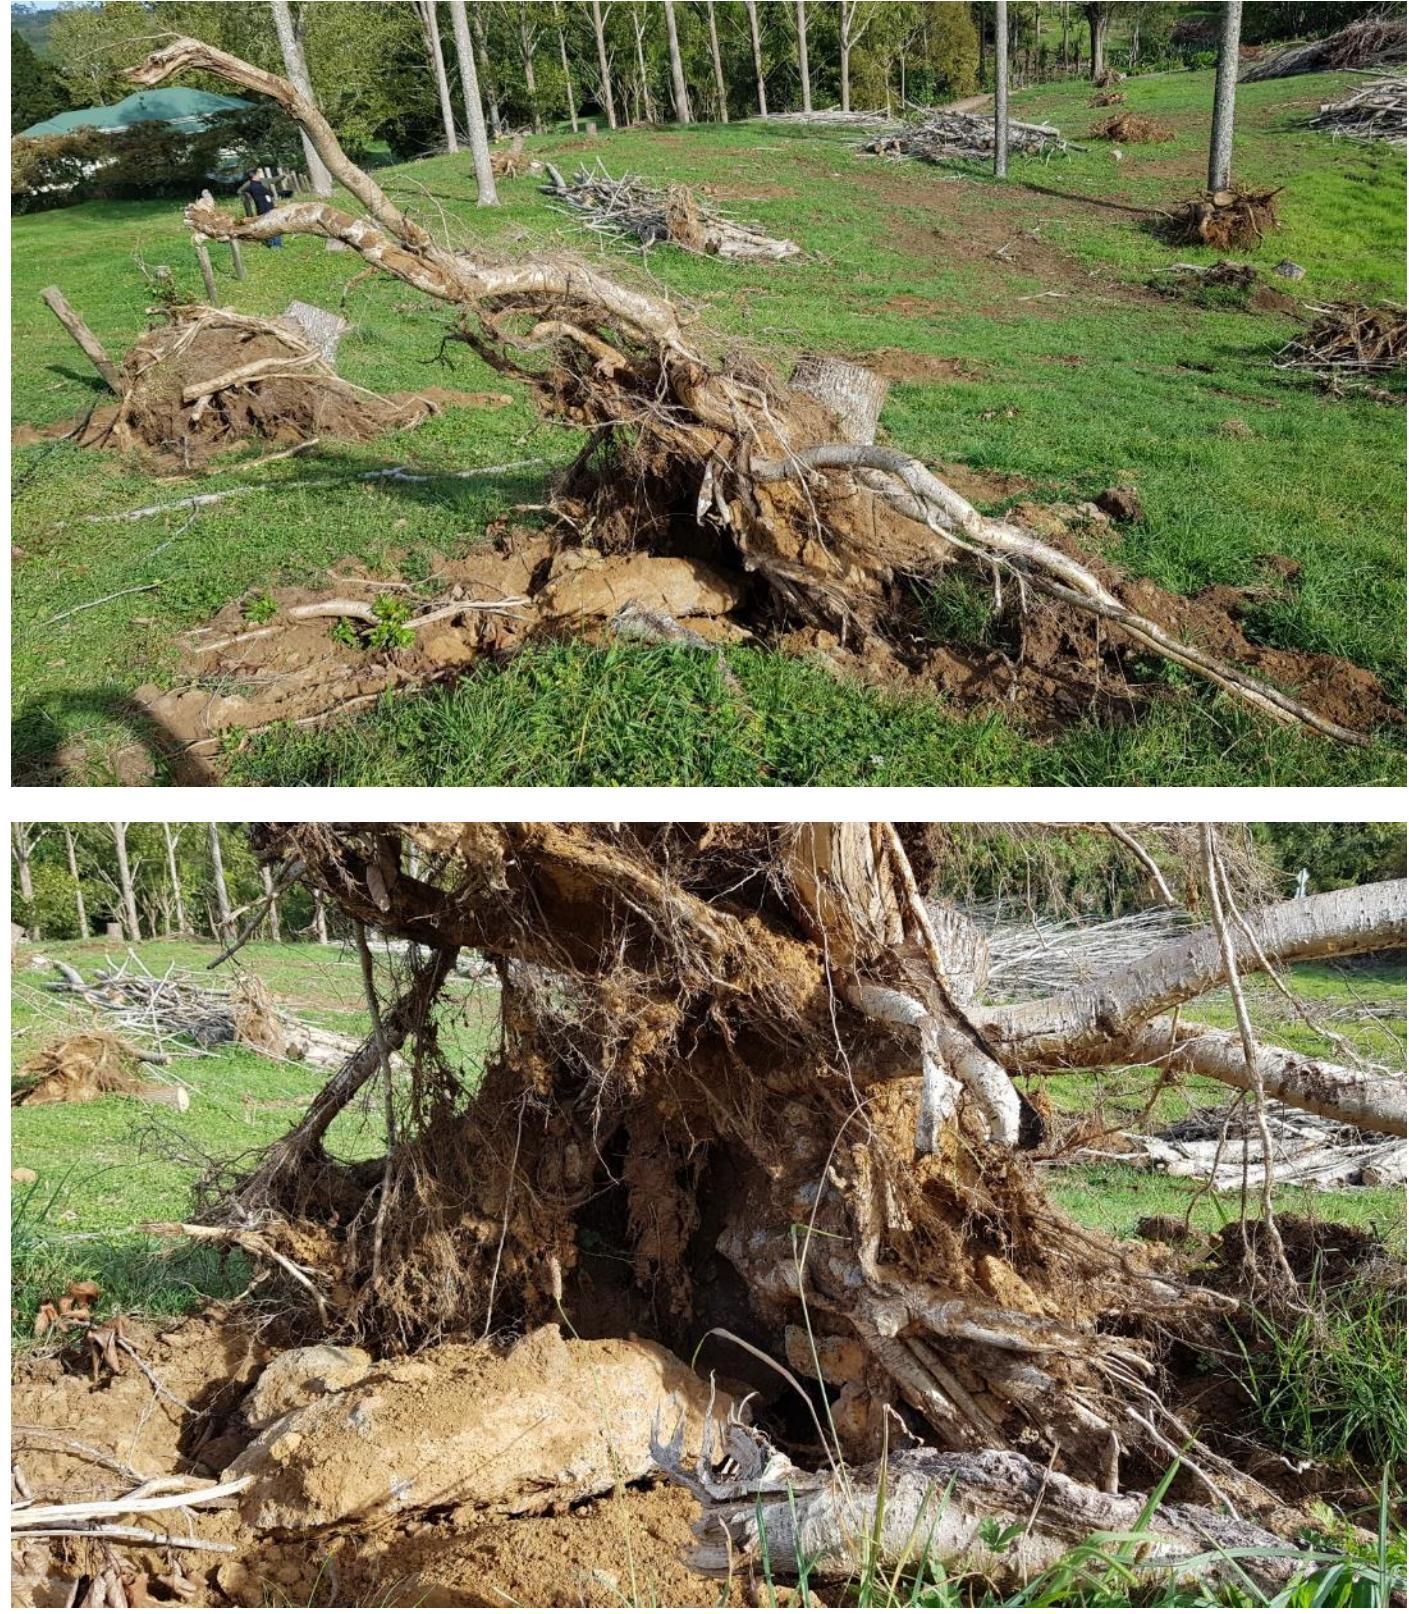
This site consisted of 220 Kawa *P. deltoides × yunnanensis* planted as poles approximately 25 years ago. These trees were planted at 7m x 7m spacing and had been pruned to create a 6m butt log free of branches, with no thinning. The soil is Ohaeawai shallow bouldery silt loam, a young volcanic clay with good drainage but has large boulders near the surface, being on the edge of a lava flow. Observations of upturned root plates showed that the tree roots had some distortion having struggled to penetrate deeply into the soil due to the presence of the boulders near the surface.

Root plate showing no taproot and some root distortion due to large boulders.

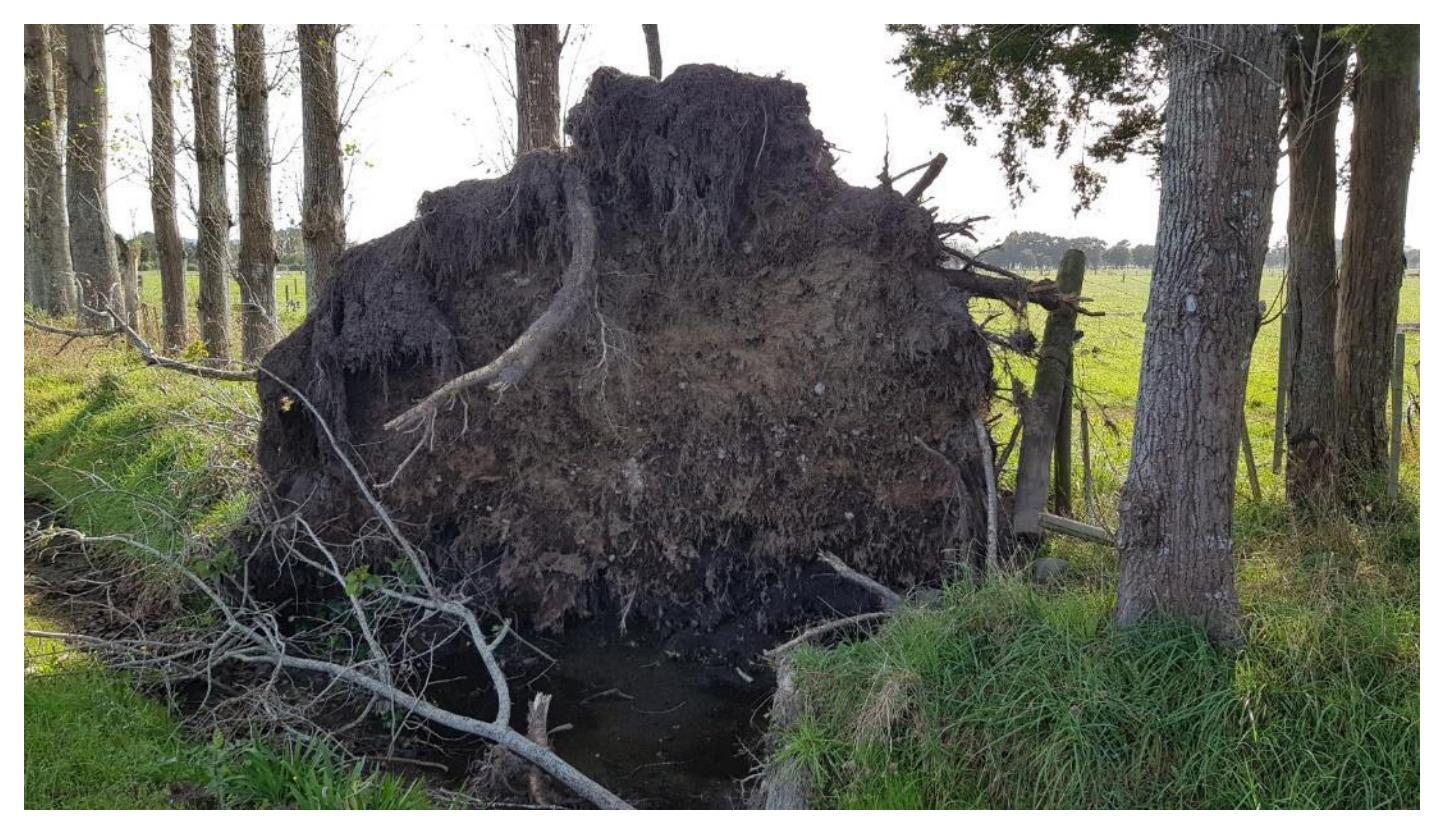
A short drive down Tokiri road found little toppling. Some old Italian hybrids planted as a shelterbelt along a drain approximately 50 years ago had come down (approx. 2%). The high-water table and resulting low soil strength probably contributed to the toppling, along with the trees being immediately adjacent to a drain. It was noted that a Kawa shelterbelt nearby had suffered no windthrow.

Old Italian hybrid root plate with standing water underneath due to the presence of a drain.

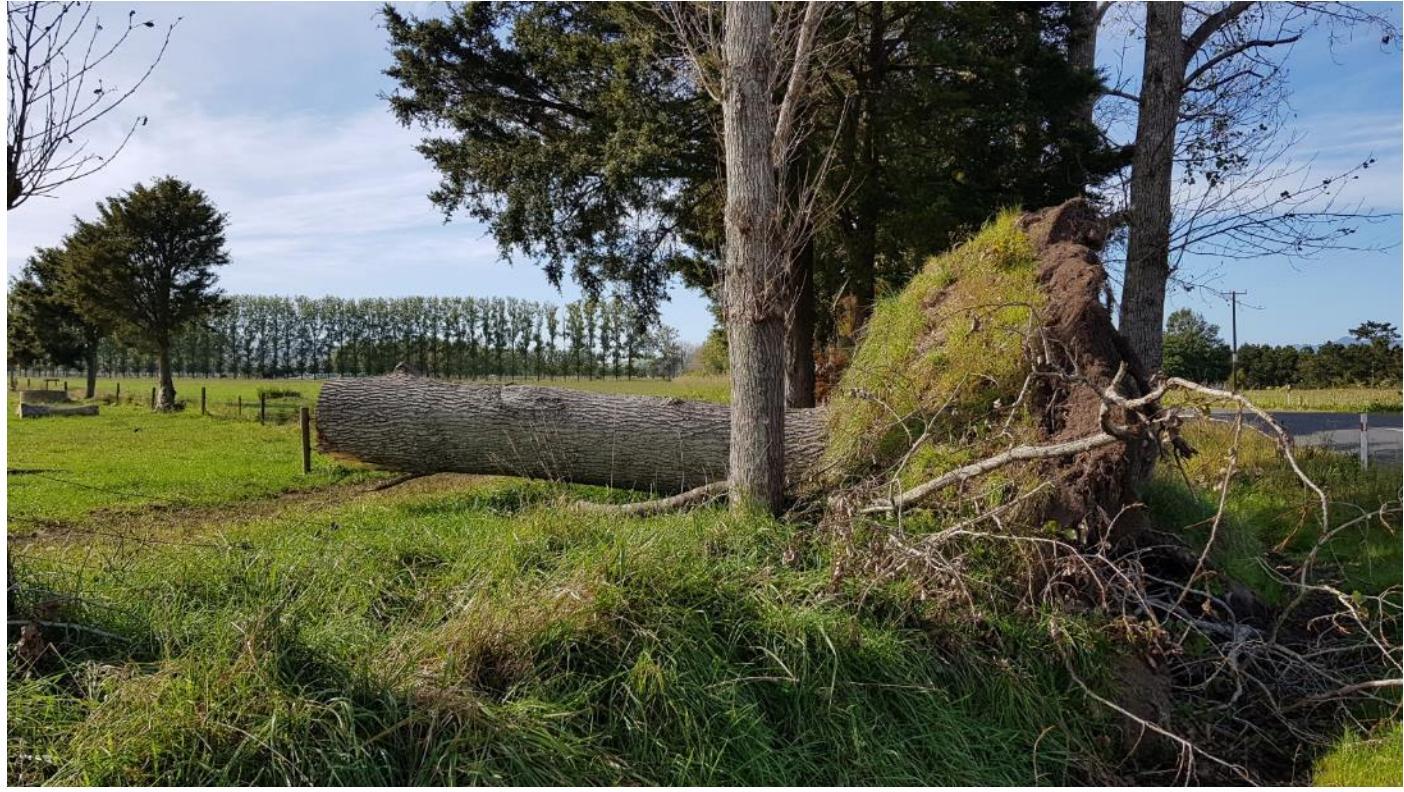
Fallen tree with unaffected Kawa shelterbelt in the background.

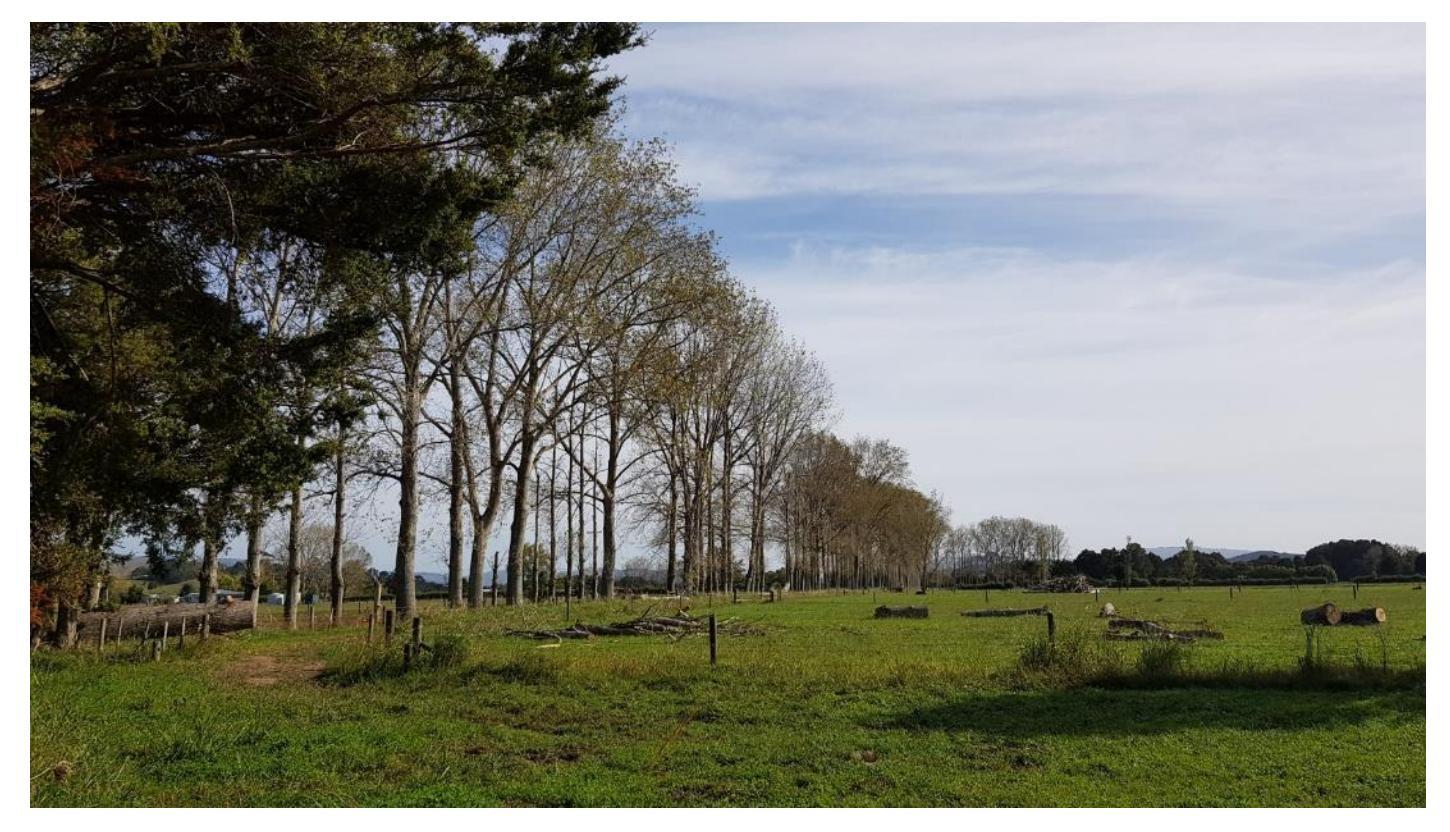
Old shelterbelt made up of Italian hybrids with fallen tree in foreground.

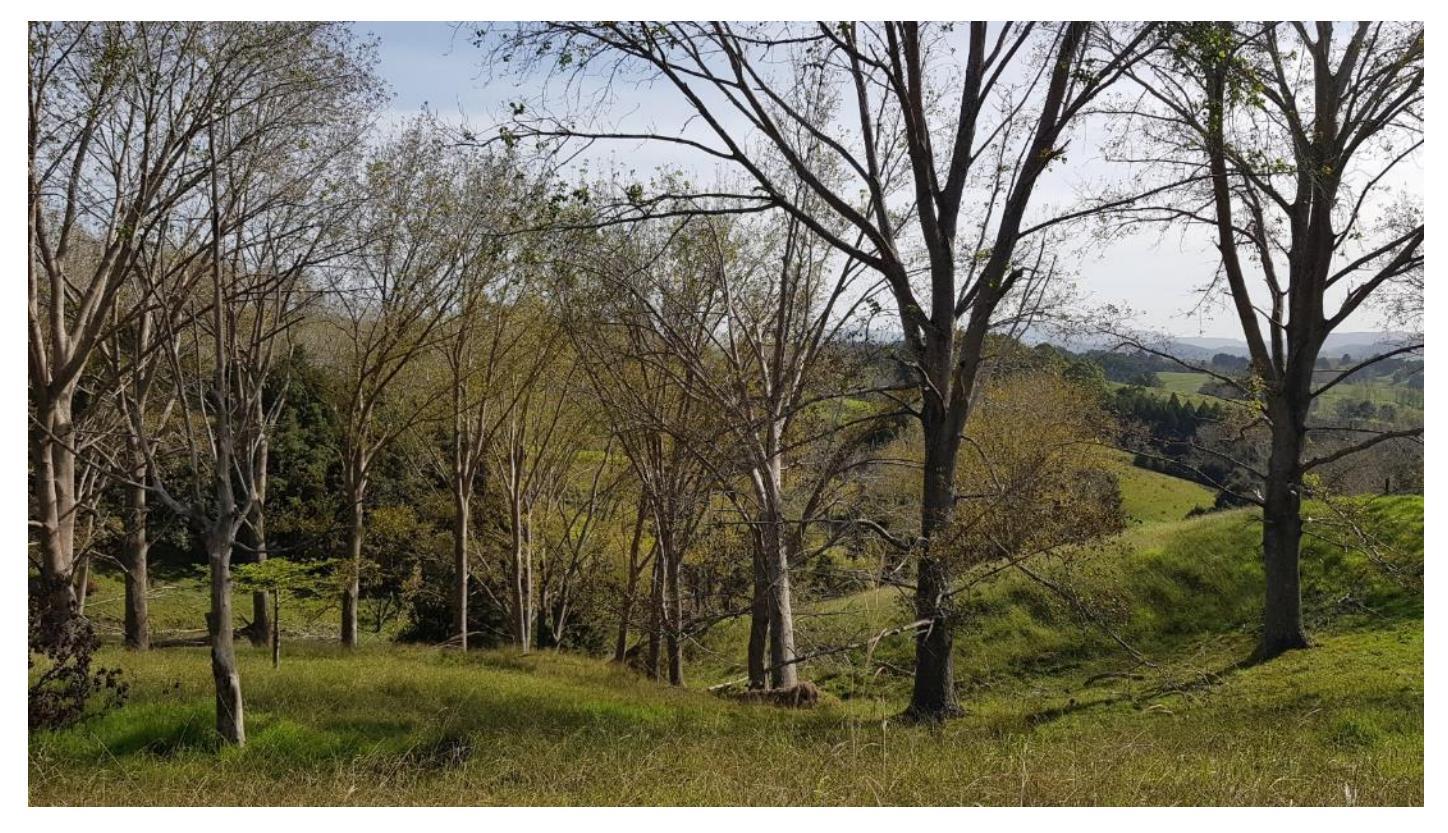
Soil type is Waiotira clay loam which is a young sandstone soil prone to tunnel gullying. Old tunnel gullies were planted with Italian hybrids, estimated to be 50+ years old. Approximately 15% have toppled. These were mature trees nearing the end of their useful life, with some having fallen prior to the cyclone. Despite the toppling, the trees have done their job very well, with no obvious signs of the tunnel gullies they were planted to treat.

Mature Italian hybrids planted some 50 years ago to treat tunnel gullies.

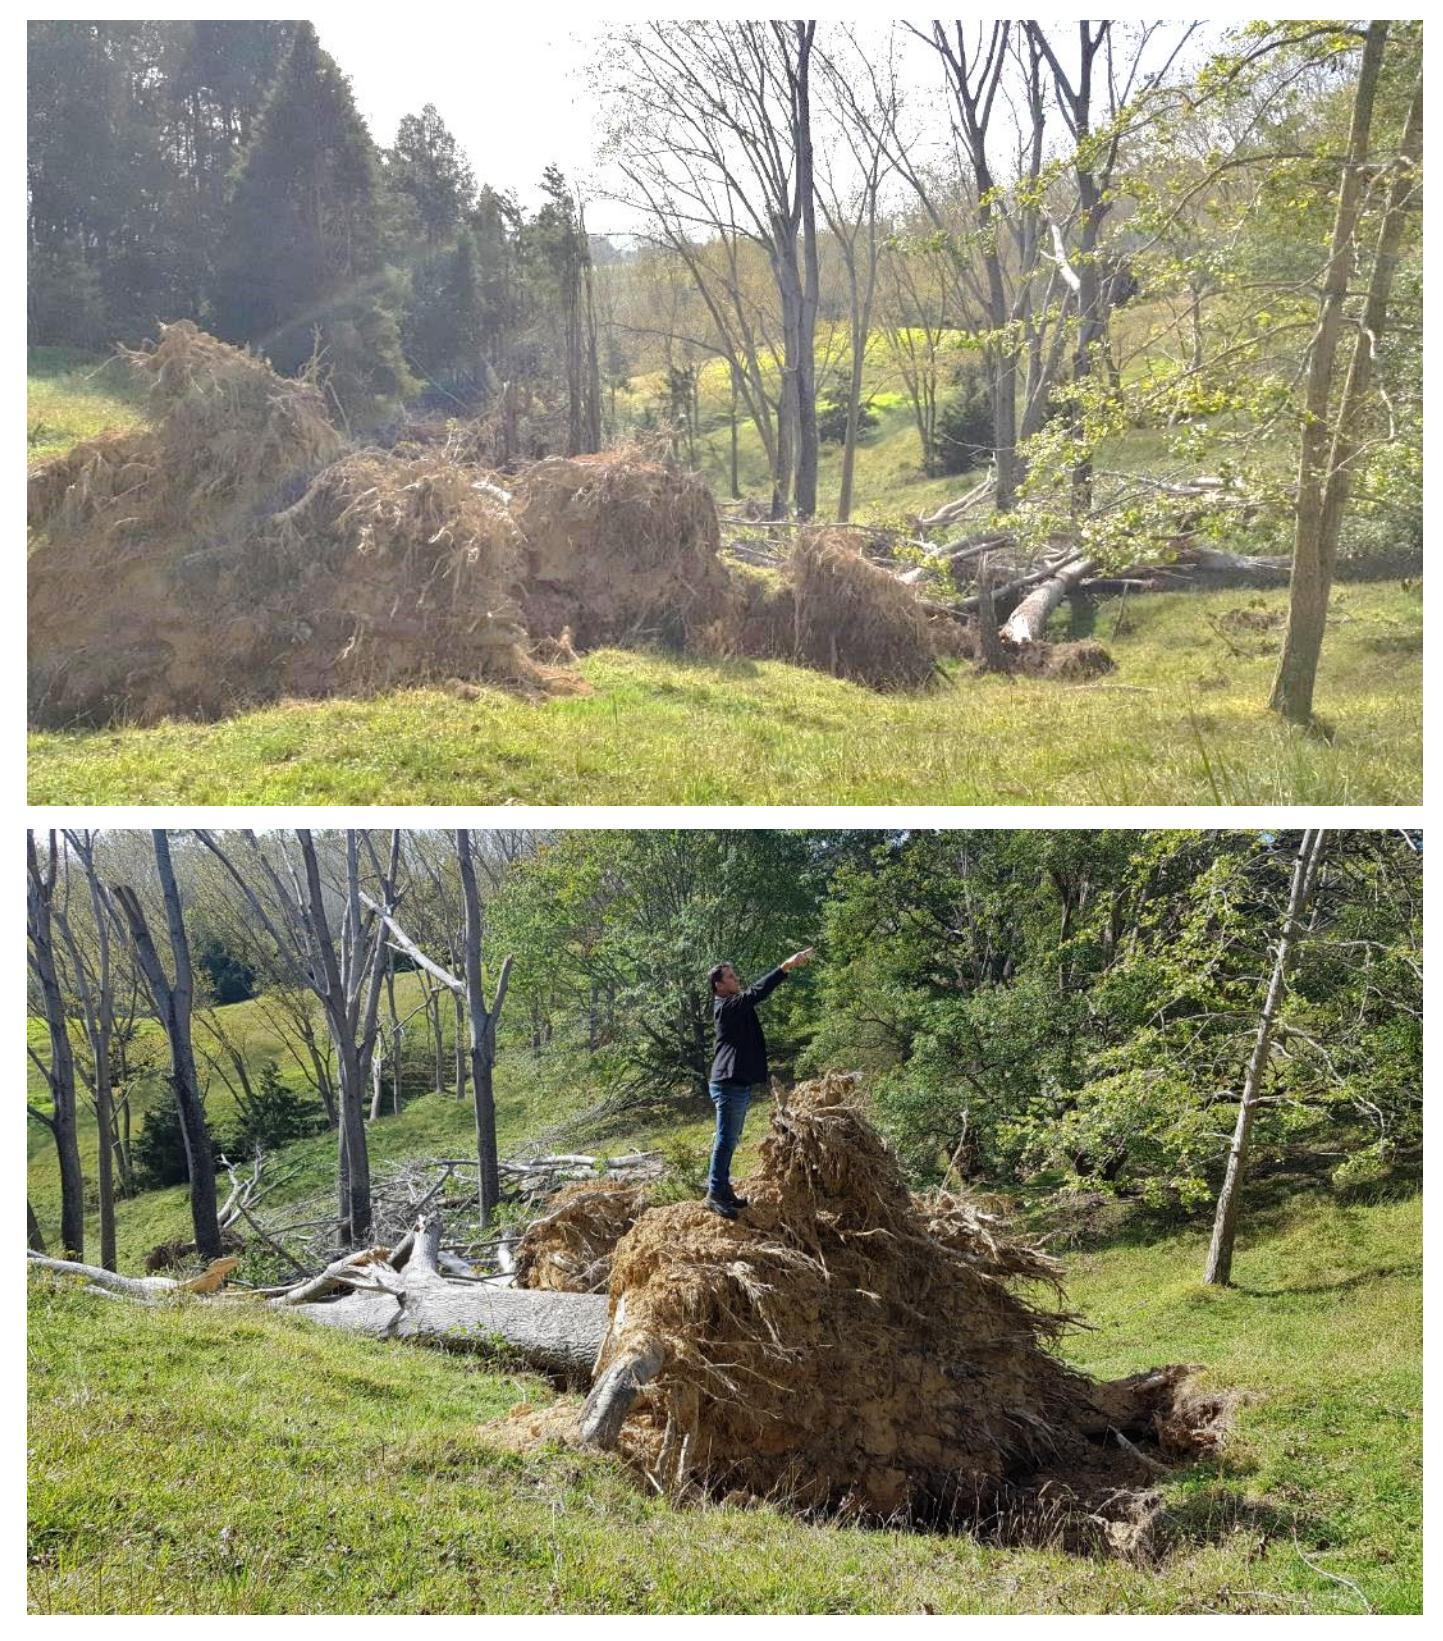
Most of the hybrids that toppled were more exposed near the top of the gully.

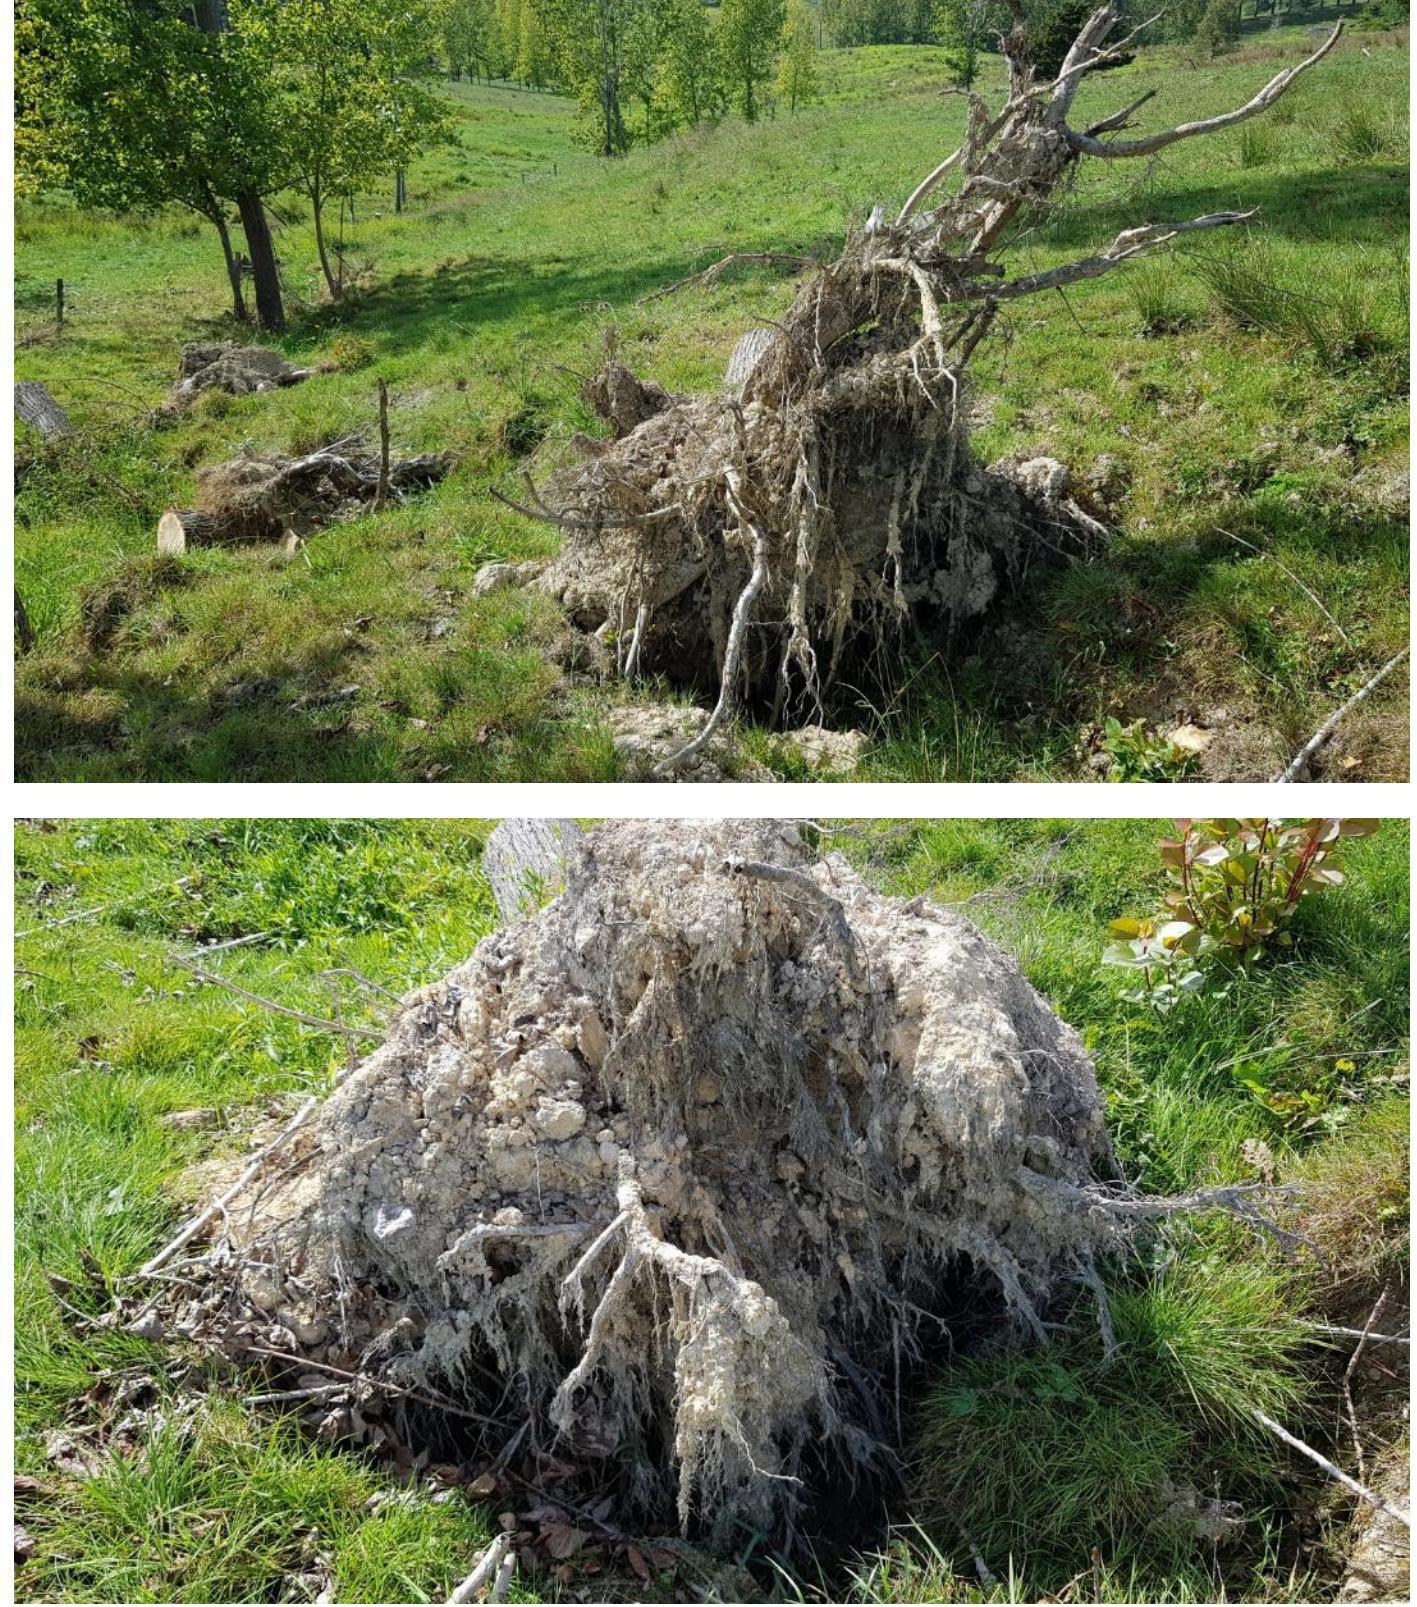
On the same farm but in a different location, more tunnel gullies planted with Kawa poplar, estimated to be 15 years old. Between 40-50% have toppled. The trees were pruned with epicormic growth and the root plates show more plunging roots compared to the Kawa planted at Maungatapere, but the root plate was still small. While the trees were planted on the mid-slope, they were very exposed to the extreme SW winds that did the most damage. A shelterbelt of older *p. radiata* adjacent to the poplars suffered no windthrow.

Some toppling of Kawa in active tunnel gullies. More plunging roots than Maungatapere but root plate quite small.

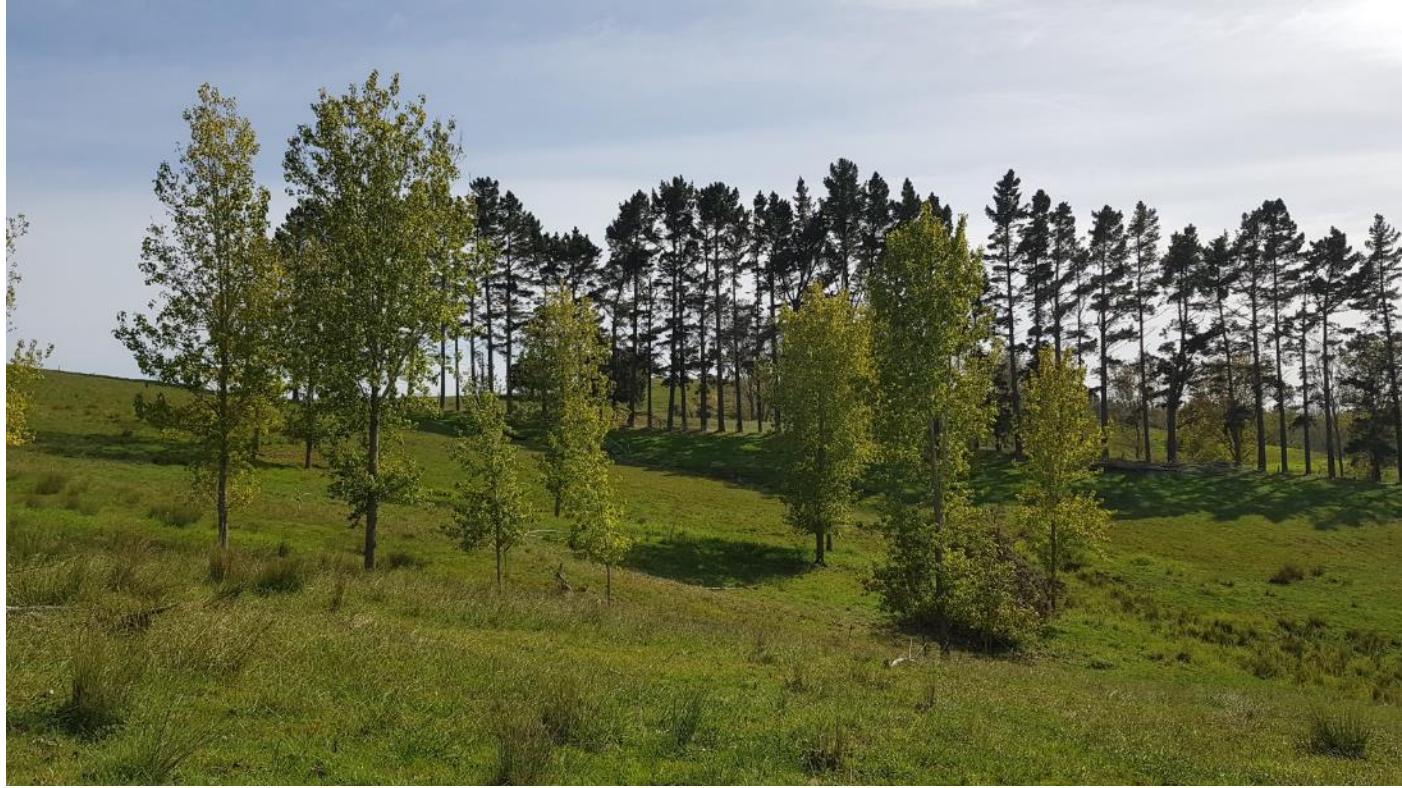
15-year-old Kawa still standing. The toppled Kawa was further downslope. Note the radiata shelterbelt in the background was unaffected by the cyclone.

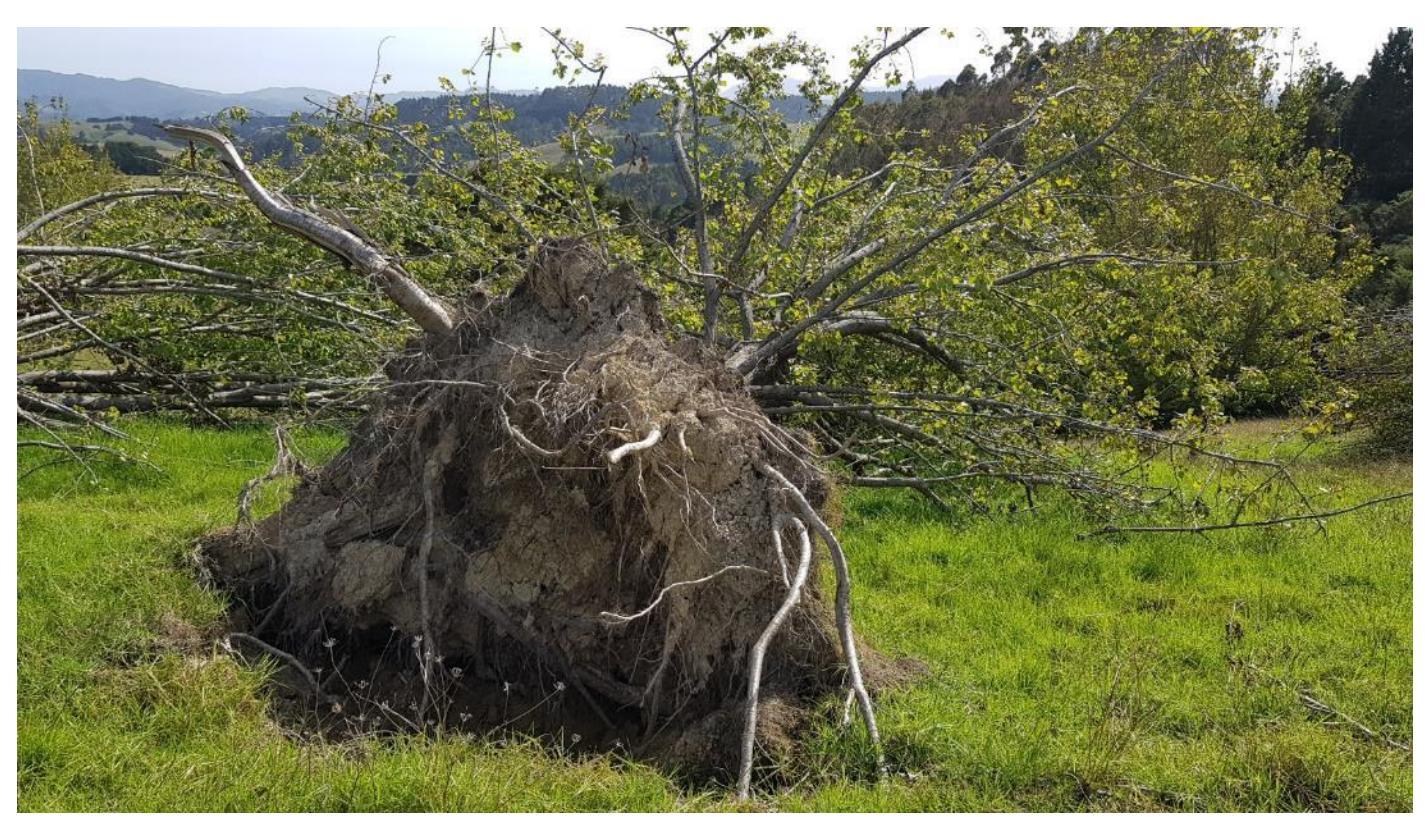
Root plates of older Kawa on a neighbouring farm. These trees were very exposed to the SW.

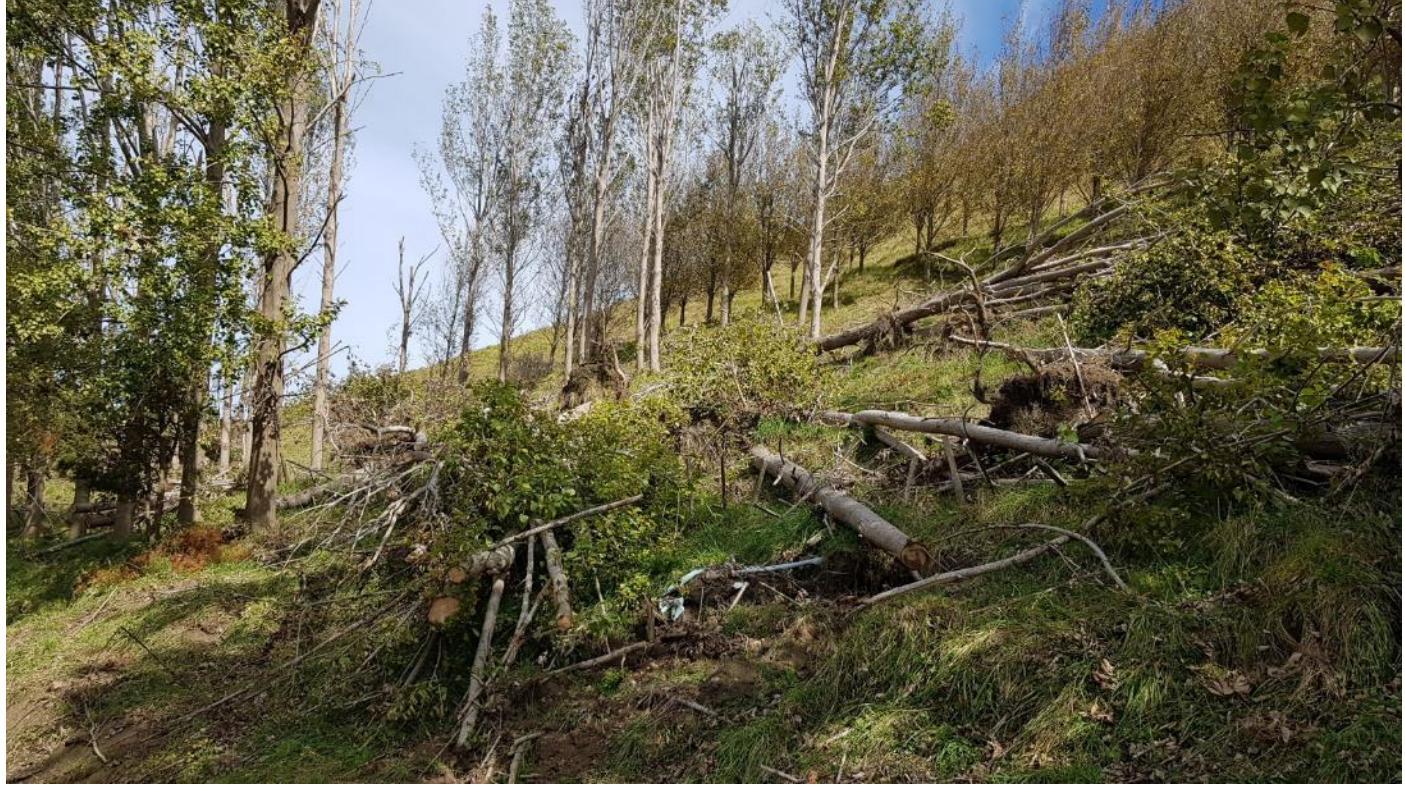
Situated on the flanks of Mt Houto in an extremely exposed location. Soil type Takitu gravelly clay loam, a young semi volcanic soil that is naturally fertile, but particularly prone to shallow and deep-seated slipping. Two clones of poplar were planted on an active slip above the road. Kawa were planted at 7-8m spacing at the base of the slip and grew tall and toppled. Another clone, possibly Veronese *P. x euramericana* was planted at the top and adjacent to the slip and remarkably suffered little windthrow, although they were smaller than the Kawa. It's estimated the trees were planted 20 years ago.

Near complete loss of Kawa in foreground, with shorter more resilient clone in background.

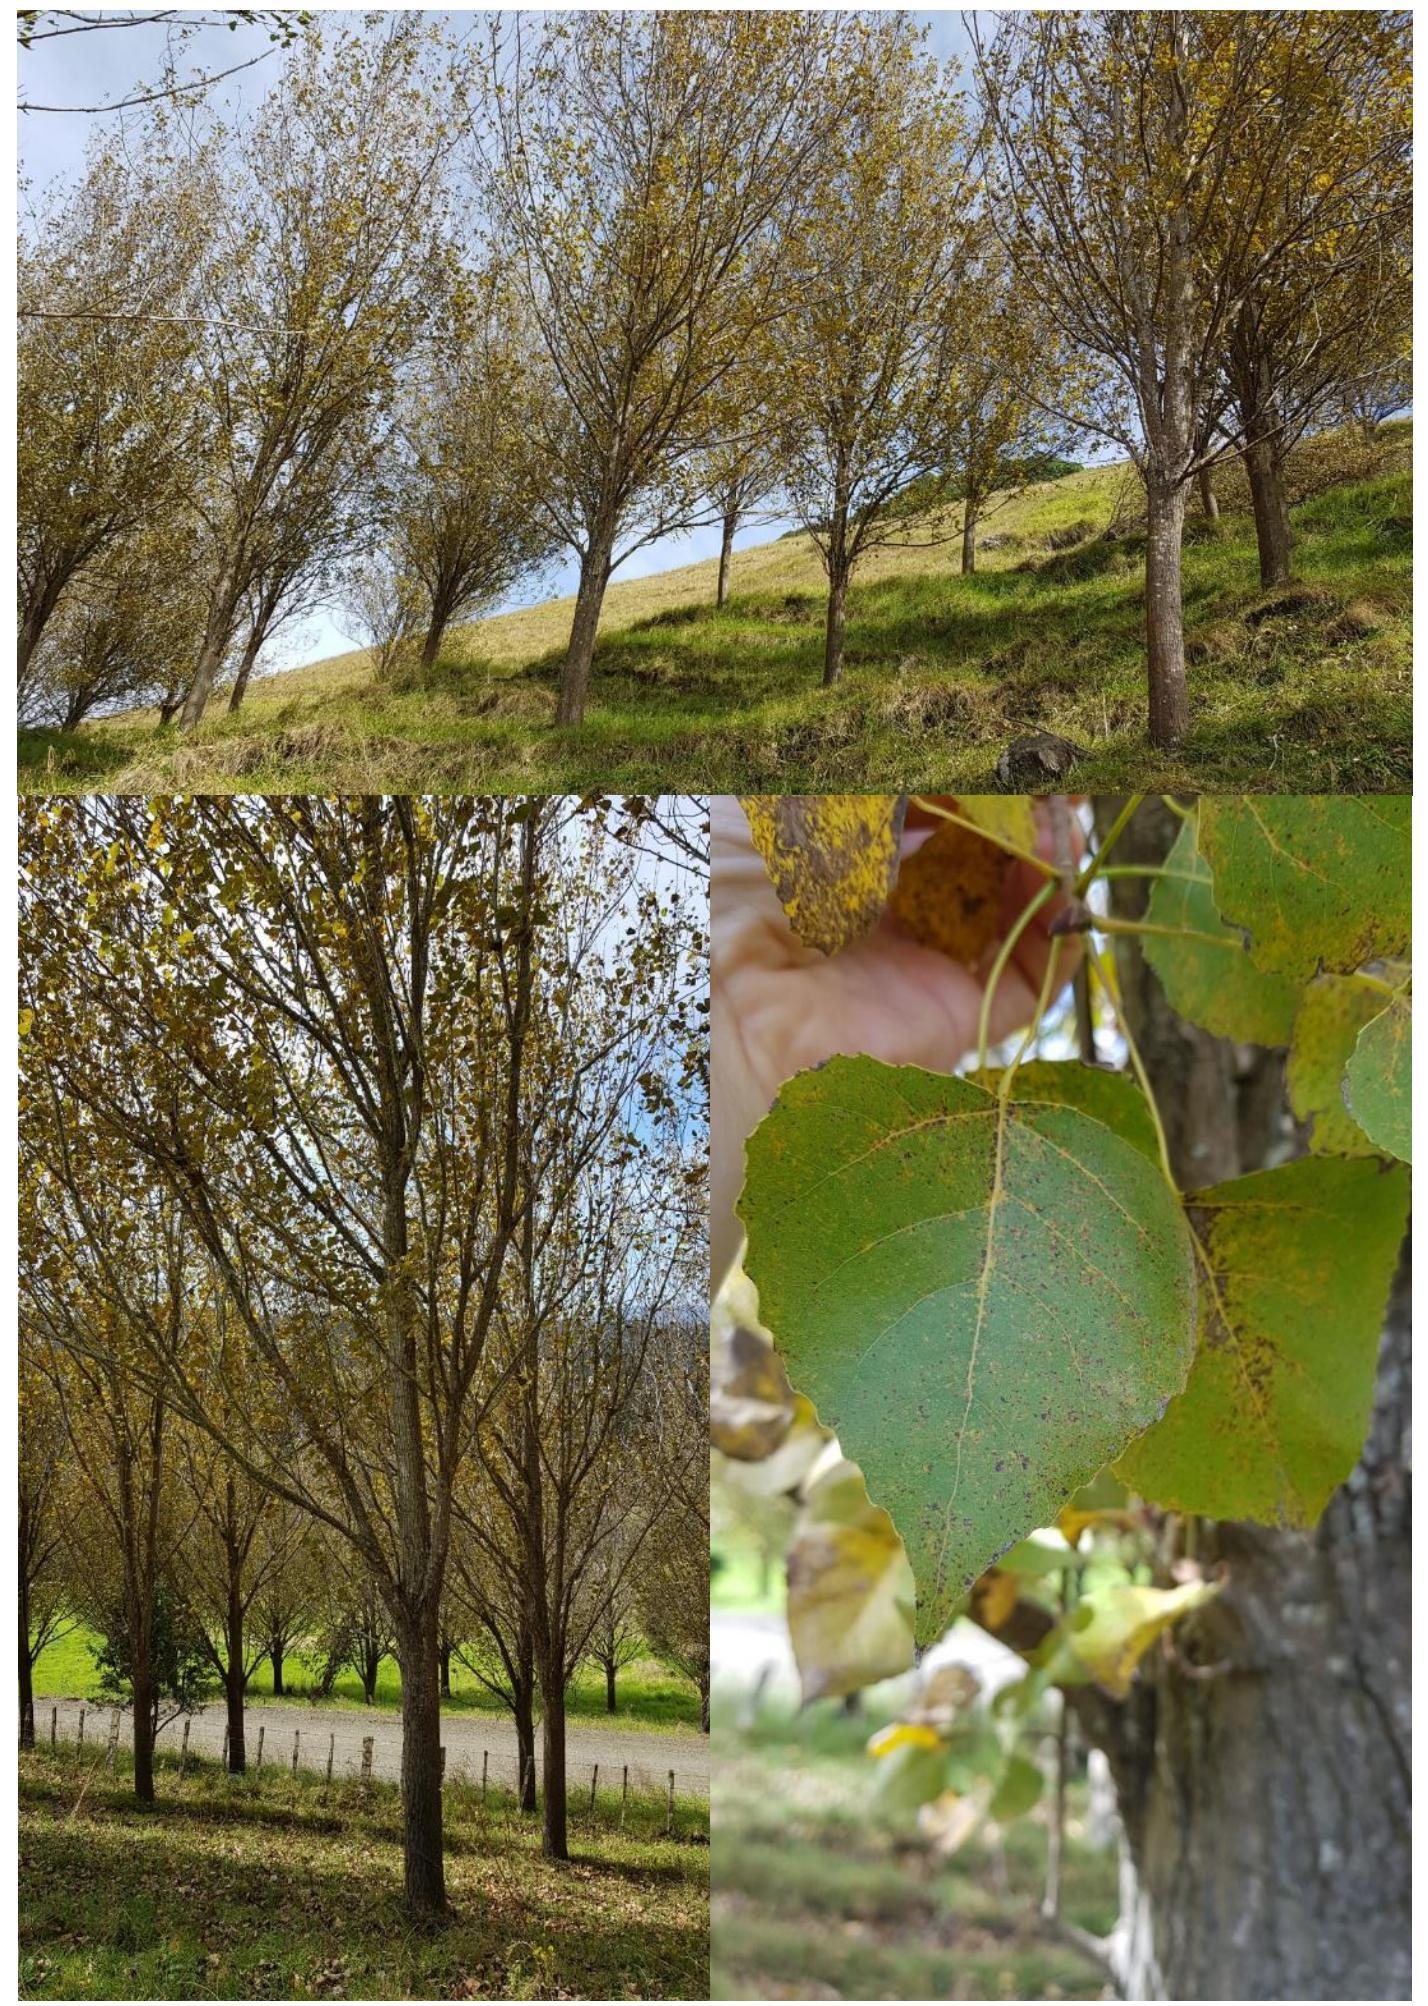
Clone (possibly Veronese) planted above and adjacent to the slip. Note form and leaf shape.

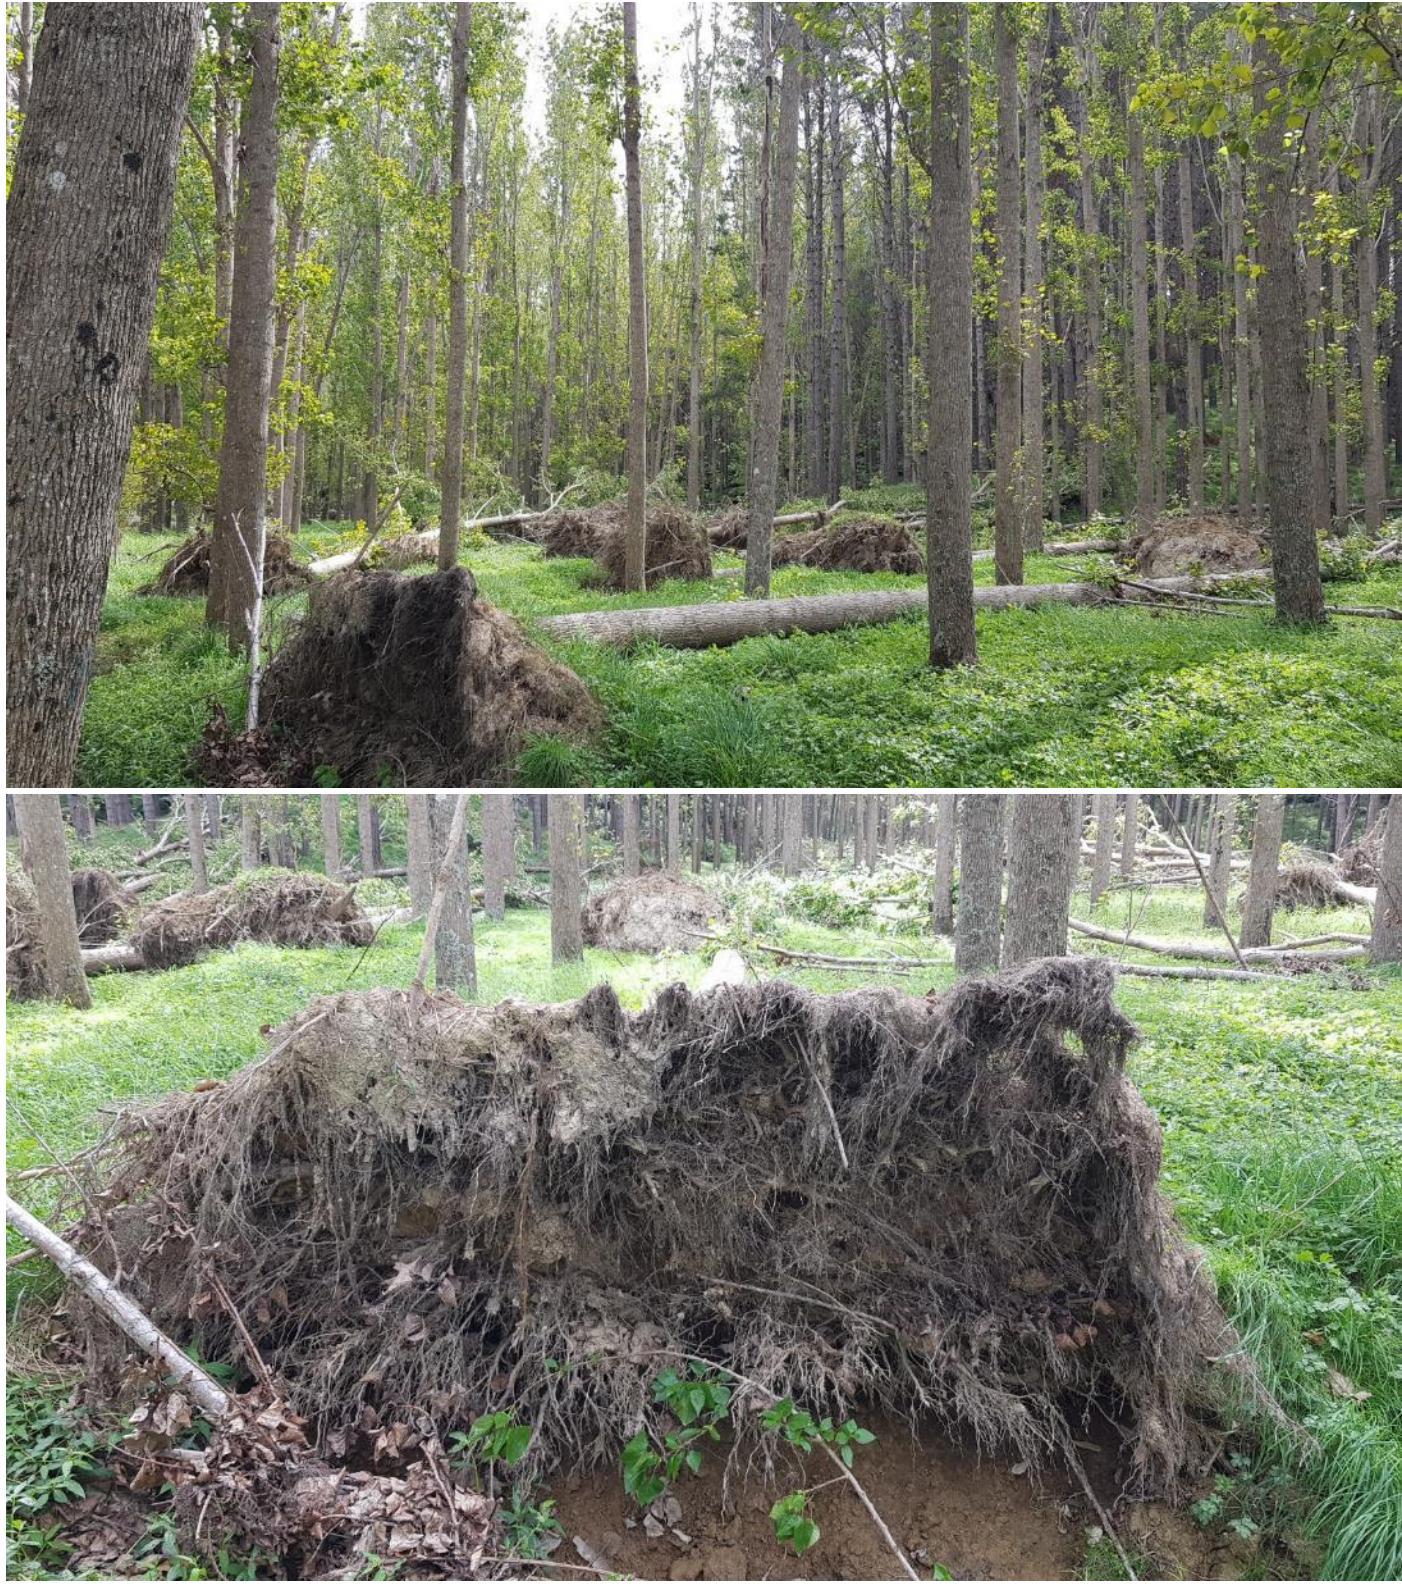
Kawa woodlot planted on the wet valley floor at 5m x 5m spacing and pruned. Radiata was planted on the hill. Sheltered from everywhere but the south. The soil is Mangakahia mottled clay loam, an alluvial soil that is poorly drained. There was quite a bit of toppling at the edge (30%), but less pronounced further into the forest (10%). The root plate was relatively shallow due to the high-water table.

Root plate quite shallow due to high water table.
