# Poplar windthrow following Cyclone Gabrielle

Date: 1 April 2023 Author: John Ballinger, Dean Satchell, Simon Webb

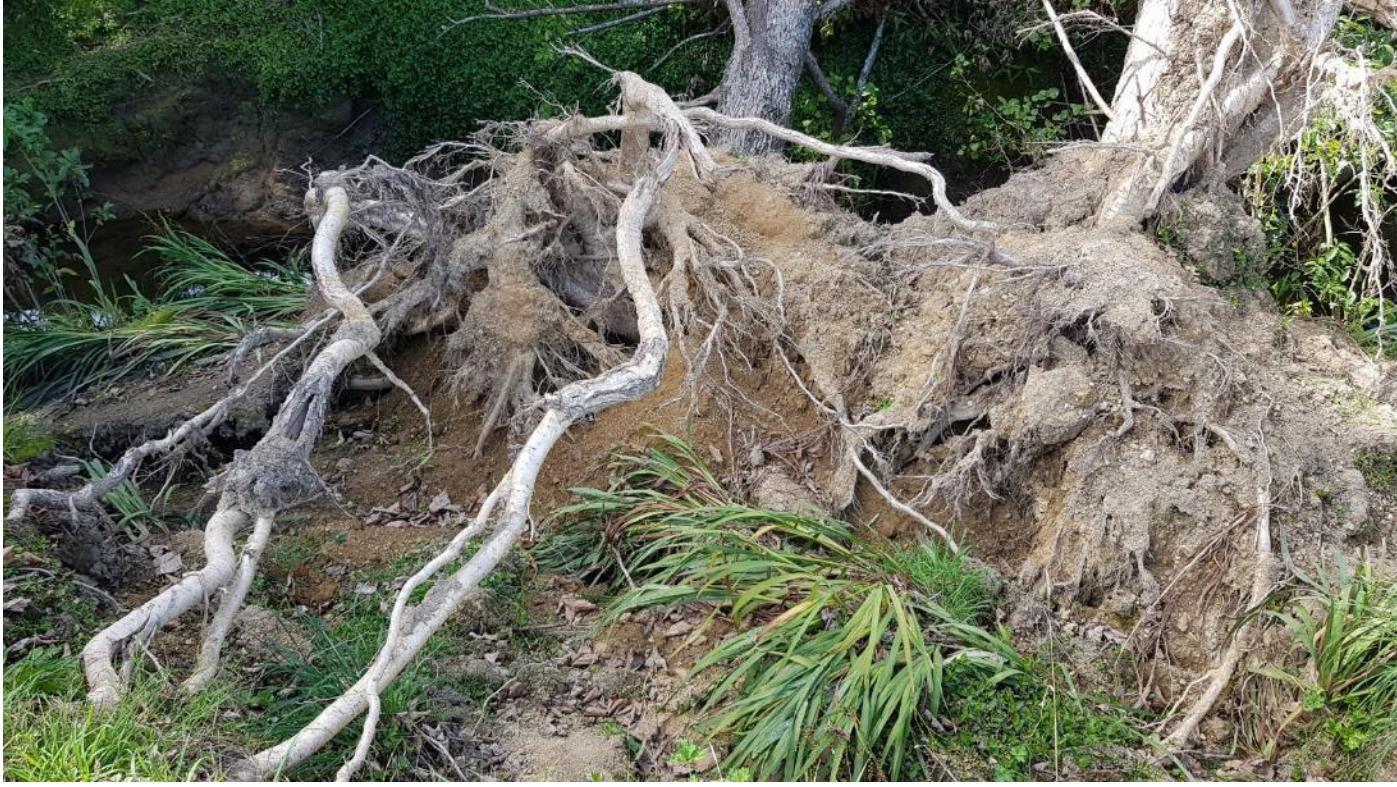
On this farm there was a small amount of toppling along streambanks and drains. The soil type is Kara sandy loam with pan, a very old podzol known colloquially as gumland or pipe clay that is very prone to gullying. Along a streambank a handful of mature Kawa (estimate 30 years old) were planted too close to the river edge on an eroding bend. A combination of stream bank undermining and extreme wind gusts pulled up the root plates, generating sediment. The big strong roots of these trees had been doing an excellent job of holding the steep bank together but ideally would have been shifted back beyond the bank full capacity.

A combination of streambank undermining and extreme wind gusts led to Kawa toppling.

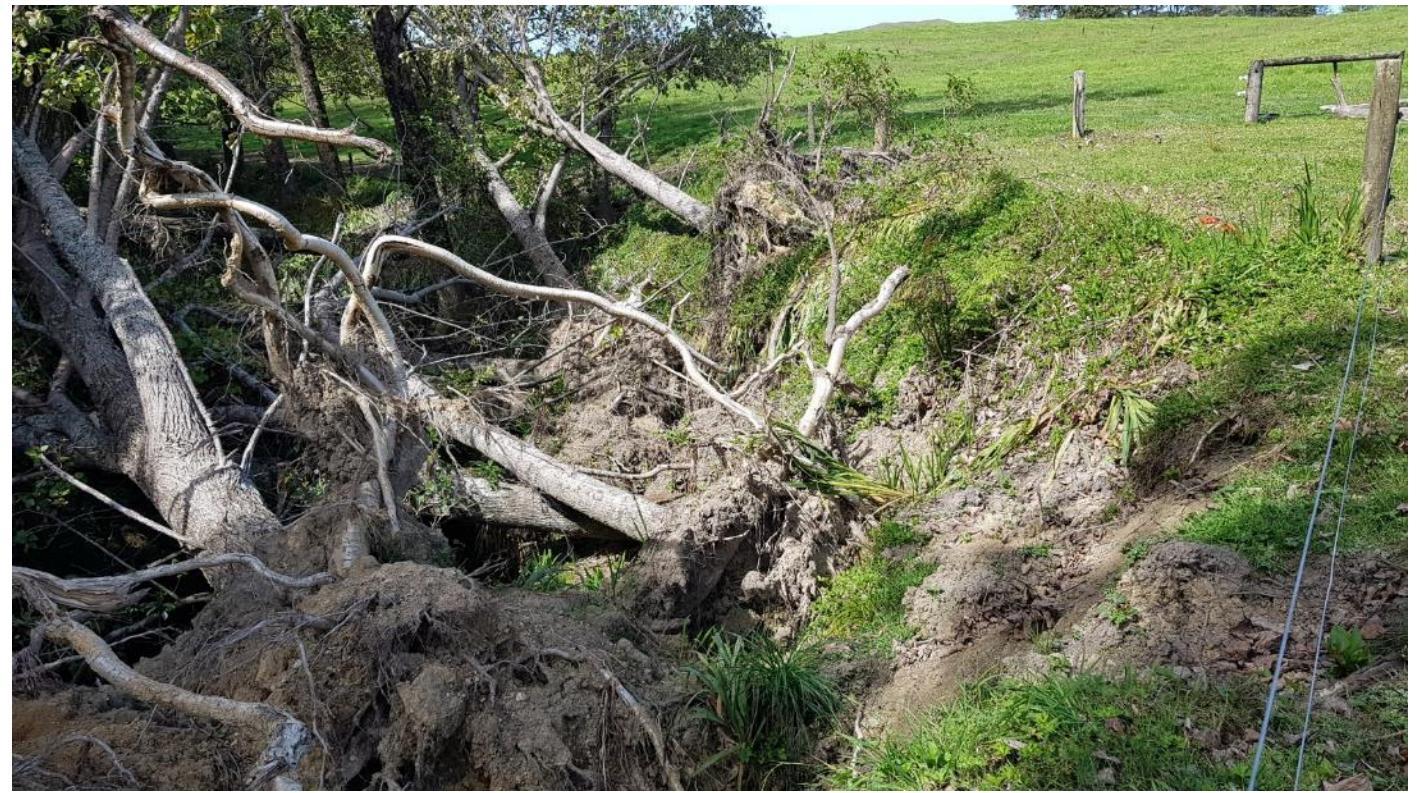
Eroding bend with toppled trees.

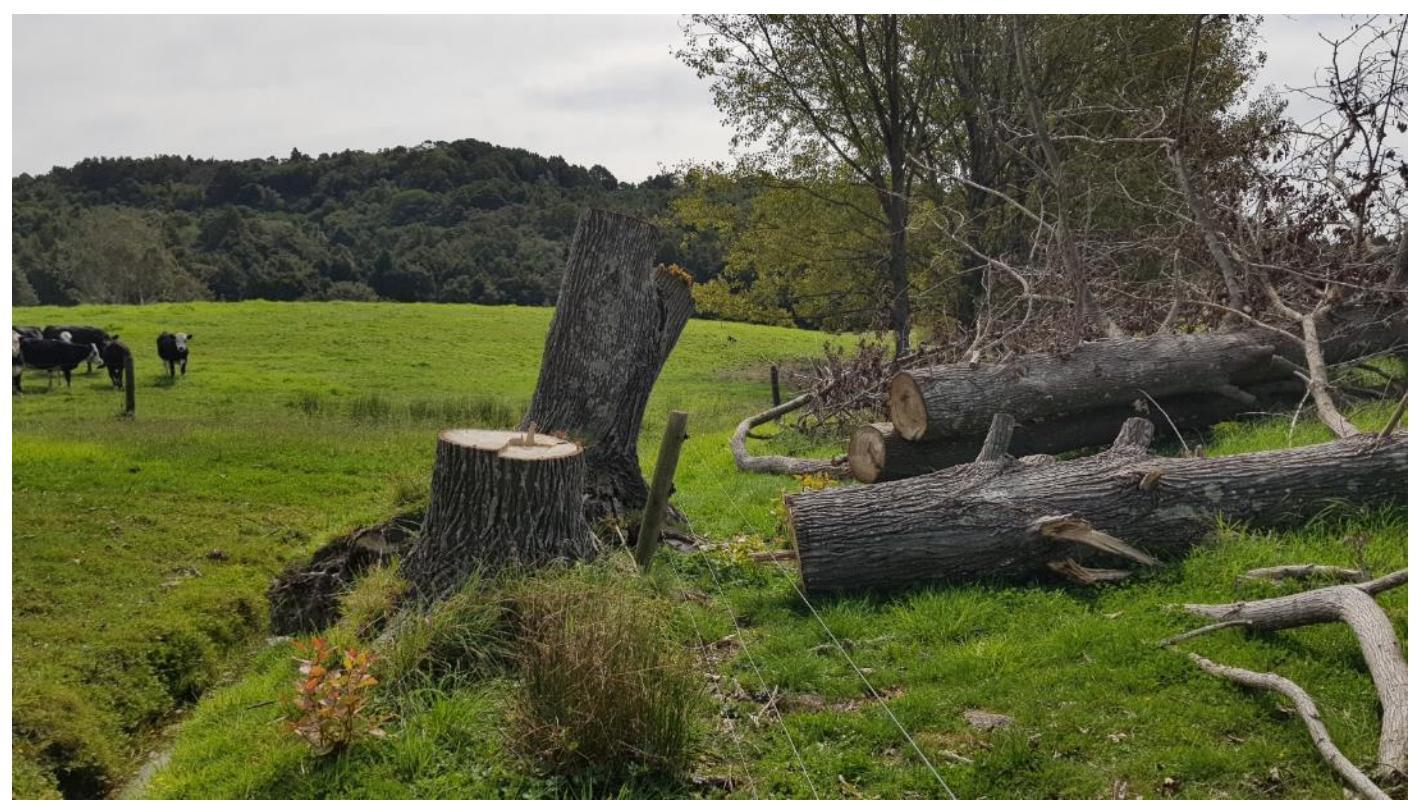
Across the farm, Kawa shelterbelts had been planted alongside drains, with approximately 5% toppling. It appears the Kawa were planted too close to the edge of the drain, with roots plunging under the drain and up and out the other side. The roots on the drain side had low root strength and unfortunately this coincided with the direction of the strongest gusts, leading to toppling. The saturated soil conditions wouldn't have helped either. Once the toppled trees were cut, the root plate sprung back to position. The trees that toppled were wider spaced Kawa in low spots. While willow is well known for their fibrous root mat that protect against scour, it was observed that these poplars provided a similar service, albeit not as extensive as willow.

Toppled Kawa along drain. Note the root mass fell back in place once the trees were cut.

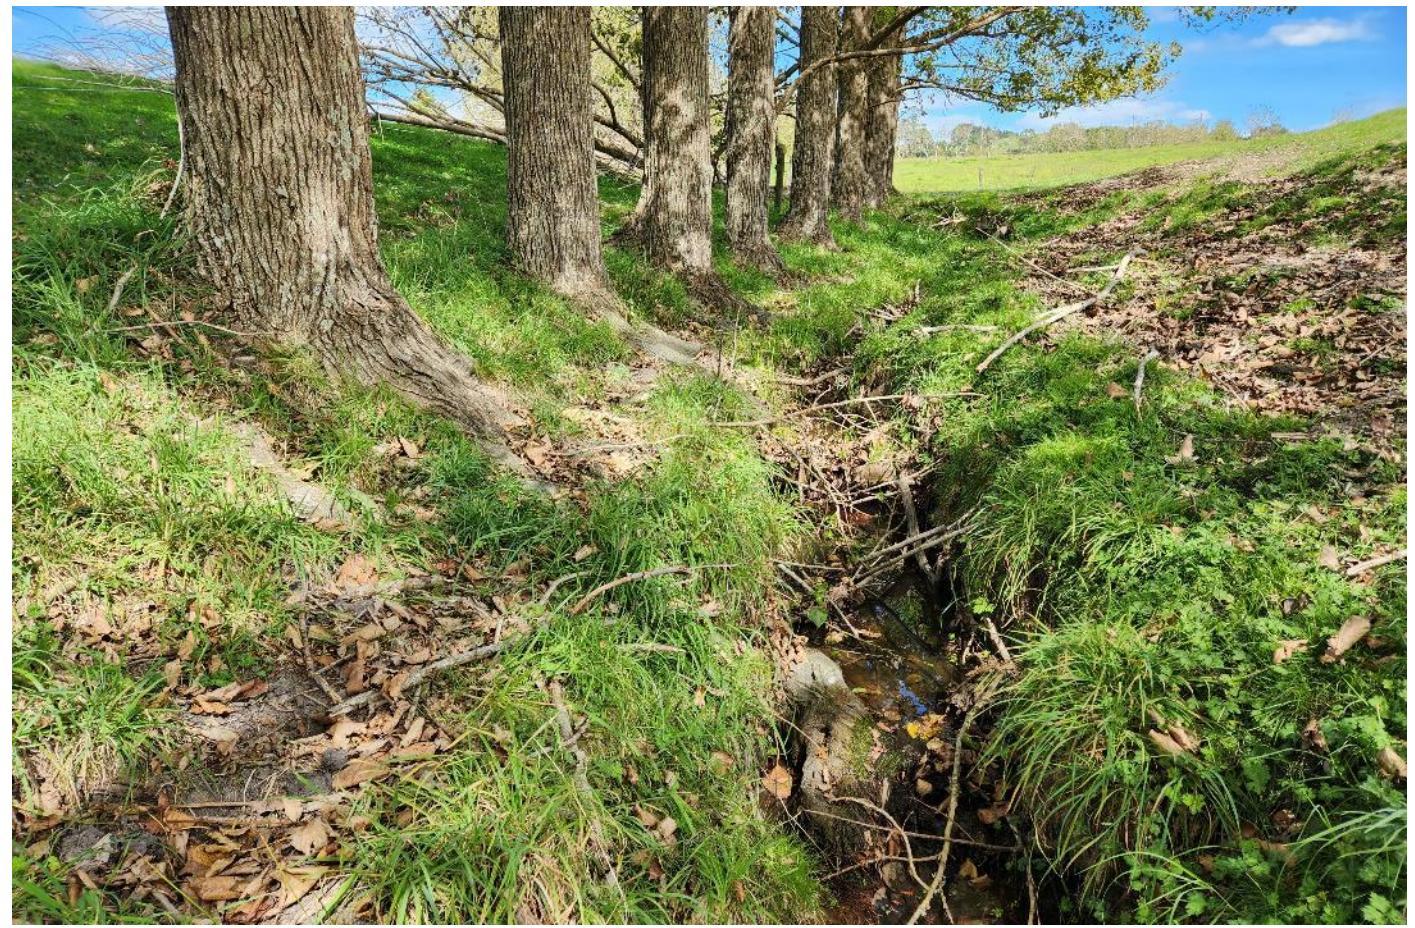
Kawa roots plunging underneath the drain. Set poplar back further to reduce risk of toppling.

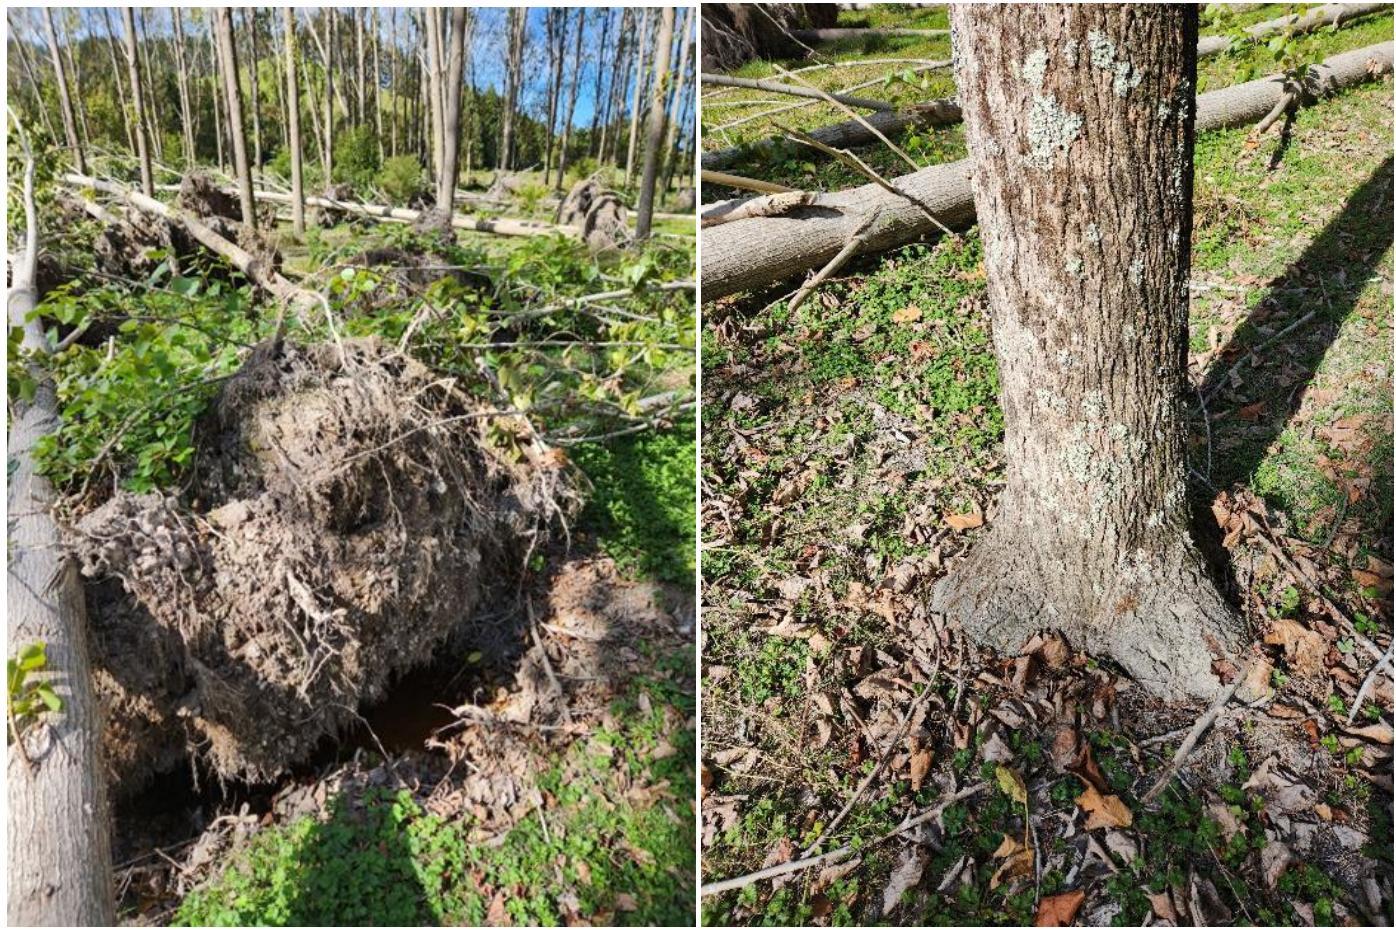
The trees are growing on Waipu clay, a terrace soil classified as having no natural drainage. Water often pools in this area and the trees were notable for having more buttressing than normal for this clone. The trees are around 23 years old, planted at 5m x 5m spacing and have been pruned but not thinned. Consequently, the height to diameter ratio is high making the trees more vulnerable to windthrow, but even if the stand had been thinned it may not have saved the trees from toppling. It's clear the trees are healthy and have grown well, and examination of the root ball showed no obvious root decay with the root plate around 600mm in depth. The root mass appeared to be too low compared with the above ground biomass

Small root mass relative to height (left); buttressing due to consistently wet soil conditions (right).

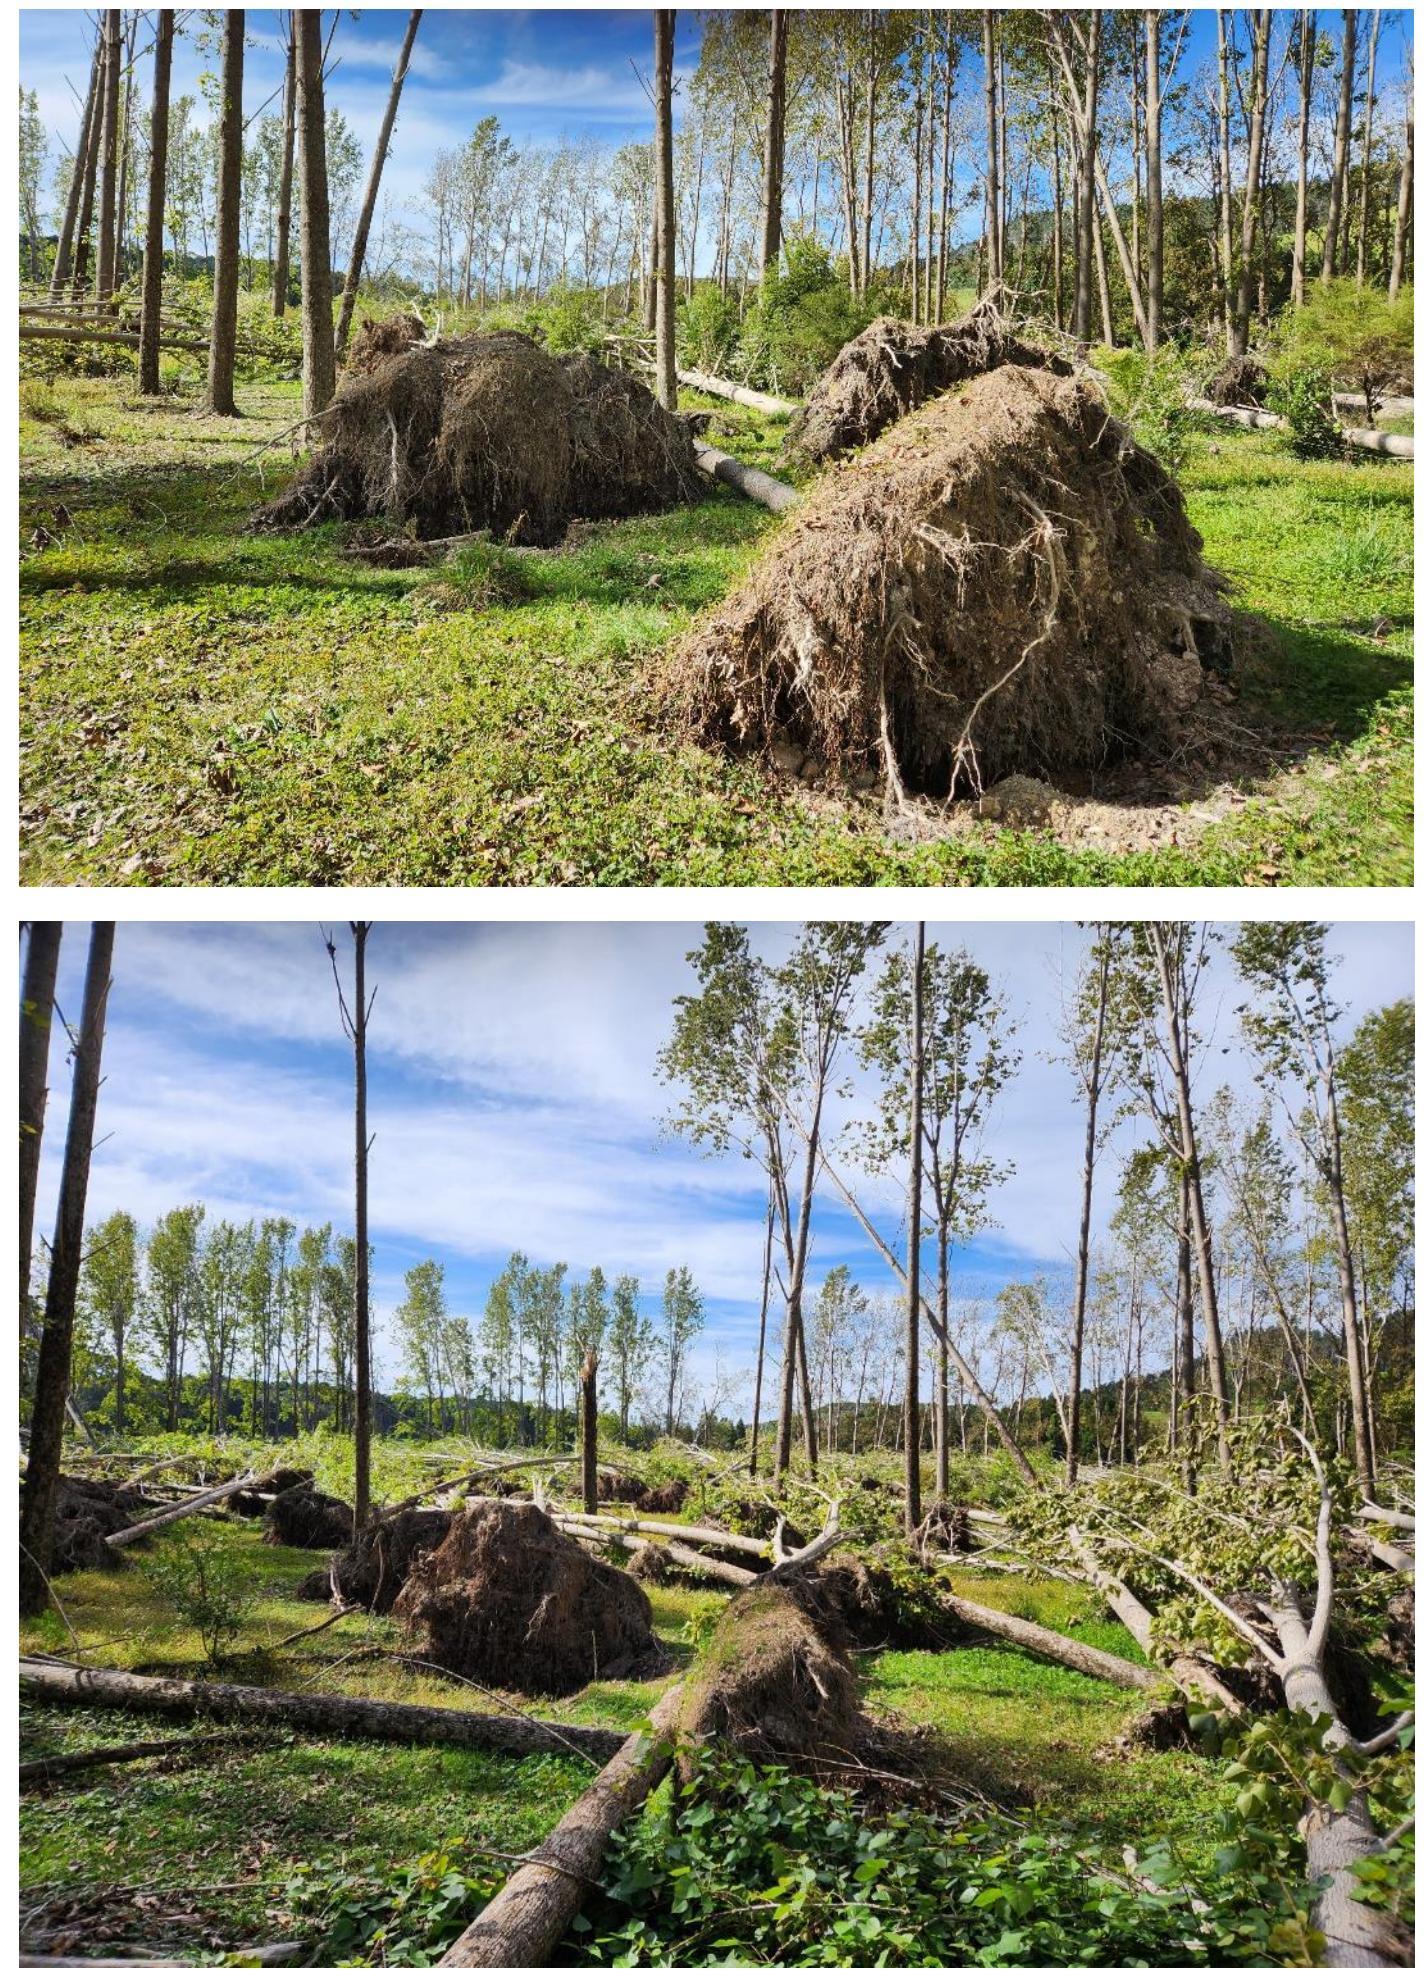
This property had an 3ha Kawa poplar woodlot. This stand suffered extensive windthrow, with around 80% toppling. A few trees succumbed to the SE winds on the first night, but most of the damage was caused by the SW gusts. This damage was unusual in that the trees on the edge were still standing, whereas the middle of the forest was devastated. This suggests wind tumbling/turbulence may have knocked over a handful of trees in the middle of the forest, that then opened the forest up to more extreme gusts the second night.

Extensive toppling within the stand. Note edge trees still standing.

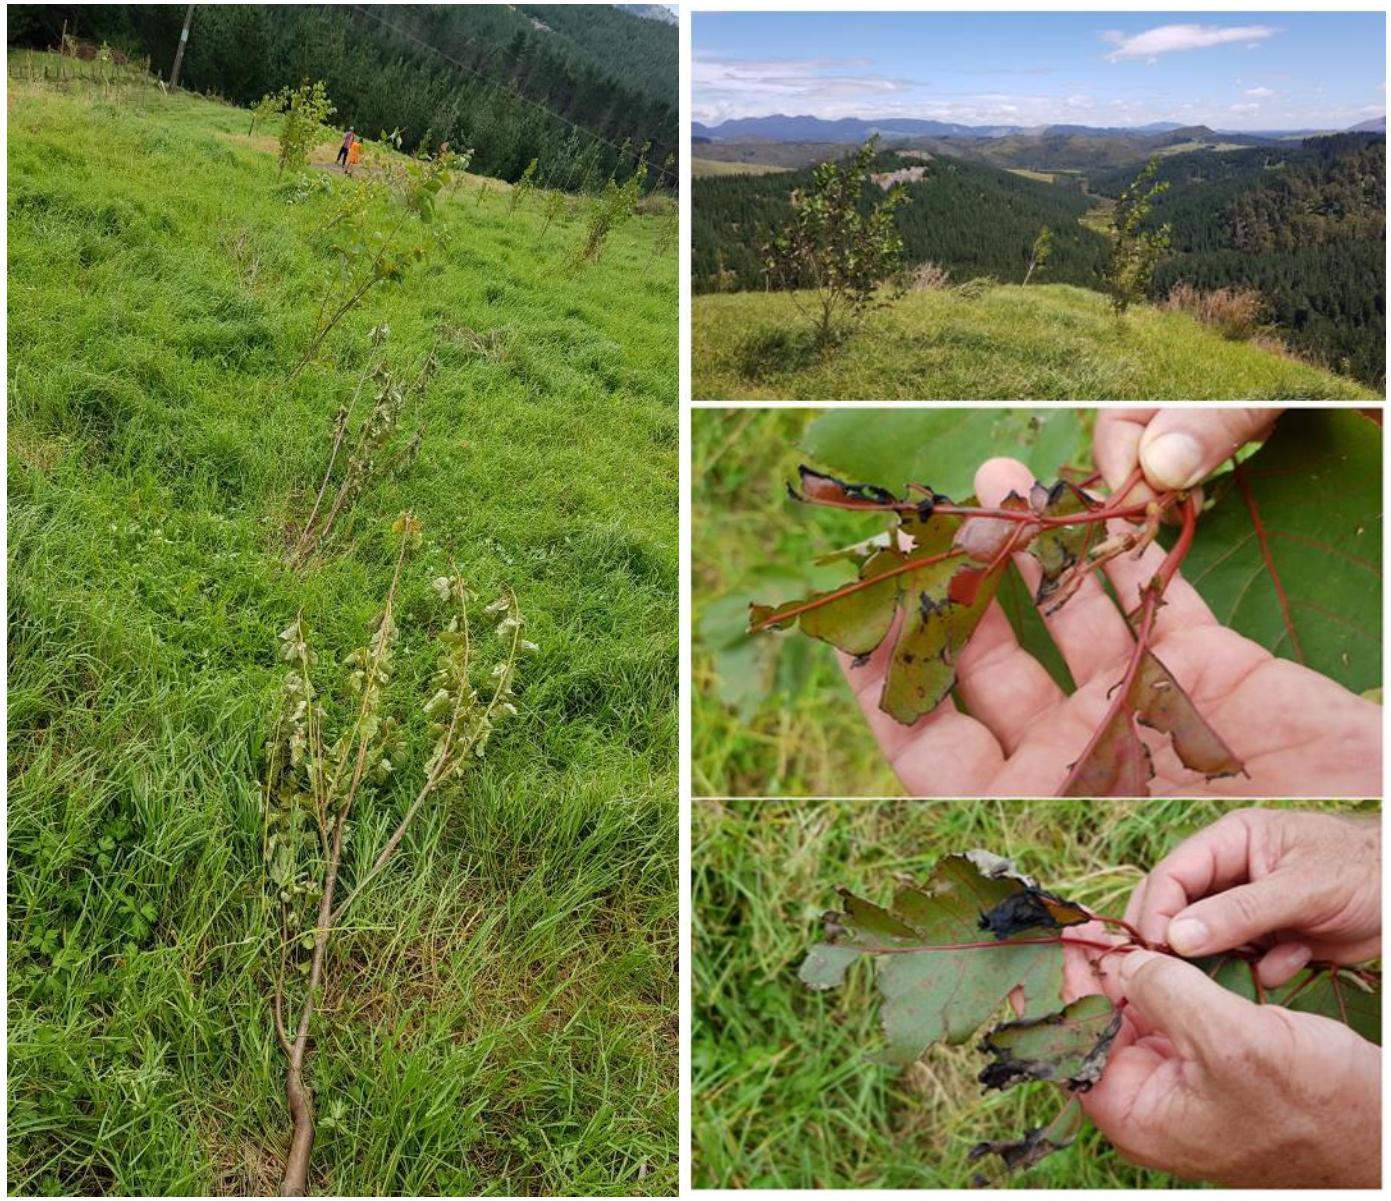
Northland Regional Council established an extensive poplar field trial on a Pamu/Landcorp Farm near Titoki in 2021. Poles, stakes, wands and rooted cuttings of various clones were planted, and a survival audit was carried out 3 days after the cyclone. This site was very exposed and a radiata plantation of similar age was completely flattened. Apart from leaf shredding, the entire site suffered very little toppling apart from one row of Kawa rooted cuttings that suffered socketing and wind throw. Adjacent Shinsei *P. nigra'LP 1'x P. maximowiczii* rooted cuttings and Veronese poles coped better in the extreme wind.

Toppled Kawa rooted cutting row (left); Highly exposed site with Shinsei wands growing well (top right); evidence of wind shredding due to extreme winds (bottom right)

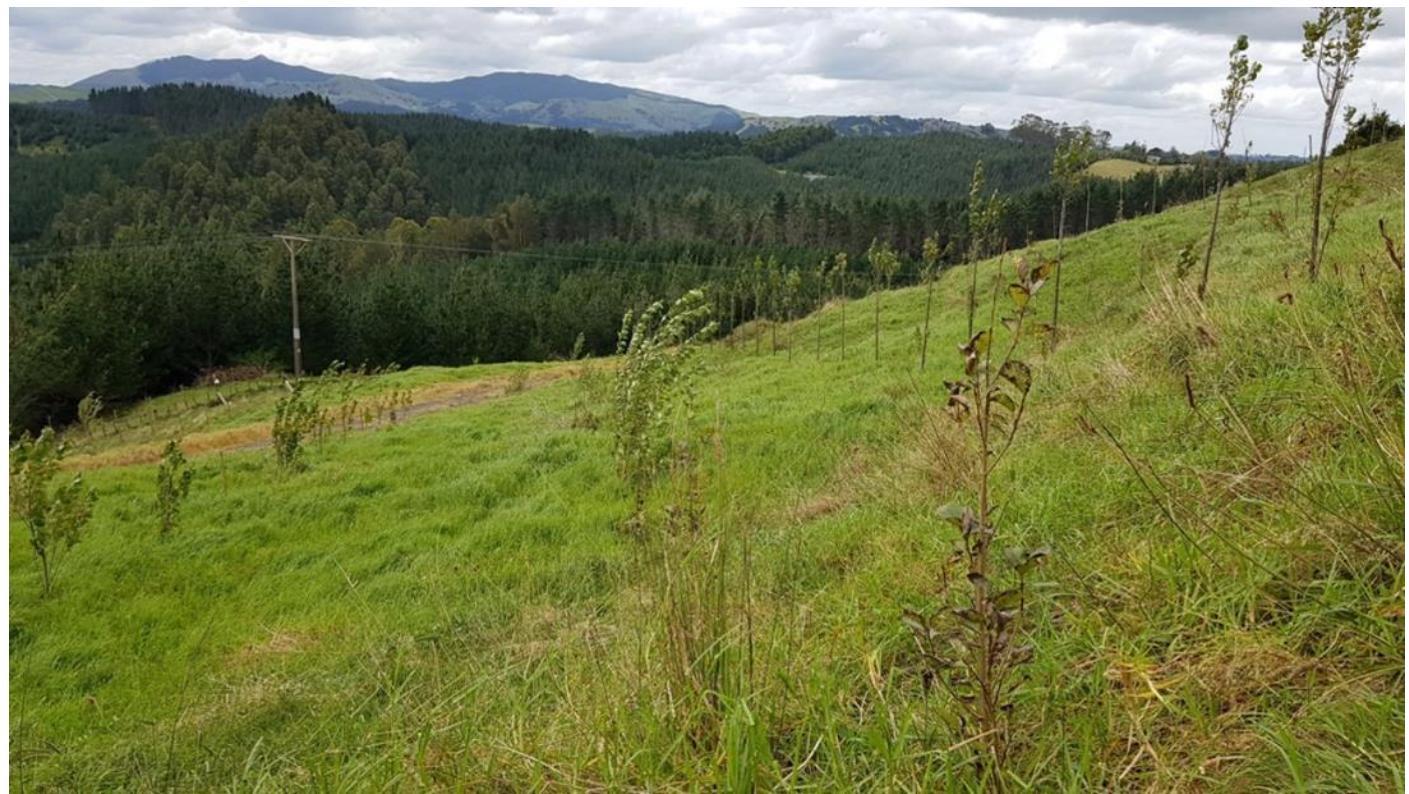
A poplar trial monitored 3 days after the cyclone had very little windthrow.

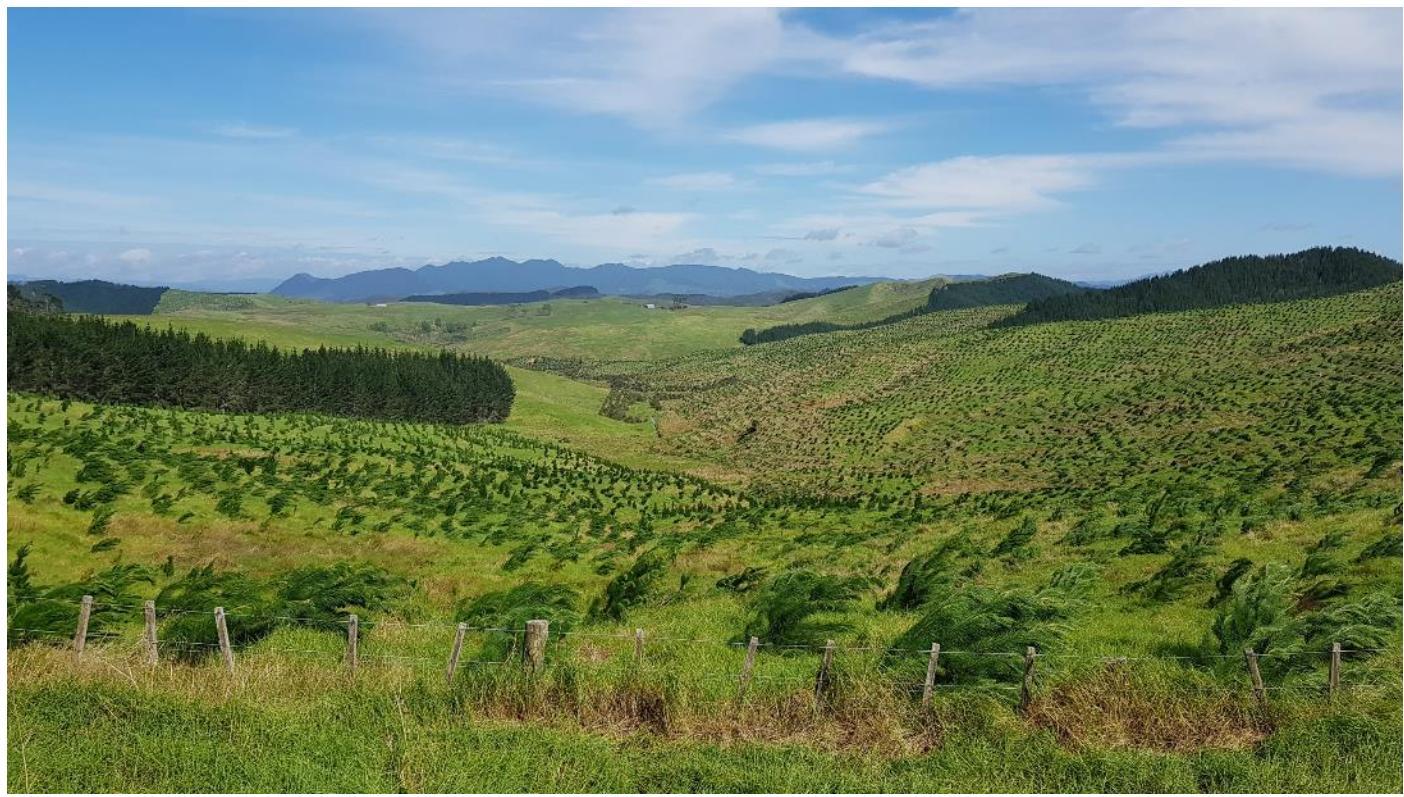
Radiata on the same farm and of the same age as the poplar trial above suffered extensive windthrow.
