## North of Dargaville

### Waingata (Waipoua) NRC Lake No. 200A

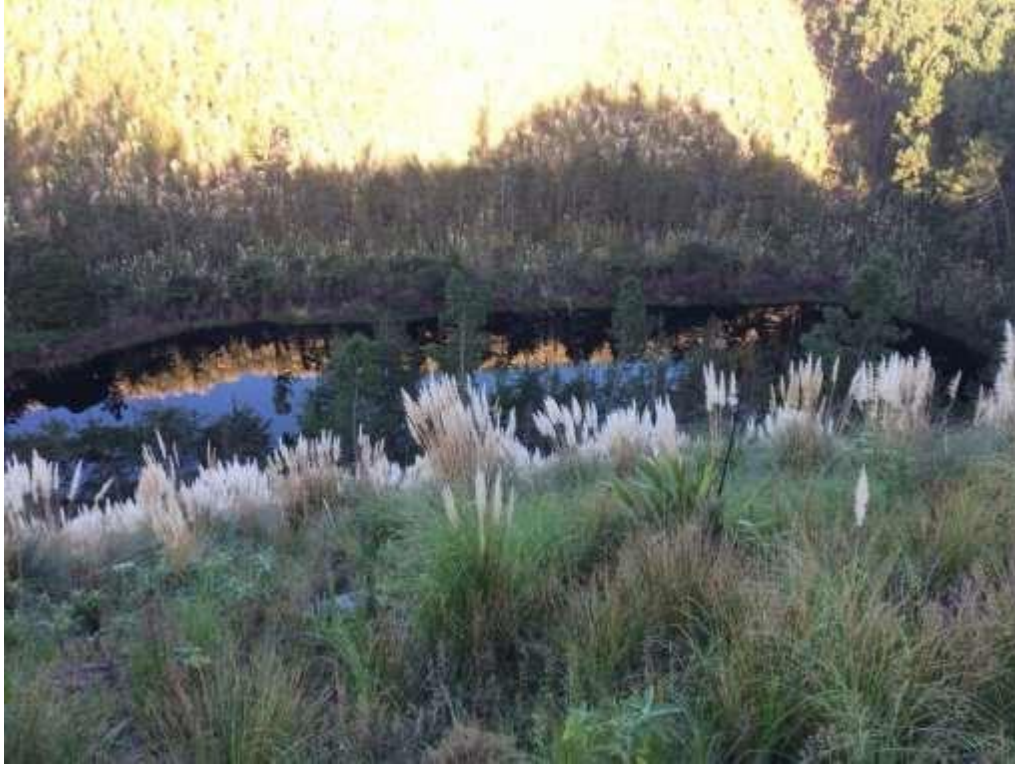
**Waingata.** Photo from the west, showing the steep, pampas dominated catchment (Photo: Lisa Forester, NRC 3 May 2018).

**Low:** A small steep sided lake, within recently harvested plantation pine forestry in the catchment. No submerged vegetation noted, lake very brown-stained.

Waingata ecological value rating is assessed as 2 "Low", a small water body, with poorly buffered habitat, low biodiversity and lacking submerged vegetation, possibly as a result of pine felling and consequent increased staining due to the release of tannic acids from decomposing pine roots/mycorrhizae.

There is a very low risk of pest plant introduction due to the difficult access, with subsequent impact likely to be low due to lack of favorable habitat. The felling of pines around much of lakes steep catchment is likely to have led to the loss of an already sparse submerged vegetation. There is a moderate risk of increased nutrient loading dependent on forestry management, but the lake is already degraded.

No regular monitoring.
