# PROPOSED SERVICE CENTRE – 47 MILLBROOK ROAD, WAIPU: ARCHAEOLOGICAL ASSESSMENT

Prepared for Vaco Investments (Waipu Project) Ltd

March 2023 (Updated from October 2022)

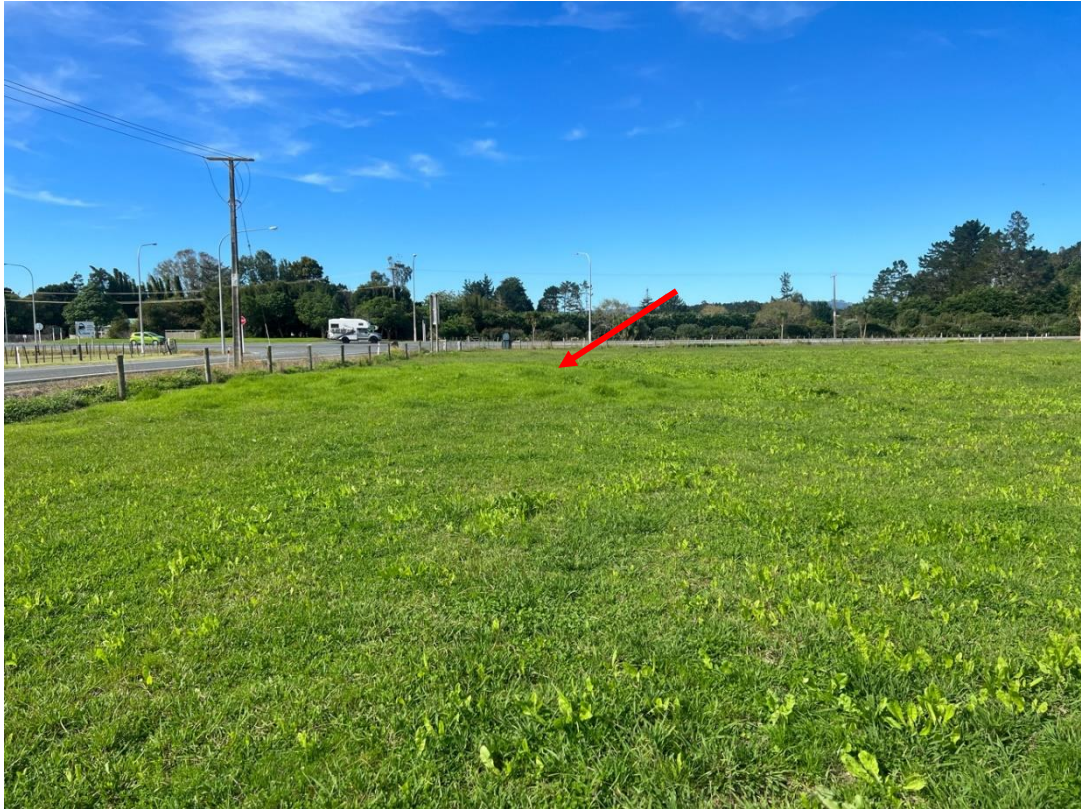
The proposed development area itself is largely flat grazing pasture with shallow undulations across the entirety of the site (see Figure 10–Figure 13). There is an unsealed access way close to the western boundary (Figure 13). A hummock/mound is visible within the eastern extent of the site, and this corresponds with the location of the low-lying mound partially investigated by Best (et al. 2003) (see Figure 14). As noted in the investigation report, it is likely that much of the area bordering State Highway 1 and Millbrook Road contains historical material associated with the archaeological site Q08/652 (McGregor’s Blacksmith) (see Figure 15 and Figure 16).

Figure 14. The low-lying mound partially excavated by Best (et al. 2003), indicated by red arrow

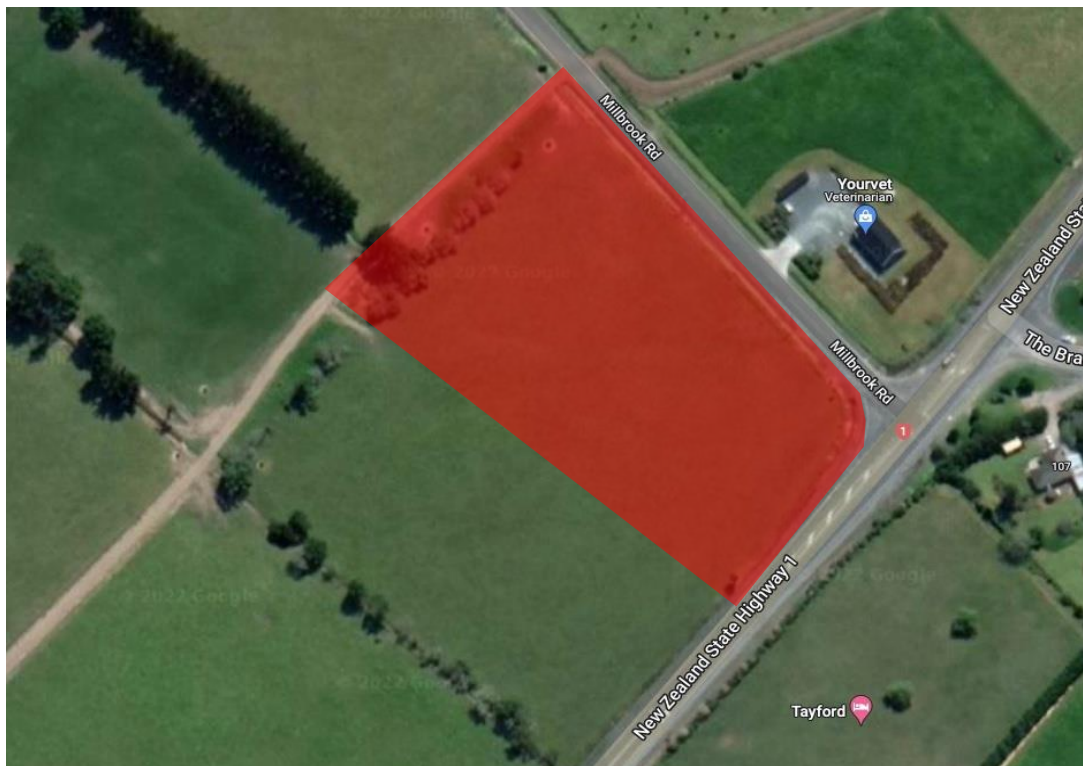
Figure 15. Potential location of archaeological material relating to site Q08/652 within the proposed development area (indicated by red shading)

If consent is granted a condition relating to archaeological monitoring within the area of archaeological potential shown on Figure 15 is recommended to identify any subsurface remains. It is also recommended that an advice note regarding the provisions of the HNZPTA is included, as an Authority under that Act will be required for the modification and investigation of archaeological remains.

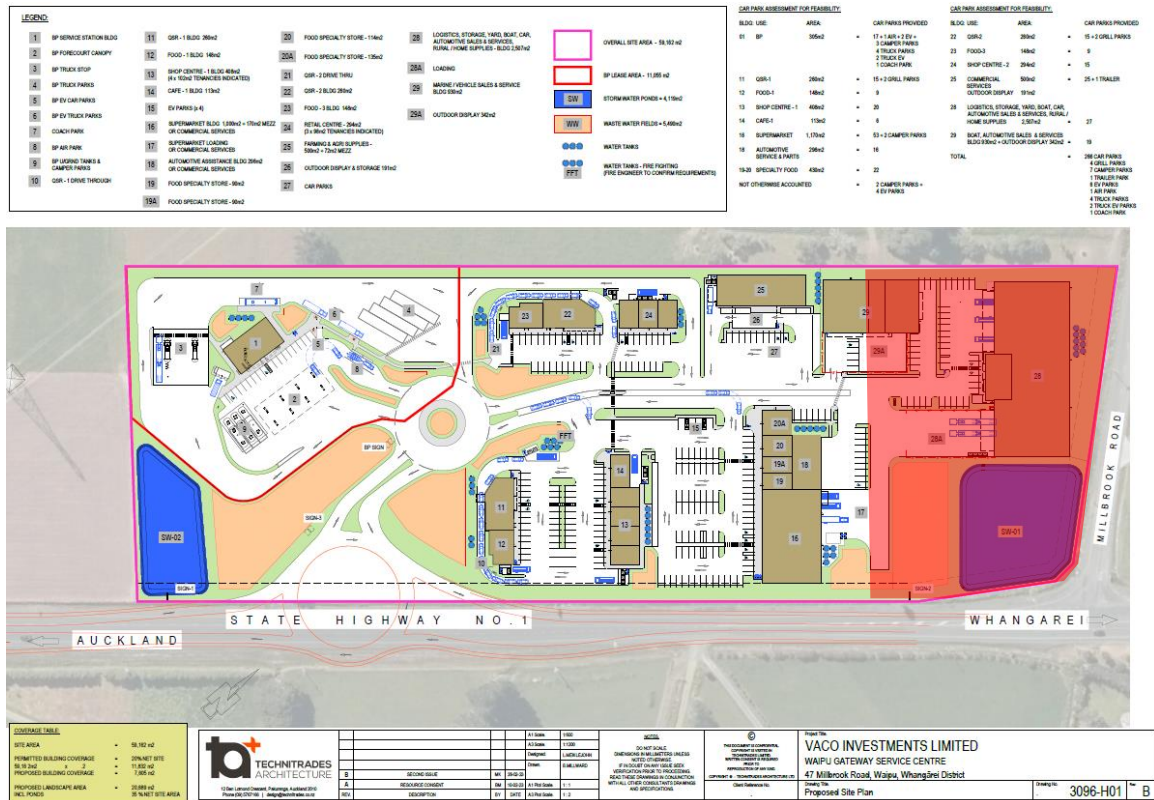
Figure 16. Potential location of archaeological material relating to the site Q08/652 (in red) overlaid on proposed development plan (source: Technitrades Architecture)

The eastern corner of the development site contains the earth mound recorded as site Q08/652. In this area the area will be excavated to allow for formation of stormwater ponds and swales. These works would completely remove the mound that contains artefacts relating to the blacksmith's shop Q08/652. An Authority from Heritage NZ would therefore be required to modify the site (see below). Any adverse effects on archaeological sites should be mitigated through archaeological investigation to recover information relating to the history of the site and Waipu area and the recovery of artefacts which can be preserved in the local or regional museum.

As the proposed development will destroy the archaeological site Q08/652, an Authority must be obtained from Heritage NZ prior to any earthworks being carried out. The conditions of the authority are likely to include archaeological monitoring and the investigation and recording of any remains affected.

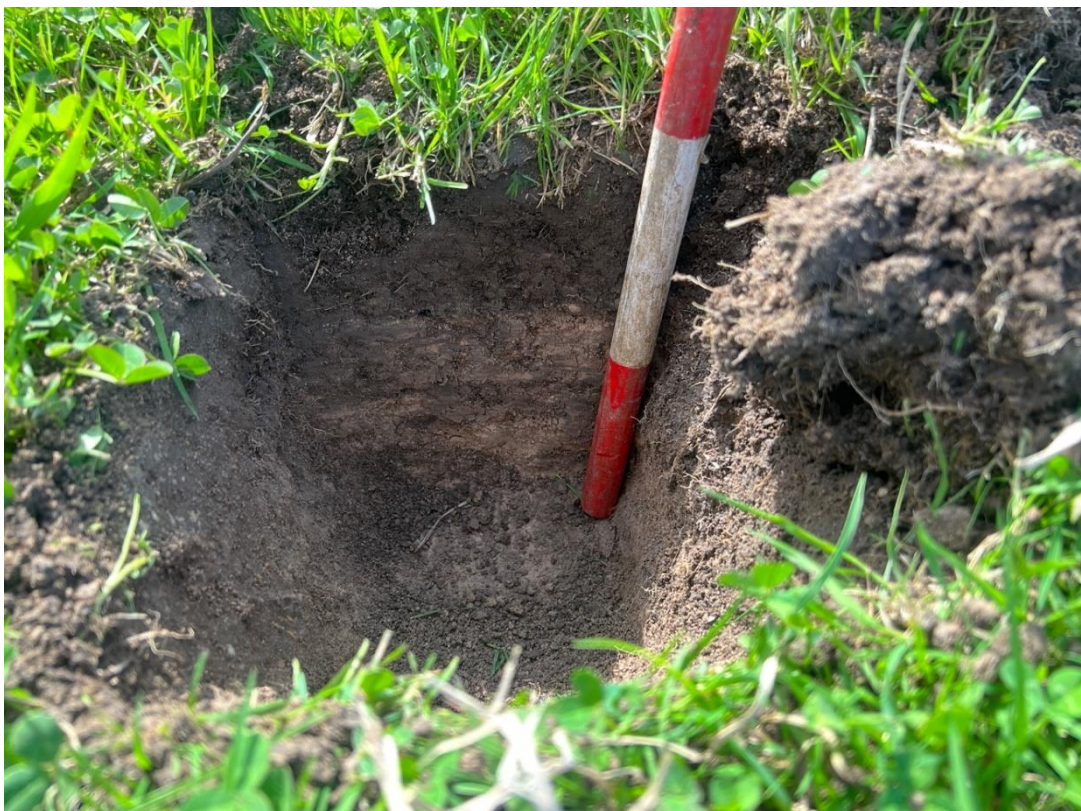
The first test pit (TP1) was located at E1728768 N6016814 and was excavated to a depth of 20cm. TP1 displayed a 9cm layer of deep brown silt, capping 11cm of mottled grey silt. No inclusion were noted within TP1 (see Figure 18).

Figure 18. Stratigraphic profile of Test Pit 1

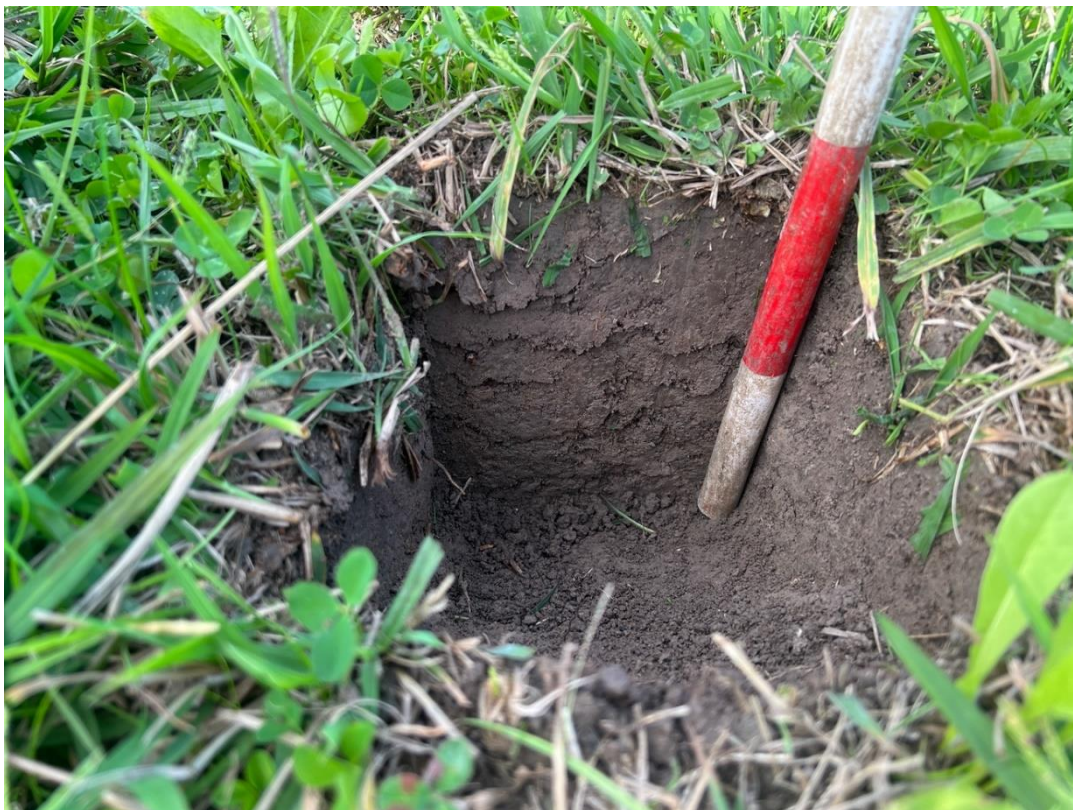
Test pit two (TP2) was located at E1728833 N6016727 and was excavated to a depth of 18cm. The subsurface stratigraphy within TP2 was entirely represented by mid-brown silt, and no inclusions were noted (see Figure 19).

**Figure 19. Stratigraphic profile of Test Pit 2**

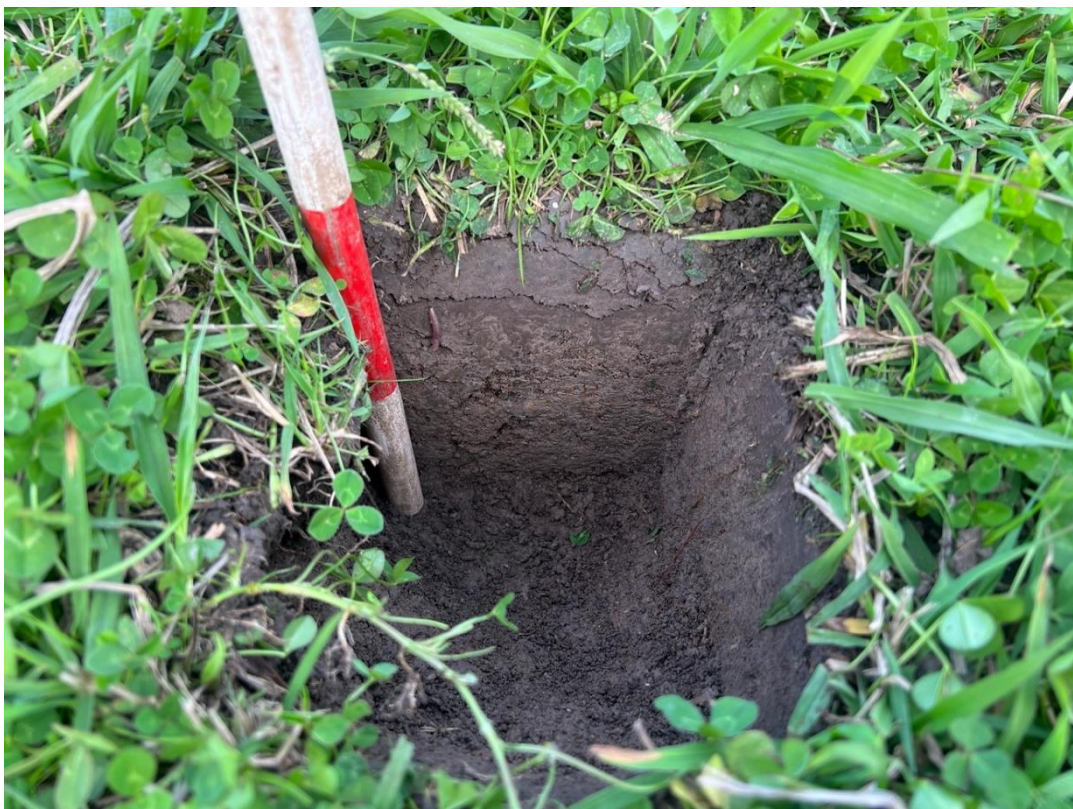
Test pit three (TP3) was located at E1728765 N6016637 and was excavated to a depth of 20cm. The stratigraphy of TP3 was consistent with that of TP2, displayed 20cm of mid-brown silt with no inclusions (see Figure 20).

**Figure 20. Stratigraphic profile of Test Pit 3**

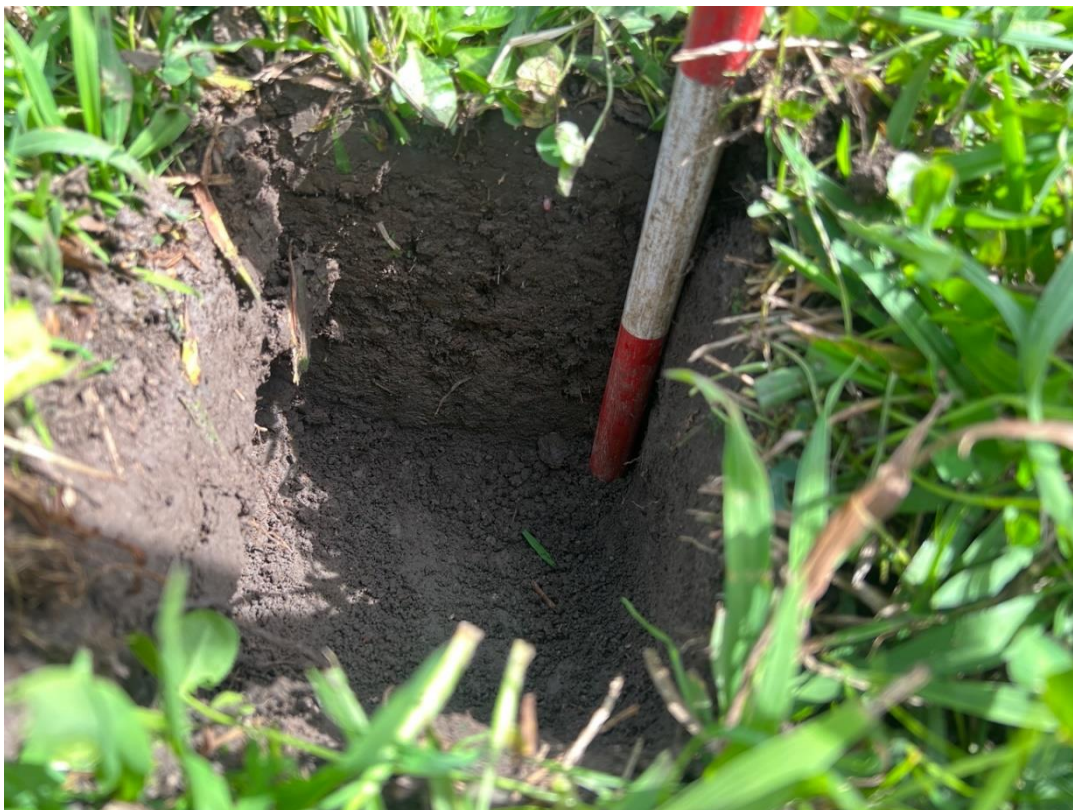
Test pit 4 (TP4) was located at E1728689 N6016697 and was excavated to a depth of 19cm. As with TP2 and TP3, the subsurface stratigraphy within TP4 was entirely represented by 19cm of mid-brown silt with no inclusions (see Figure 21).

**Figure 21. Stratigraphic profile of Test Pit 4**

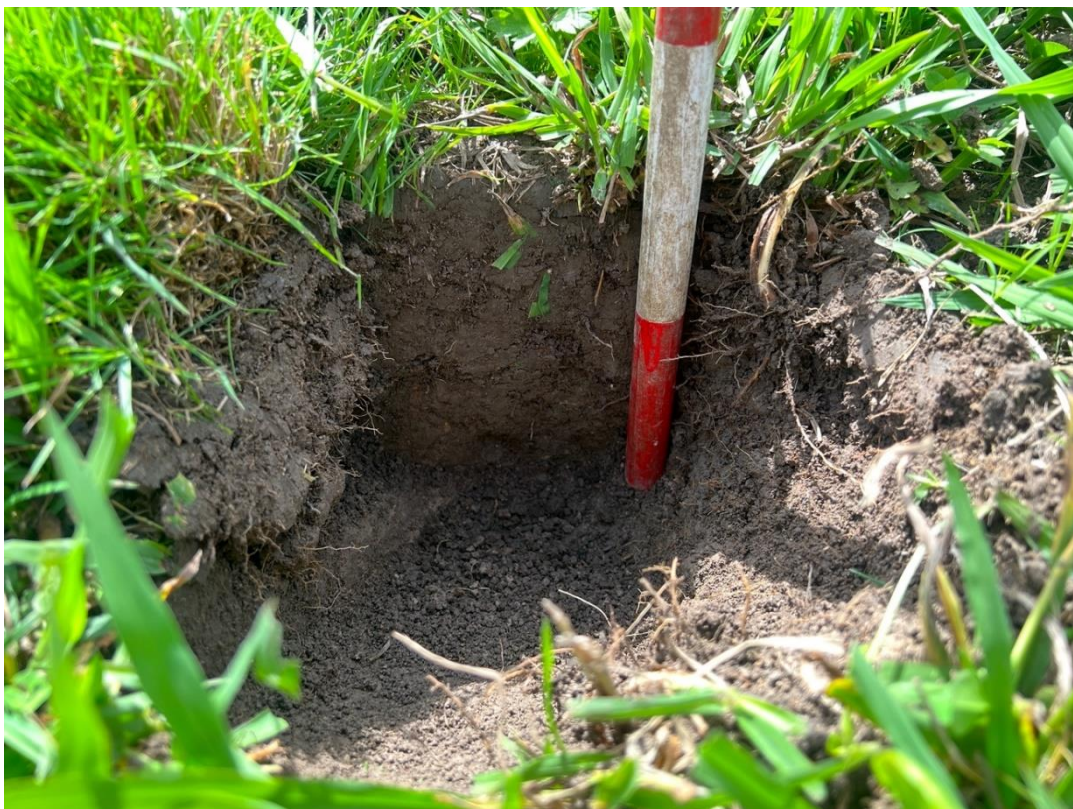
Test pit five (TP5) was located at E1728741 N6016712 and was excavated to a depth of 16cm. TP5 displayed subsurface stratigraphy comprised of mid-brown silt with no inclusions (see Figure 22).

**Figure 22. Stratigraphic profile of Test Pit 5**
