COASTAL MONITORING

Coastal Water Quality

Marine Bathing Water Quality

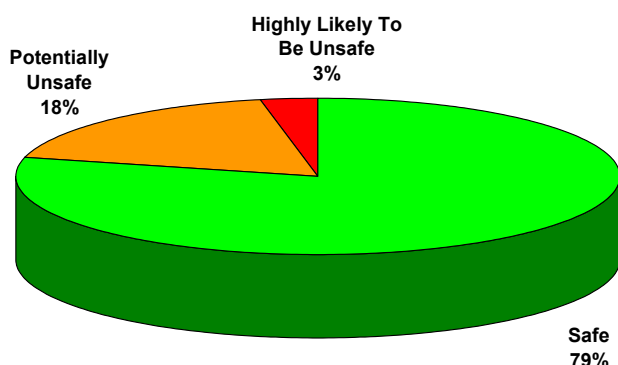
Figure 6.1: Safety status of all sites based on the end of season median

Figure 6.1 summarises the 2001/02 water quality results as compared to the Northland water quality guidelines.

A brief description of the water quality monitoring results for 2001/02 is given in the following sections. It is important to note that this description, and the accompanying diagrams, relates only to the end of season median result unless stated otherwise.

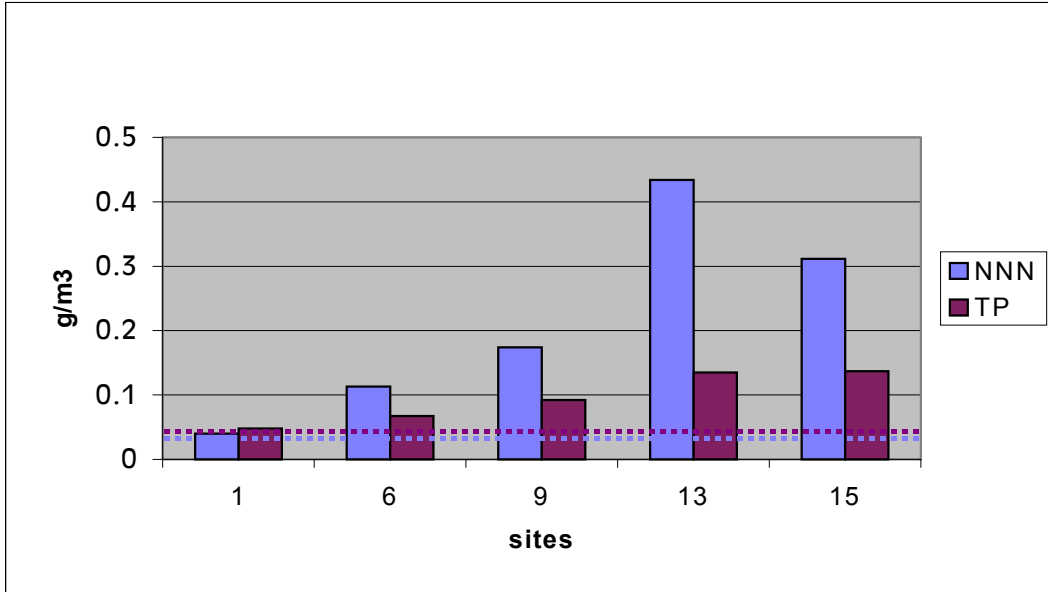
The nitrogen and total phosphorous levels for five sites on the Upper Harbour run are depicted in figure 6.3. As shown, all sites from Kissing Point (site 6) upstream, are well above the trigger levels for both nitrogen and total phosphorous.

Figure 6.3: Nitrogen and Phosphorous counts for the Upper Harbour run. The dashed line represents the ANZECC (2000) trigger guidelines for each nutrient (as depicted in its respective colour).

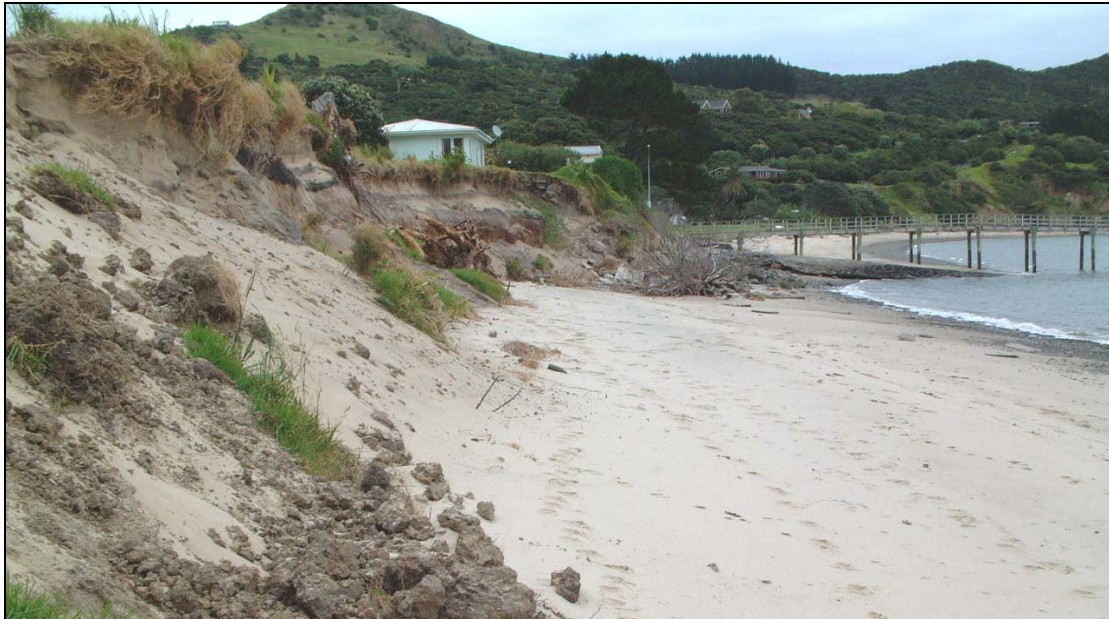
Erosion of the Omapere foreshore. An example of a coastal hazard. The Coastal Hazard Zone for this area is currently under review.

Nearshore profiles are collected using a small boat and depth sounder and extended up the foreshore to include the foredune using a theodolite and Electronic Distance Metre (EDM). The seaward edge of the foredune is mapped using Global Positioning System (GPS) equipment, with dune crest heights established using theodolite and EDM survey equipment.

This information is then incorporated with historical survey information and used to determine the extent of both short term and long-term erosion episodes. This then allows development of the CHZ, which are adopted into the District Council's district plans.

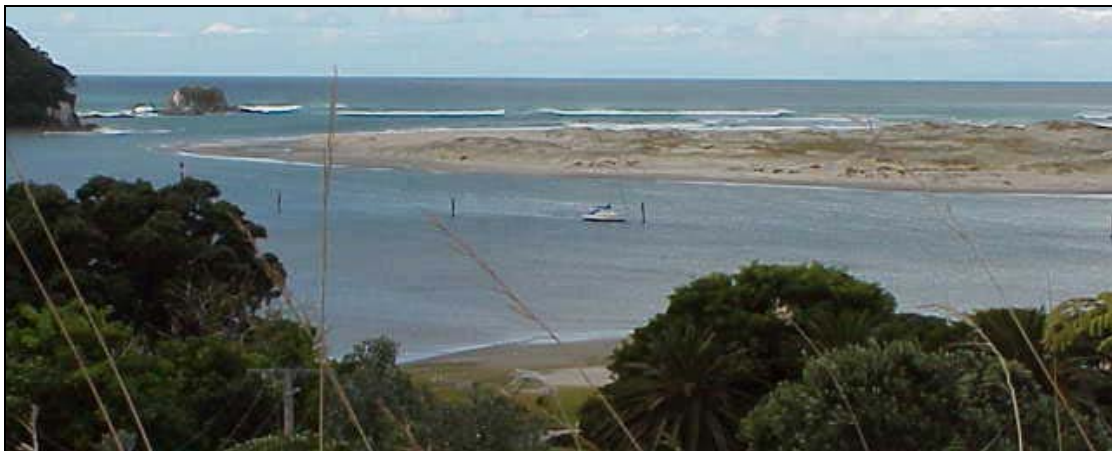
The distal end of Mangawhai Spit as seen from Mangawhai. The sporadically vegetated and undulating dunefield is characteristic of the distal end of the spit.

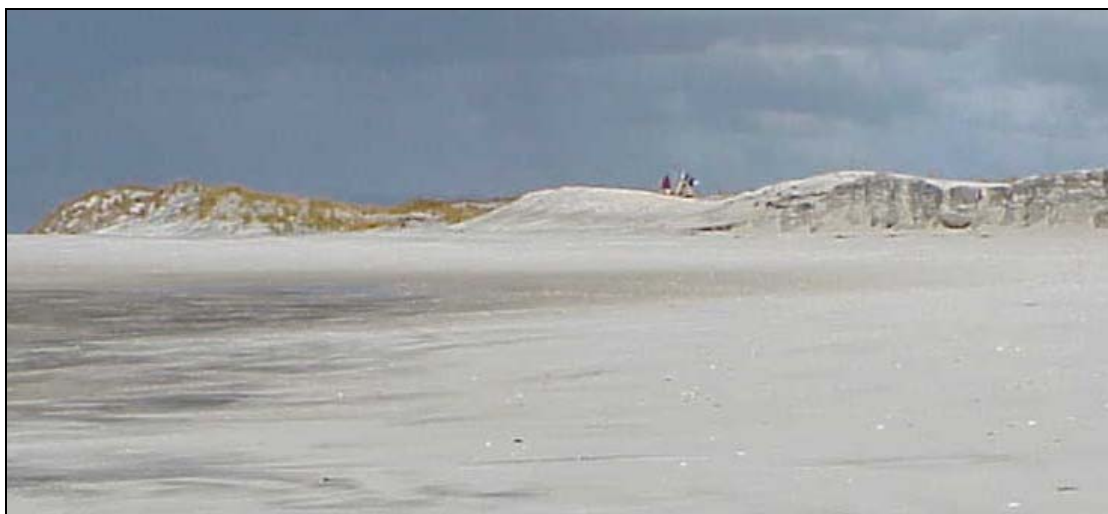
Dunes showing contrasting states of 'health'. On the left a well vegetated foredune and to the right a scarp-ed foredune indicative of recent erosion.

The foredune is an integral part of any coastal system as this area acts as a buffer zone between the sea and the land retreating and accreting during storm and fairweather events respectively, or remaining static when in equilibrium. The toe of the foredune is located at the seaward base of the dune. This dune feature provides a useful reference line from which to measure dune stability over time.

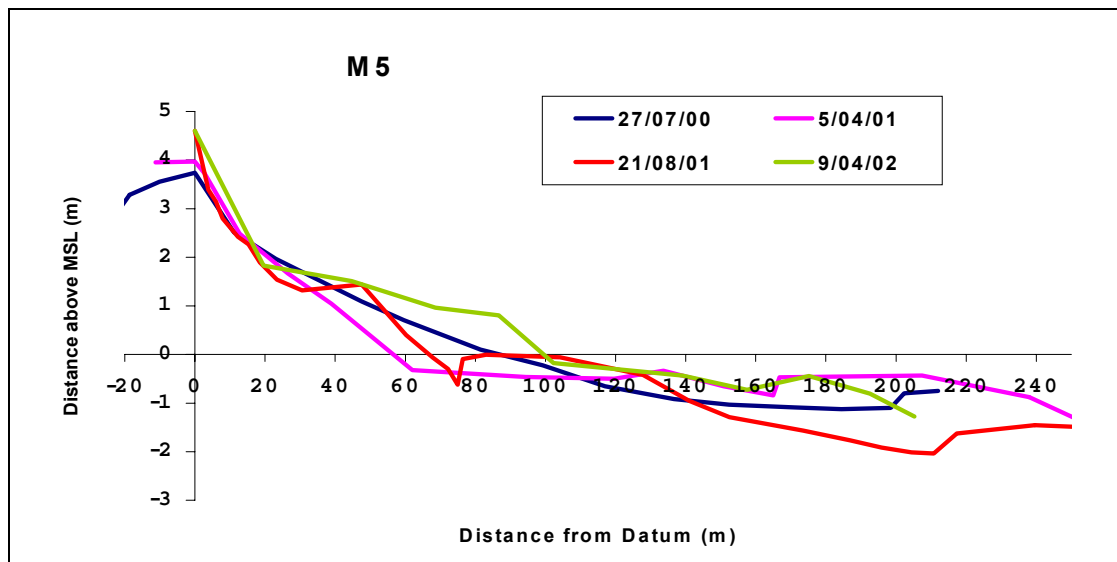
Cross shore profiles measure the height of a beach relative to a known datum. These profiles enable changes in volumes of sediment over the intertidal beach profile to be determined and also enable the identification trends in the general 'health' of a beach over time.

- Since July 2000 to present the profiles have showed sporadic episodes of erosion and accretion.
- There appears to be a seasonal influence on these events, with a typical pattern appearing of accretion in summer and erosion in winter.
- The overall pattern evident in the profiles is for erosion on the northeast part of the spit (profile M1), graduating to mixed erosion and accretion further south (profiles M2 & M3) and greater accretion even further south (profile M5).

Figure 6.8: An example of the cross shore profile data. This is profile M5.
