Te Hiku

Lake Morehurehu, NRC Lake No. 32

Summary	Lake Morehurehu
Surveyed:	2006, 2009, 2013, 2014, 2016 and 2025
Overall ranking:	Outstanding: Remote lake with diverse native submerged and emergent vegetation including endangered species, good water quality. Improvement from High score reported from 2013 to 2016, as submerged vegetation recovers following pine forestry harvesting.
Threats:	Introduction of invasive submerged and emergent pest plants could occur as there is access to the lake on forestry tracks. Pine forest harvesting in the future may lead to a degradation of submerged vegetation.
Management recommendations:	Carry out ecological condition monitoring on a five yearly basis.

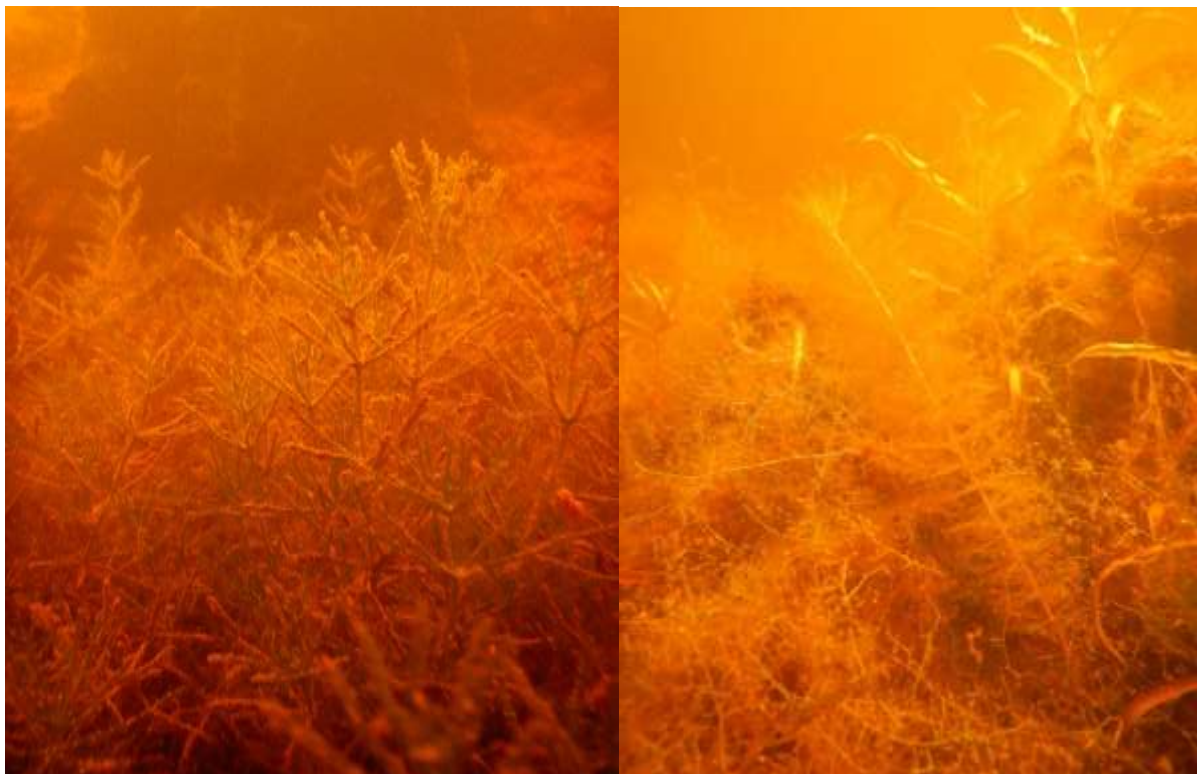
Lake Morehurehu: Submerged vegetation growing in humic stained water; *Chara australis* (left), *Myriophyllum propinquum*, *Potamogeton cheesemanii* and *Utricularia gibba* (right) (Mary de Winton 2025).

Charophytes dominated the vegetation to depths between 2.2 to 3.2 m and charophyte meadows (cover >75%) were present to between 1.7 to 2.2 m. The dominant species was *Chara australis* with some areas of *Nitella* sp. aff. *cristata* and lesser amounts of *Chara acanthophytis*, *Nitella leonhardi* and *N. mucosa*. Pondweeds (*Potamogeton cheesemanii* and *P. ochreatus*) were common to 1.8 m depth. *Myriophyllum propinquum* was only present in shallow water to 1.2 m depth. The invasive bladderwort (*Utricularia gibba*) formed some high cover patches in shallow water, extending to 2.2 to 2.9 m depth. In shallow water, filamentous green algae intermingled with bladderwort. A dense cyanobacterial cover (rubbery jelly coating on sediment) was noted below the submerged macrophyte cover to 3.5 to 4 m depth.

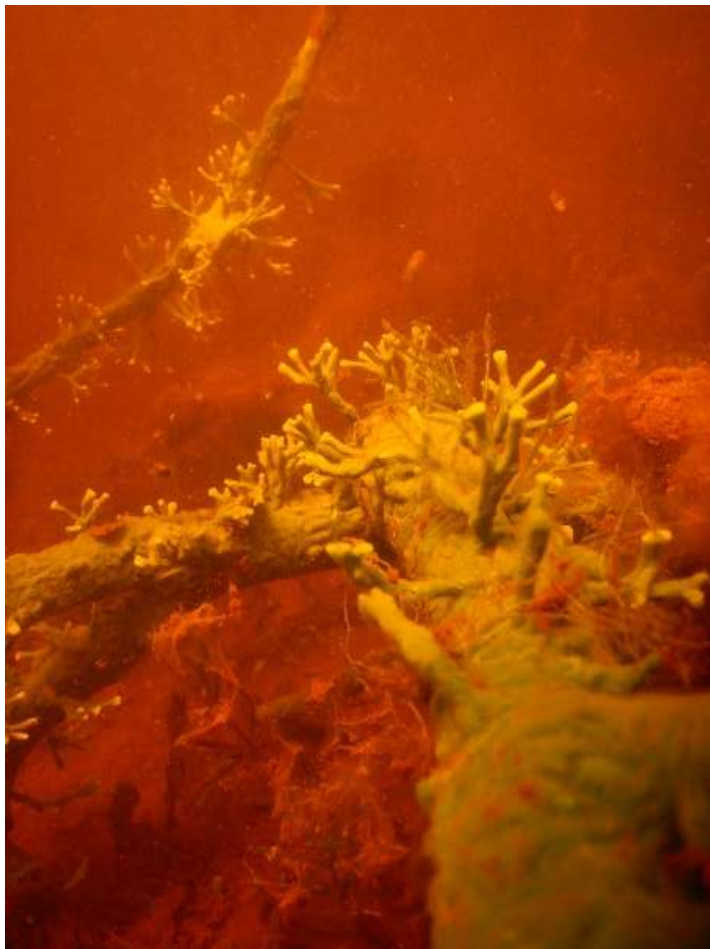
Divers reported sponge gardens as very common throughout surveyed depths on wood, plants, mussel shells and bare sediment.

Lake Morehurehu: Sponges colonising submerged tree branches (Mary de Winton 2025).
