4.17 Lake Waingaro (Central Northland), NRC Lake No. 167; surveyed in 2005

4.18 Lake Waiporohita (Karikari), NRC Lake No. 99; surveyed in 2005 and 2011

4.19 Lake Waro (Hikurangi) Lake No. 410; surveyed in 2006 and 2011

5 Kai-iwi and north Dargaville lakes

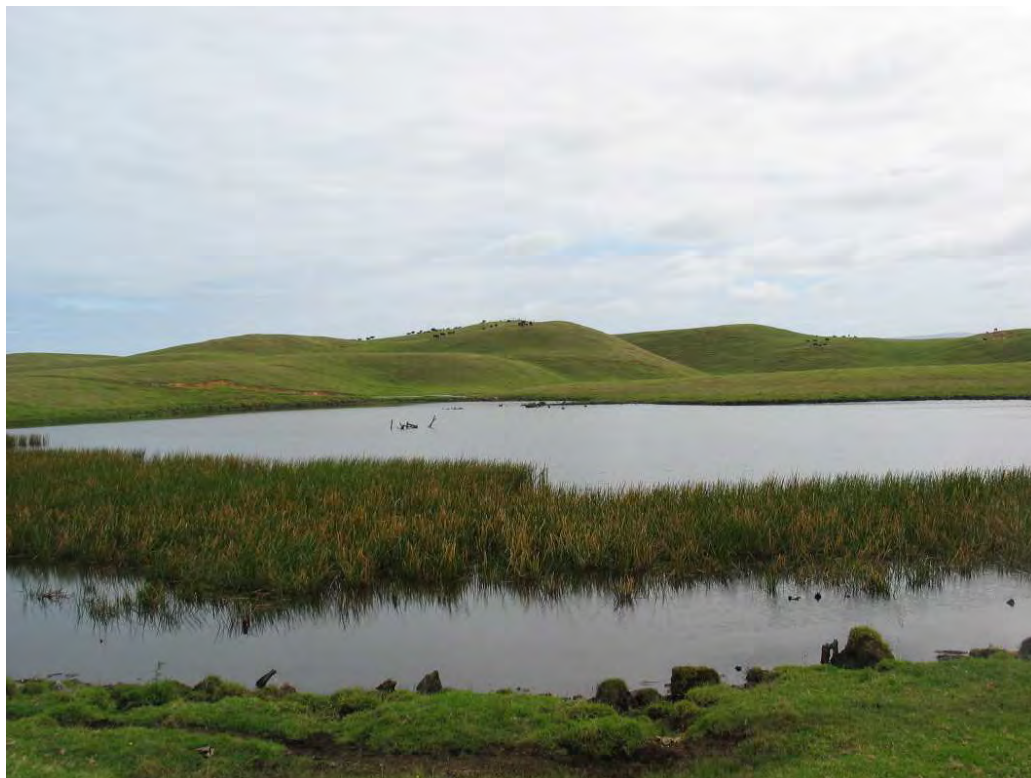
Plate: McEvoy's Lake showing the pasture catchment and impacts of cattle access.

No Management recommendations apart from cattle exclusion.

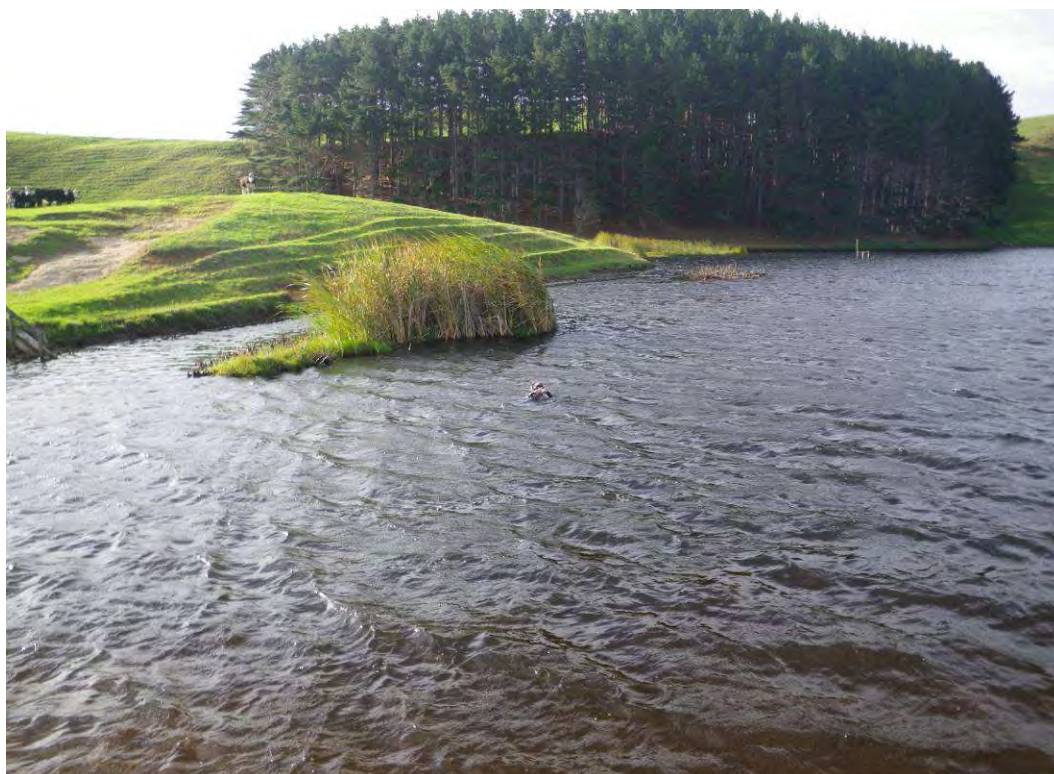
Plate: Midgley's Lake 2011 showing the pasture and pockets of plantation pine catchment with remnant emergent vegetation remaining after grass carp introduction in 2007.

In 2011, apart from the turf species and a few stunted *Chara australis* plants, all submerged vegetation has been removed by grass carp.

Fencing the lake perimeter will reduce the risk of alligator weed introduction via cattle, promote marginal species development, and reduce nutrient inputs.

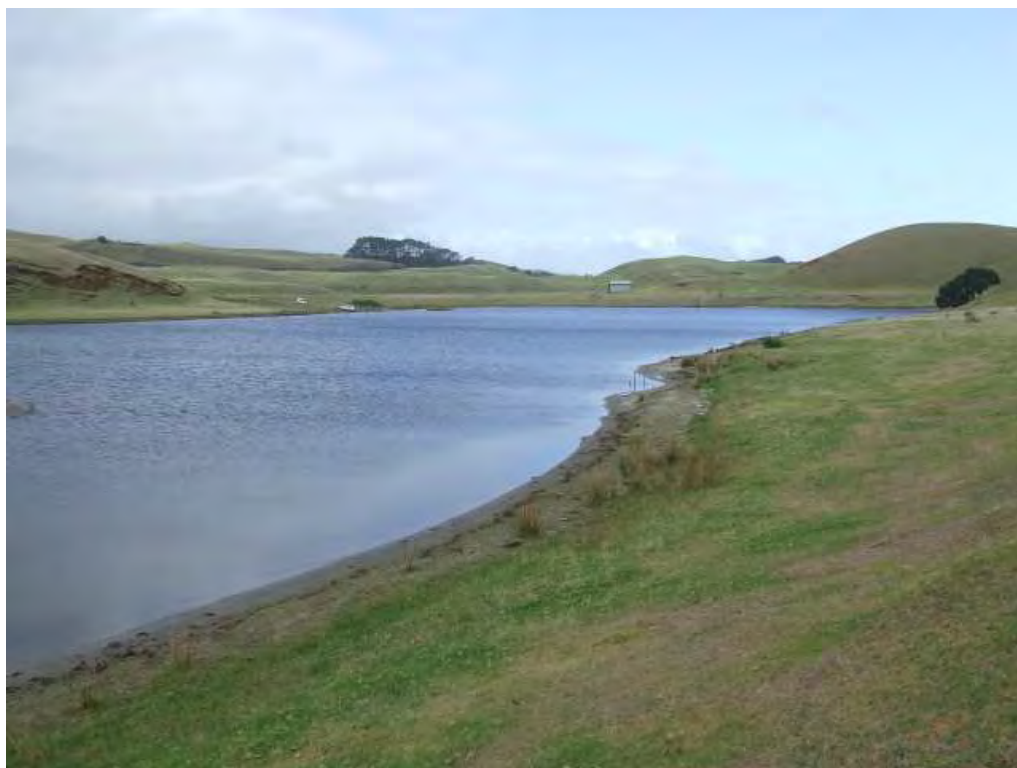
Plate: Shag Lake showing grazing to the lakeshore.

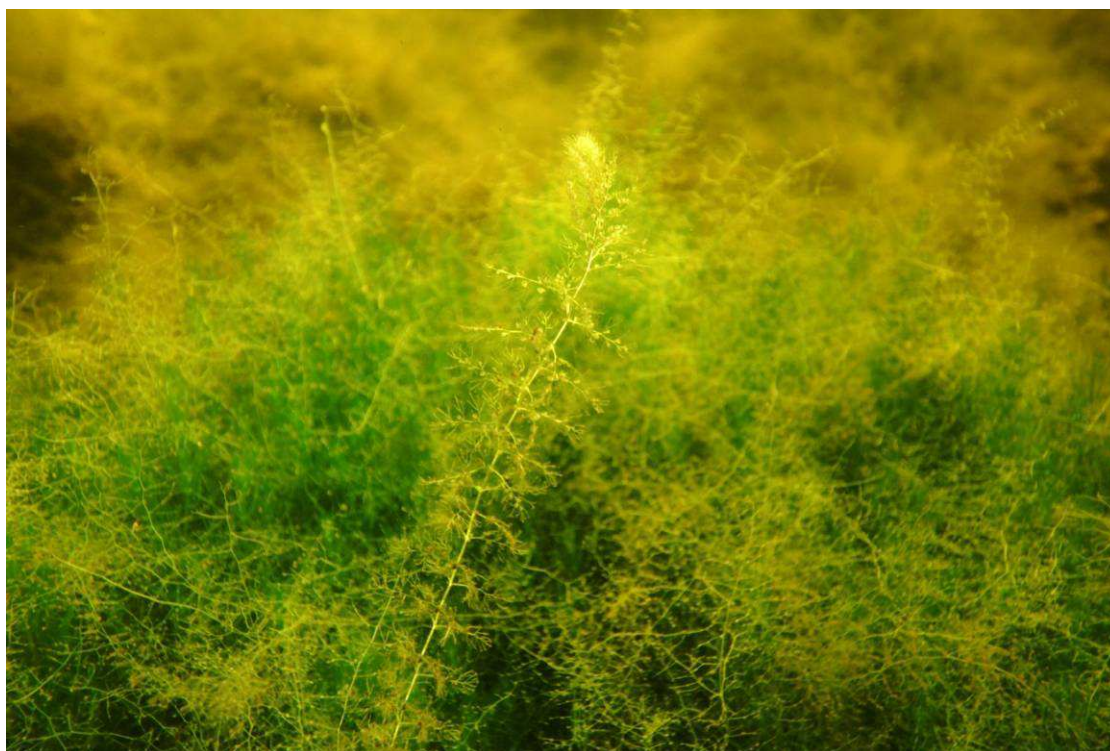
The nationally endangered *Utricularia australis* co-existing with dense mats of the exotic *U. gibba* in Te Riu Lagoon.

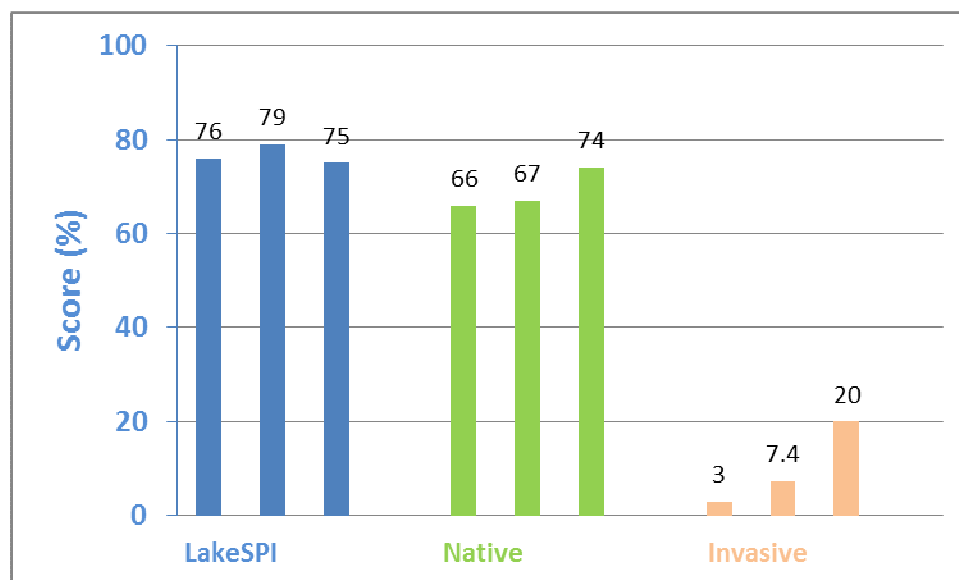
Figure: LakeSPI Index for Lake Waikare 2011 as % of potential score, Native Condition Index, and Invasive Impact Index (from left to right) with 2005, 2007 and 2011 values shown respectively.

An excellent LakeSPI score of 75% was driven by the large extent of native vegetation and presence of charophyte meadows with little impact from invasive exotic plants. Deep-growing *U. gibba* is a new observation for New Zealand and has increased the Invasive Index of this lake from 3% to 20%.

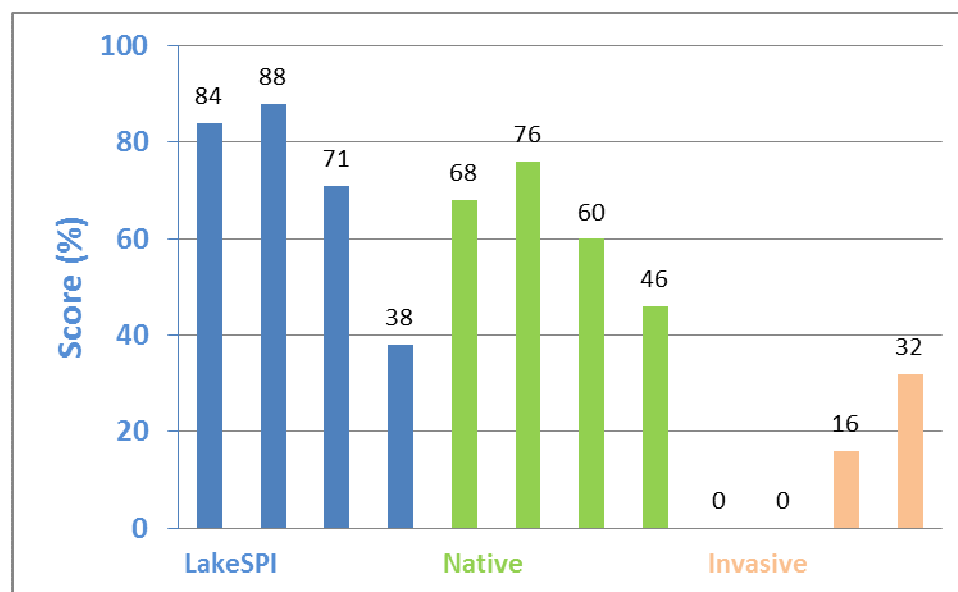
Figure: LakeSPI Index as % of potential score, Native Condition Index, and Invasive Impact Index (from left to right) with 2001, 2005, 2007, 2012, values shown respectively.

The LakeSPI score of 38% was low due to one of the 3 profiles having no submerged vegetation present. Otherwise indicators were good with a slightly deeper bottom limit and an increase in charophyte meadows. *U. gibba* invasive impact has increased further but is not displacing native vegetation. It is now categorised by LakeSPI as being in a moderate ecological condition with a LakeSPI index of 37%.

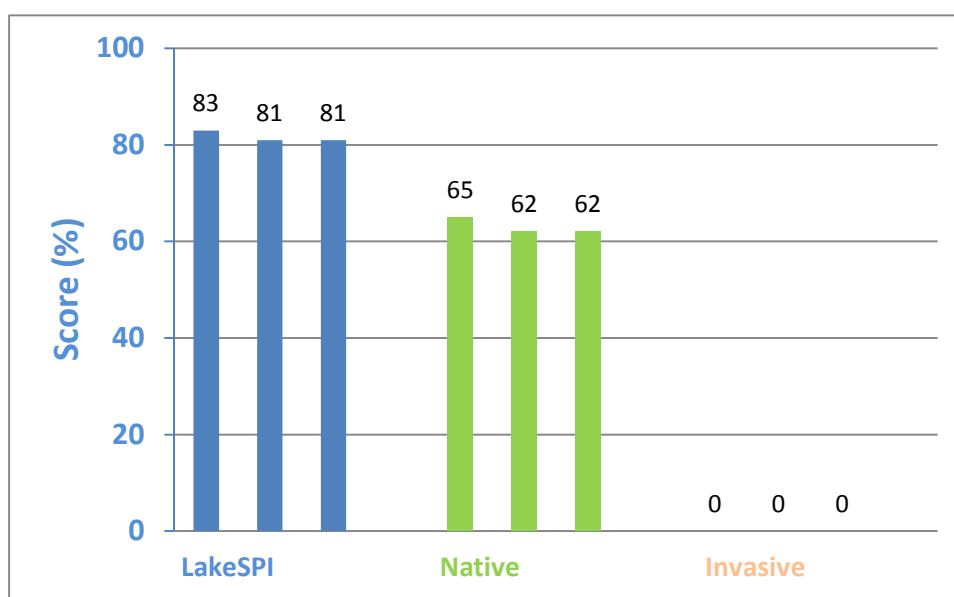
Figure 6-2: LakeSPI Index as % of potential score for Lake Karaka with Native Condition Index, and Invasive Impact Index 2005; 2007; 2012 (from left to right).

Lake Karaka is in 'excellent' ecological condition as categorised by LakeSPI (Table 6-2, Figure 6-2). Its high LakeSPI index of 81% reflects its extensive charophyte meadows and a lack of invasive species.
