6. Pouto Peninsula

6.1 Grevilles Lagoon, the lake north of Kapoai (Pouto), NRC Lake No. 295; surveyed in 2005.

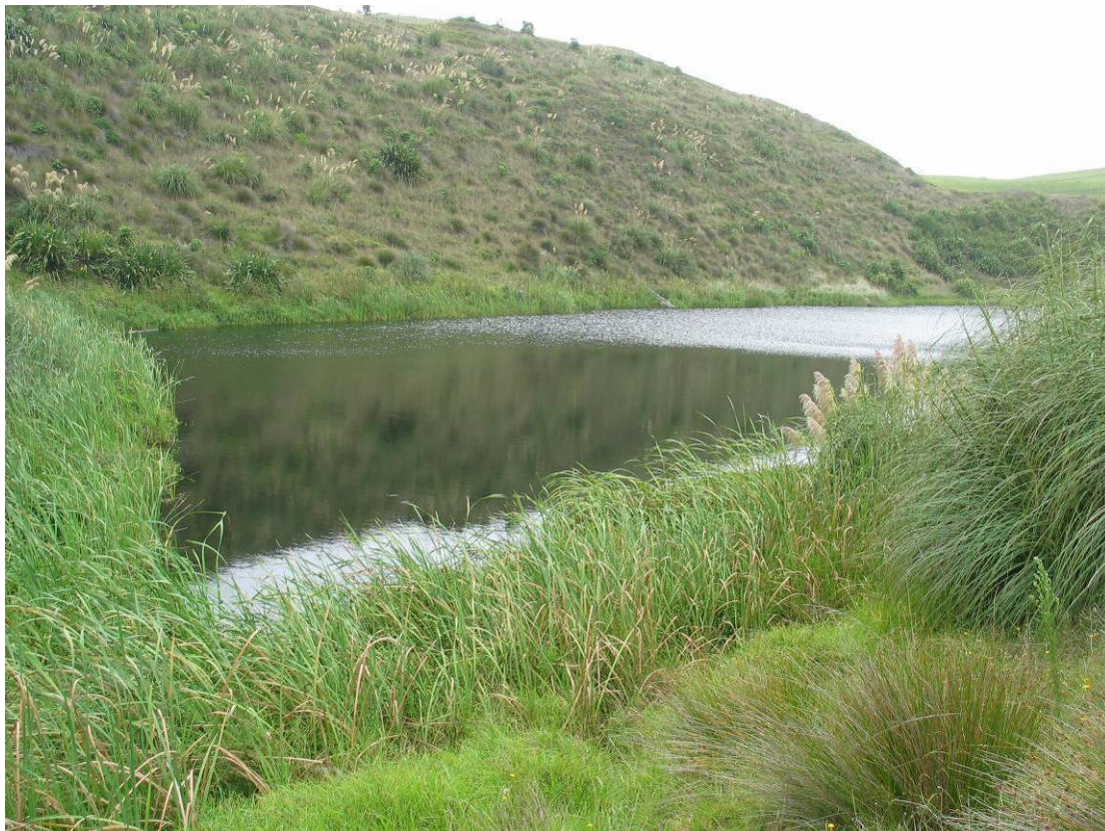
Plate: Grevilles Lagoon, set in a pastoral catchment, with margins retired.

Moderate: Fully fenced with native submerged vegetation, but emergent zone impacted by the weed *Alternanthera philoxeroides*.

The margins have recently been retired from grazing and planting has been undertaken. Alligator weed is well established at this site. No monitoring is recommended.

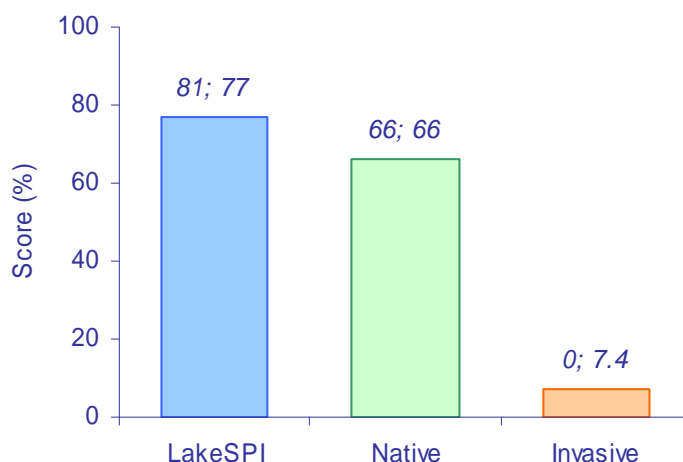
Figure: 2007 LakeSPI Index as % of potential score, Native Condition Index, and Invasive Impact Index (from left to right) with 2005; 2007 values shown respectively.

A relatively high LakeSPI score of 77% was calculated, as there was little invasive impact at the sites sampled and the vegetation was diverse and growing to 10 m.

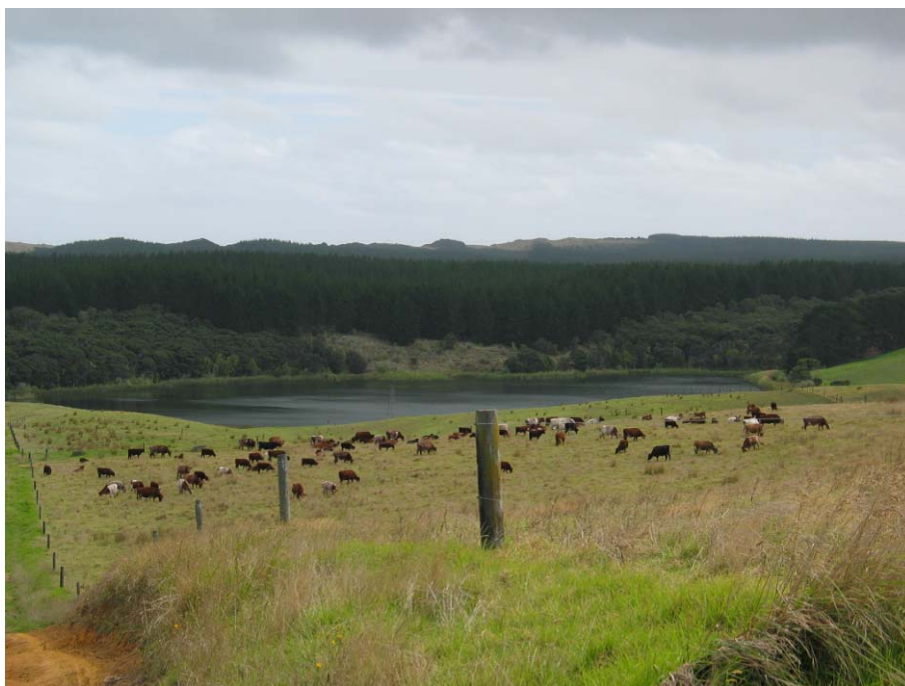
Plate: Lake Kahuparere showing pasture foreground, and pine forest on sand dunes to the rear.

The relatively poor visibility and presence of filamentous algae covering the submerged vegetation indicated nutrient enrichment. Cattle access to the east shoreline not only has damaged the marginal vegetation through grazing and trampling, but can also lead to direct addition of nutrients to the lake by defecation and urine. Fencing of

the margin was noted in 2009, with a corresponding decline in the abundance of filamentous algae.

Lake condition monitoring every 5 years.

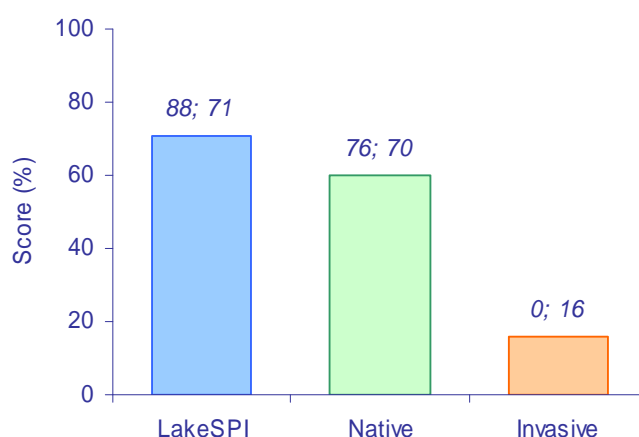
Figure: 2007 LakeSPI Index as % of potential score, Native Condition Index, and Invasive Impact Index (from left to right) with 2005; 2007 values shown respectively.

High LakeSPI score of 71% driven by high cover native vegetation to 5.6 m but decreased from 2005 assessment due to *U. gibba* invasive impact.

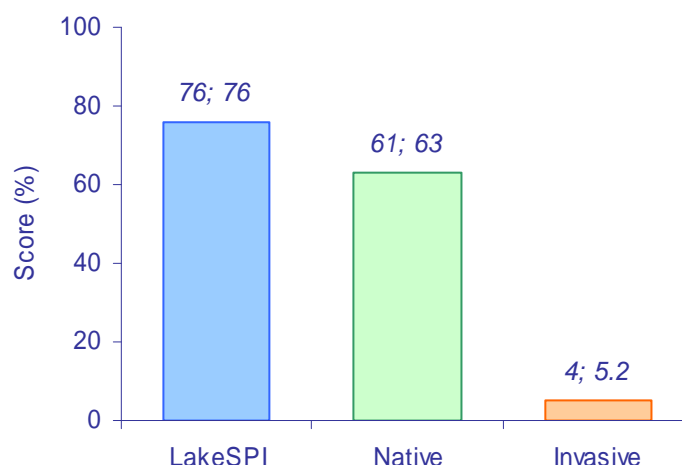
Figure: 2007 LakeSPI Index as % of potential score, Native Condition Index, and Invasive Impact Index (from left to right) with 2005; 2007 values shown respectively.

A high LakeSPI score of 76% was driven by high cover native vegetation to 7.7 m and a lack of invasive species, apart from a few plants of *P. crispus* at one profile.

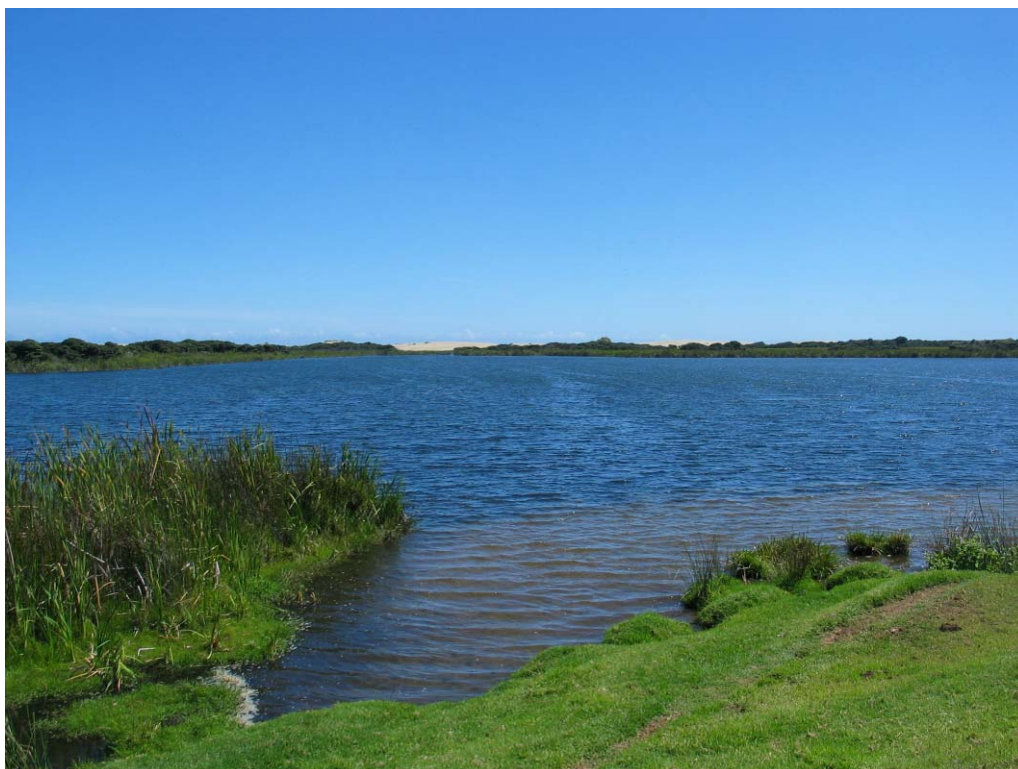
Plate: Lake Karaka viewed from the access point showing pasture to the lake edge. The remainder of the lake margin is wetland.

Advocate fencing off the eastern shoreline to prevent cattle access to the lake.

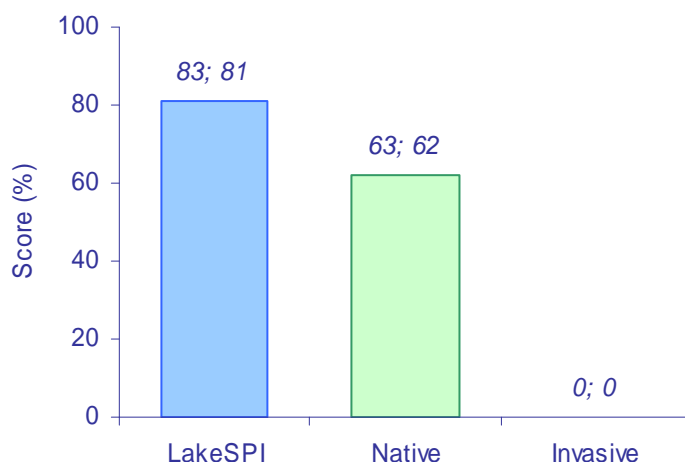
Figure: 2007 LakeSPI Index as % of potential score, Native Condition Index, and Invasive Impact Index (from left to right) with 2005; 2007 values shown respectively.

A high LakeSPI score of 81% reflects extensive charophyte meadows and a lack of invasive species.

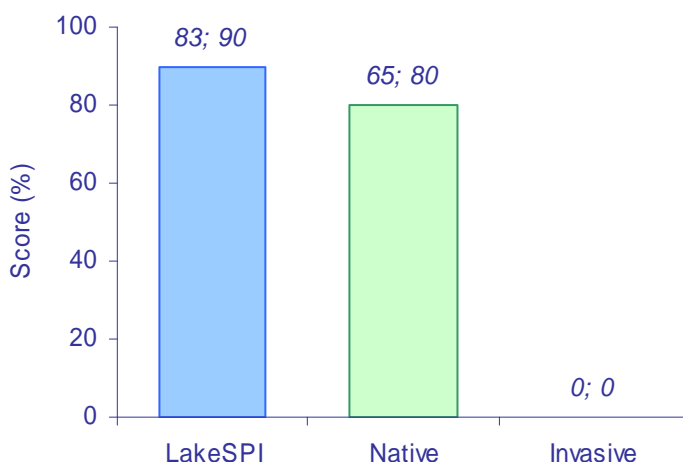
Figure: 2007 LakeSPI Index as % of potential score, Native Condition Index, and Invasive Impact Index (from left to right) with 2005; 2007 values shown respectively.

The high LakeSPI condition of 90 % reflects high cover charophyte meadows and absence of introduced submerged invasive weeds. The increase in value since 2005 is because the deep portion of the lake was found and charophyte meadows grew to beyond 5 m deep.

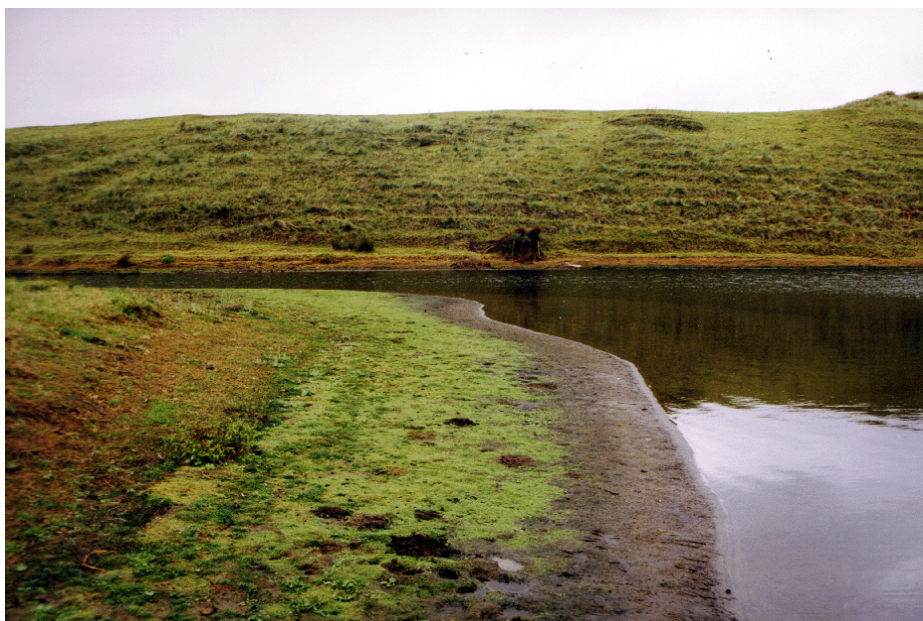
Plate: Southern end of Lake Parawanui showing the pasture catchment and grazed margin with an exposed turf community.

Low: A degraded lake, with poor water quality, grazed lake margins, sparse submerged vegetation and pest fish present.

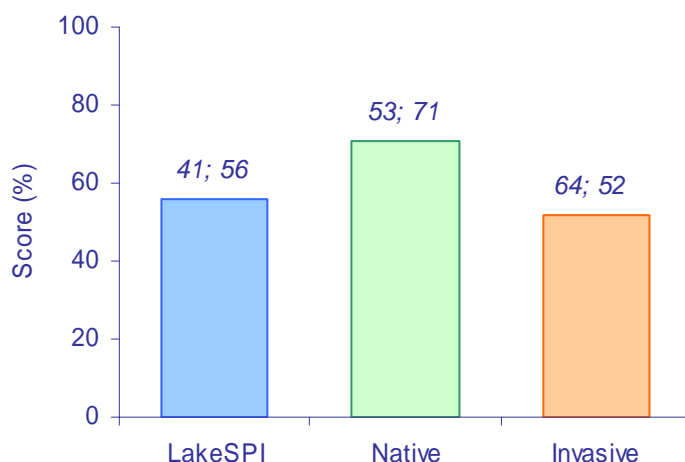
Figure: 2007 LakeSPI Index as % of potential score, Native Condition Index, and Invasive Impact Index (from left to right) with 2005; 2007 values shown respectively, values shown indicating a marked improvement in the lake.

The LakeSPI Index has improved markedly. A closer look at the difference since 2005 found that charophyte meadows were limited to around 6 m deep in 2005 but in 2007 extended to around 10 m. Such a large increase in native cover also reduced the Invasive Index as it occupied a smaller % of the total vegetation. Water clarity in the lake is likely to have improved or perhaps the lake has not stratified in 2007 but was in 2005.

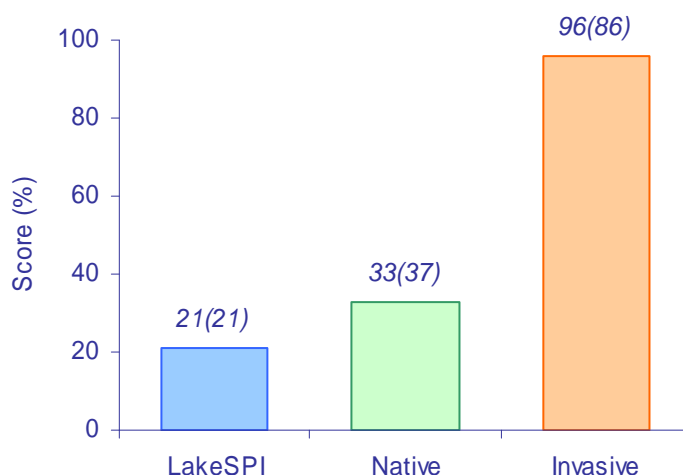
Figure: LakeSPI Index as % of potential score, Native Condition Index, and Invasive Impact Index (from left to right) with 2005 scores in brackets.

A very low LakeSPI score of 21% as *E. densa* and *C. demersum* have greatly reduced native values in the lake.

Recommendations to isolate the lake to contain the submerged invasive weeds have been followed to protect the nearby pristine lakes. Eradication of submerged weeds by introduction of grass carp has been implemented and this eradication strategy will be monitored.

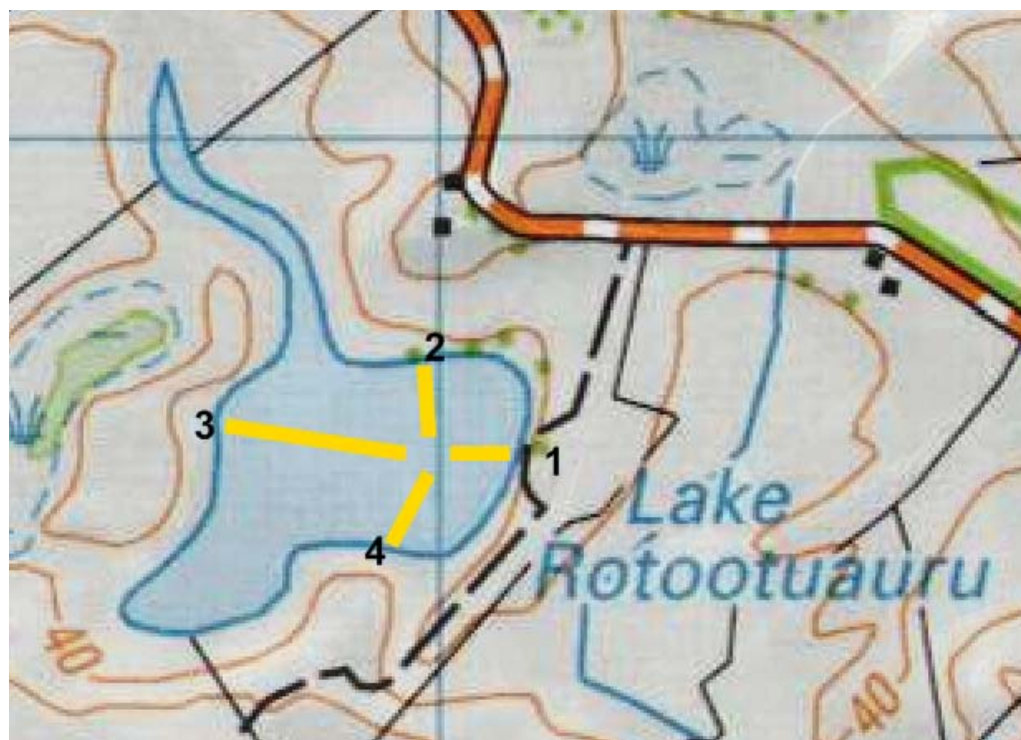
A sonar survey of the lake was conducted along the four SCUBA profiles as shown on the map. In addition observations were made of the vegetation in the north arm.

Map: Lake Roto-otuaauru showing the location of the four profile sites.

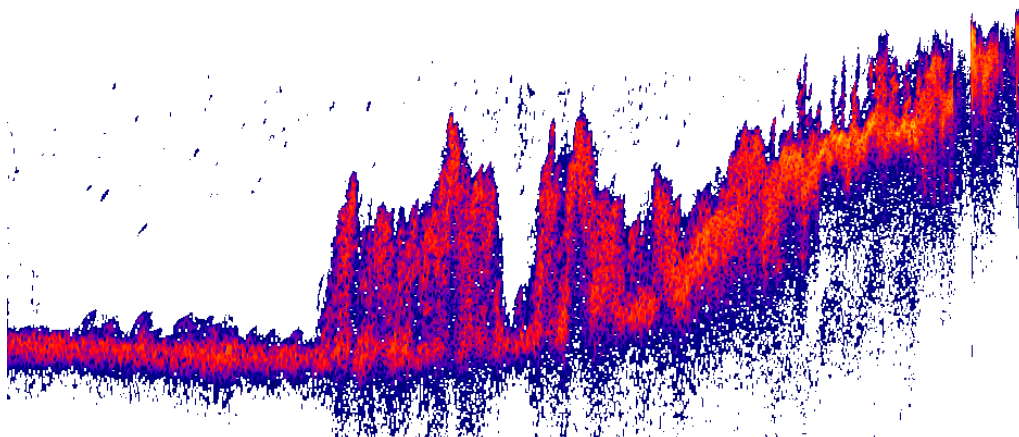
Sonar image Profile 1:

The sonar image shows an outline of the weed beds in April 2009. This transect is about 120 m long and the maximum depth is 5 m to the top of the red band (soft sediment) at left of image. See the map of Lake Roto-otua for profile location.

In ground truthing these profiles it was noted that kuta beds (*Eleocharis spachelata*) dominated the emergent vegetation on the margins of the lake. Egeria dominated the vegetation on profiles from about 2 m water depth (near the outer margin of the kuta beds) to 2.8 m and hornwort dominated from 2.8 m to 5 m, the maximum depth the submerged vegetation grew to. Egeria mostly grew to about 1 m of the surface (swan browsed) whereas hornwort was often surface-reaching even from 5 m water depth. Profile 2 had the only significant native submerged vegetation which were made up mainly of charophytes and restricted to less than 1.8 m water depth. Hornwort was the dominant plant in the northern arm with a large area of egeria at the entrance.

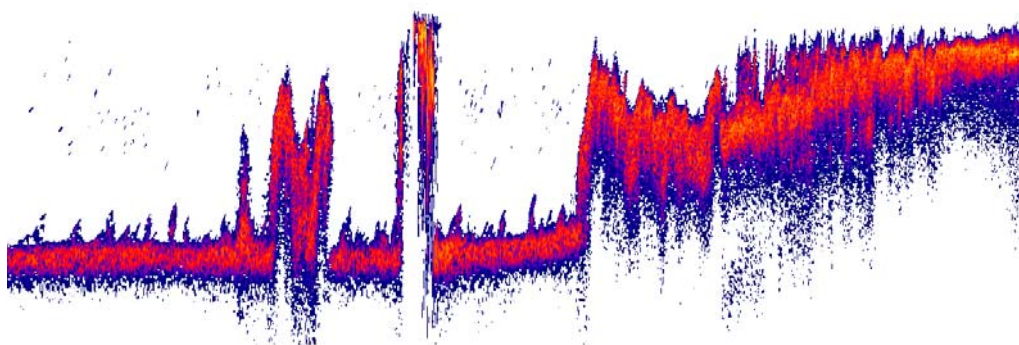
Sonar image Profile 2:

The sonar image shows an outline of the weed beds in April 2009. This transect is about 150 m long and the maximum depth is 5 m to the top of the red band (soft sediment) at left of image. See the map of Lake Roto-otua for profile location.

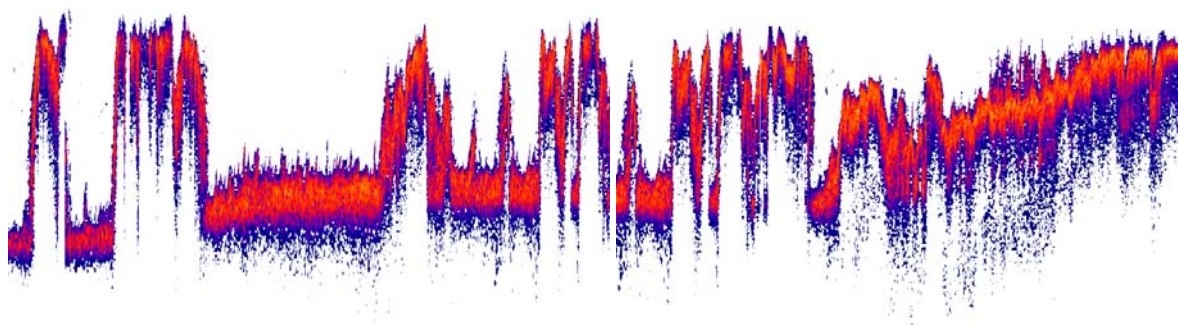
Sonar image Profile 3: The sonar image shows an outline of the weed beds in April 2009. This transect is about 350 m long and the maximum depth and height of weed bed is 5 m to the top of the red band (soft sediment) at left of image. See the map of Lake Roto-otua for profile location.

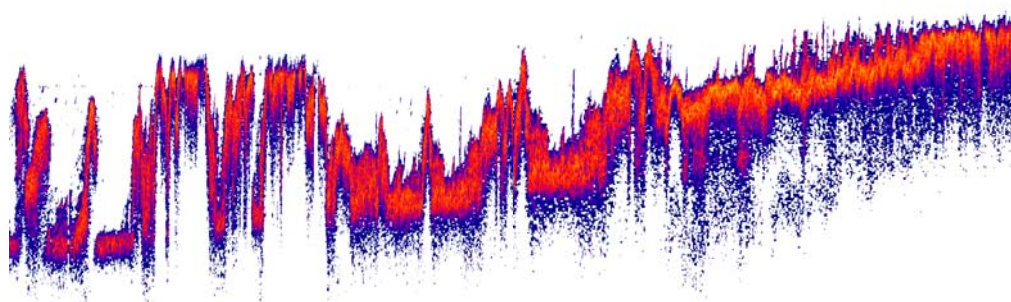
Sonar image Profile 4: The sonar image shows an outline of the weed beds in April 2009. This transect is about 160 m long and the maximum depth and height of weed bed is 5 m to the top of the red band (soft sediment) at left of image. See the map of Lake Roto-otua for profile location.

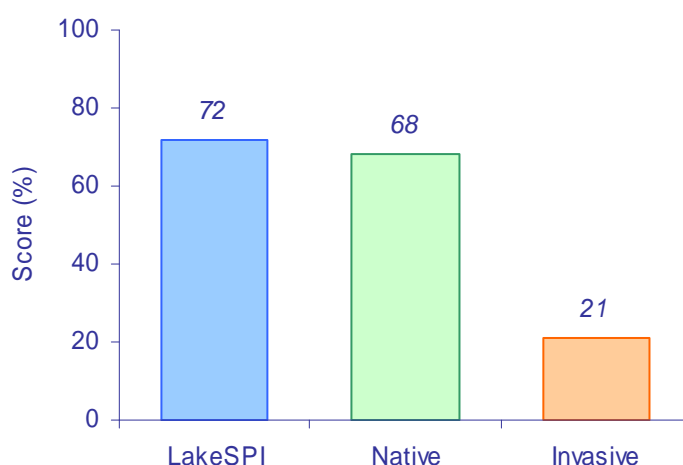
Figure: LakeSPI Index as % of potential score, Native Condition Index, and Invasive Impact Index (from left to right).

The invasive impact is from *Utricularia gibba*; otherwise the lake has a high LakeSPI.

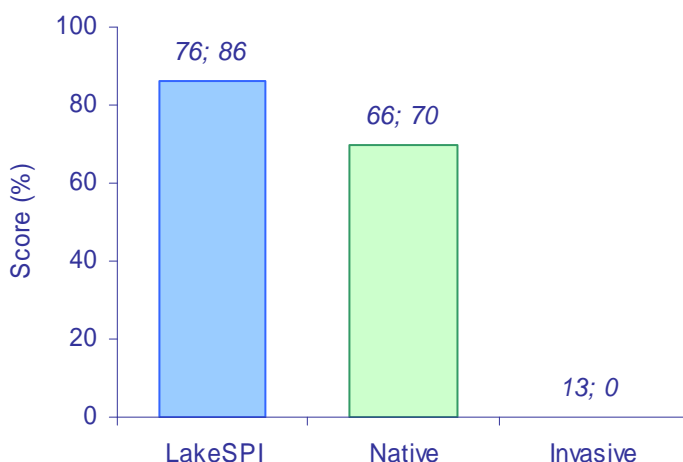
Figure: 2007 LakeSPI Index as % of potential score, Native Condition Index, and Invasive Impact Index (from left to right) with 2005; 2007 values shown respectively.

The improvement in lake condition was due to *P. crispus* presence in 2005, but not recorded in 2007. The lake had a high LakeSPI Index of 86% with no invasive macrophyte impact.

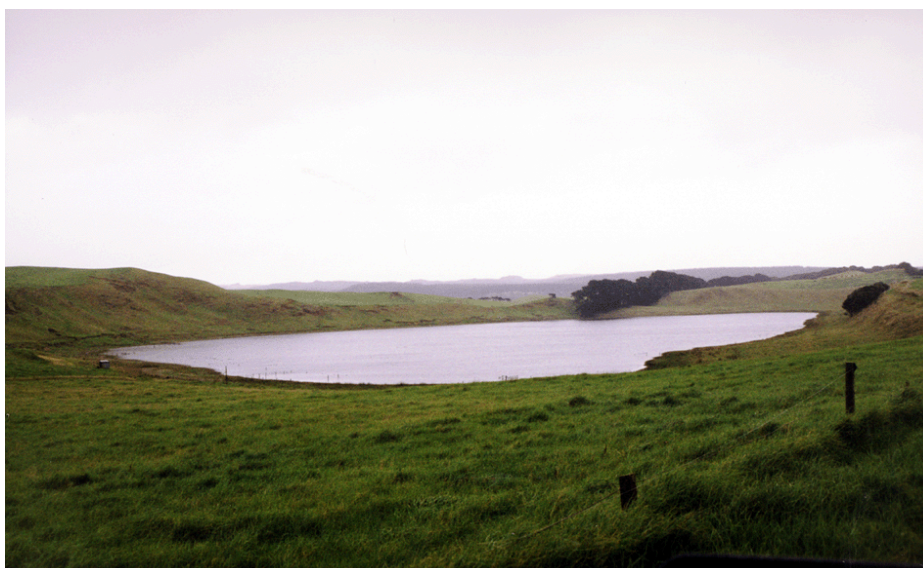
Plate: Lake Waingata surrounded by pasture with emergent vegetation completely lacking.

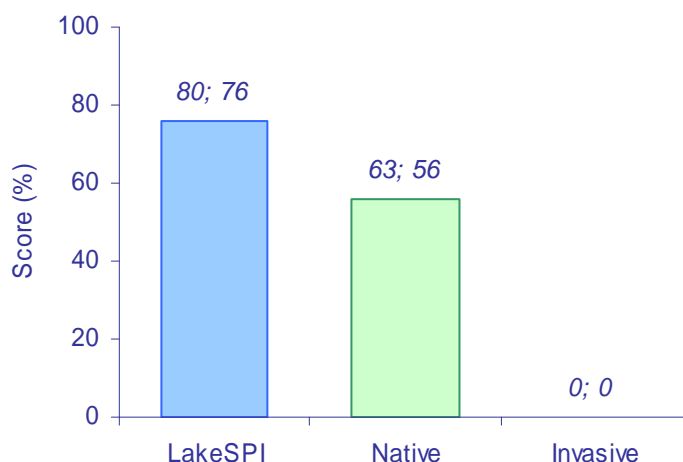
Figure: 2007 LakeSPI Index as % of potential score, Native Condition Index, and Invasive Impact Index (from left to right) with 2005; 2007 values shown respectively.

A high LakeSPI score of 76% is driven by a totally native vegetation, but moderated by poor water clarity and shallow depth limits.
