Water quality and ecology

State of water quality in Mangere catchment

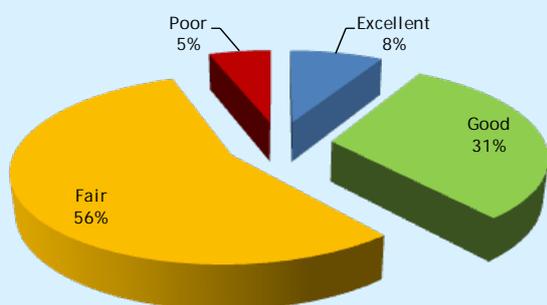
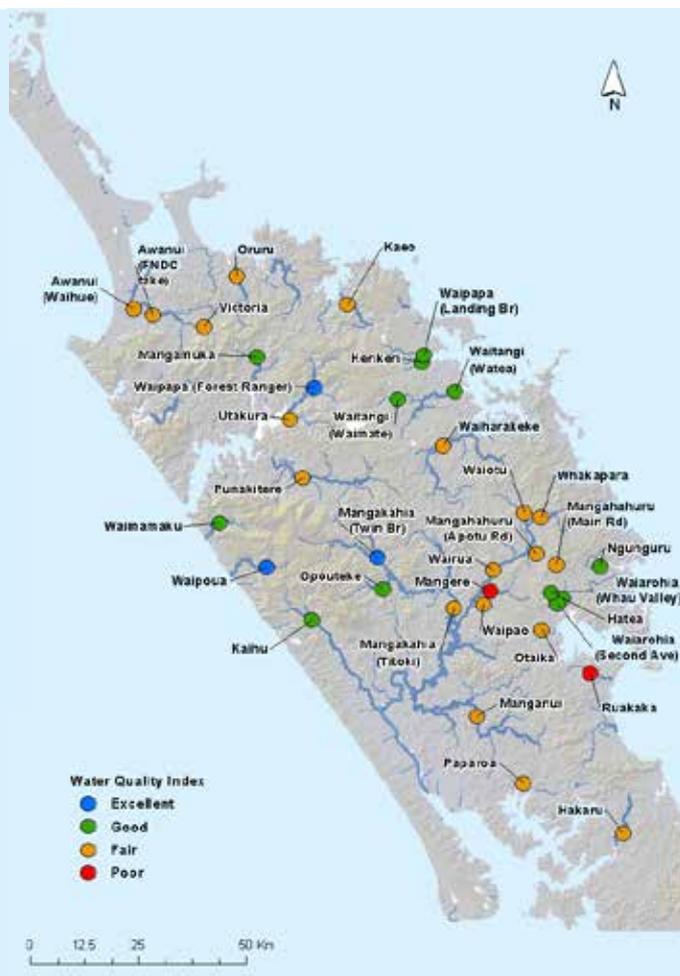
Percentage breakdown of overall water quality grade at monitoring sites

Mangere River's 'poor' water quality index score places it in the bottom 5% of Northland's monitored rivers.

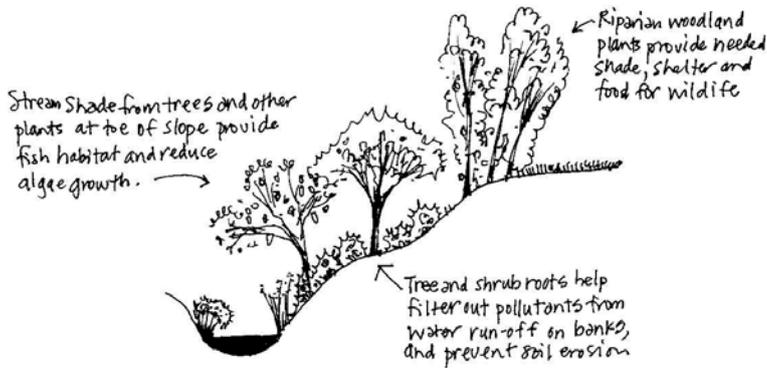
The Mangere River is surrounded by pasture. In many places livestock have direct access to the river which results in unstable banks and high in-stream sediment loads.

While the totara trees along much of the Mangere's stream bank provide good shade, little understory vegetation exists to help trap sediment. Stream diversity is poor due to the homogenous nature of the river which provides only one habitat and flow type.

Habitat assessment data is consistent with the poor water quality at the Knights Road site, resulting in 'MARGINAL' score for ecological health.
