NORTHLAND RIVERS HABITAT ASSESSMENT

2008 - 2010

July 2011
Northland Regional Council
Private Bag 9021
Whangarei 0140
Freephone: 0800 002 004

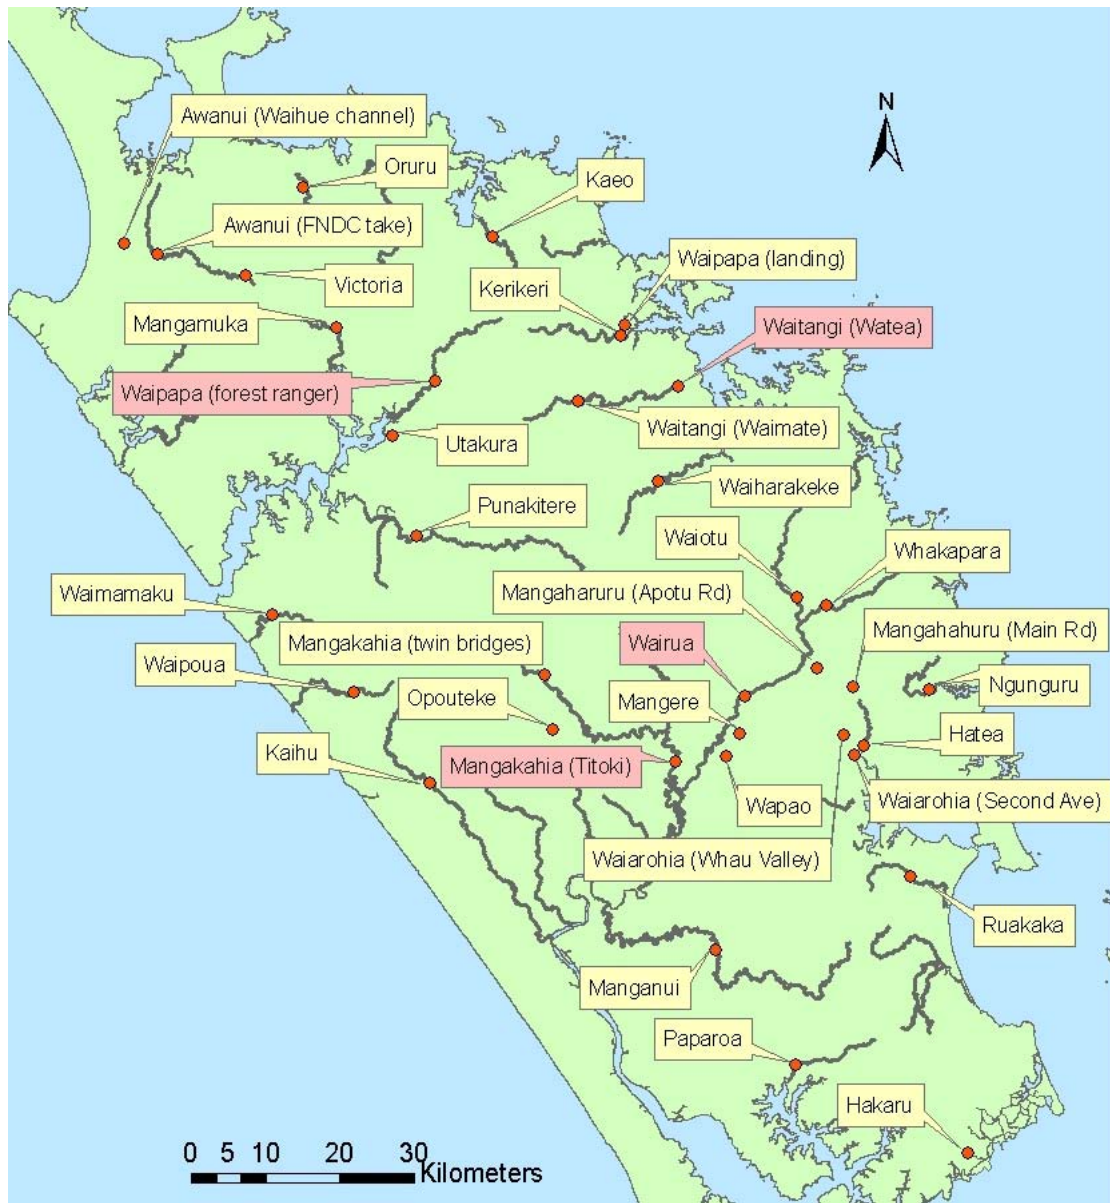
Figure 1: Map showing the 35 Regional Water Quality Monitoring Network sites (National River Water Quality Network sites in pink).

The sites assessed by the Council are those included in the Regional River Water Quality Monitoring Network (RWQMN). There are currently 35 sites in this network; 31 of which are monitored by the Council and four by the National Institute of Water and Atmospheric Research (NIWA) (shown in pink in Figure 1).

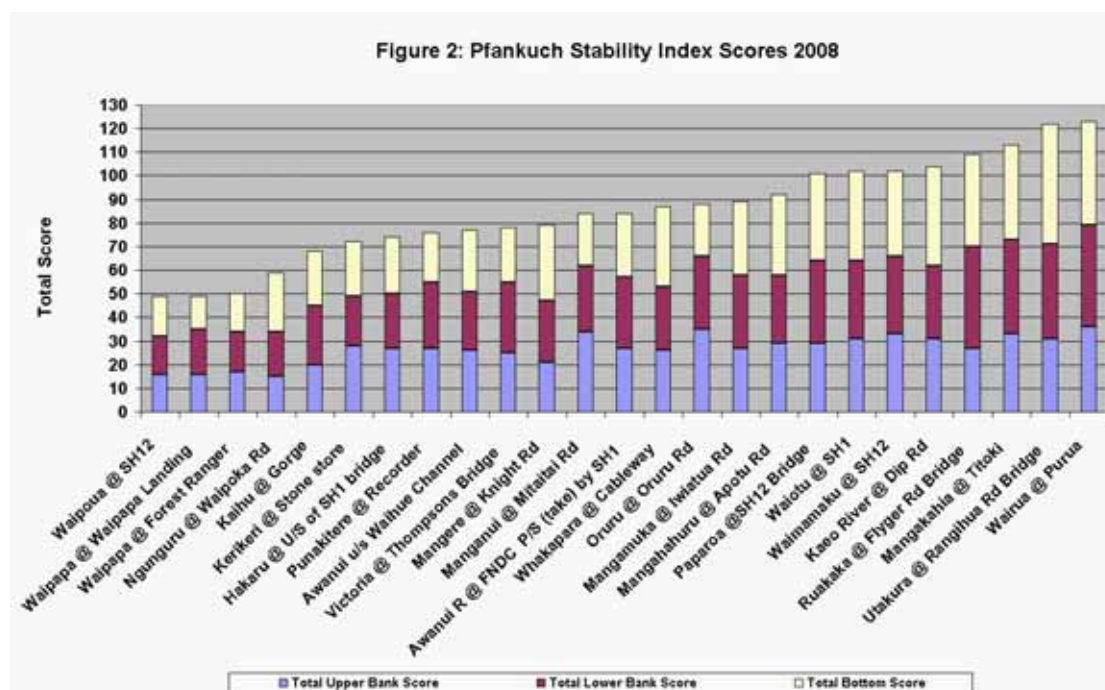
Figure 2 shows the total Pfankuch Stability Score, broken down into upper bank, lower bank and bottom scores, for all sites assessed in 2008. Sites are ranked from lowest score (most stable habitat) to highest score (least stable habitat).

Of the 25 sites assessed in 2008, none had excellent stability (a score of less than 38); eight sites had good stability (39-76), 15 sites had fair stability (77-114) and two sites had poor stability (>115).

The three most stable sites were Waipoua (49), Waipapa at Waipapa Landing (49) and Waipapa at Forest Ranger (50). The two least stable sites were Utakura (122) and Wairua (123).

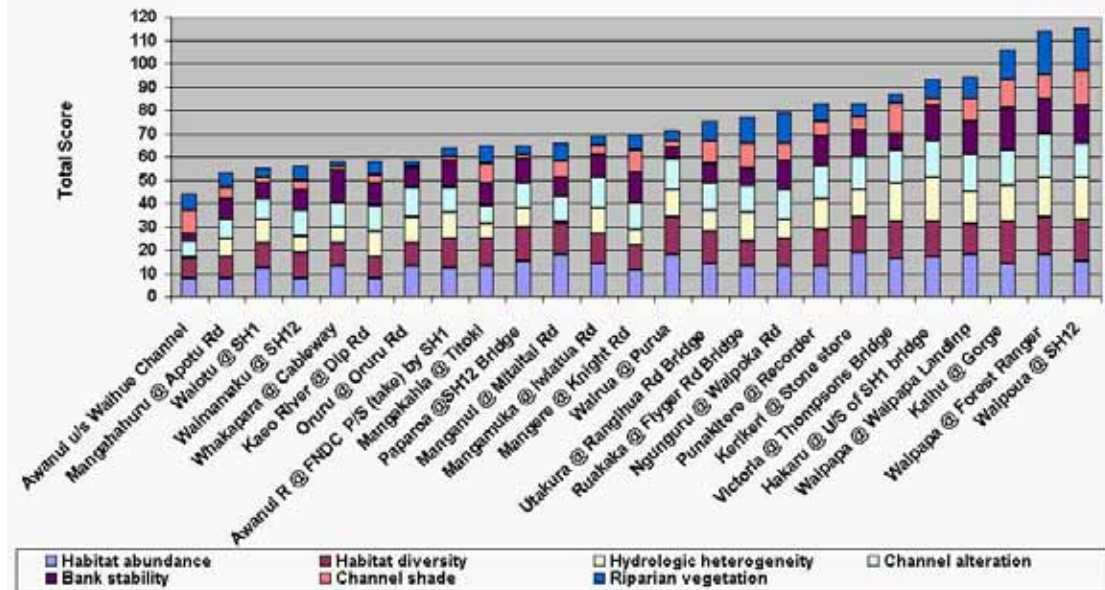
Figure 3: Habitat Quality Scores 2008

Figure 3 shows total habitat quality scores, broken down into component parts, for all sites assessed in 2008. Sites are ranked from lowest score (poorest habitat) to highest score (best habitat).

Of the 25 sites assessed in 2008, none had a poor habitat (a score of less than 38), 14 sites had a marginal habitat (39-73), nine sites had a sub-optimal habitat (74-108) and two sites, Waipapa at Forest Ranger and Waipoua, had an optimal habitat (109-140).

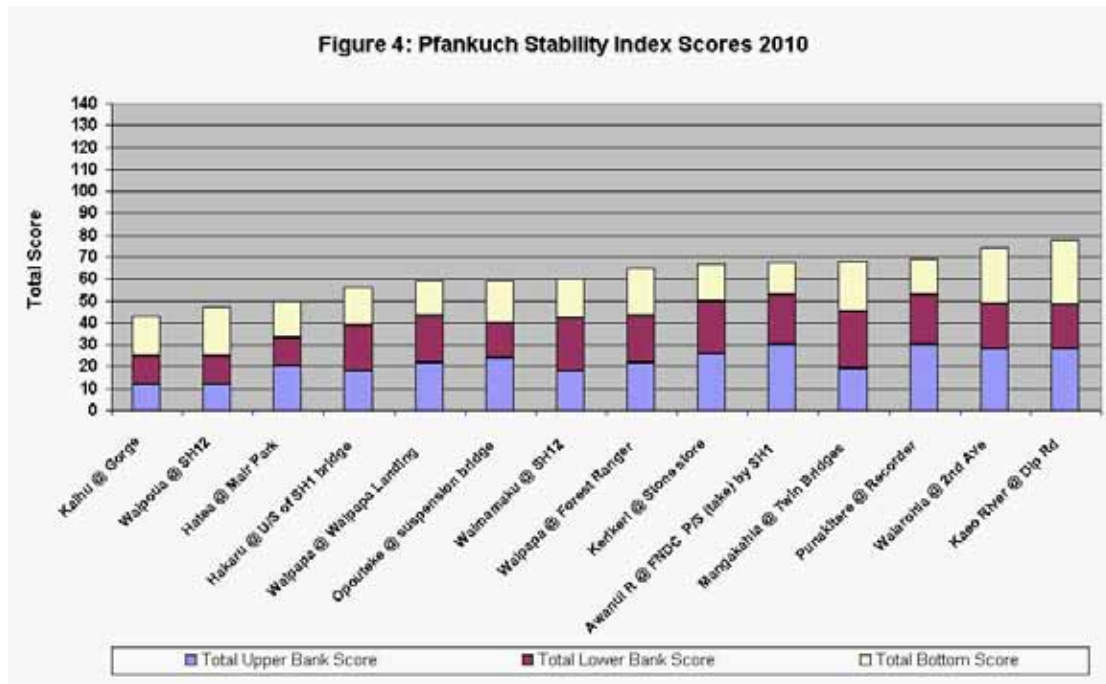
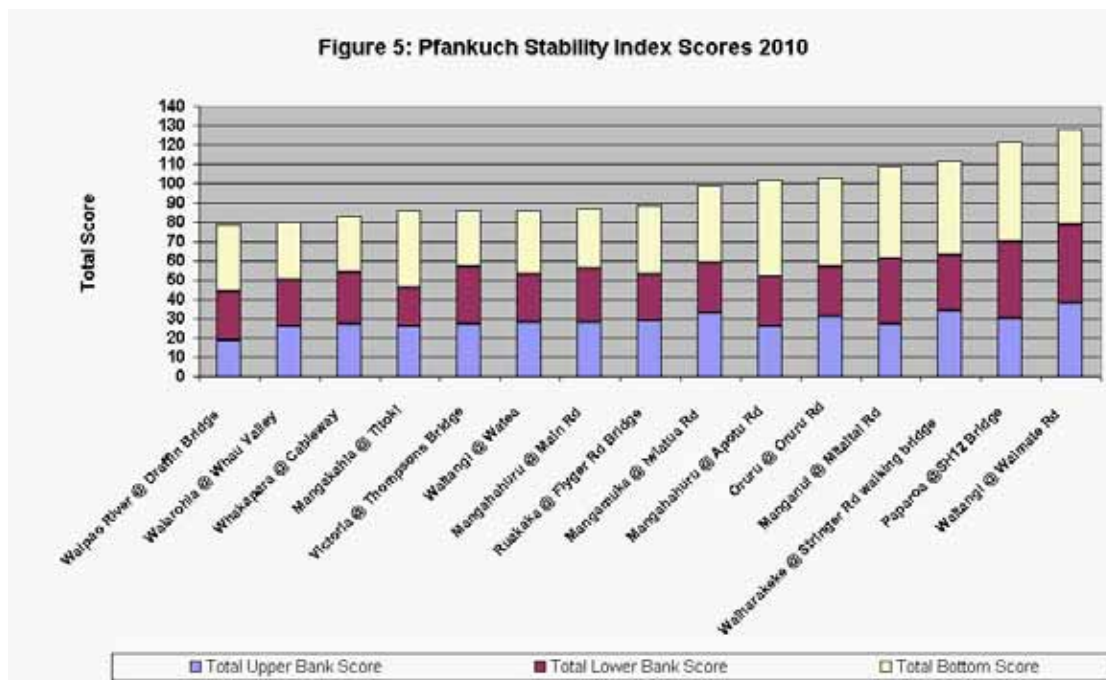
Figures 4 and 5 show the total Pfankuch Stability Score, broken down into upper bank, lower bank and bottom scores, for all sites assessed in 2010. Sites are ranked from lowest score (most stable habitat) to highest score (least stable habitat).

Six sites – Utakura, Ngunguru, Awanui at Waihue channel, Waiotu, Mangere and Wairua - could not be waded due to depth. These sites do not have bottom data and it was therefore not possible to calculate a stability score for these sites in 2010.

Of the sites assessed, no sites had excellent stability; 13 sites had good stability, 14 sites had fair stability and two sites had poor stability.

The two most stable sites in 2010 were Kaihu (43) and Waipoua (47). In comparison, the two most stable sites in 2008 were Waipoua (49) and Waipapa at Waipapa Landing (49). Kaihu was the fifth most stable site in 2008 with a score of 68 and so appears to have become more stable over the past two years. Waipapa at Waipapa Landing was fifth most stable in 2010 with a score of 59 and so appears to be slightly less stable in 2010.

The two least stable sites in 2010 were Waitangi at Waimate (128), followed by Paparoa (122). In comparison, the two least stable sites in 2008 were Wairua and Utakura. Neither of these sites could be graded in 2010 and so a comparison between years cannot be made.

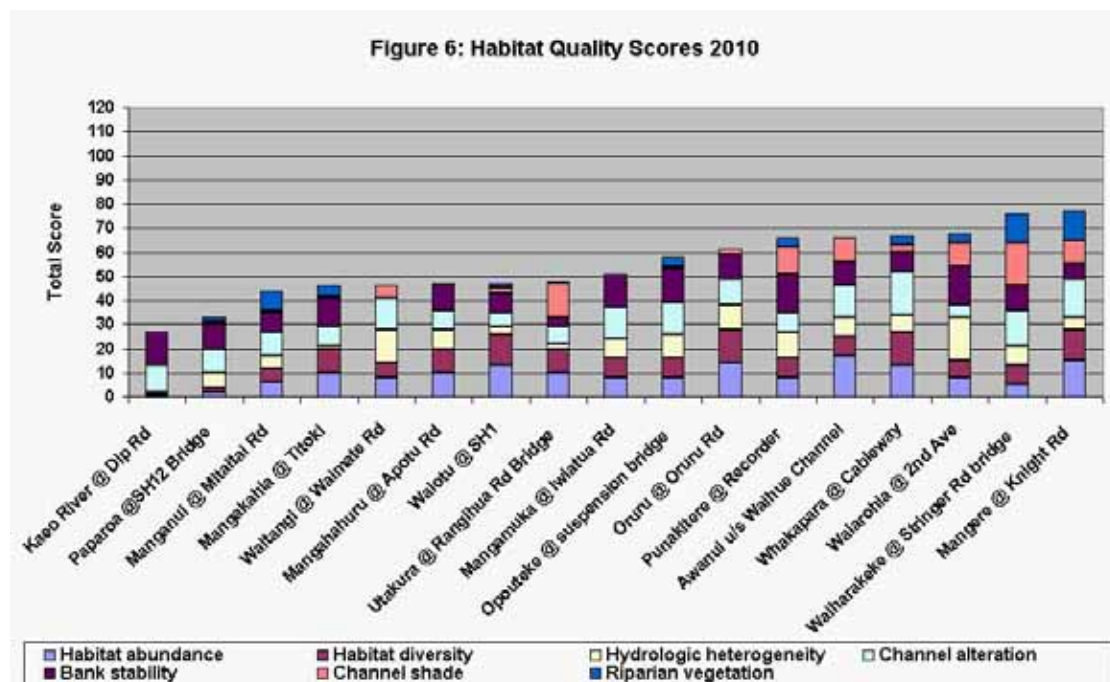
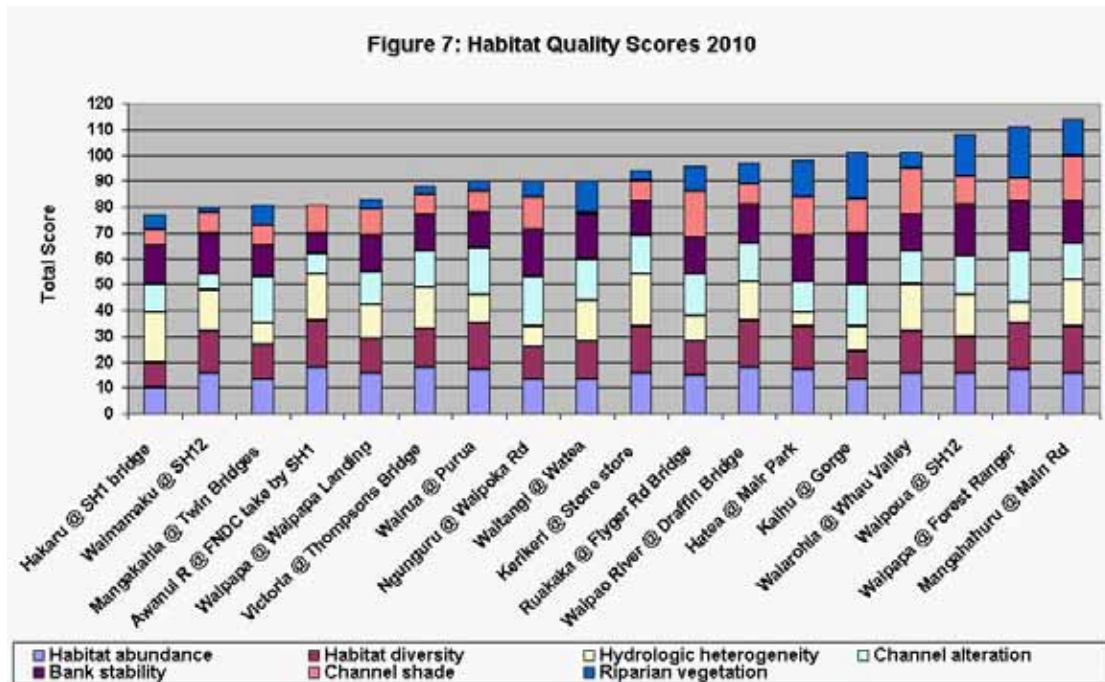
Figures 6 and 7 show total habitat quality scores, broken down into component parts, for all sites assessed in 2010. Sites are ranked from lowest score (poorest habitat) to highest score (best habitat).

Of the 35 sites assessed in 2010, two had poor habitat quality, 13 sites had a marginal habitat, 18 sites had a sub-optimal habitat and two sites had an optimal habitat.

The two sites with optimal habitat in 2010 were Mangahahuru at Main Road (114) and Waipapa at Forest Ranger (111). In 2008, the two best sites were Waipoua (115) and Waipapa at Forest Ranger (114). Changes in habitat quality at these two sites appear to have been negligible over the last two years, even though the site on the Waipoua River has fallen one grading from optimal to sub-optimal. The Mangahahuru at Main Road was not assessed in 2008 and so a comparison of scores at this site cannot be made.

The two poorest sites in 2010 were the Kaeo River (27) and Paparoa (33). In 2008, the two worst sites were Awanui at Waihue Channel (44) and Mangahahuru at Apotu Road (53). Awanui at Waihue was graded thirteenth poorest in 2010 with a score of 66. This indicates that habitat quality at this site has improved slightly in the last two years. Mangahahuru at Apotu Road was graded sixth poorest in 2010 with a score of 47. The difference between the score in 2008 and 2010 is negligible suggesting there has been little change in habitat quality at this site in the last two years.

In 2008, Kaeo was graded sixth poorest with a score of 58. This indicates that habitat quality has deteriorated at this site over the last two years. In 2008, Paparoa was graded tenth poorest with a score of 65. This indicates that habitat quality at this site has also deteriorated over the last two years.

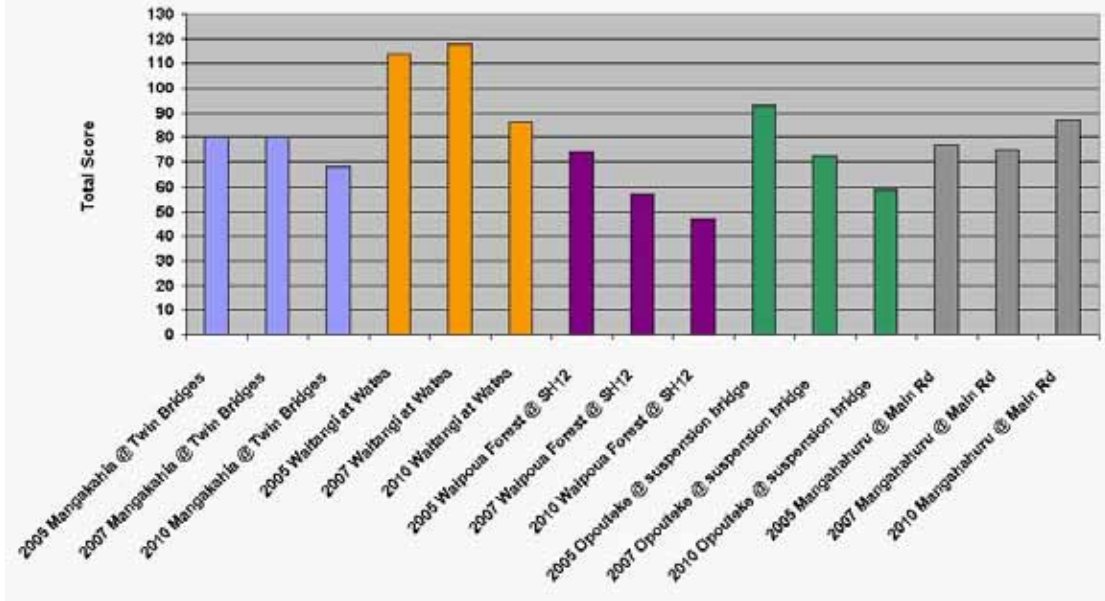
Figure 8: Pfankuch Stability Index Scores 2005-2010

Figures 8, 9, 10 and 11 show Pfankuch Stability Index Scores for sites that have three or more years' data. The method for surveying stream stability is subjective and so minor variations in score from year to year may be as a result of surveyor bias.

Overall, since 2005, the stability of 13 sites appears to have improved; the stability of three sites, Ruakaka River, Wairua River and Mangahahuru at Main Road, appears to have decreased and the stability of four sites, Mangahahuru at Apotu Road, Kaihu River, Awanui at FNDC water take and Waiotu River – appears to be stable.

Seven sites have moved up or down a grade. Two sites have gone from fair to good stability in the last four to five years - Awanui at Waihue and Opouteke River. Four sites have gone from poor to fair stability in the last four to five years – Whakapara River, Kaeo River, Waitangi at Watea and Victoria River. One site – Wairua River - has gone from fair to poor stability in the last four years.

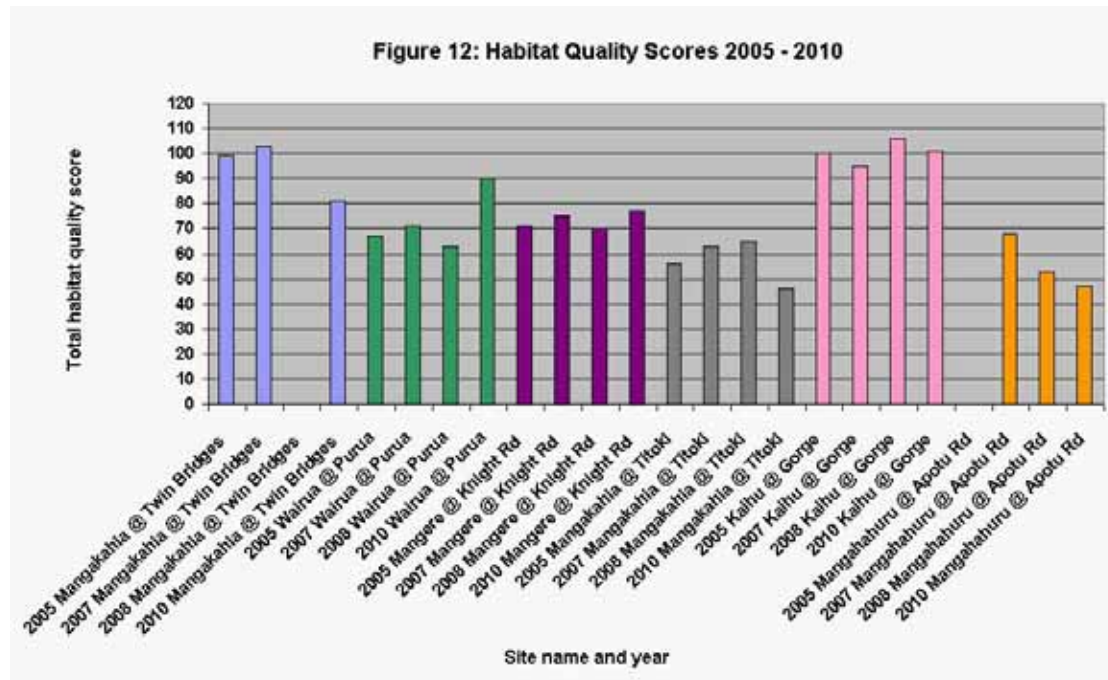
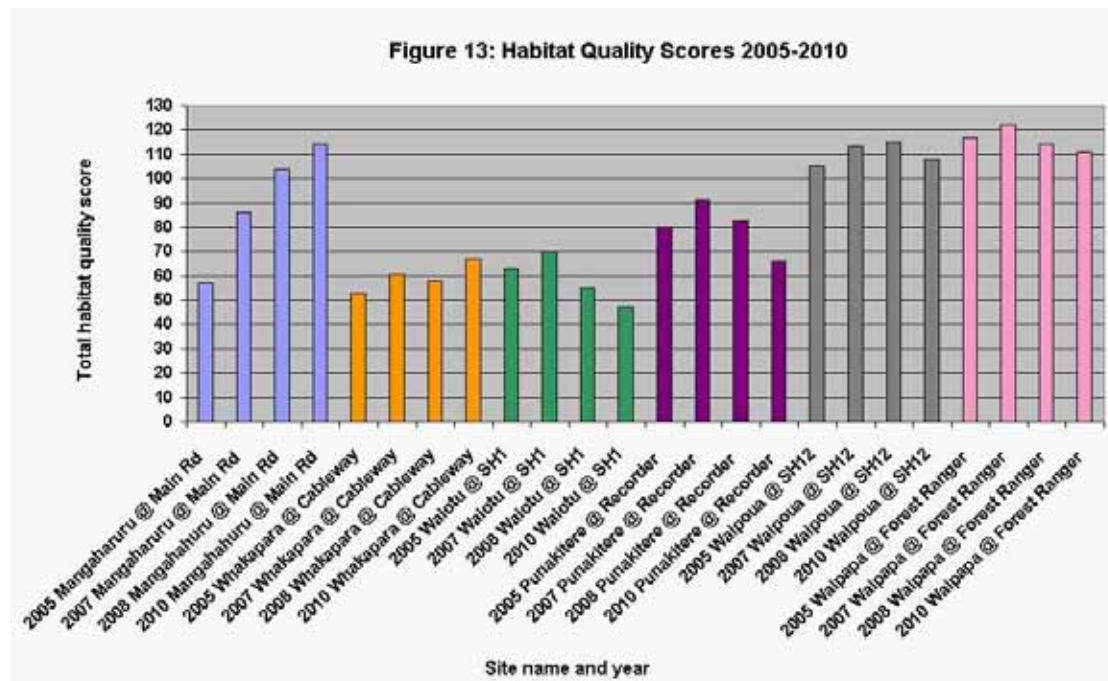
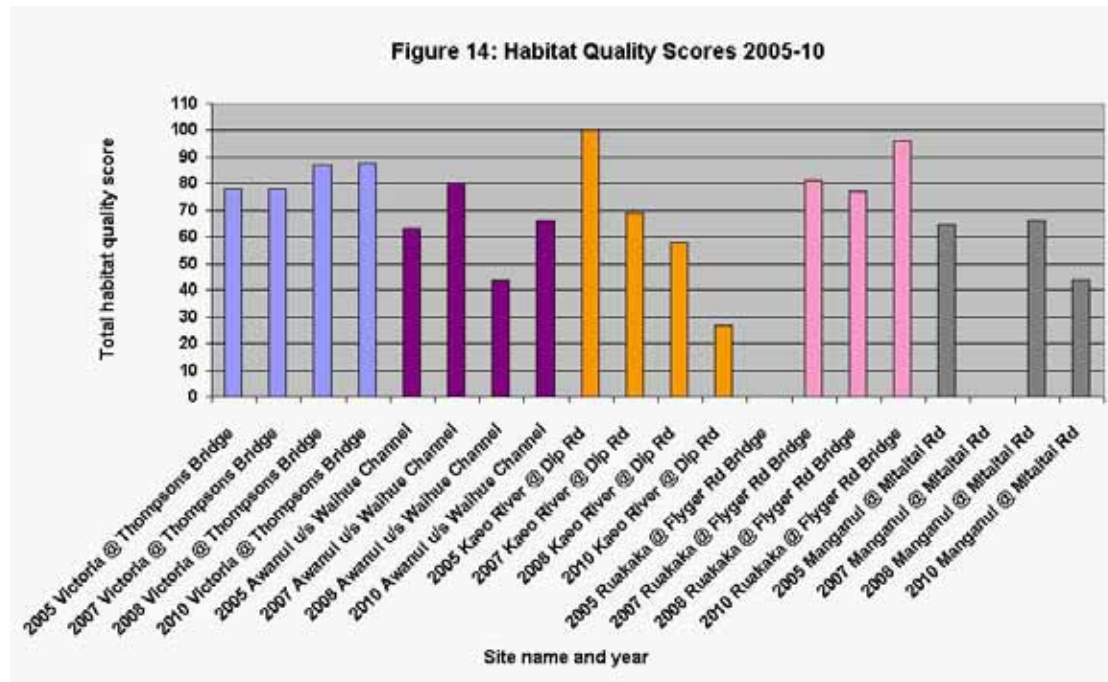
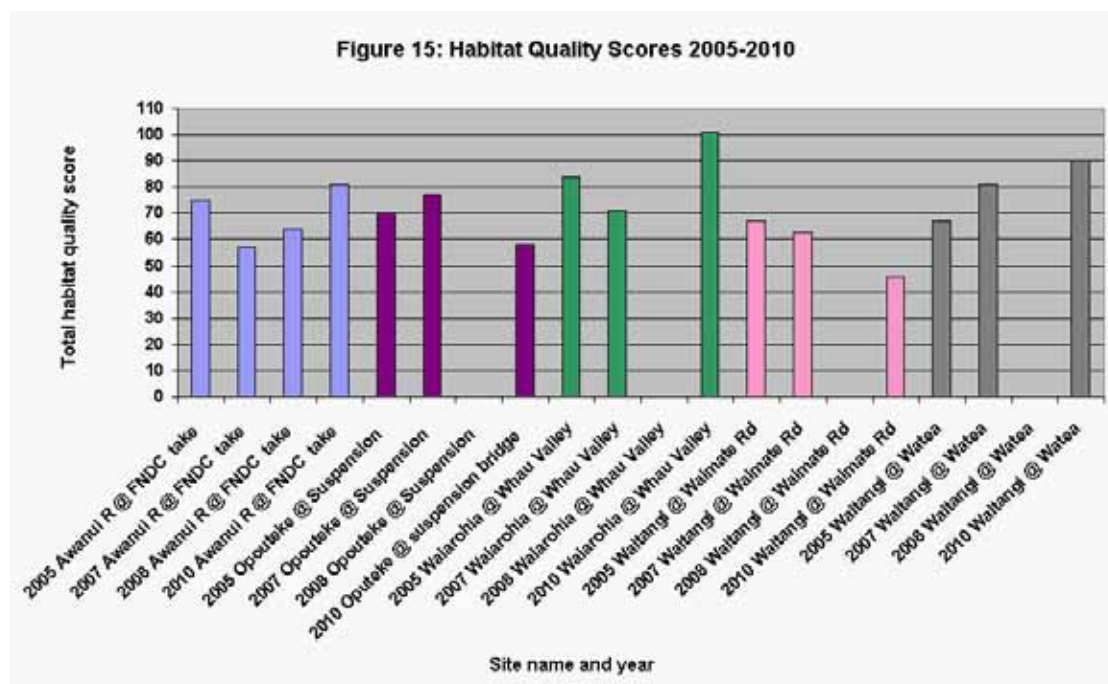
Figures 12, 13, 14 and 15 show habitat quality data for sites that have three or more years' data. The method for surveying habitat quality is highly subjective and so minor variations in score from year to year may be as a result of surveyor bias.

Overall, since 2005, the habitat at nine sites appears to have increased in quality; the habitat at ten sites appears to have decreased in quality and habitat quality at three sites has remained relatively stable.

Significant changes appear to have occurred in the Kaeo River (downward trend from sub-optimal to poor habitat quality), Mangahuru at Main Road (upward trend from marginal to sub-optimal), Waitangi at Watea (upward trend from marginal to sub-optimal), Wairua (upward trend from marginal to sub-optimal), Ruakaka (downward trend from sub-optimal to marginal) and Punakitere (downward trend from sub-optimal to marginal).

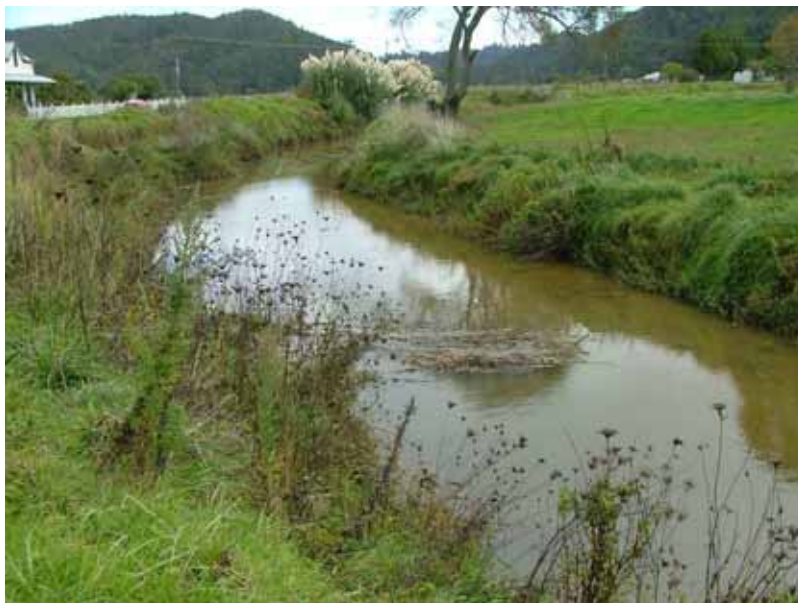
The **Kaeo River** is subject to frequent flooding events, erosion/cutting and deposition. It is likely that these events have had an impact on habitat quality at this site. Some parts of the Kaeo River are also open to stock access, which may have an impact on habitat quality. Habitat quality has fallen from sub-optimal to poor in the last five years.

However, the site has fair stability and stability appears to have improved in the last five years from poor in 2005. This may be due to channel stabilisation work that has been undertaken on the river for flood prevention purposes. Habitat quality will take longer to recover than channel stability and may not improve unless riparian fencing and planting is undertaken, to reduce the effect of livestock on riparian vegetation.

There is currently insufficient water quality data for this site to complete formal trend analysis however, no trends are apparent in the data collected to date. The site ranks number 27th out of 35 for macroinvertebrate species richness (number of species present), which would be a reflection of poor habitat quality and availability and lack of channel shading. It has an MCI and SQMCI value that indicate moderate levels of pollution.

Photo: Kaeo River, upstream view

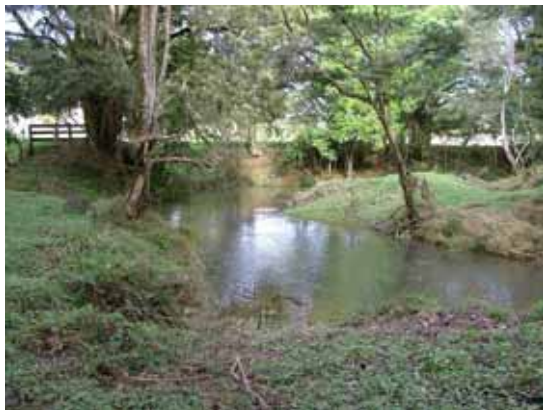
The site on the **Mangahuru at Main Road** is within an area of native bush and is fenced from livestock access, although livestock do occasionally access this area. The surrounding land-use is exotic forestry and pasture. There is some bank cutting and erosion of the bends in the river however the banks are relatively stable. Habitat quality has risen from marginal to optimal in the last five years and the site has fair

stability. The improvement in habitat quality may be a reflection of a more stable channel and low-intensity land-use in the upper catchment. It may also be a reflection of maturing riparian vegetation and an increase in channel shading.

Time trend analysis of data collected for this site indicates an increasing trend in turbidity. However, water quality is generally good. The site ranks eighth for macroinvertebrate species richness and eighth for %EPT, which is a reflection of good habitat quality and good channel shading. The site has an MCI and SQMCI that indicate clean water and the site ranks third and second respectively in these categories.

Photo: Mangahahuru at Main Road

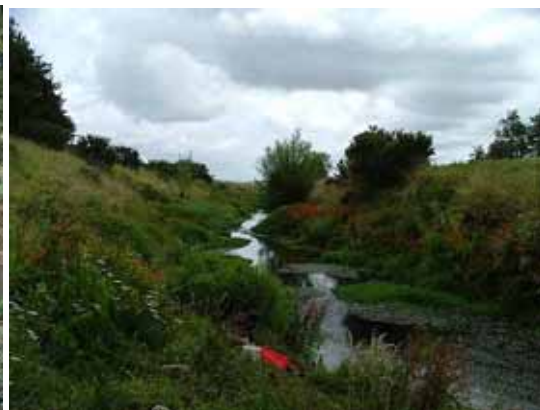
This site is in the upstream catchment of the Mangahahuru River, which feeds into the Wairua River. In comparison, the site further downstream at Apotu Road has marginal habitat quality and fair stability. This site ranks 15th for macroinvertebrate species richness and 29th for % EPT. The site has an MCI and SQMCI that indicates severe pollution, which is a reflection of the more intensive pastoral land-use in the downstream catchment of this river.

Photo: Mangahahuru at Apotu Road

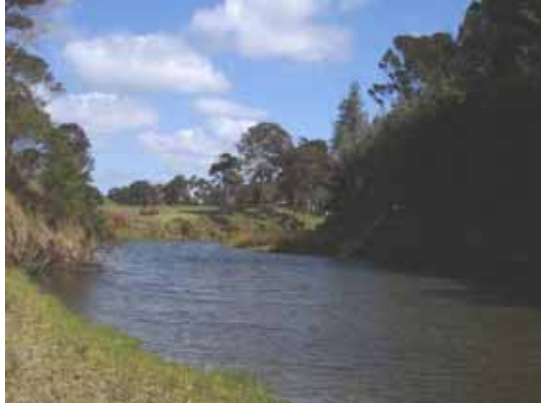
The **Waitangi at Watea** site is above the Haruru Falls, in a small area of bush, towards the bottom of the Waitangi River catchment. The site is not open to livestock access. Habitat quality has risen from marginal to sub-optimal in the last five years at the site. The site has fair stability.

Time trend analysis on water quality data collected from this site indicates an increasing trend in dissolved oxygen and pH and a decrease in total phosphorus and dissolved reactive phosphorus. These trends suggest an improvement in water quality.

However, the site ranks 22nd for macroinvertebrate species richness and 33rd for %EPT. The site has an MCI and SQMCI score indicating severe pollution. Although this site ranks highly for habitat quality and has good water quality, in-stream habitat was greatly affected by flooding three years ago. A high proportion of in-stream habitat and bank-side vegetation was lost from the site and the macroinvertebrate community would have been greatly reduced. Scouring of the river bed also created deep pools, which are less attractive to certain macroinvertebrate fauna. It will take time for the habitat to recover and for macroinvertebrates to re-colonise suitable habitat at this site.

Photo: Waitangi at Watea

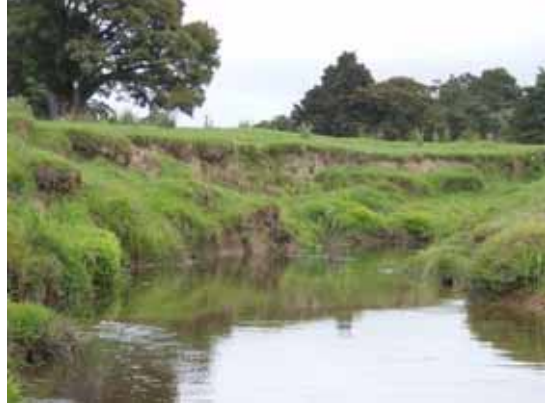
In comparison, the site upstream at Waimate Road has marginal habitat quality and poor channel stability. Water quality at this site is moderate. However, the site ranks second for macroinvertebrate species richness. It has an MCI and SQMCI score that indicate mild and moderate pollution respectively. This site is in an area of intensive pastoral farming and is open to livestock access, with little shading, however a variety of in-stream habitats, including woody debris, silts and gravels; riffles, pools and runs increase the taxonomic richness.

Photo: Waitangi at Waimate

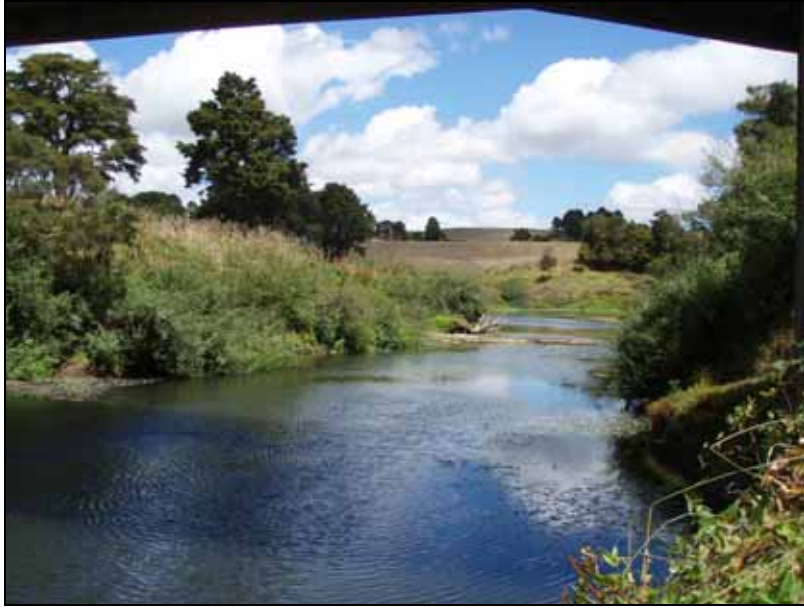
The **Wairua River** catchment is large with several rivers draining into it, including the Mangahuru and Whakapara. The catchment comprises mixed, intensive land-use but at the sampling site, surrounding land-use includes native bush and pastoral farming. The site assessed is open to livestock access and has 20% channel shading. Habitat quality at this site has gone from marginal to sub-optimal in the last five years. However, channel stability has gone from fair to poor in the same time.

Time trend analysis of data collected from the site indicates an increase in conductivity, dissolved oxygen, pH and clarity and a decrease in nutrients. This suggests that water quality is improving at the site.

The site ranks 30th for macroinvertebrate species richness and 24th for %EPT. The MCI and SQMCI score indicate moderate and severe pollution respectively.

Photo: Wairua River

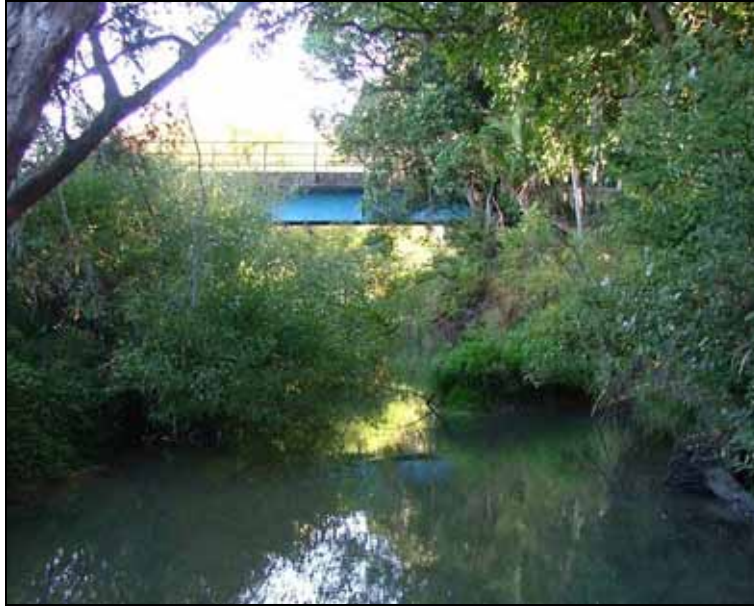
The **Ruakaka River** catchment is relatively small and land-use is largely pastoral farming, with areas of native bush in the upper catchment. The site assessed is not open to livestock access and has 90% channel shading. Habitat quality has declined from sub-optimal to marginal in the last five years. Channel stability is fair.

Time trend analysis has not been undertaken on water quality data for this site. Water quality is generally very poor, with the site ranked worst for water quality out of 35 sites monitored in 2008-09.

The site ranks 25th for macroinvertebrate species richness but third for %EPT. The site has an MCI that indicates clean water and an SQMCI that indicates mild pollution. These results appear contradictory however the sampling methodology used at this site favours the high scoring taxa found in woody debris and so this pushes the MCI and SQMCI scores up, even though the species richness is low. These scores should therefore be used with caution.

Photo: Ruakaka River
