Mangere – Water Quantity Update

24 June 2014

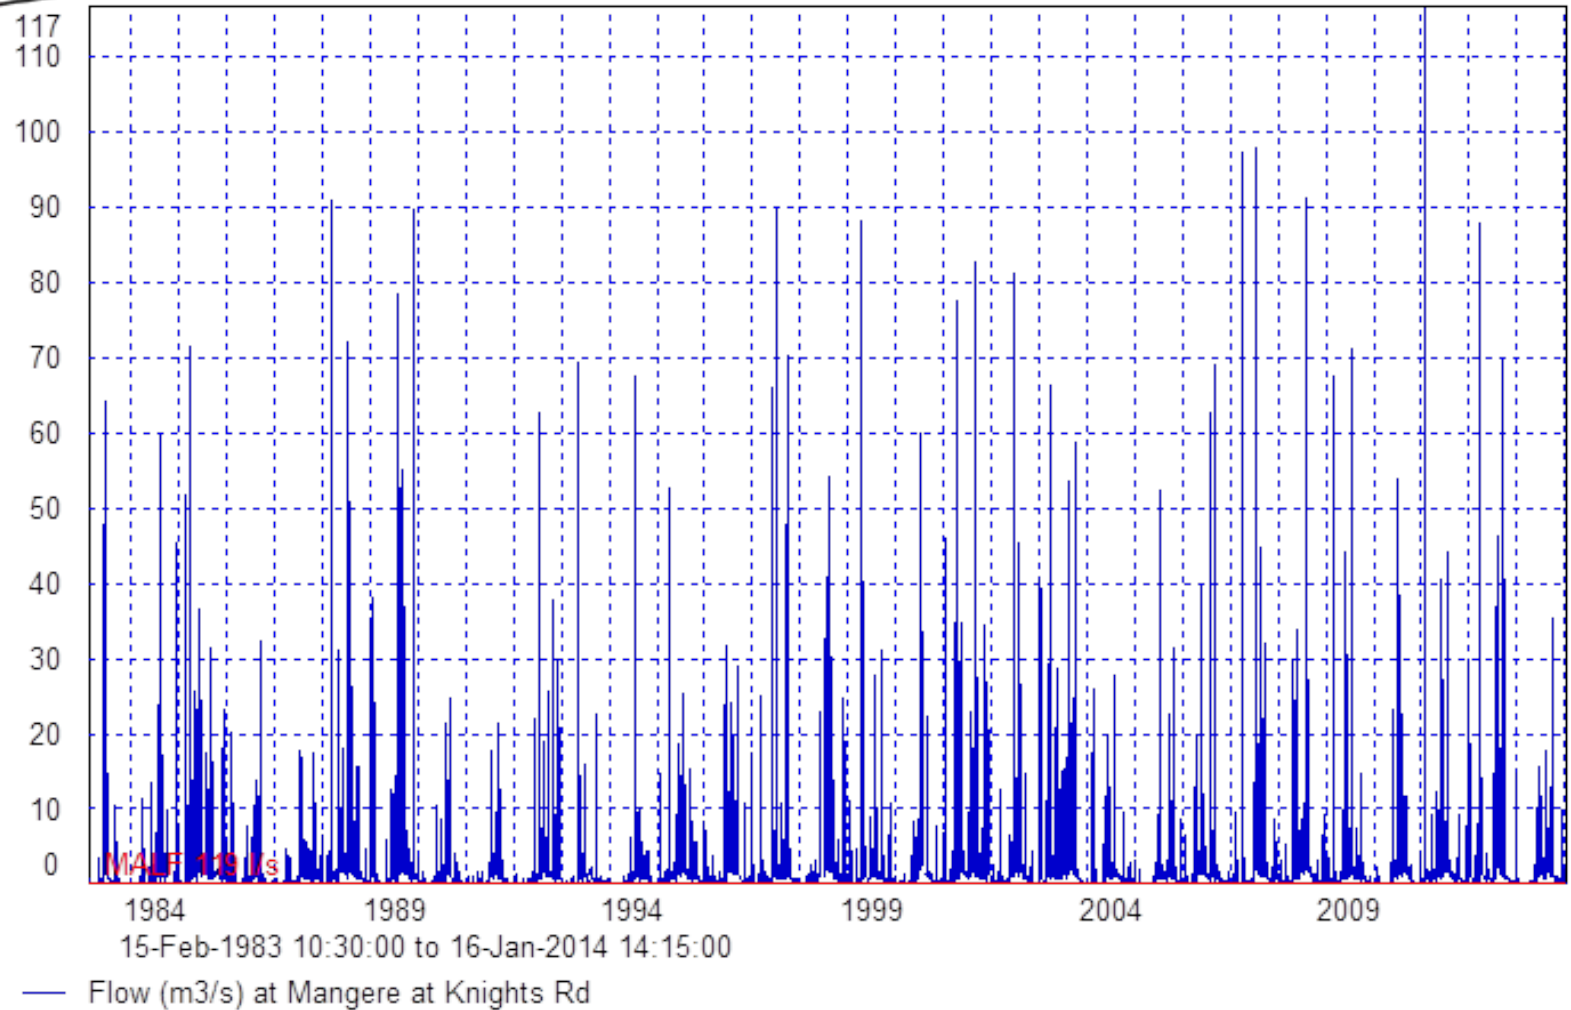
Flows at Knights Road

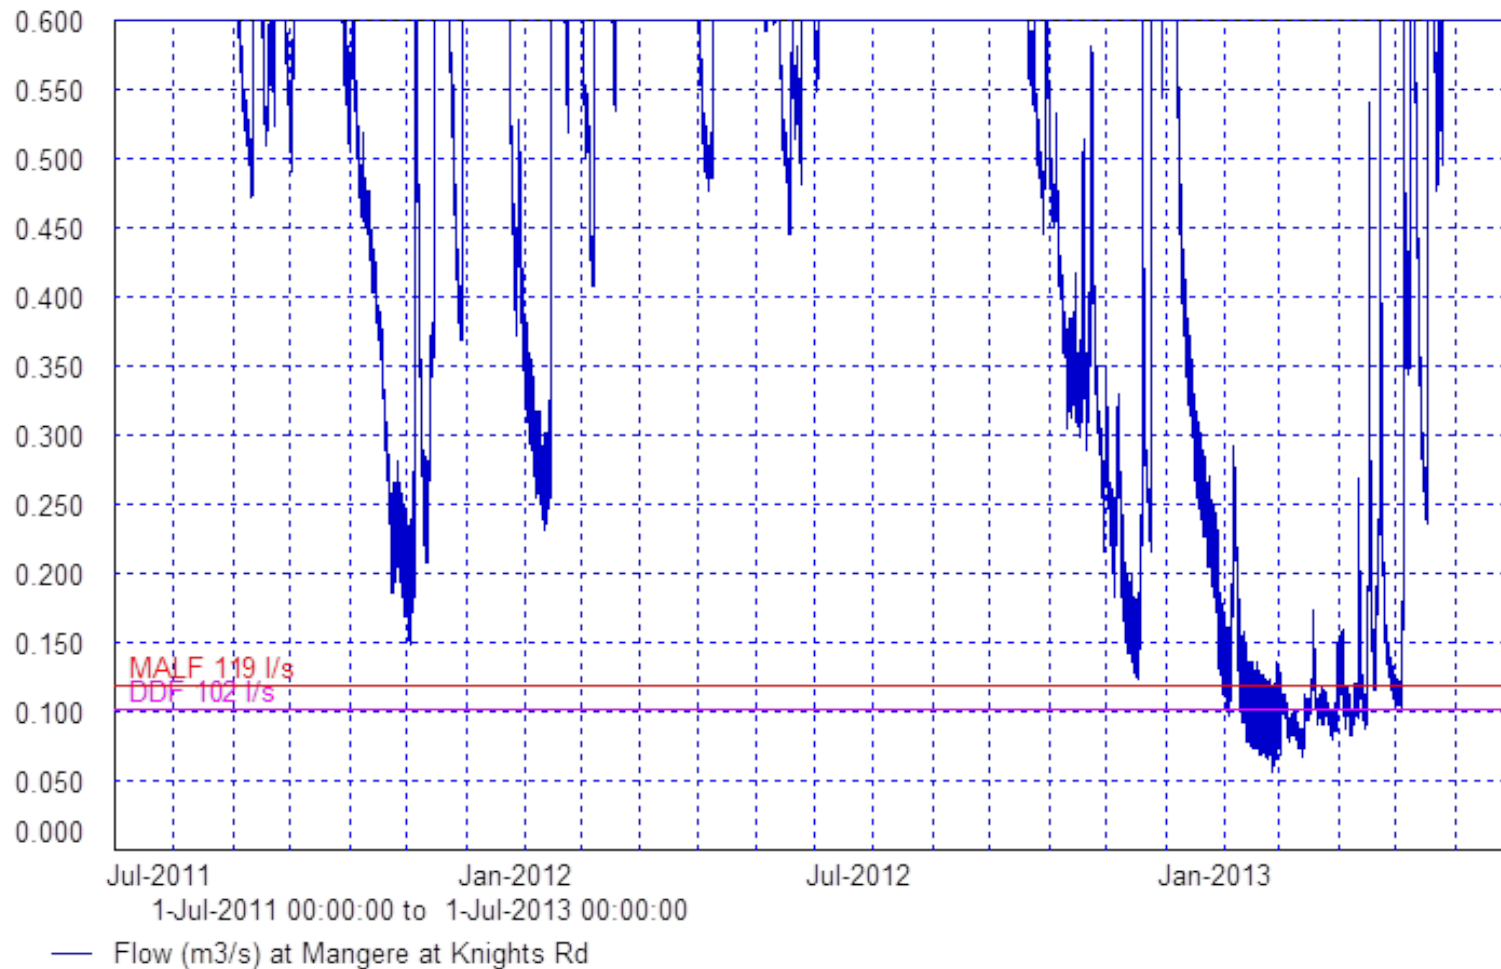
Flows at Knights Road

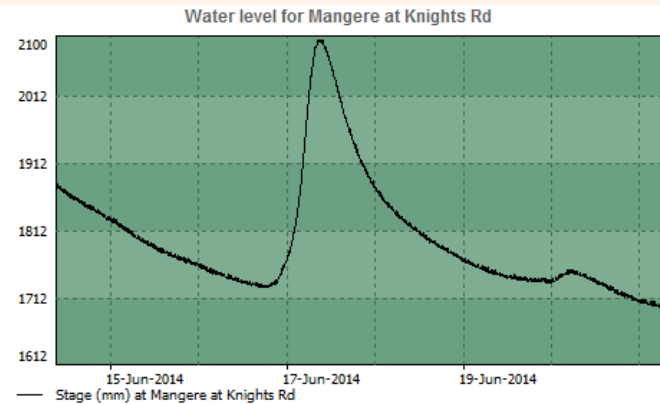
[View the actual water level values for the last 7 days](#)

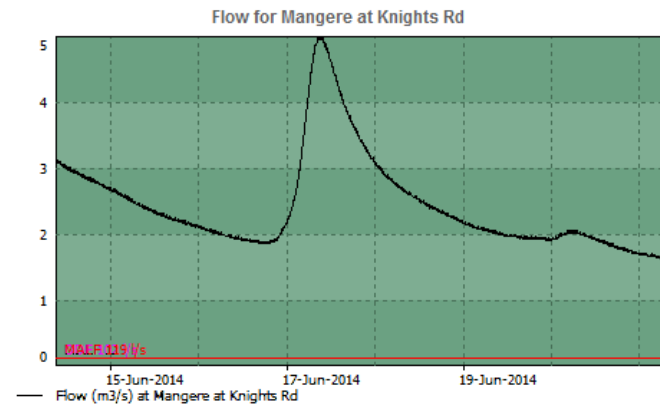
[View the actual water flow values for the last 7 days](#)

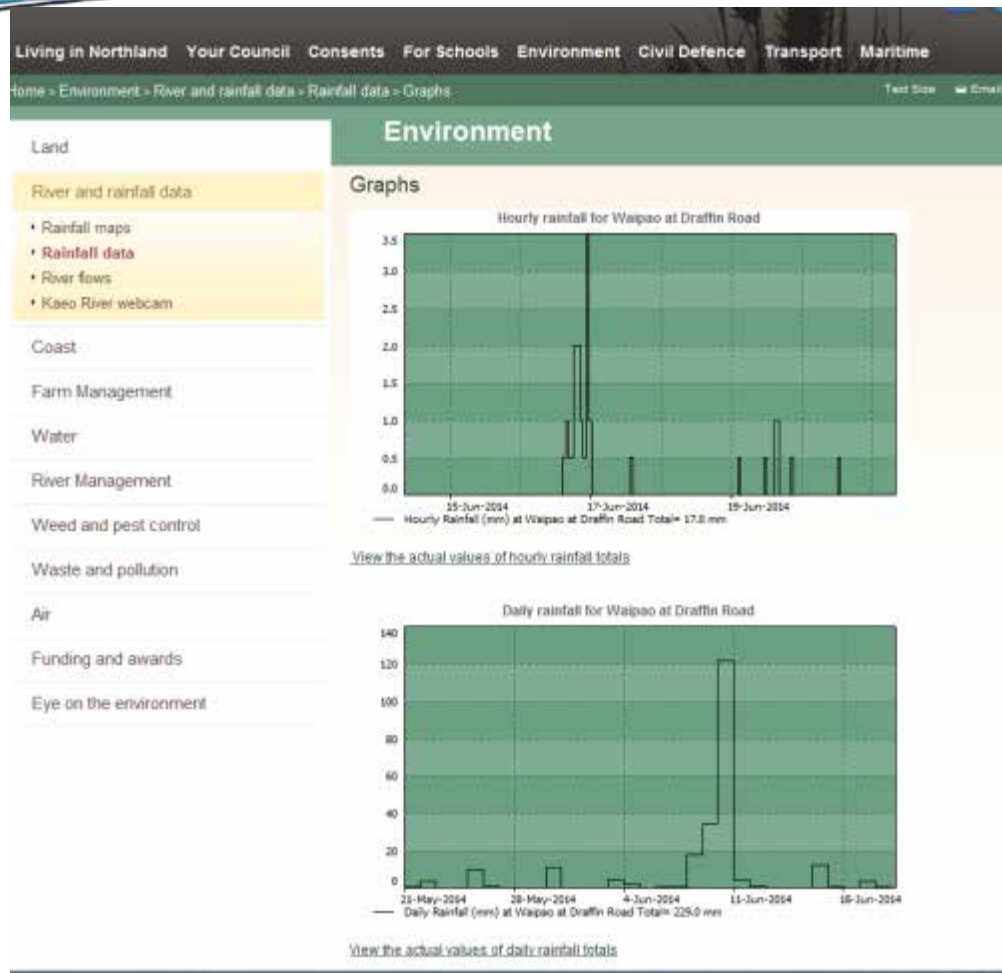
Rainfall at Draffin Road, Waipao

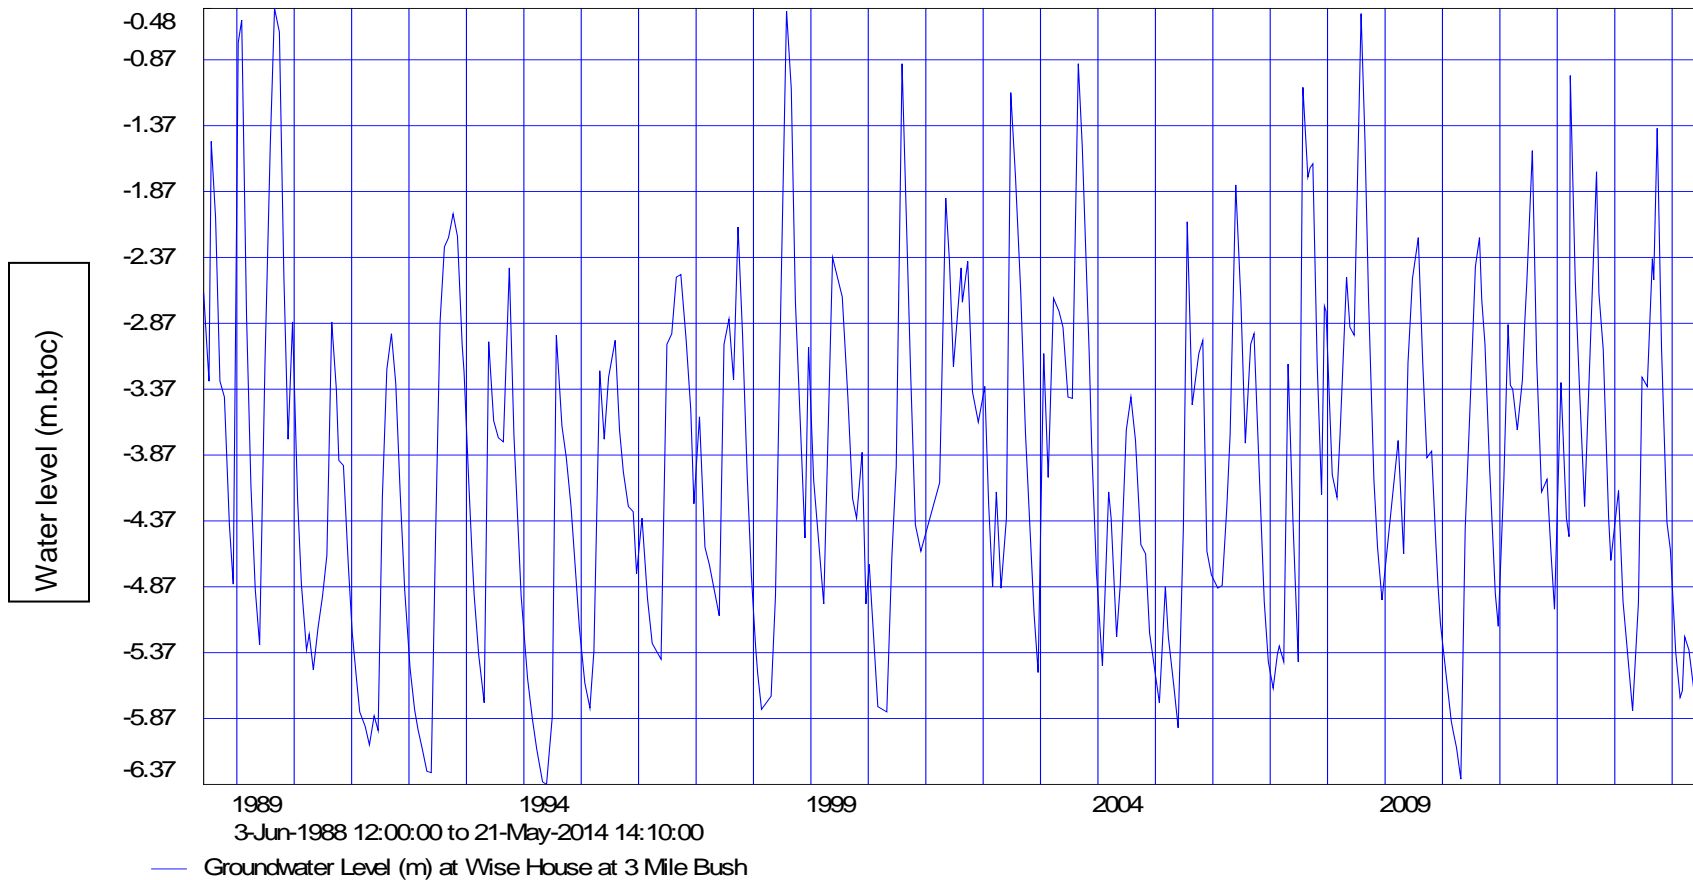
Groundwater levels at Wise Three Mile Bush
