COASTAL MONITORING

Recreational Bathing Water Quality

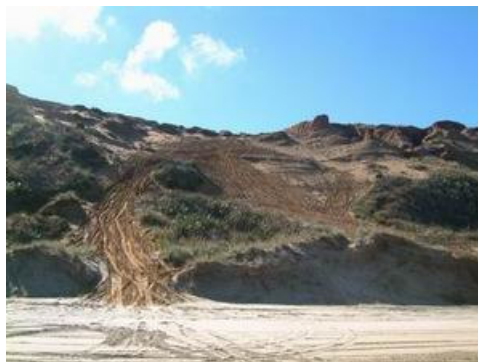
In response to increased pressure from coastal development, hazard management issues and the establishment of coast care groups, the Northland Regional Council has sought to develop a **coast care programme** (refer page 19). The aim of this programme is to enable communities to better understand coastal processes and initiate protection, restoration and enhancement of dune ecosystems through the establishment and resourcing of community based coast care groups. The photograph below demonstrates the damage humans can have on coastal dunes showing vehicle damage to dunes on the West Coast.

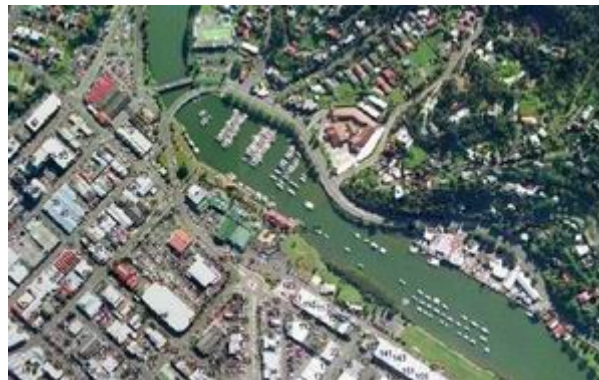
The photo below is the Town Basin Marina in Whangarei, one of the sampling sites used in the 2006 resurvey.

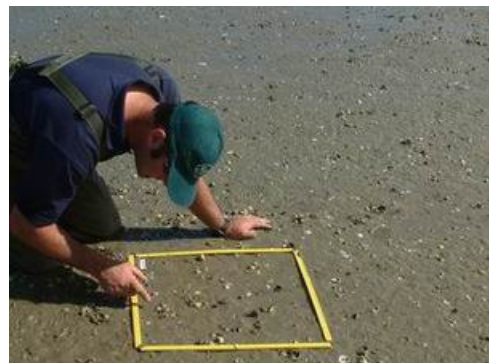
The photograph (right) shows a NRC staff member carrying out epifaunal sampling in the Ruakaka Estuary sampling station.

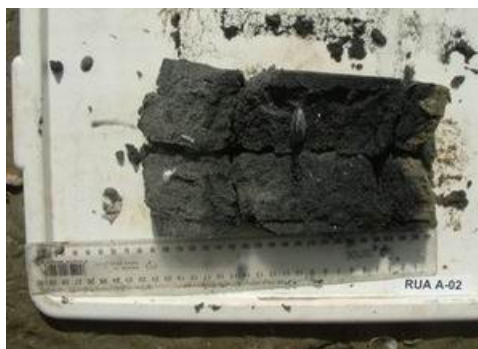
In both Whangarei and Ruakaka estuaries there were no significant macroalgae beds observed, although *Ulva lactuca* (sea lettuce) was present in strandlines. Concentrations of sediment chlorophyll *a* indicated low to moderate microalgal mat development. Sand was the dominant sediment in both Whangarei and Ruakaka, making up 91.4% and 97.5% of the total sediments on average respectively. The redox layer ranged between 5 to 15 mm in the Whangarei sampling stations and 10 to 20 mm in the Ruakaka sampling station (an example of the redox layer is shown in the photograph below).

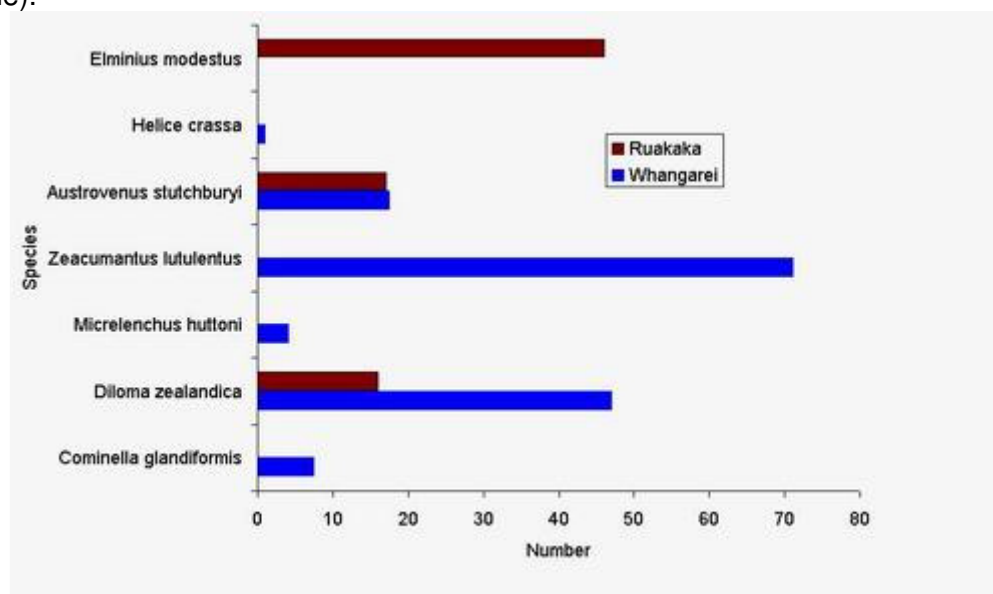
The mean abundance of epifauna was reasonably variable between estuaries. The most abundant species in the three Whangarei sampling stations was the Gastropod *Zeacumantus lutulentus* (koeti/horn shell) and to a lesser extent *Diloma zealandica* (mudflat topshell). By contrast the most abundant species in Ruakaka Estuary was *Elminius modestus* (estuarine barnacle) followed by the bivalve *Austrovenus stutchburyi* (cockle).

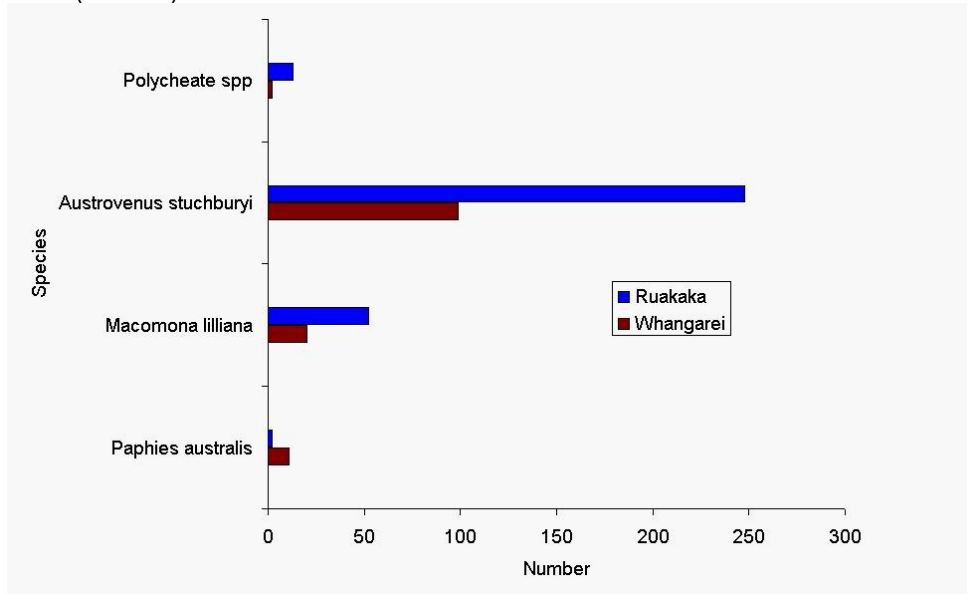
Infaunal species richness and abundance was dominated by bivalves in both estuaries sampled during 2005-06. Cockles (*A. stutchburyi*) were the most abundant followed by wedge shells (*Macomona lilliana*) and pipi's (*Paphies australis*). Small numbers of polychaetes (worms) were also identified.

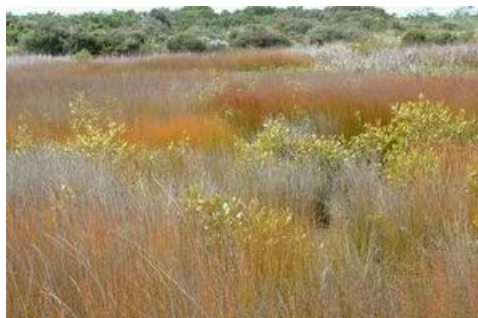
The most abundant vegetative habitat in the upper reaches was *Avicennia marina var. resinifera* (mangrove). There is anecdotal evidence (confirmed by old aerial photos) that the extent of mangroves has increased in the last thirty years within the upper reaches. The remaining habitats were rushland, dominated by *Leptocarpus similis* (oioi/jointed wire rush) and to a lesser degree *Juncus kraussii* (wiwi/sea rush), which dominated the margins of the middle reaches. The lower reaches were lacking intertidal vegetation. There were minor areas of scrubland, herbfield and macro algae beds. The photo below shows marshmeadow in Ruakaka Estuary.

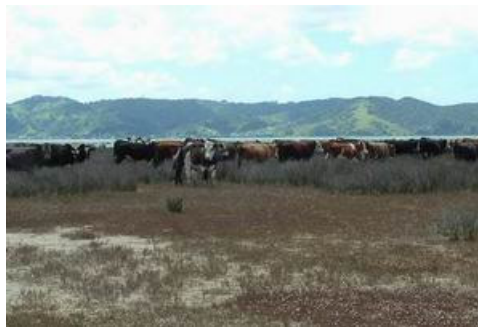
The survey of the intertidal habitat of the Whangarei Harbour indicated a relatively broad range of habitats, dominated in the upper harbour by mangrove scrubland, de-vegetated substrate and a mixture of remnant rushland. The remnant rushland was largely due to stock damage as a consequence of unfenced coastal margins, as is the case in the photo below. The substrate in the upper reaches was dominated by a mixture of soft mud/sand.

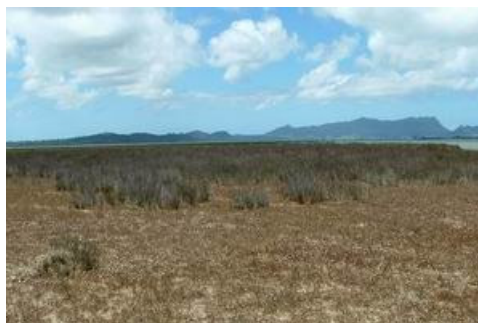
The lower reaches were dominated by subtidal water and intertidal margins dominated by mostly firm sandy beaches with rocky headlands. Mangroves dominated some parts of the lower reaches (e.g. Parua Bay), while *Metrosideros exelsa* (pohutukawa) dominated many of the sandy shores. The photo below shows herbfield habitat in Whangarei harbour.

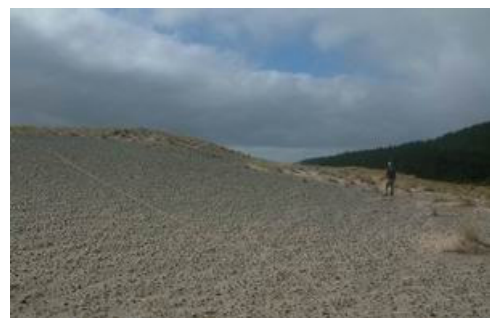
The photograph shows a Paleo-tsunami deposit up to about 35 metres amsl at Tom Bowling Bay.

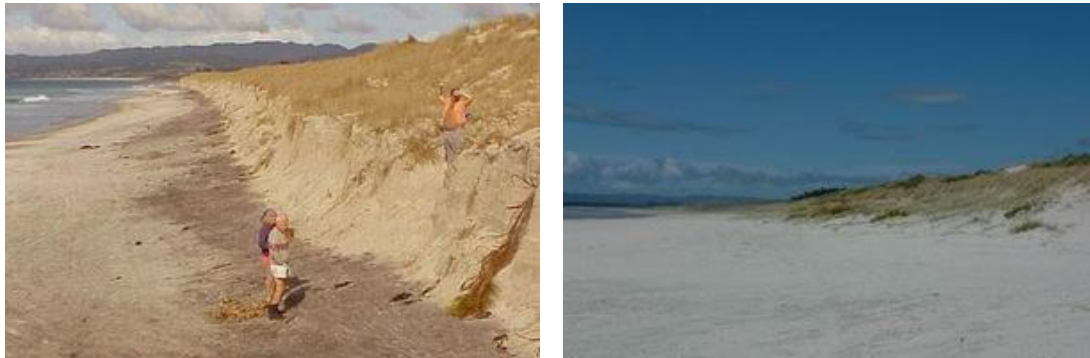
The photographs below of Bream Bay on the east coast of Northland highlight how the foredune can change. The left photo was taken in July 2000 following a period of sustained onshore winds that caused substantial erosion to a number of east coast beaches, while the photo on the right is from December 2005 following a period of calmer conditions enabling formation of incipient foredune and accumulation of sand on the beach.

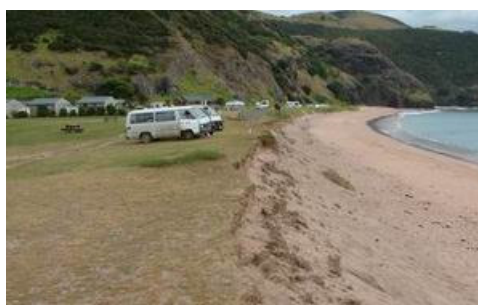
Tauranga Bay is an example of a beach with a highly modified foredune as shown in the photograph below (March 2004). The foredune continues to show net negative retreat due to modification of the dune complex, exclusion of suitable native foredune vegetation and lack of appropriate pedestrian access to the beach.

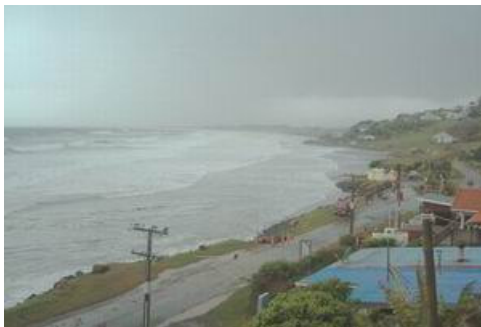
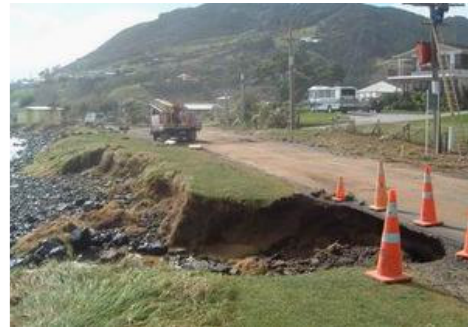
Substantial erosion occurred to the Ahipara foreshore north of the Wairoa Stream, with erosion of between 5 - 10 metres. Localised coastal inundation also caused temporary flooding of the road and low-lying properties. The photographs below shows Ahipara during the storm (left) and an area affected by inundation and erosion (right).

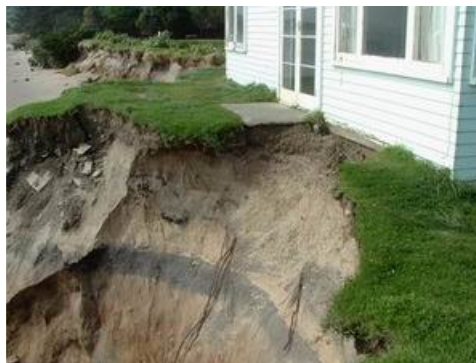
Substantial erosion also affected the Omapere foreshore, with differential erosion of between 1 - 4 metres on average along most of the Omapere foreshore. At least one dwelling was put at direct risk from this event with the concrete foundation overhanging the edge of the eroded dune scarp, as shown in the photograph below.

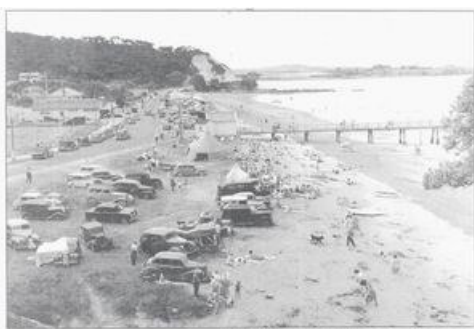
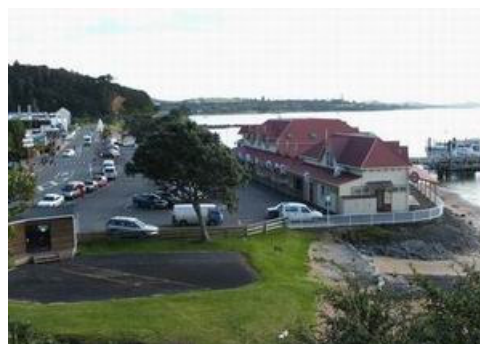
In many places the coast is the first line of defence between the land and the sea with dune systems providing an effective buffer protecting land and infrastructure from coastal erosion and flooding. Since habitation by humans, and particularly within the last 150 years, the dune environment has been degraded through inappropriate coastal development, farming practices, the introduction of pest species, sand extraction and damage by pedestrians and vehicles. The photographs below are an example of coastal development impacting on a dune system, showing Paihia Waterfront in 1953 (left) and in 2006 (right).

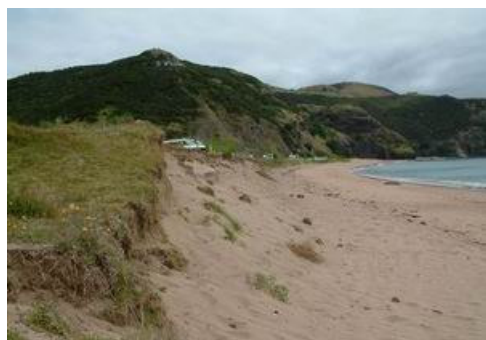
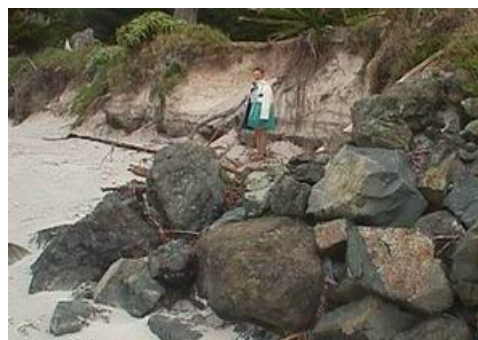
In areas where the front of the dune (foredune) has been extensively modified and native vegetation such as pingao and *Spinifex* sp. have been removed, the dunes have lost their ability to rebuild such as at Tauranga Bay shown in the left photo below. Loss of sand from the dune system over time leads to long term retreat of the foredune. When the sea threatens land and infrastructure the typical response has been to armour the coastline with hard materials such as rocks, concrete rubble, steel and iron which lowers the beach profile causing the high tide beach to be lost and subsequently degrading natural character such as at Rangiputa in the right photo below.

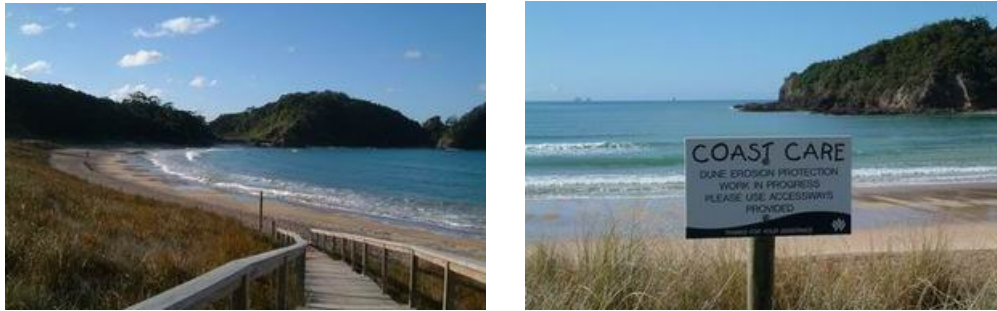
awareness of coastal issues. The photographs below show work that has been carried out at Matapouri Bay, including planting, fencing to protect the dunes, a walkway and signage to educate beach users.

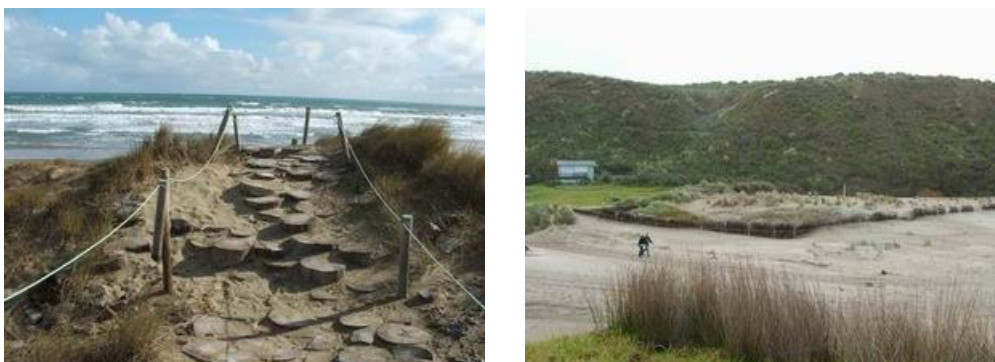
The photographs below show coast care work that has been carried out at Waipapakauri (left) and Omamari beach (right).
