COASTAL MONITORING

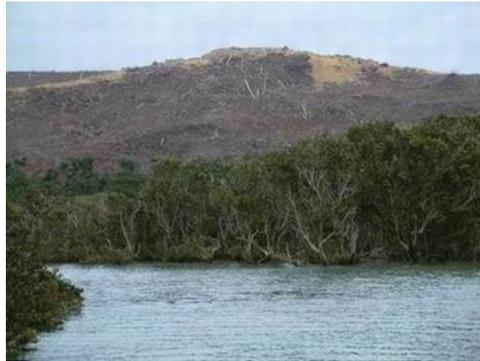
Photo: Waiheuheu Channel

The photo below shows the upper reaches of the Waiheuheu Channel of the Parengarenga Harbour. Results for the sediment samples from this site had high proportions of mud/silt, nitrogen and organic matter, indicative of recent high sedimentation, most likely related to forestry harvesting operations.

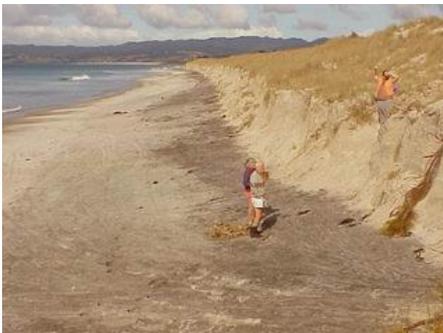
The photographs below of Bream Bay on the East Coast of Northland highlight how the foredune can change. The left photo was taken in July 2000 following a period of sustained onshore winds that caused substantial erosion to a number of east coast beaches, while the photo on the right is from August 2003 following a period of calmer conditions enabling formation of incipient foredune and accumulation of sand on the beach.

July 2000 – onshore winds caused substantial erosion.

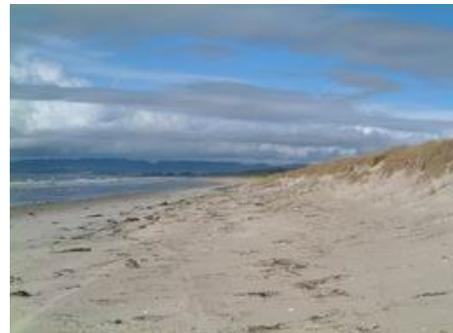
August 2003 – formation of incipient foredune.
