Northland River Water Quality Monitoring Network State and Trends 2010

**April 2011
Northland Regional Council
Private Bag 9021
Whāngārei Mail Centre
Whāngārei 0148
Free phone: 0800 002 004**

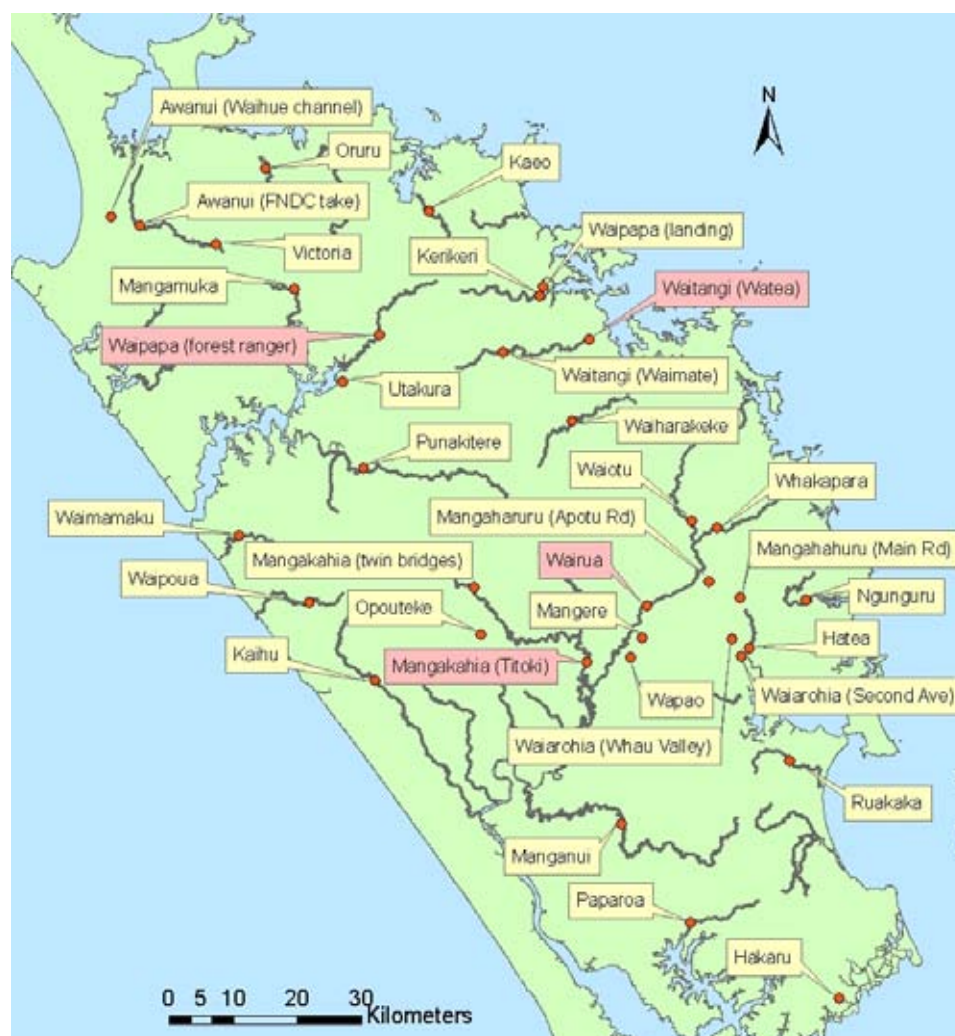
Figure 1: Map showing the 35 Regional Water Quality Monitoring Network sites (National River Water Quality Network sites in pink).

Northland's River Water Quality Monitoring Network was established in September 1996 and initially included nine river sites throughout Northland. Since 1996 a further 22 sites have been added to the network. The four Northland sites in the National River Water Quality Network monitored by National Institute of Water and Atmospheric Research Limited (NIWA) are also incorporated into our regional network. So there are currently 35 sites throughout Northland monitored monthly for water quality. These sites are shown in figure 1 (below).
