PART ONE: IDENTIFICATION

<b>Place Name:</b>	WHANGAROA GENERAL STORE (BOYD GALLERY) WHANGAROA				
<b>Image:</b>

## PART TWO: HISTORIC HERITAGE EVALUATION

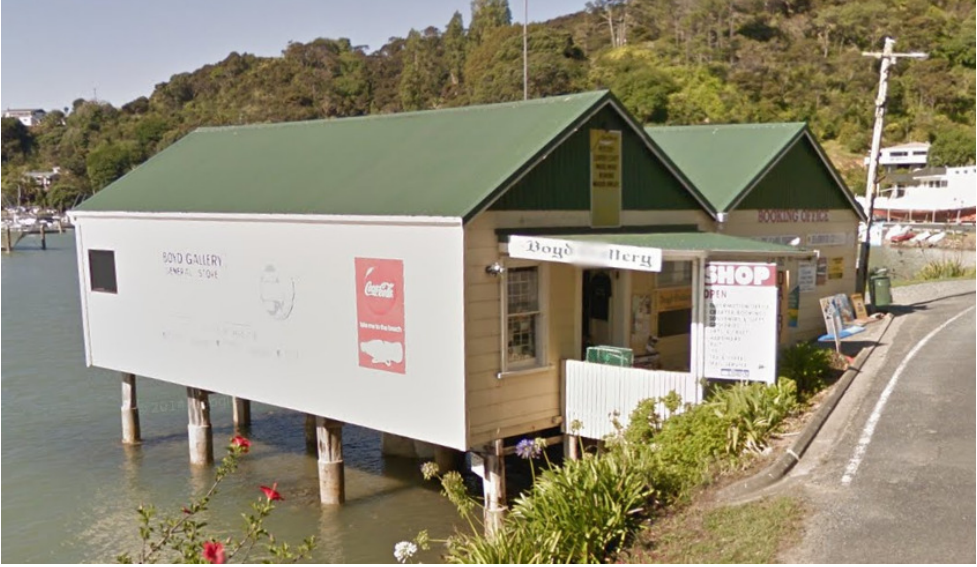
<p>Image Copyright ( February 2013) Google Streetview</p>				
<b>Site Address:</b>	537 Whangaroa Rd, Whangaroa				
<b>Legal Description:</b>					
<b>Certificate of Title:</b>	N/A				
<b>Physical Description:</b>	Constructed ca. 1883 – 1896 as store and sample room . The building is predominantly rectangular, with a slight ‘L’ shape. The principal dimensions of the building are 13.1 metres x 12.65 metres (covering an area of approximately 140 square metres). The majority of the building is positioned over the coastal marine area. The entrance of the store on the eastern side of the building is on the landward side of MHWS. The building is of a timber construction, set on concrete piles with timber bearers				
<b>Site Type:</b>	Commercial Building				
<b>Approx. date (or range)</b>	Ca. 1883 – 1896 based on survey plans and photographs

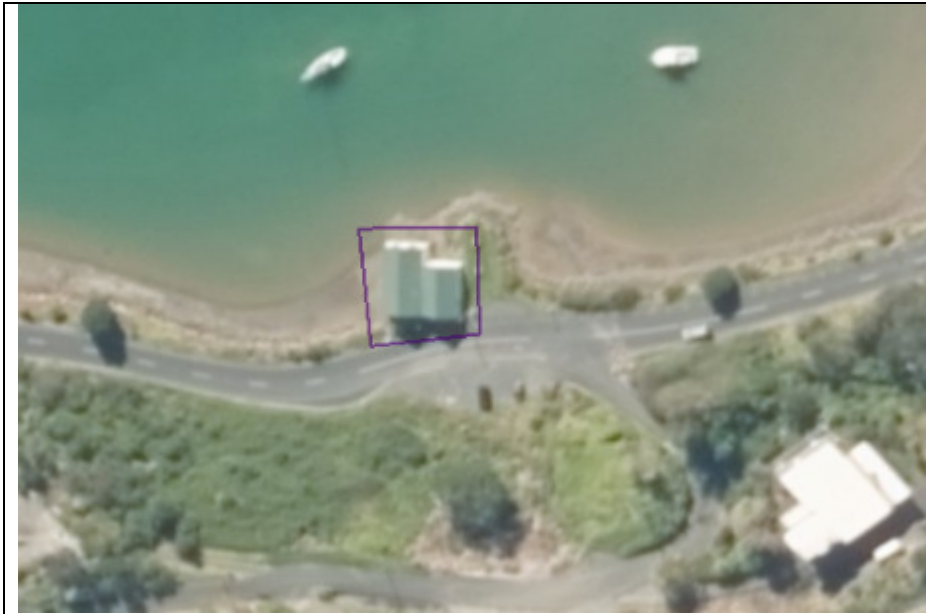
**PART SIX- EXTENT OF PLACE**

<b>Easting:</b>	<b>1667680</b>	<b>Northing:</b>	<b>6120850</b>	<b>Position:</b>	Whole of building
<b>Note</b>
