Mangere River Fish Study

**Submitted to:
DairyNZ Ltd
Private Bag 3221
Hamilton**

freshsolutions
water
environmental consultants

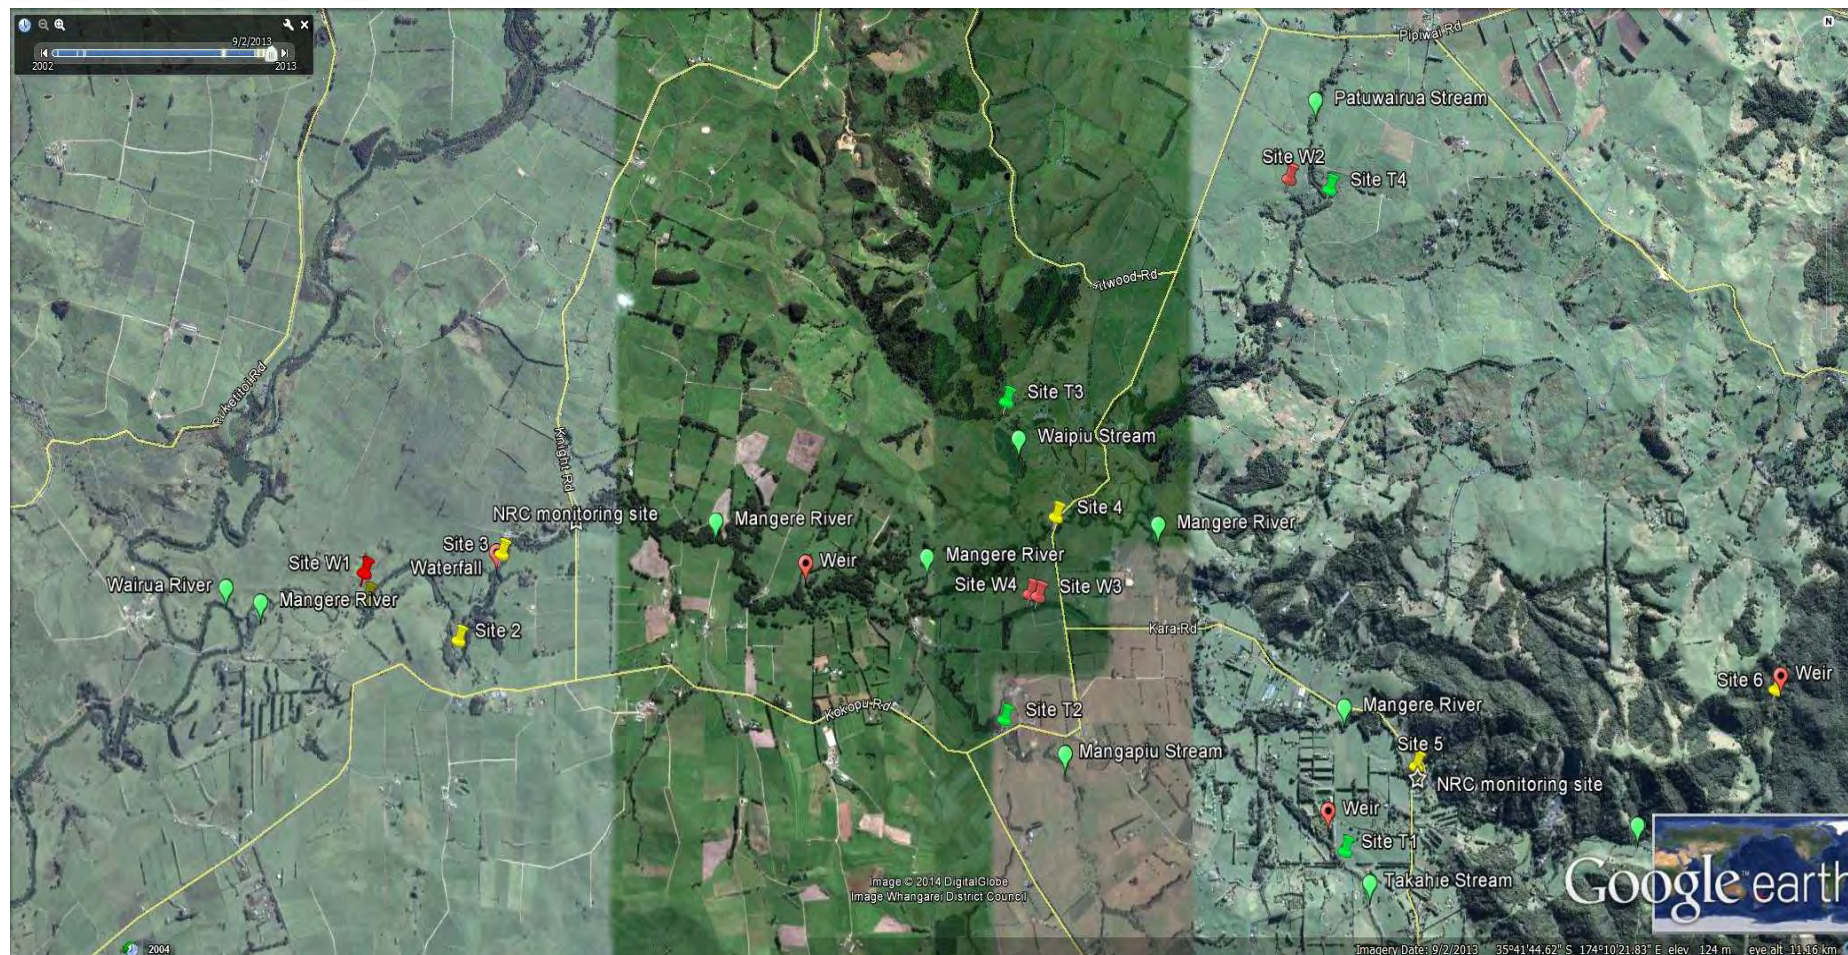
Figure 2: Survey site locations.

Catchment information contained within NRC (2011) along with information provided by NRC (e.g. weir locations) was used along with information gathered during the catchment visit on 20th March 2013 to select sites. The sampling sites are shown on Figure 2 and presented in Table 1.

A weir near the downstream boundary of the Pukenui Forest (immediately downstream of Site 6) is also likely to prevent upstream passage for non climbing species (Figure 2 and Figure 4).

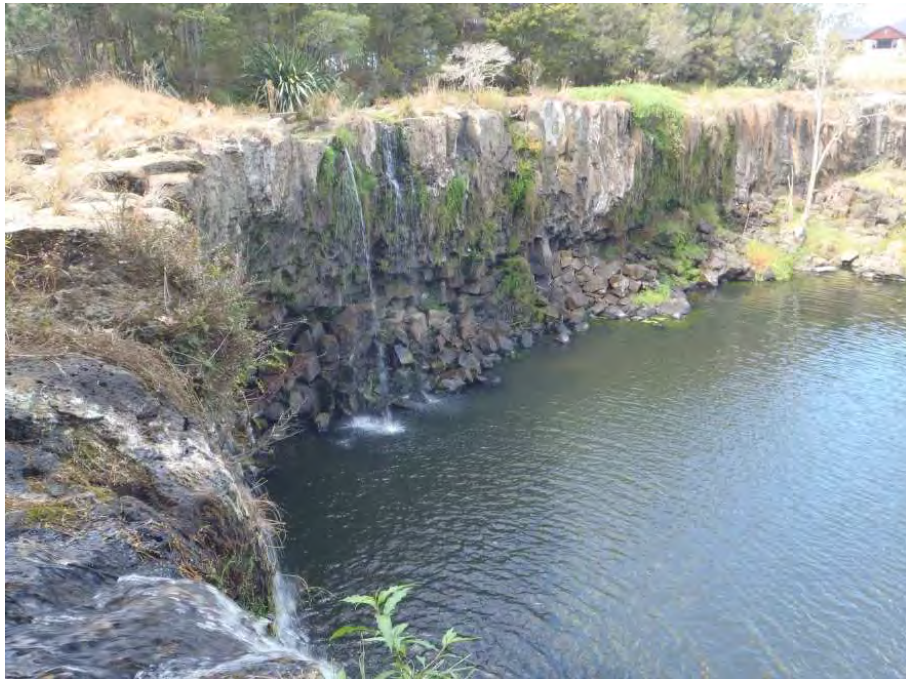
One of the dominant features of the Mangere River are the Mangere Falls in the lower reaches, located between Site 2 and Site 3 (Figure 3). The falls are a major barrier for fish and prevent upstream migration for all but the strongest climbers such as elvers. Large numbers of elvers are seen attempting to climb the falls in January each year (Bruce Savill pers. com.).

Figure 3: View of the Mangere Falls in late March 2013.

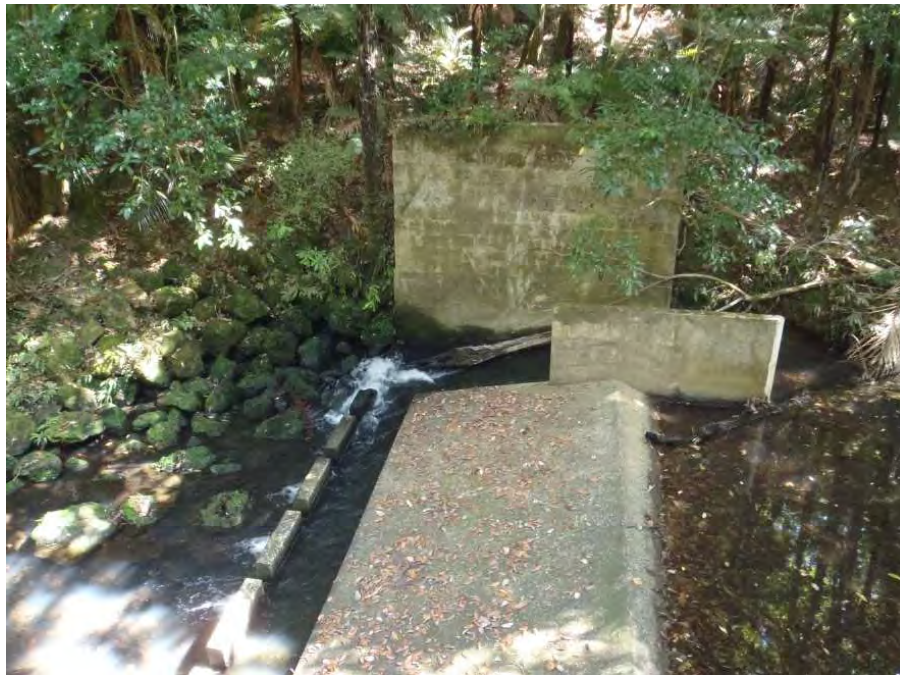
Figure 4: View of the Mangere Stream weir in Pukenui Forest.

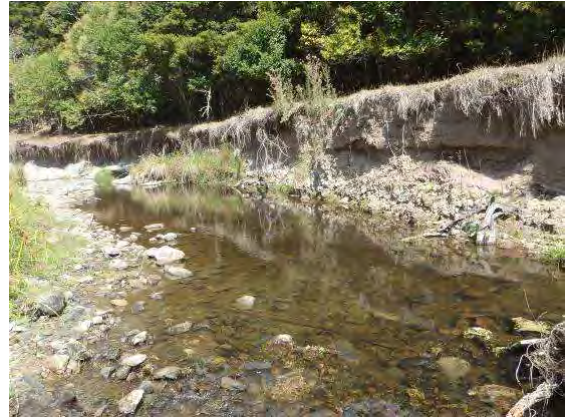
Site 2.

Figure 5: View of main stem study sites surveyed in Summer 2013.

River banks throughout the middle and lower catchment are unstable, particularly in sections where the river has cut a deep U shaped channel and where the erosive forces during high river flows result in slumping (see Site 2, Figure 5). Fencing and planting these sections with plant species capable of reducing erosion such as flaxes and sedges will reduce sediment inputs and improve water quality.

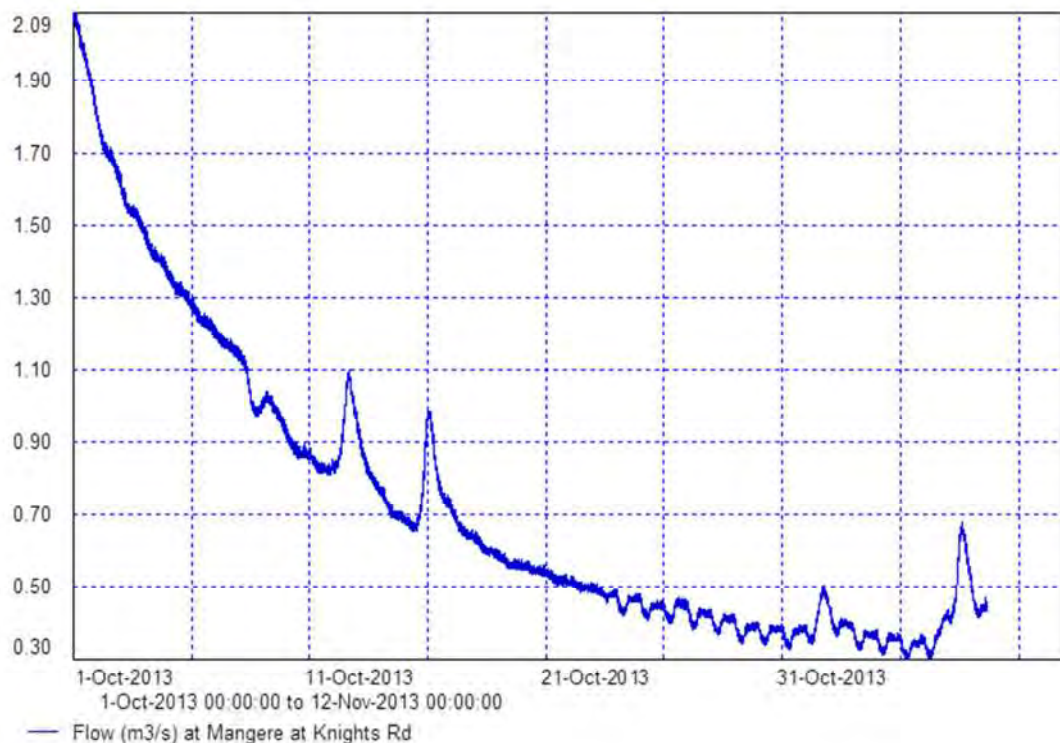
The Spring survey was undertaken during a sustained period of settled weather and low river flows. The Mangere River flow on the days of the survey was approximately 450 L/s (Figure 8).

Figure 8: Mangere River flow at Knights Road Bridge prior to the Spring survey.
