Northland Lakes Ecological Status 2013

Prepared for Northland Regional Council

NIWA Client Report No:	HAM2013-088
Report date:	August 2013
NIWA Project:	NRC13205

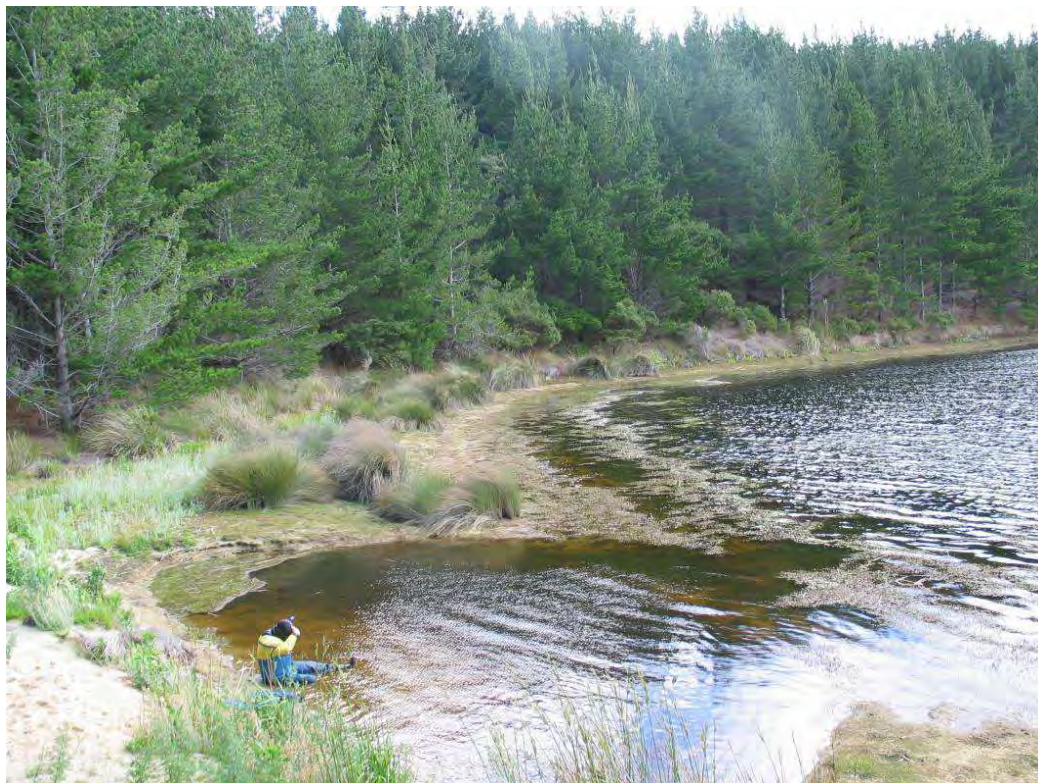
Plate: Lake Austria margin showing exposed turf communities and *Apodasmia similis* tussocks. Note humic stained water and floating mats of *Utricularia gibba* (centre right).

Moderate: This humic-stained lake was severely impacted by the pest plant *Utricularia gibba* and water level is decreasing, but it provides valuable habitat for endangered water birds.

The lake is highly impacted by *U. gibba*, but the likelihood of introduction of other alien species is low. No monitoring is recommended.

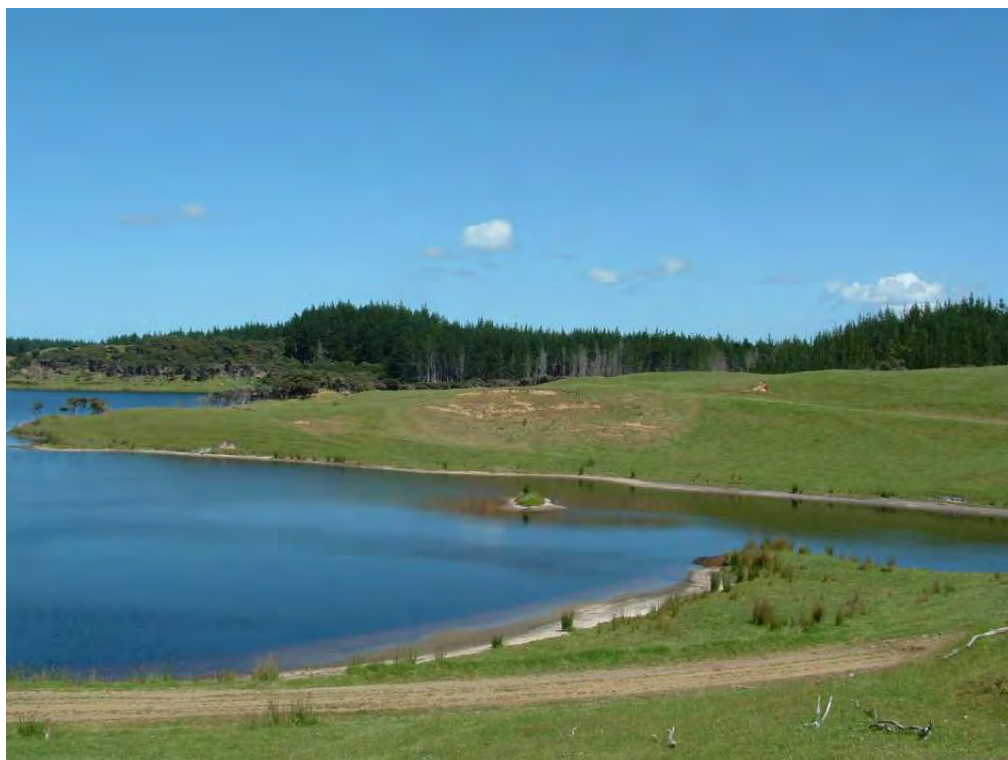
Plate: Lake Bulrush showing the lack of emergent vegetation and unfenced shoreline.

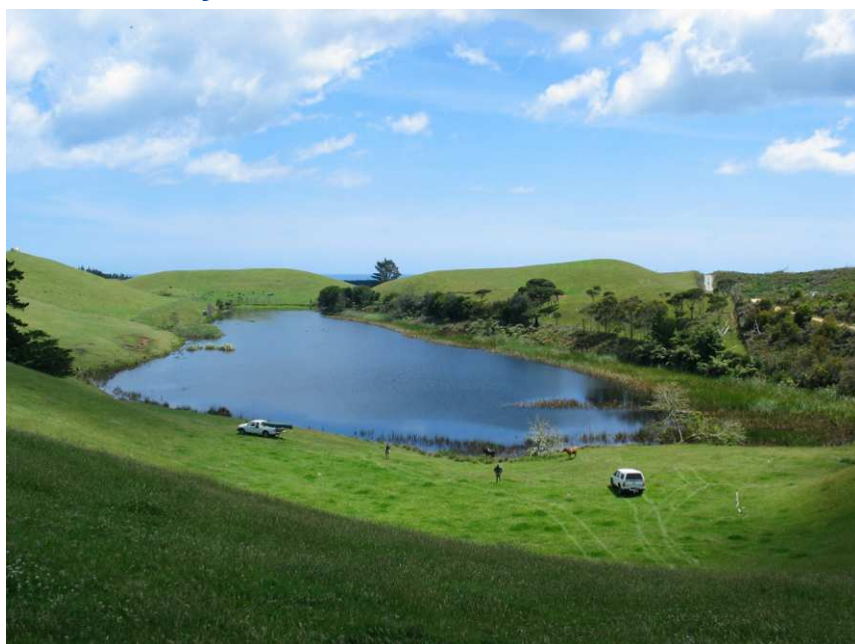
Plate: Carrot Lake photographed from the east end, showing areas of unfenced pastoral catchment and cattle access to lake.

E. densa impacts are likely to be high. Nutrient run-off from pastoral practices threatens water quality and is a likely cause of submerged vegetation bottom limits retracting from 5.7 m in 2004 to 3 m in 2010.

Retirement of the lake edges around the eastern sector of the lake will encourage wetland vegetation and some interception of diffuse nutrient run-off.

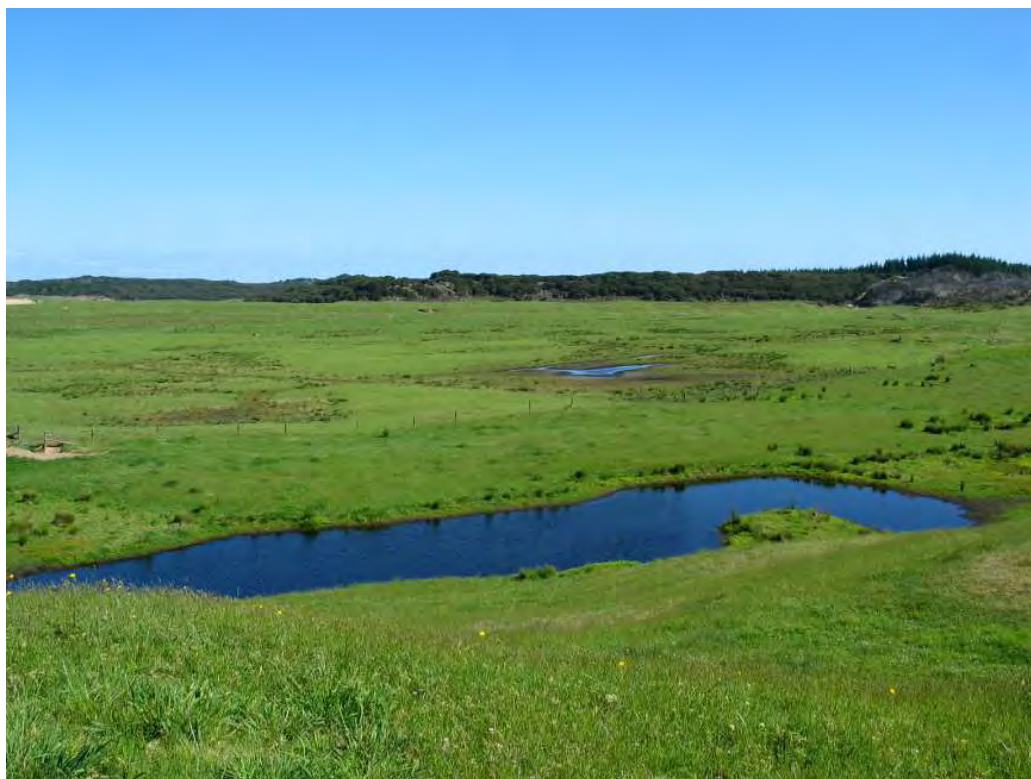
Plate: Remnant pools in pasture occupying the area previously containing Half Mile Lagoon.

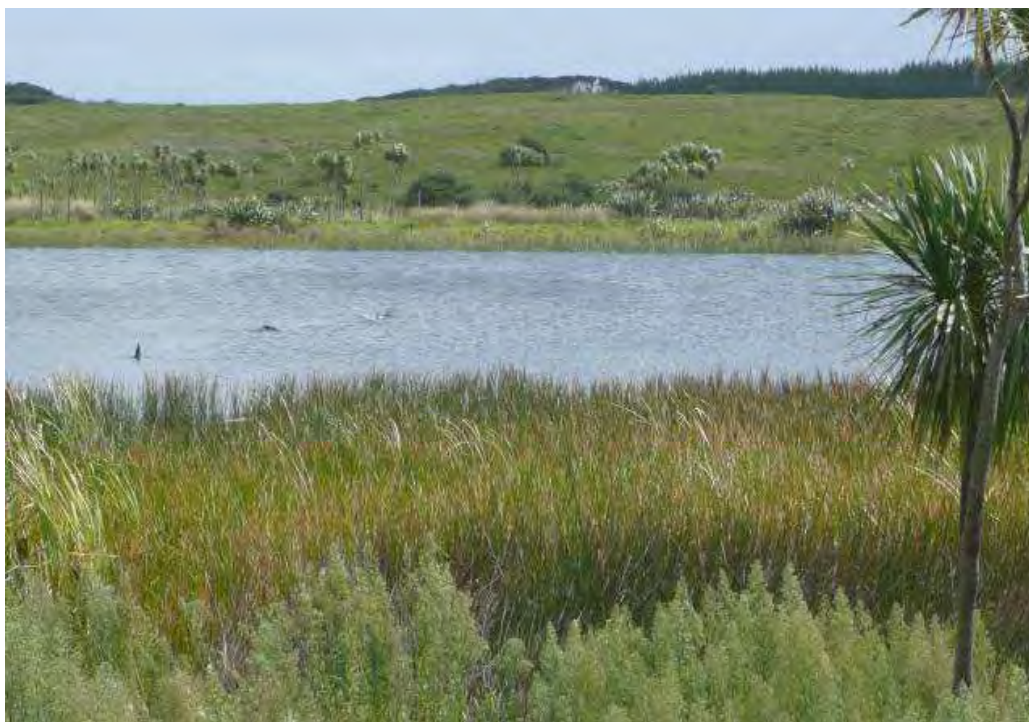
Plate 1: Lake Heather set in a pasture catchment fenced off with a wetland margin.

Alligator weed (*Alternanthera philoxeroides*) poses a threat to emergent vegetation. *C. demersum* and *E. densa* are well established as surface-reaching beds throughout much of the lake. Crack willow (*Salix fragilis*) was removed from a maimai location since the 2009 visit and report.

Eradication of *C. demersum* and *E. densa* from the lake using grass carp is progressing. Assess feasibility of alligator weed control/eradication. Lake native biodiversity value monitoring is recommended every 5 years and annually monitoring for grass carp progress with exotic weed removal.

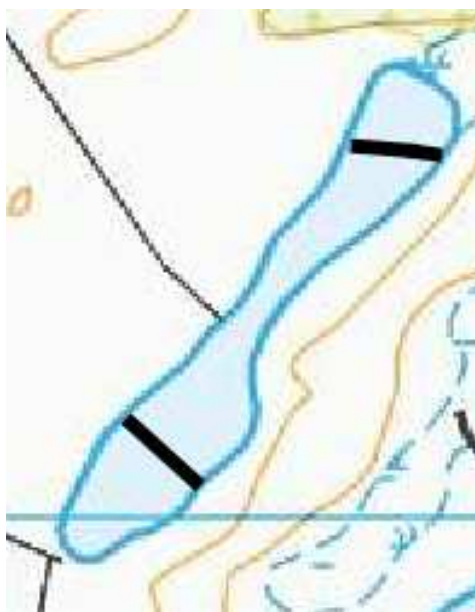
The two baseline profiles recorded prior to grass carp release in 2010 were repeated in 2011, 2012 and 2013 (Figure below).

Figure: Lake Heather showing the location of the 2 profiles monitored, with one in each basin. In 2011 the *E. densa* had been heavily grazed but little damage was noted on the *C. demersum*. In April 2012 the *E. densa* had been heavily grazed and reduced to basal stalks (Figure below) but only about 50% of the *C. demersum* has been removed. Most of the *C. demersum* was still recorded up to 2.2 m tall. In 2013 the *E. densa* had all gone and *C. demersum* further reduced. The rate of progress for grass carp in removing the weed beds is slower than in Lake Swan, probably because of the large amount of *T. orientalis* accessible for consumption, but they are making steady progress.

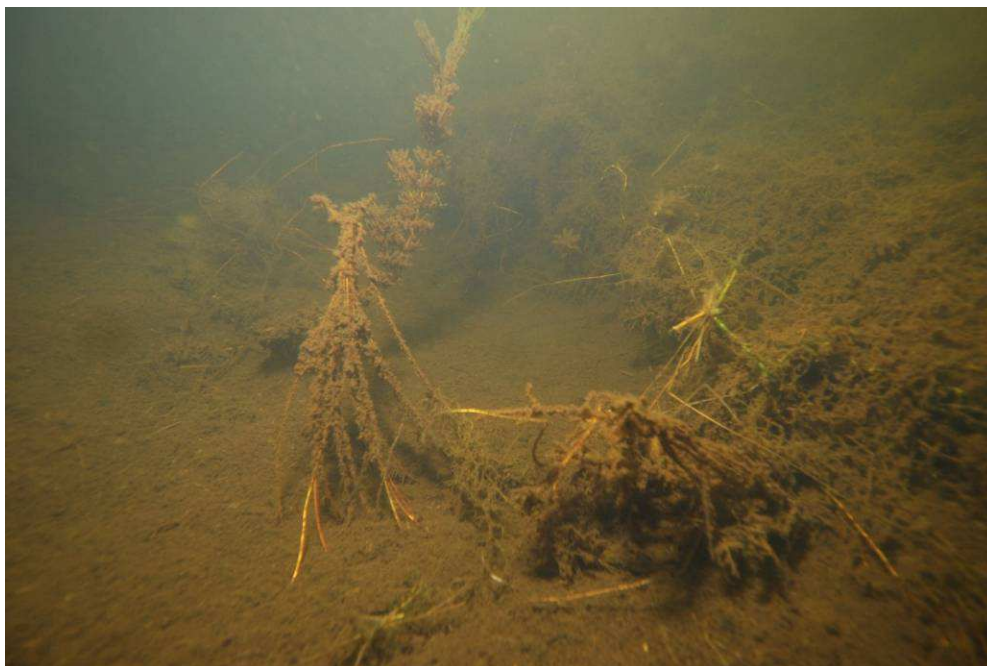
Figure: *E. densa* remnants 2012 in Lake Heather at 2.6 m deep heavily grazed by grass carp.

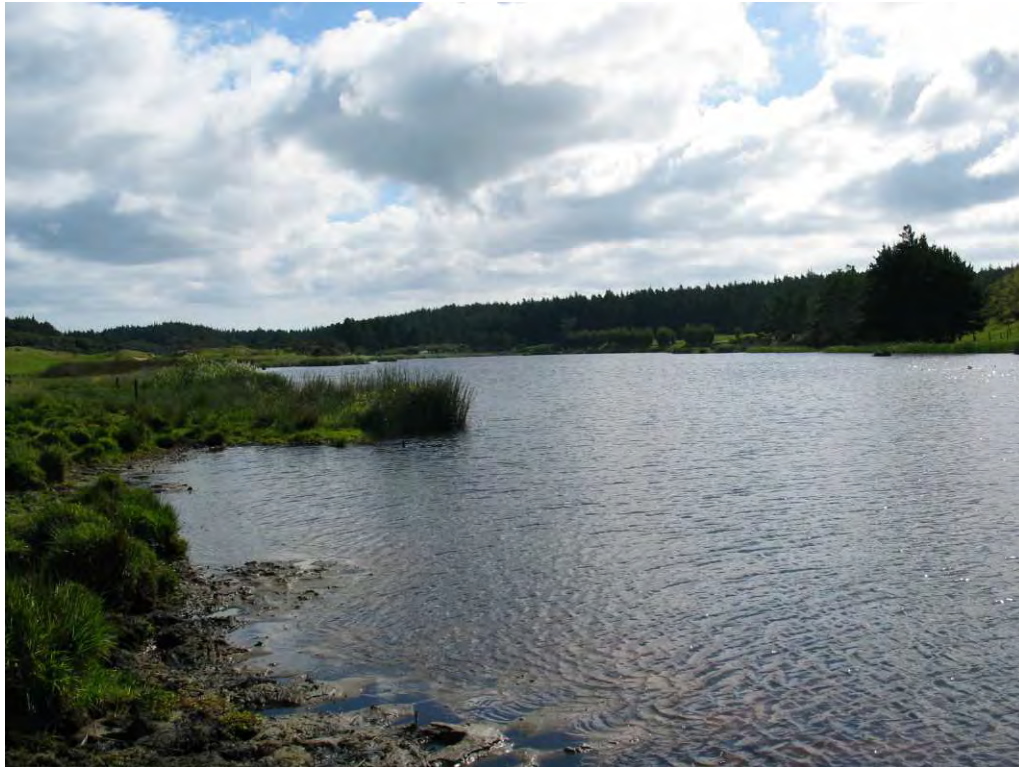
Plate: Katavich Lake showing margin of lake impacted by cattle access.

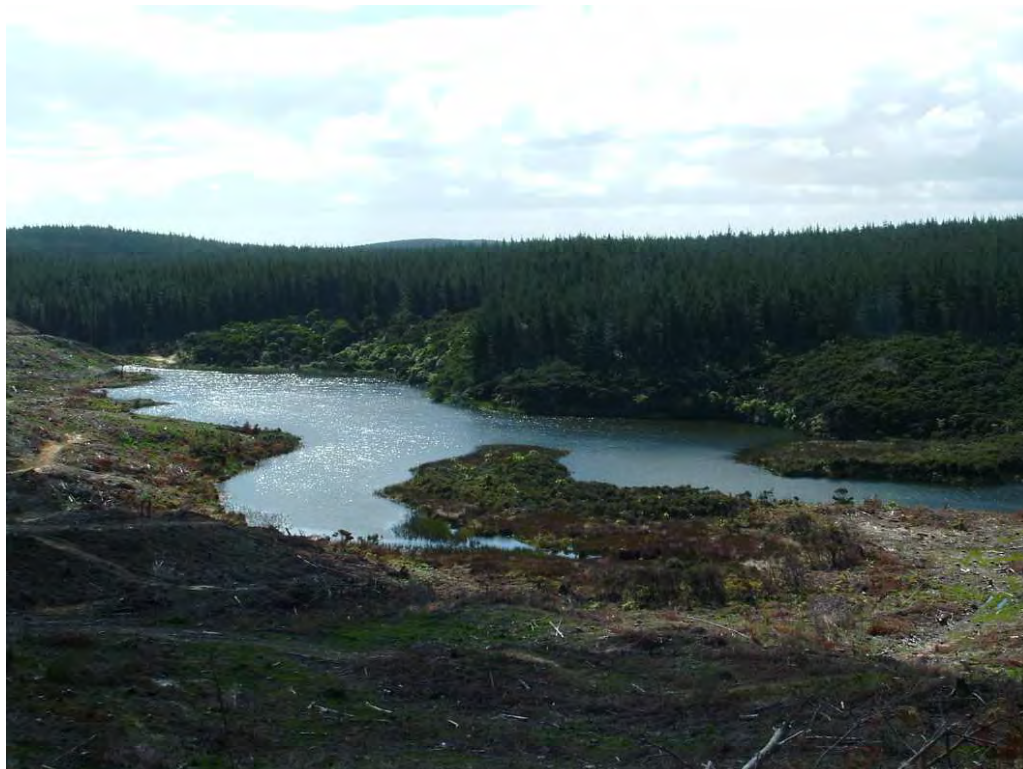
Plate: Lake Kihona set in a forestry catchment, note the recent harvesting and limited development of emergent vegetation.

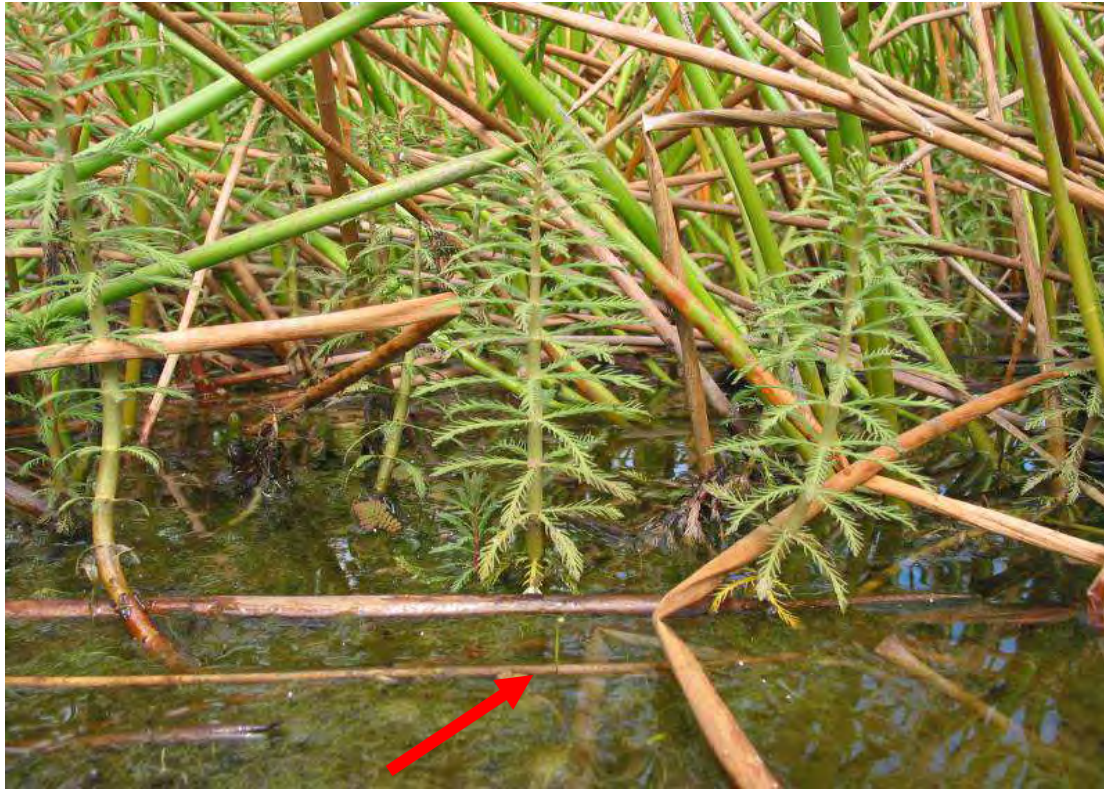
Plate 2: The nationally threatened *Myriophyllum robustum* growing amongst the emergent sedge *Eleocharis sphacelata* in Lake Little Gem in about 0.5 m of water. Note the dense mat of the invasive *Utricularia gibba* with lone small flower stalk (red arrow).

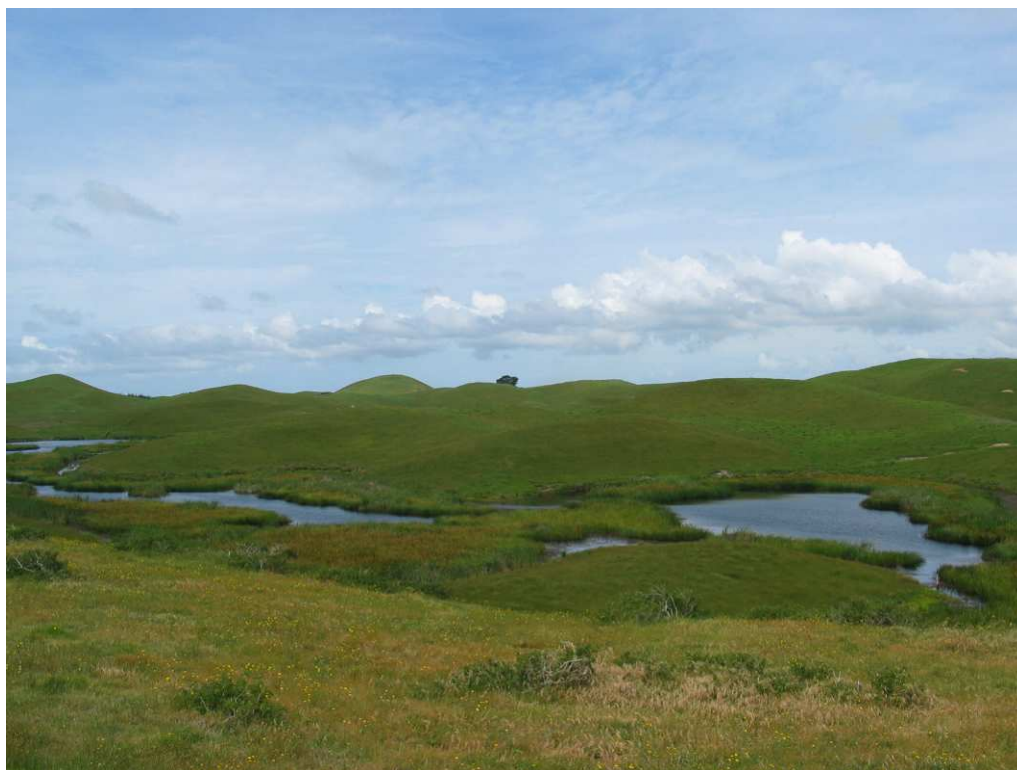
Plate: Mini Lake, set in pasture, showing the narrow ribbon-like nature of the lake with large emergent beds of raupo (*Typha orientalis*) and kuta (*Eleocharis sphacelata*).

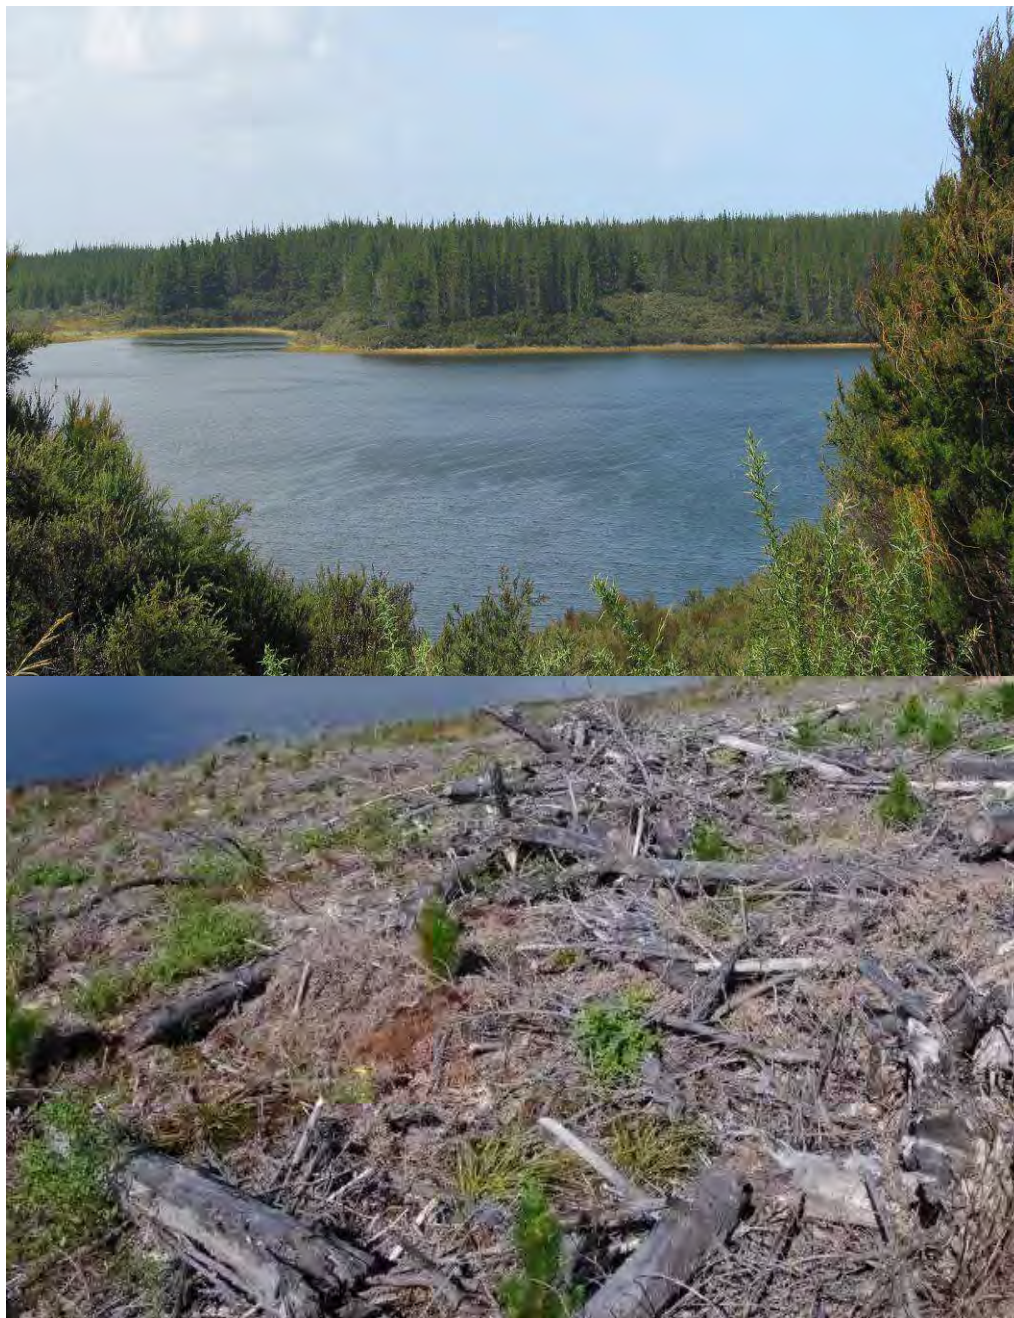
Plate: Lake Morehurehu set in mature plantation pine (top 2009), but recently felled and re-planted (bottom 2013).

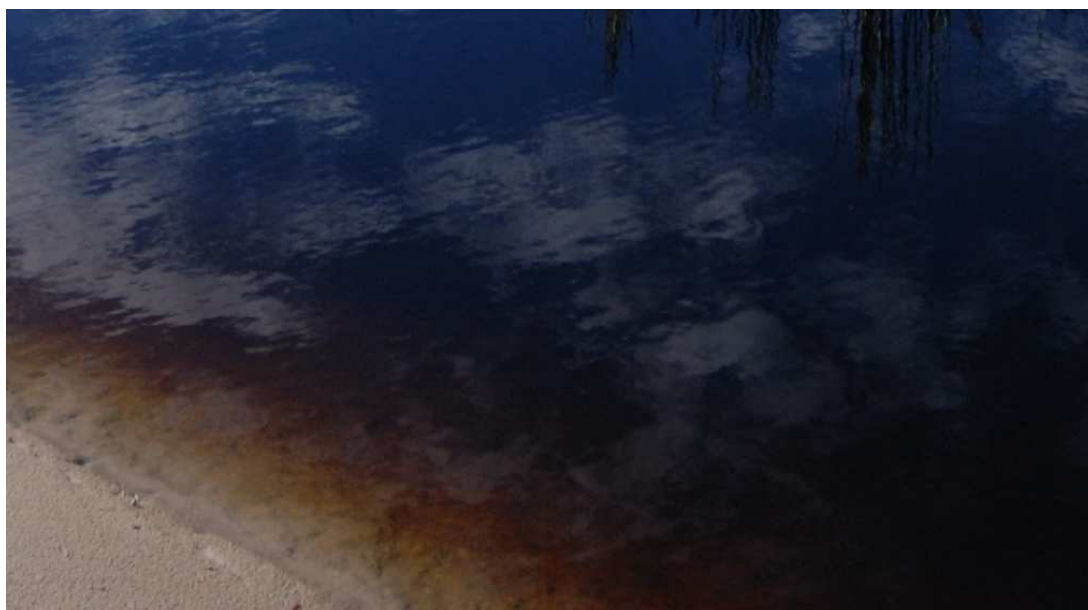
Based on the 2009 survey a Lake Ecological Value rating of 12 (Outstanding) was calculated. A deterioration in the rating of the following parameters: water quality (water transparency and total nitrogen values from 2010 to 2013 indicate Eutrophic condition whereas chlorophyll a and total phosphorus indicate Mesotrophic condition) and loss of aquatic vegetation integrity has resulted in a revised score of 10 (High).

Figure 3-1: Lake Morehurehu with dark brown / red stained water with less than 1 m in water visibility.

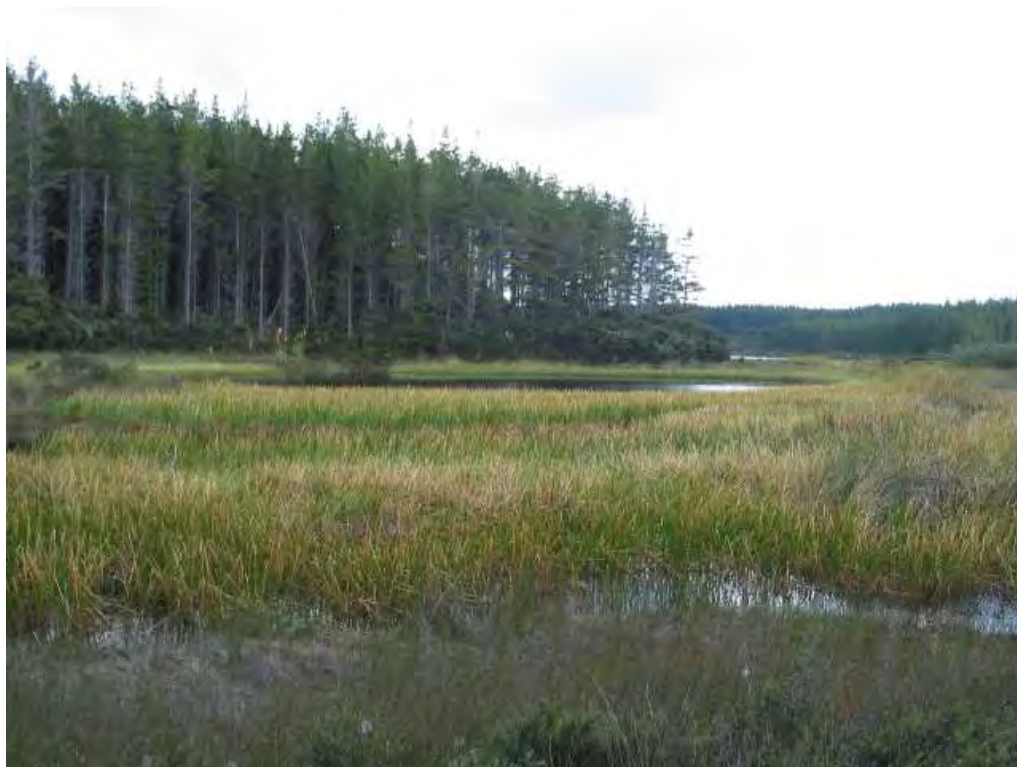
Plate: Morehurehu South 1, a coastal dune lake set in wetland margin of Lake Morehurehu mobile sand dunes, scrub and pine plantation forestry.

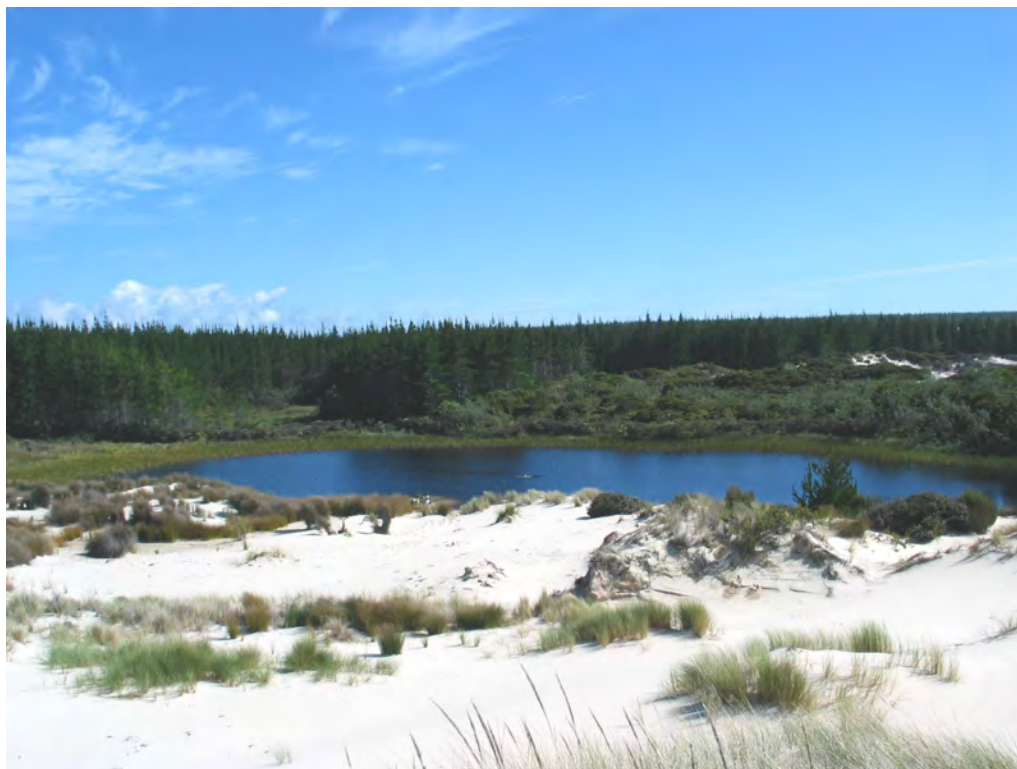
Plate: Morehurehu South 2, a coastal dune lake set in mobile sand dunes, scrub and pine plantation forestry 2006.

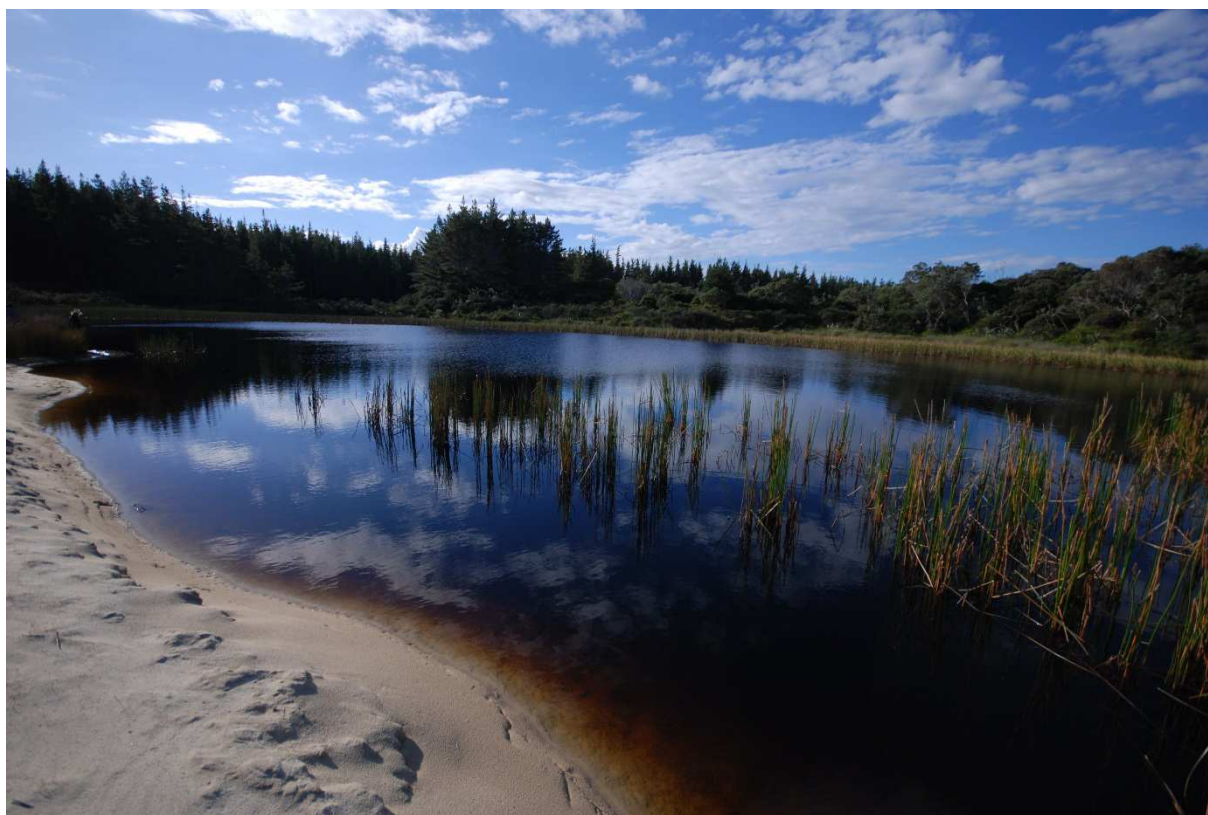
Based on the 2006 survey a Lake Ecological Value rating of 10 (High) was calculated. A deterioration in the rating of the following parameters: aquatic vegetation diversity and integrity (essentially a loss of submerged vegetation, with a decline of diversity from 1 to 0 and integrity from 3 to 0) and endangered species (loss of *U. australis*) has resulted in a revised score of 5 (Moderate). Water quality was not measured at this lake but water transparency had declined (Figure 3-2).

Figure 3-2: Morehurehu South April 2013 with no pine harvesting in the immediate catchment, but this lake has never-the-less gone from clear (>3 m transparency) to very dark brown (< 0.5 m transparency) as have other lake in the catchment.

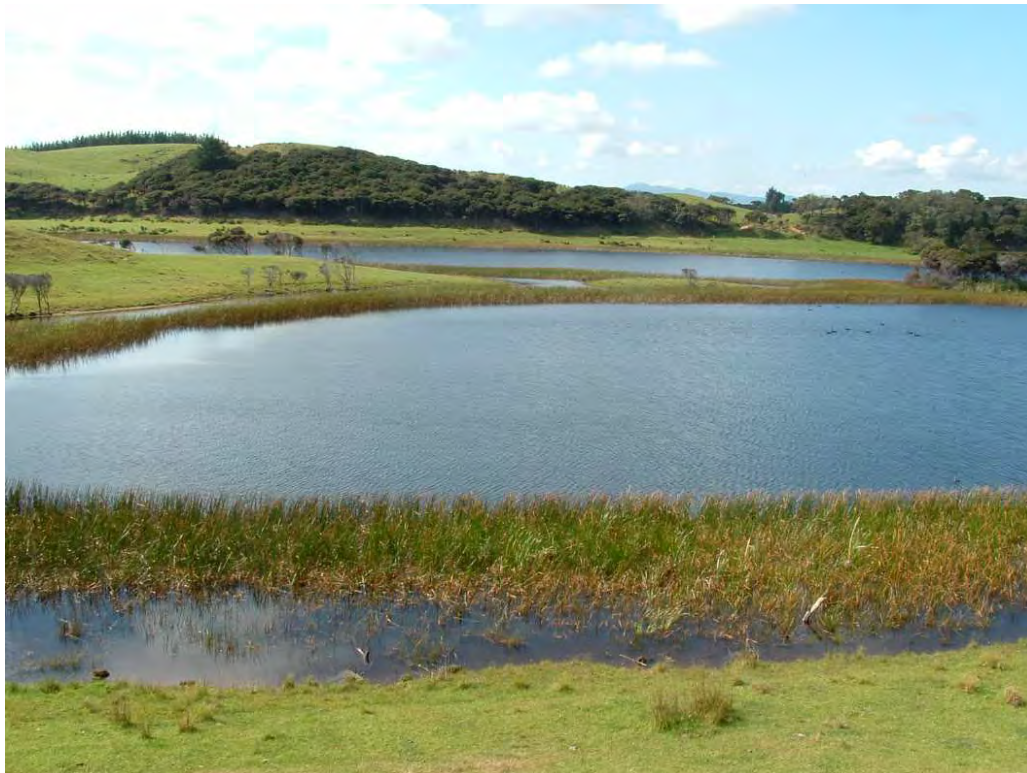
Plate: Ngakapua South Basin looking towards the North Basin separated by a bed of emergent kuta (*Eleocharis sphacelata*). Note the grazing impacts confining emergent vegetation to deeper water.

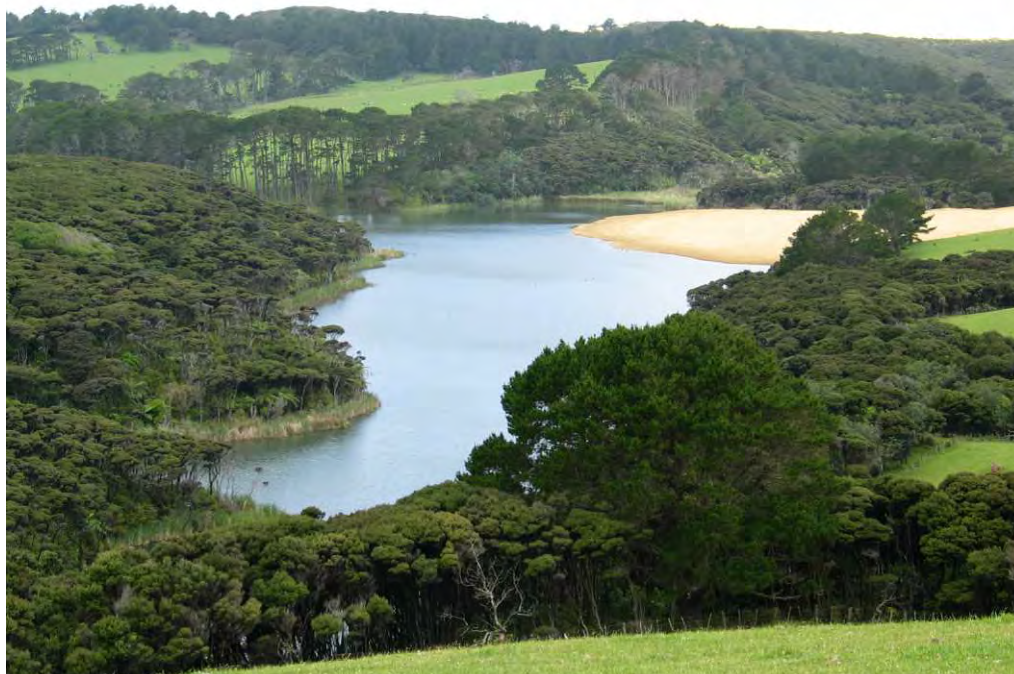
Plate: Lake Ngakeketa showing steep scrub catchment, mobile dune (right) with outlet behind this.

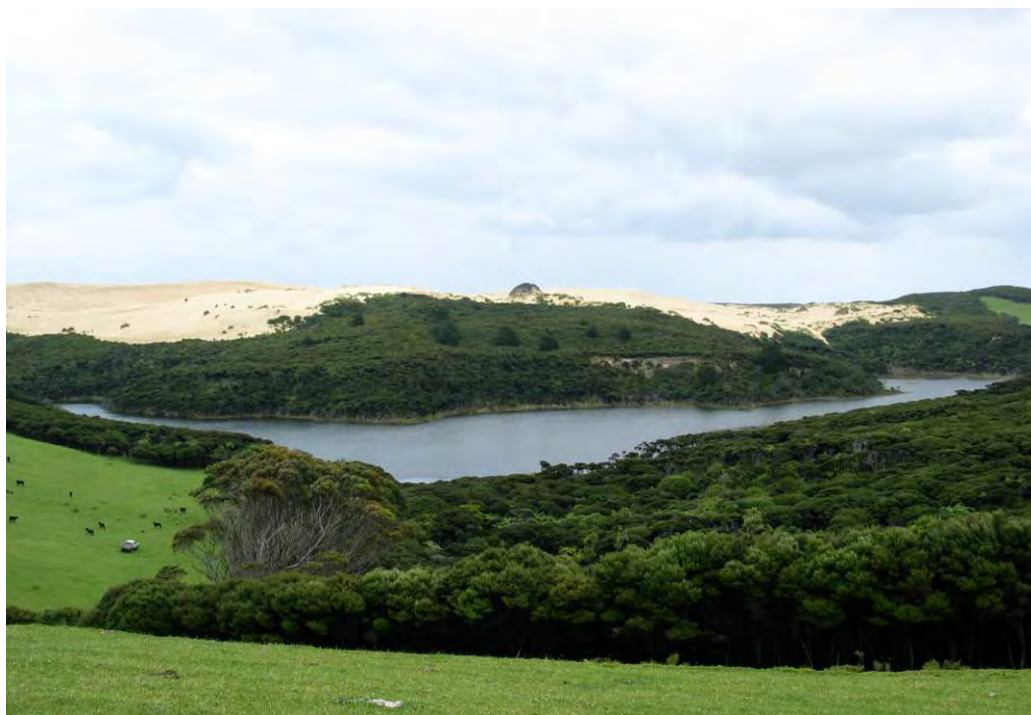
Plate: Lake north of Lake Ngakeketa (head of Te Paki Stream), showing the forested surrounds, with pasture and mobile dunes also in the catchment.

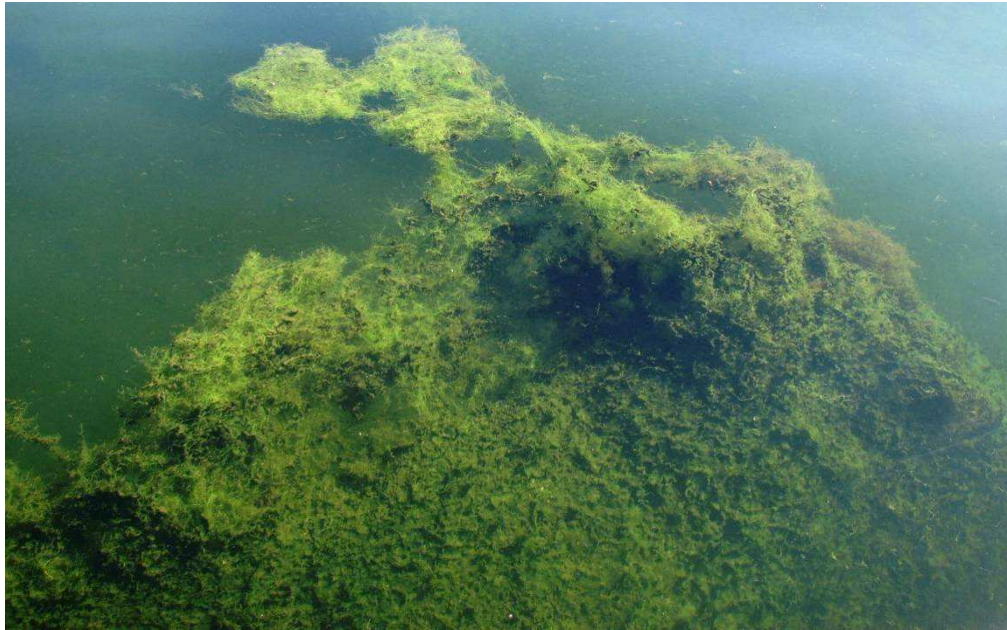
Plate 2: Lake Ngatu, *Utricularia gibba*, an invasive plant pictured in autumn lifting off the bottom and rafting on the surface (photo Kevin Matthews 30 May 2007).

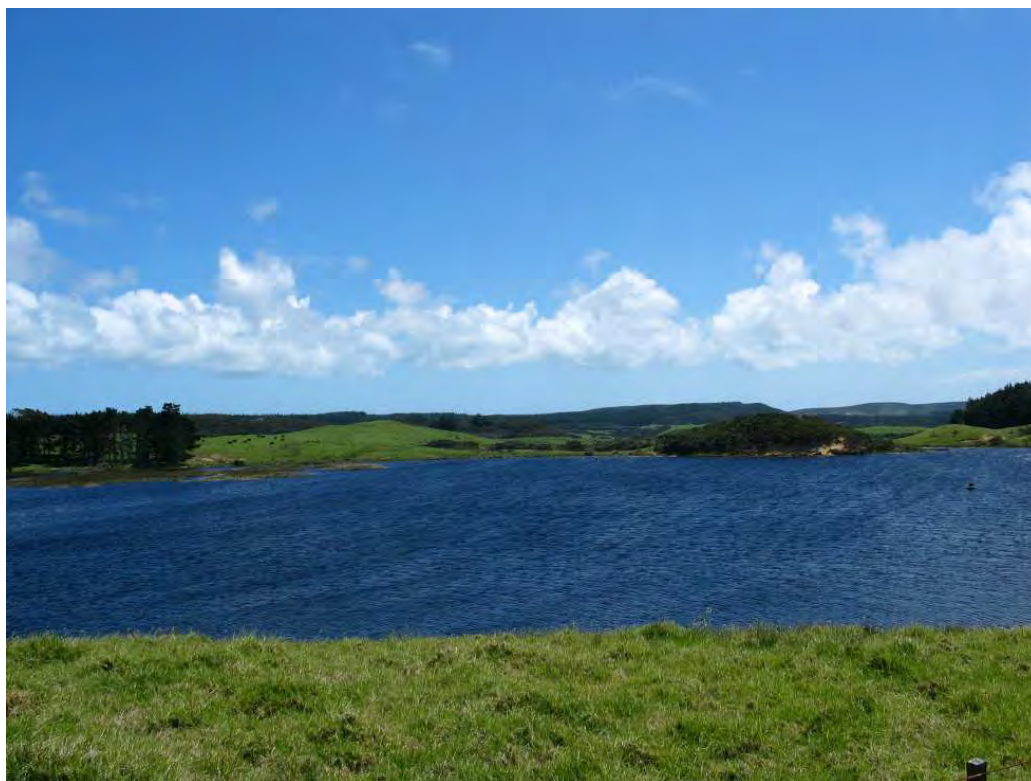
Plate: Lake Ngatuwhete with a mostly pasture catchment, note the beds of emergent vegetation dominated by kuta (*Eleocharis sphacelata*) (middle left).
