# Vessel Hull Fouling as a Marine Biosecurity Indicator in the Top of the South: 2014 Survey

Barrie Forrest

May 2014

**Technical Report 2014/01**

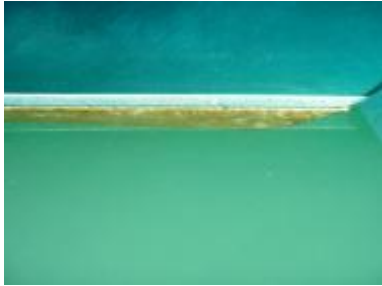
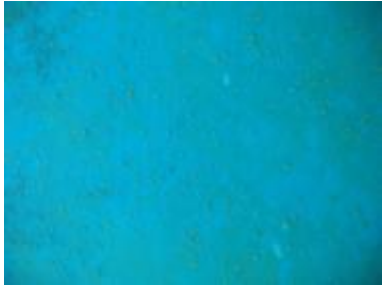
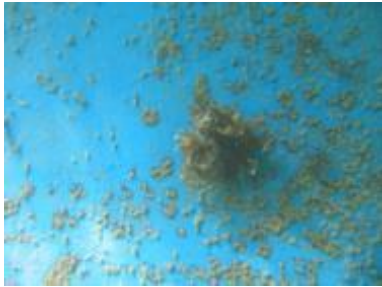
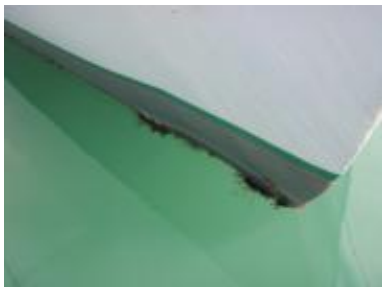
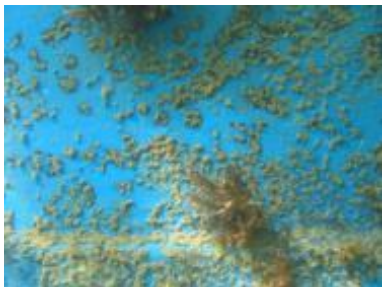
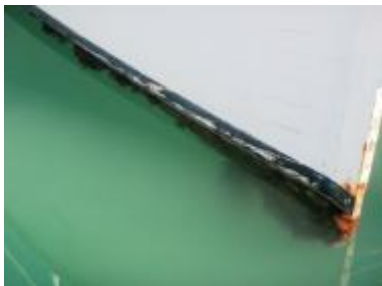
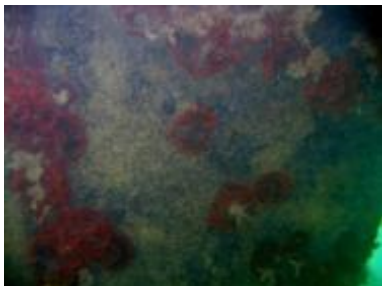
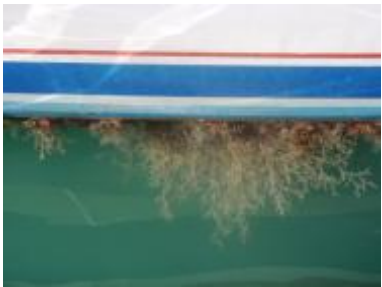
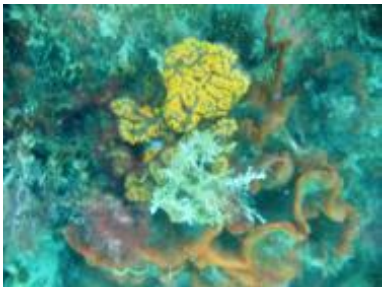
Figure 2. Examples of surface and underwater LOF categories. The photographs are close-up, hence should be considered only as a rough guide.

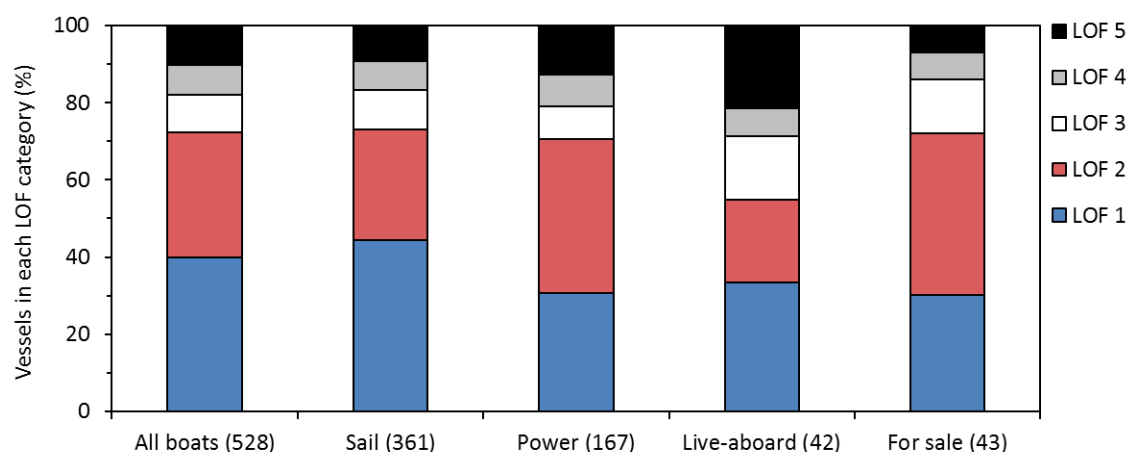
In terms of boat characteristics, Figure 4 shows the greatest prevalence of LOF 4 and 5 scores on the 42 live-aboard vessels. This pattern possibly reflects less interest by the boat owners in maintaining these vessels, compared to active boaters for whom excessive fouling would compromise vessel performance. Powered vessels were generally more heavily fouled than sail boats, probably indicating that some power boats are not antifouled. However, because of the relatively fast speeds that many power boats operate at, survival of fouling during voyages would likely be relatively low. Previous studies have indicated that speeds of ca. 10 knots or greater lead to low survival of hull fouling organisms (Coutts *et al.* 2010a,b).

**Figure 4.** Proportion of surface LOF scores 1-5 in relation to some key vessel characteristics in the 2014 survey. Brackets after boat type indicate number of vessels.

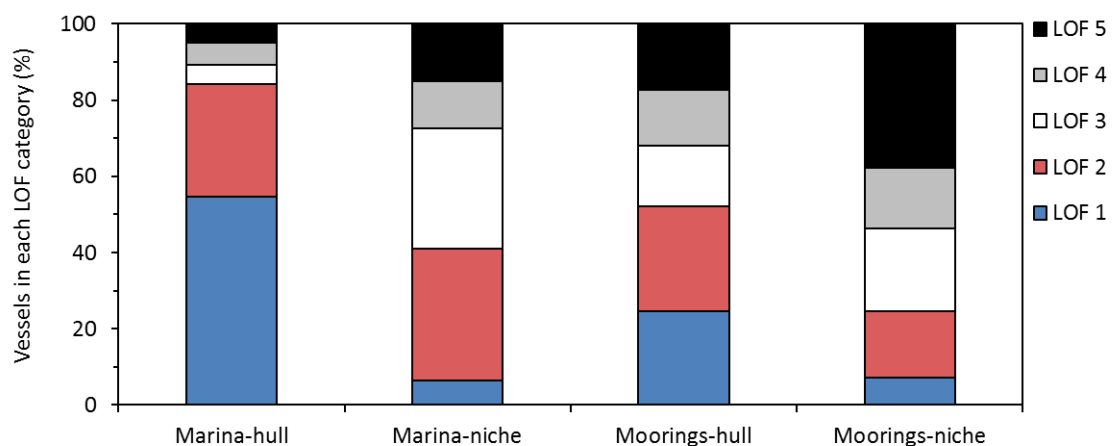
Patterns of fouling among hull locations revealed a greater LOF in niche areas of all vessels, compared with the main laminar surfaces (Figure 6). Niche areas of moored vessels had particularly high fouling, with ca. 54% of boats having LOF 4 and 5. The contrast between main hull and niche areas is consistent with 2013, and with many previous studies of vessel fouling (Inglis *et al.* 2010; Lacoursière-Roussel *et al.* 2012). Such differences in part reflect the lack of antifouling coatings in many niche areas. On yachts for example, it is common to see a high cover of fouling on the bottom of the keel, even when the main hull appears clean and well-antifouled. Since yachts rest on their keel when on hardstand, this area often does not receive an antifoulant, hence can be quickly recolonised when the boat is returned to the water.

**Figure 6.** Proportion of in-water LOF scores 1-5 among main hull and niche areas in the 2014 survey, comparing Nelson marina (n=139 random vessels) with data pooled across the moored vessels (n=69).

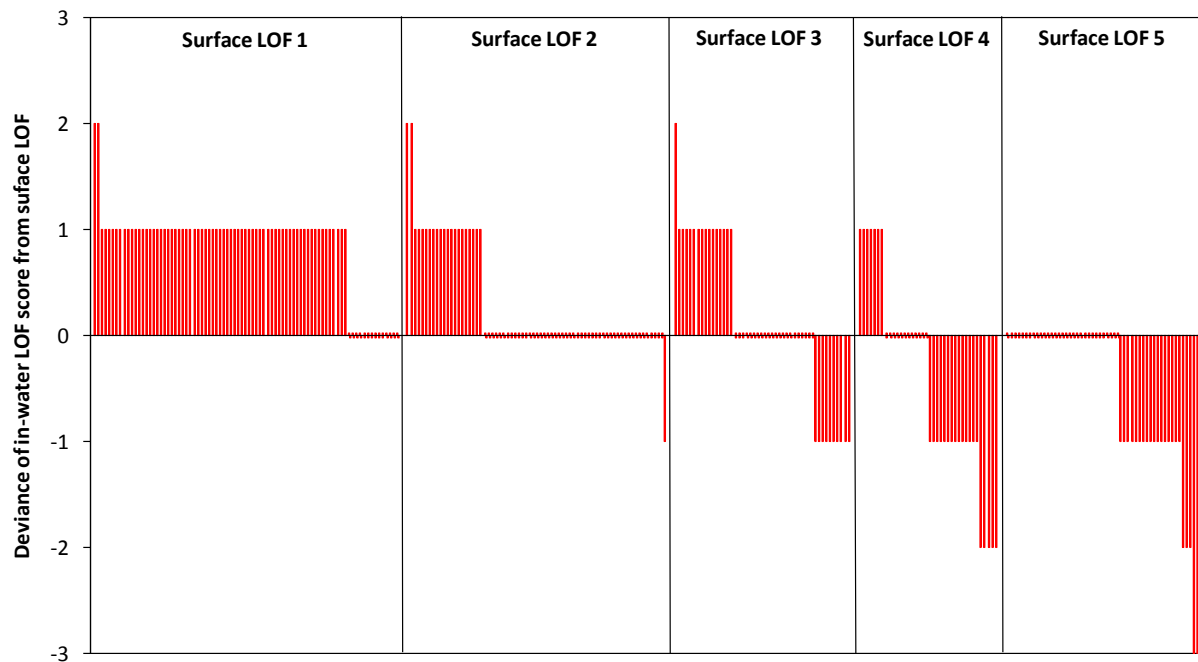
Table 4 and Figure 8 show that at low surface LOF (1 & 2), in-water scores often exceeded surface scores; i.e. surface assessment underestimated the true in-water LOF. However, in most of these cases the in-water LOF score was only one category higher. For example, for 81% of surface LOF 1 scores, the in-water LOF was 2 (i.e. a deviance of 1 in Table 4), often because of light niche-area fouling that could not be seen from the surface. In some cases this reflected poor water clarity (especially in Nelson), and in the case of some longer vessels in Nelson marina the stern niche areas could not be seen from the marina walkway. Another factor was that some boaters clean their vessels in areas they can reach from the surface, thus giving a misleading indication of fouling deeper on the hull.

**Figure 8.** Deviance of in-water LOF from surface LOF for each of the 294 vessels sampled in-water in 2014, grouped by LOF. Positive red bars indicate that in-water scores exceeded surface scores, absence of bars (red line) indicates that scores were the same, and negative bars indicate that in-water scores were less than surface scores.
