15 Te Mimiha (Helena)

Coastal Erosion Hazard Assessment

Coastal Erosion Hazard Assessment Te Mimiha (Helena Bay)

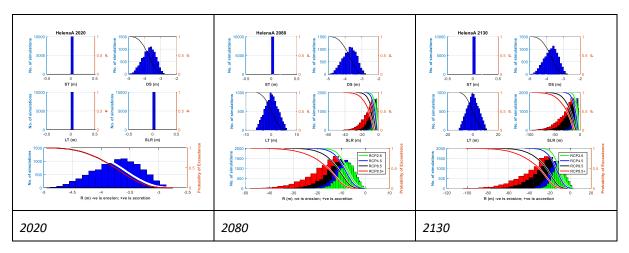
Figure 15-1 Histograms of parameter samples and the resultant shoreline distances for 2020, 2080 and 2130 timeframes for cell 15A

Histograms of individual components and resultant CEHZ distances using a Monte Carlo technique are shown in Figure 15-1 to Figure 15-3. Coastal Erosion Hazard Zone widths are presented within Table 15-2 to 15-4 and Figure 15-4.

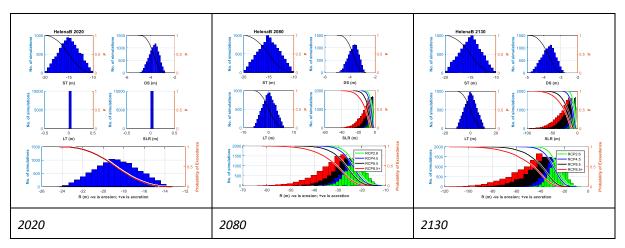
Figure 15-2 Histograms of parameter samples and the resultant shoreline distances for 2020, 2080 and 2130 timeframes for cell 15B

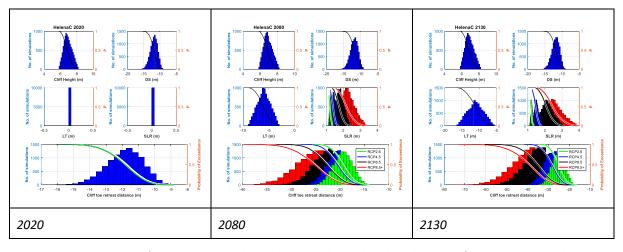
Figure 15-3 Histograms of parameter samples and the resultant shoreline distances for 2020, 2080 and 2130 timeframes for cell 15C

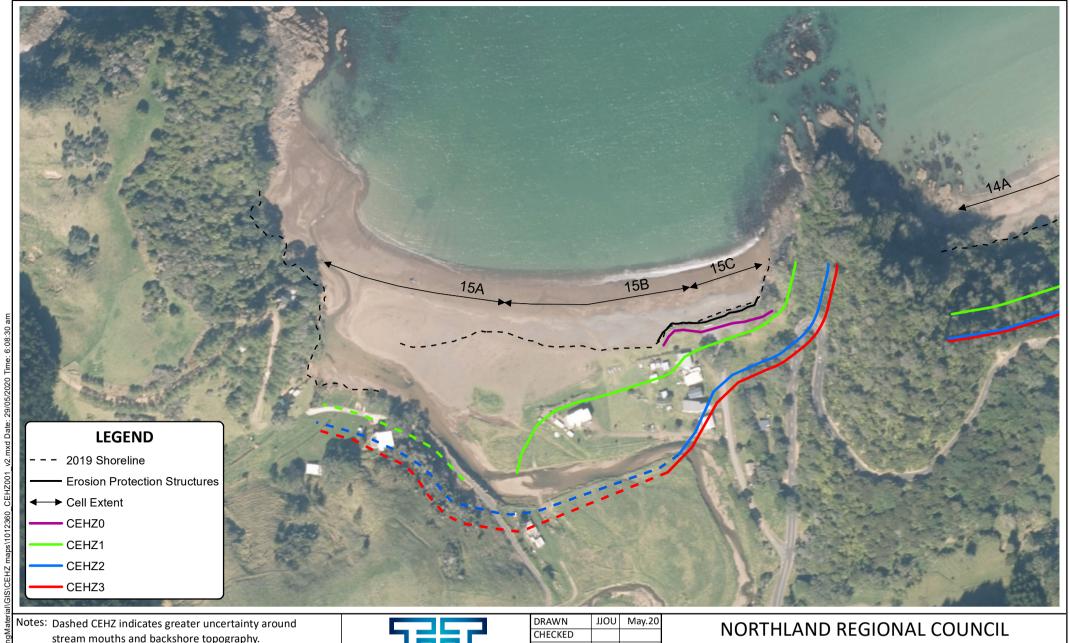
Figure 15-4

stream mouths and backshore topography. Northland 0.4m Rural Aerial Photos (2014-2016).

CEHZs have been mapped in agreement with the calculated values, although the CEHZ2 and CEHZ3 values have been located landward of the Te Mimihia Stream rather than on the landward edge of the low vegetated spit and is dashed to reflect the uncertainties to the north. Note that cell 15A has experienced accretion since about 1950 along approximately 150 m, with CEHZs offset from the accreted most recent shoreline.

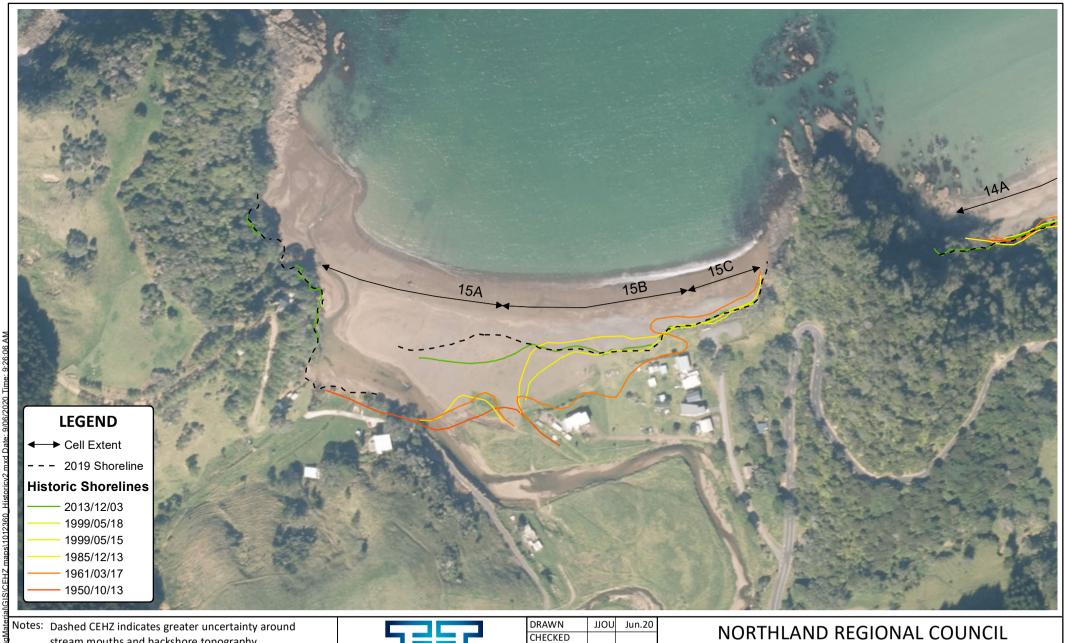
stream mouths and backshore topography. Northland 0.4m Rural Aerial Photos (2014-2016).

Historic Shorelines Te Mimiha (Helena Bay)

Figure 15-5 shows the available historic shorelines for Te Mimiha (Helena).
