WAITANGI CATCHMENT

WATER QUALITY UPDATE

Date: April 2016

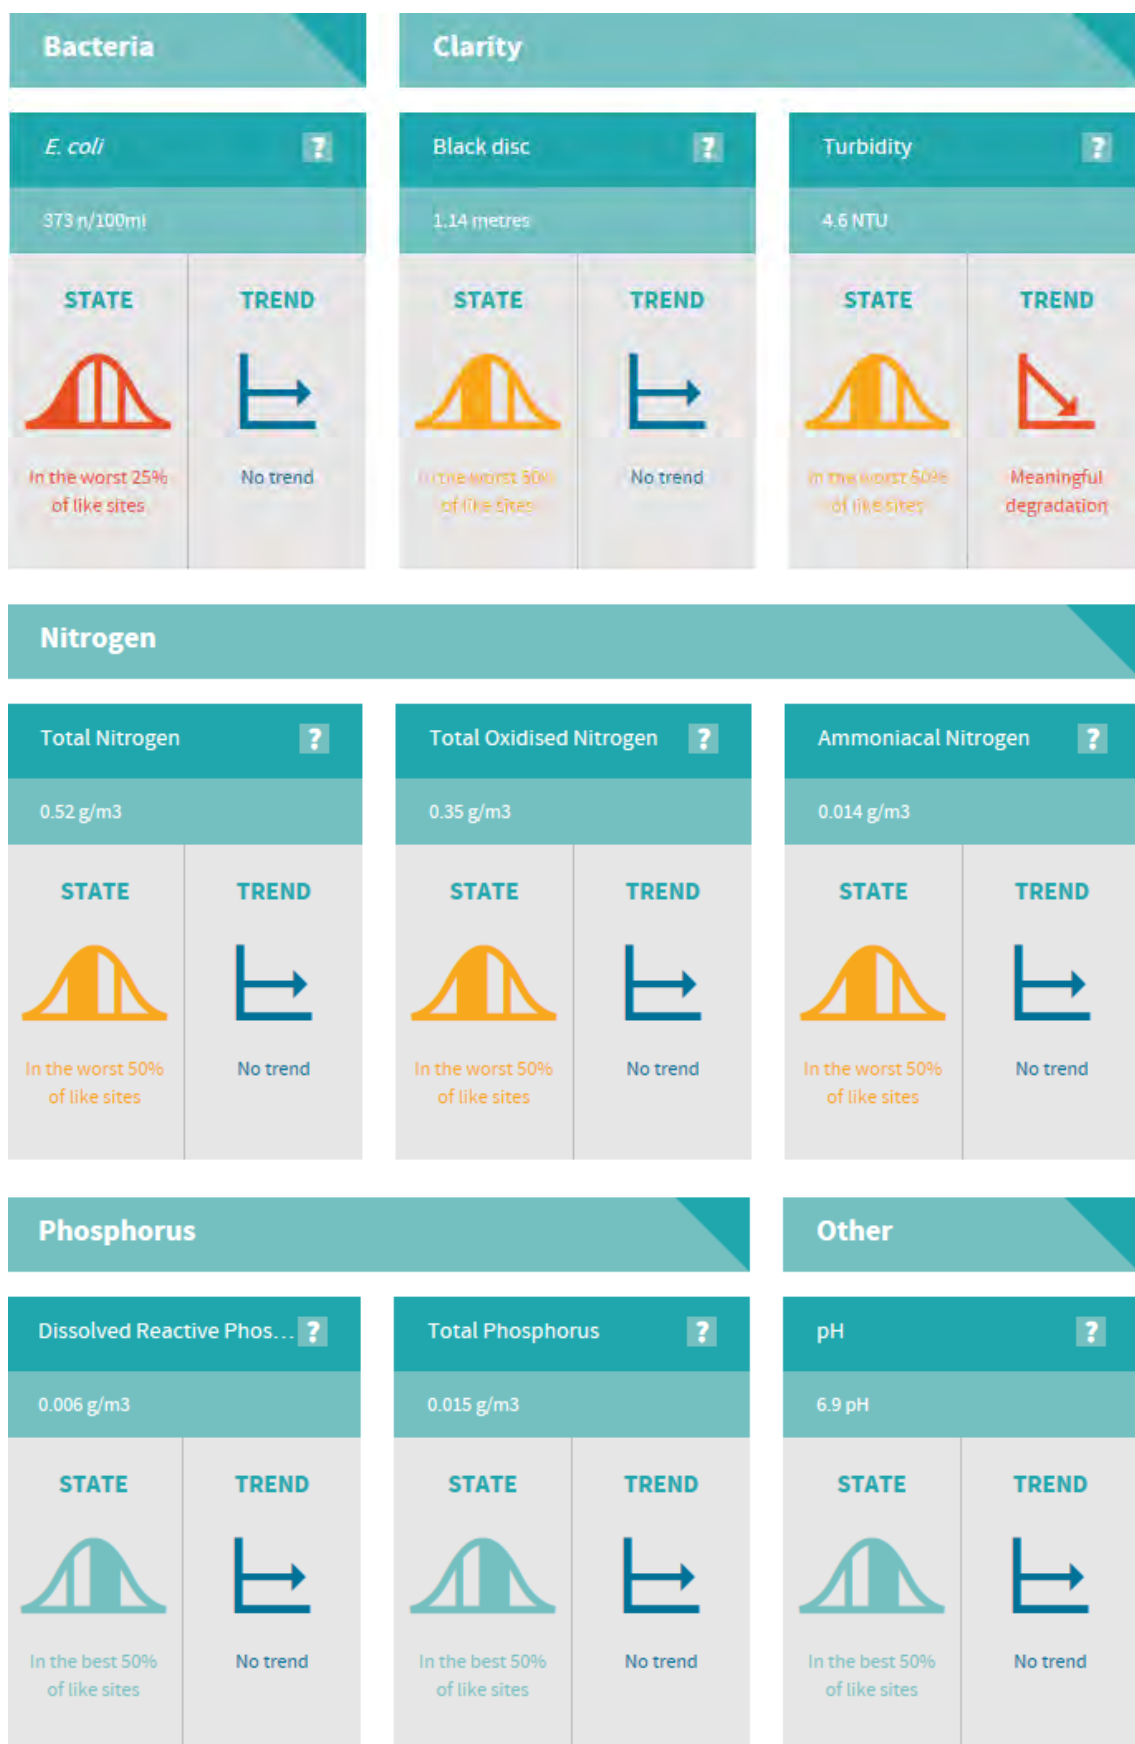
Figure 2: Current water quality state at the Waitangi at Waimate North Road RWQMN site compared to similar sites in New Zealand with 10 year trends for nine water quality parameters (excerpt from Land Air Water Aotearoa (LAWA) website).

Currently the only sites with long term water quality data in the Waitangi catchment are the Waitangi at Waimate North Road, and the Waitangi at Wakelins which is a site monitored by the National Institute of Water and Atmospheric research (NIWA). These sites have been monitored since 2002 and 1989 respectively. Land Air Water Aotearoa ([LAWA](http://www.lawa.org.nz))¹, a website which brings together water quality data from regional councils throughout New Zealand, currently provides results for *E. coli*, turbidity, and nutrients, i.e. nitrogen and phosphorus, rank amongst the worst 50 percent of similar sites in New Zealand (Figure 2 and Figure 3). *E. coli* levels in the Waitangi at Waimate North site are amongst the worst 25 percent.

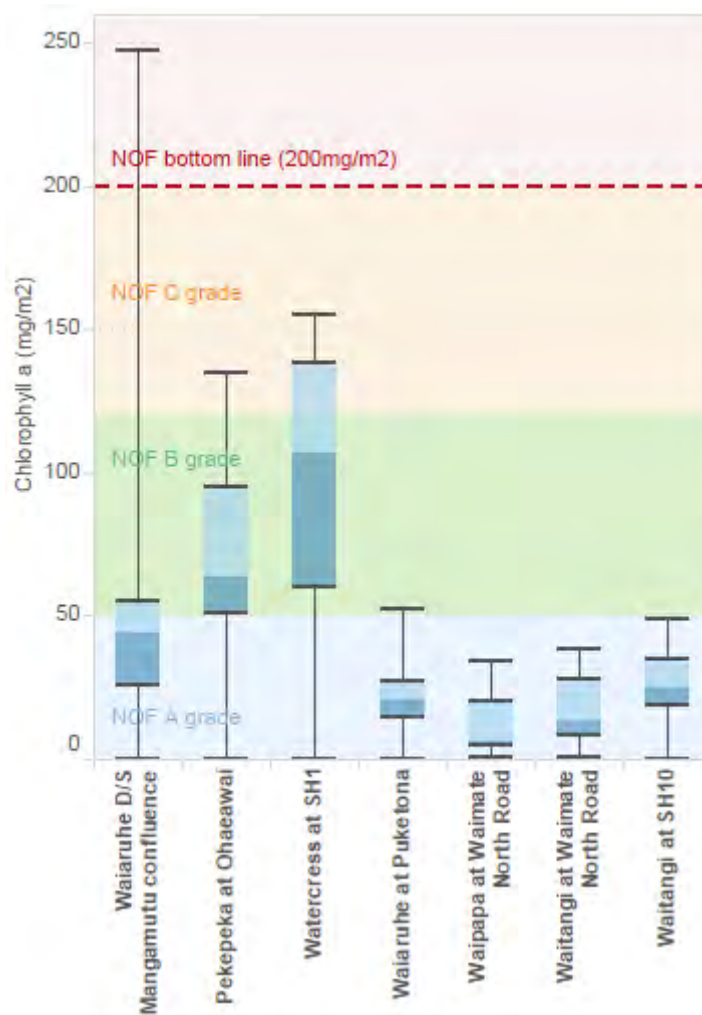
Figure 8: Chlorophyll a (July 2014 to June 2015) with corresponding NOF grades.

The NOF guidelines recommend at least three years of data to complete and interpret periphyton results. One year of data currently available suggest that three sites may be prone to periphyton blooms and fail the national bottom line of a maximum value of 200mg Chl a/m²: Pekapeka at Oheawai, Waiauru D/S Mangamutu confluence and Watercress at SH1 (Figure 8).

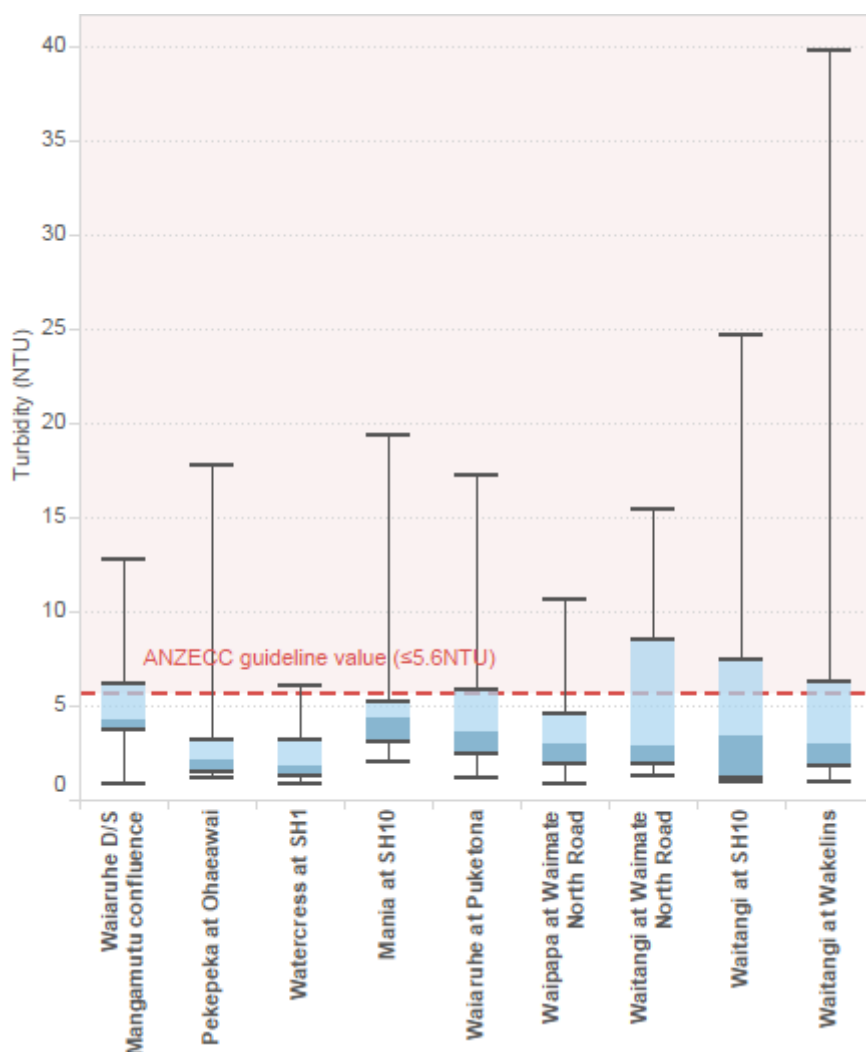
Figure 9: Turbidity (July 2014 to June 2015) with ANZECC guideline value.

Currently there is no measure for turbidity in the NOF. However, median turbidity levels from July 2014 to June 2015 met ANZECC guideline value for lowland rivers (≤ 5.6 NTU) at all sites (Figure 9).

However some samples were high, well above the guideline value, particularly in the Waitangi catchment. The Waitangi at Waimate North Road recorded the most extreme levels which could be associated with serious erosion issues in its tributary, as well as bank erosion at the site (Figure 15).

- All three Waitangi catchment sites, i.e. Waimate North Road, SH10 and Wakelins, exhibit occasional elevated turbidity levels (Figure 9) and spikes in *E. coli* levels (Figure 10) possibly associated with land run-offs during high rainfall events. While this in part may be linked to erosion issues occurring in its tributary, the Whangai Stream, all three sites have serious issues with slumping banks (Figure 15). Data at both RWQMN sites, i.e. Waitangi at Waimate North Road and Waitangi at Wakelins, also suggests turbidity levels have deteriorated over the past 10 years. These sites also recorded poor habitat scores of 60 percent or less of reference condition (Figure 14).

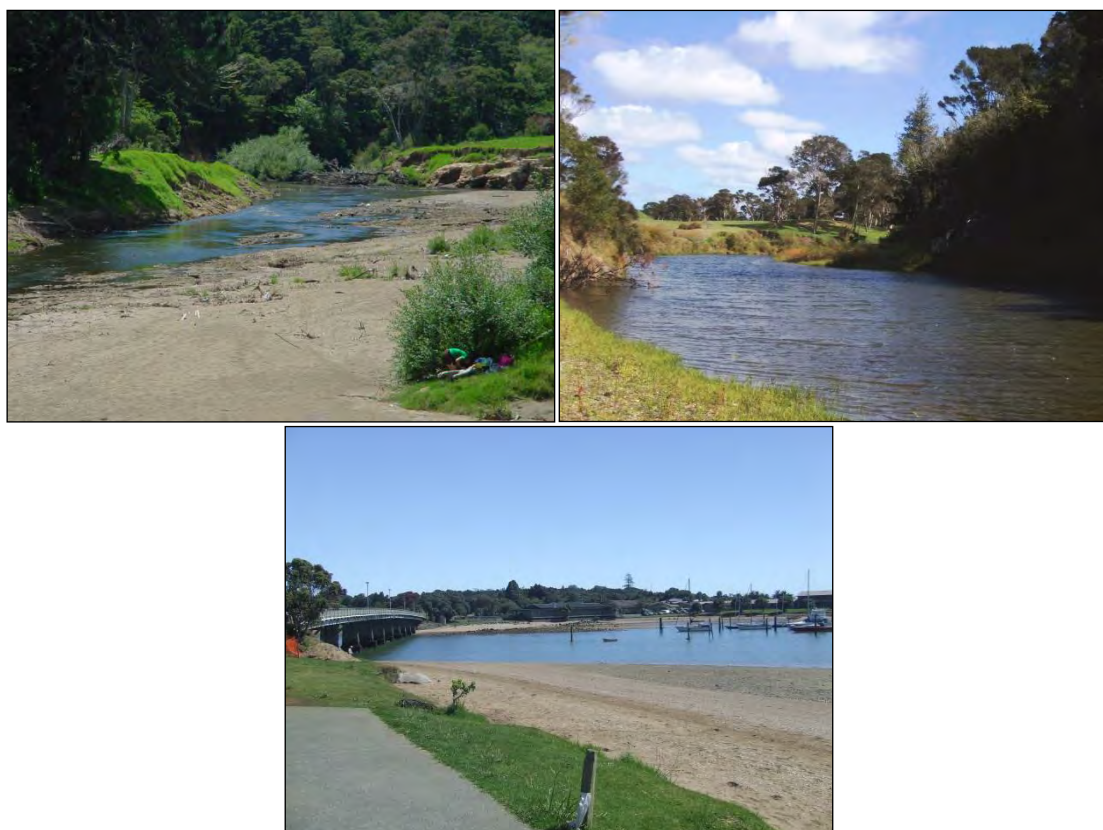
Figure 11: Swimming water quality sites at Lily Pond (top left), Watea (right) and Waitangi Bridge (below).

Two sites are currently monitored on the Waitangi River as part of the council's Recreational Swimming Water Quality programme² (Figure 11). One site located between Puketona and Haruru Falls at Lily Pond was monitored from 2004 to 2011. This site was decommissioned due to safety reasons and replaced in 2012 with the site at Watea (also known as Wakelins and located further downstream). The second site currently monitored is located at the river mouth at Waitangi Bridge.

Between 2004 and 2011, 88 samples were collected during the summer months and complied with the suitability for swimming guidelines for freshwater (*E. coli* ≤550MPN/100mL) 58 percent of the time with a median *E. coli* level of 238MPN/100mL at Lily Pond. Thirty five samples were collected between 2012 and 2015 from the site at Watea. Results complied with the suitability for swimming guidelines 86 percent of the time with a median *E. coli* level of 122MPN/100mL. Between 2004 and 2015, 135 samples were collected and complied with the guideline for marine water (*Enterococci* ≤280MPN/100mL) 92 percent of the time at Waitangi Bridge.

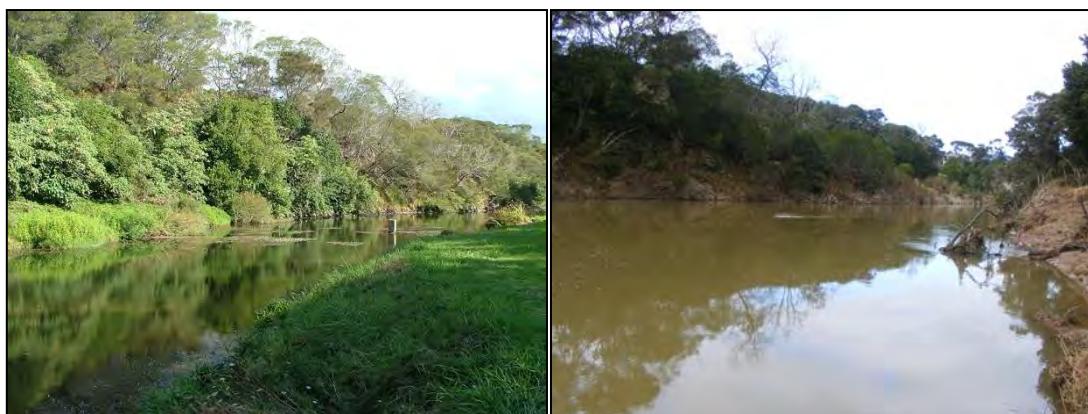
Figure 15: Bank and channel erosion at the Waitangi at Wakelins site before (left) and after (right) the 2014 flooding event.

severely impacted by flooding in 2014 (Figure 15). Both sites have uniform flow and have substrates composed of mainly sediment/sand providing little habitat diversity (NRC 2012). These figures are correlated to lowest MCI scores recorded at both sites (Figure 13).

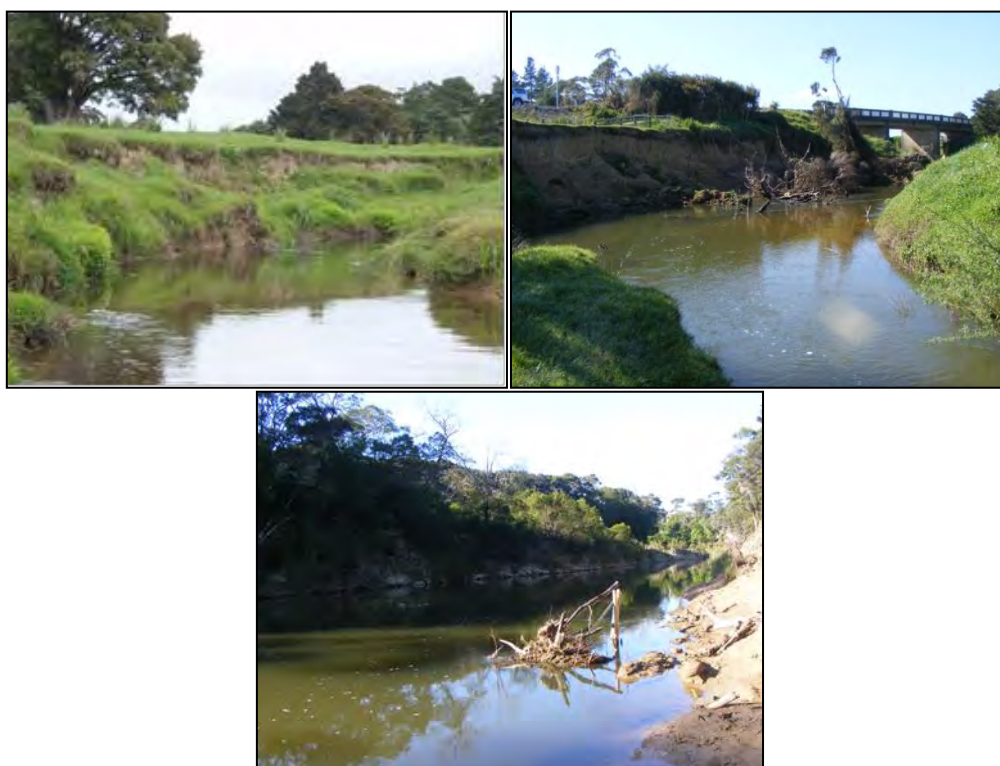
Figure 16: Erosion occurring at Waitangi River sites. From upstream to downstream order down the catchment: Waimate North Road site (top left), SH10 site (top right), Wakelins site (bottom).
