Poutō Peninsula

Rotokawau (Poutō), NRC Lake No. 364.

| Summary | Rotokawau |
| Surveyed: | 2001, 2005, 2007, 2012, 2015, 2018 and 2021 (reconnaissance). |

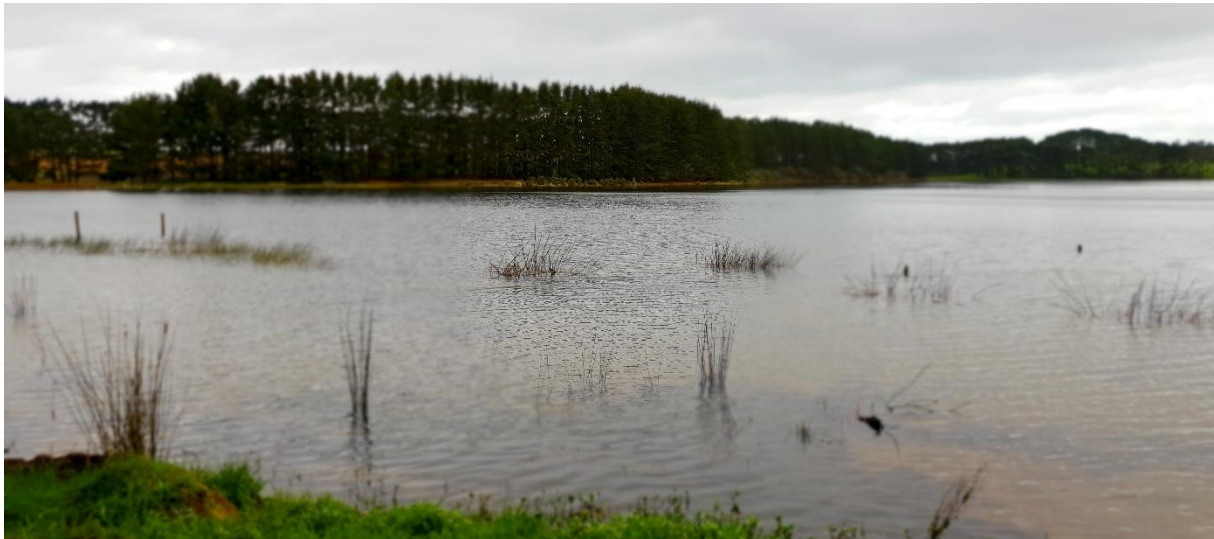
Rotokawau. Photo from entry point on western margin looking over at a line of pine trees on the northern margin. (Photo: Tracey Burton 19 September 2018).

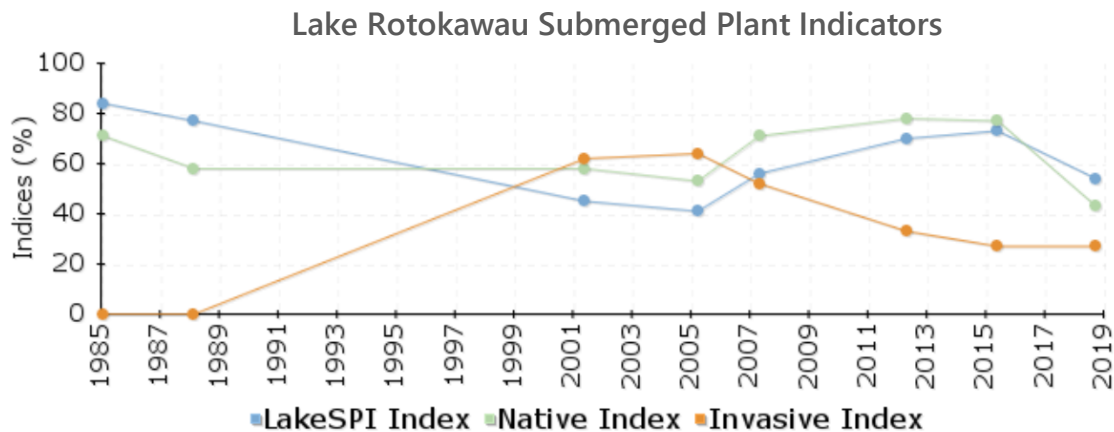
LakeSPI results for Rotokawau. LakeSPI Indices expressed as a percentage of lake maximum potential.

Rotokawau is categorised as being in high ecological condition with a LakeSPI Index of 54%. LakeSPI had declined from 73% in 2015, reflecting a large decrease in the Native Condition Index, from 77% in 2015 to 43% in 2018. With no further increase in the Invasive Impact Index, LakeSPI scores had declined as a result of water quality issues and not further invasive impact.

Prior to the 2018 survey, the LakeSPI index had continued to improve from 2005 to 2015 as a result of a reduction in the invasive impact scores. In 2015, egeria and *U. gibba* did not exceed a 10% cover at any of the baseline sites, but improved water clarity (greater than 5 m during the 2012 and 2015 surveys) contributed to the expansion of native charophyte meadows down to >10 m.

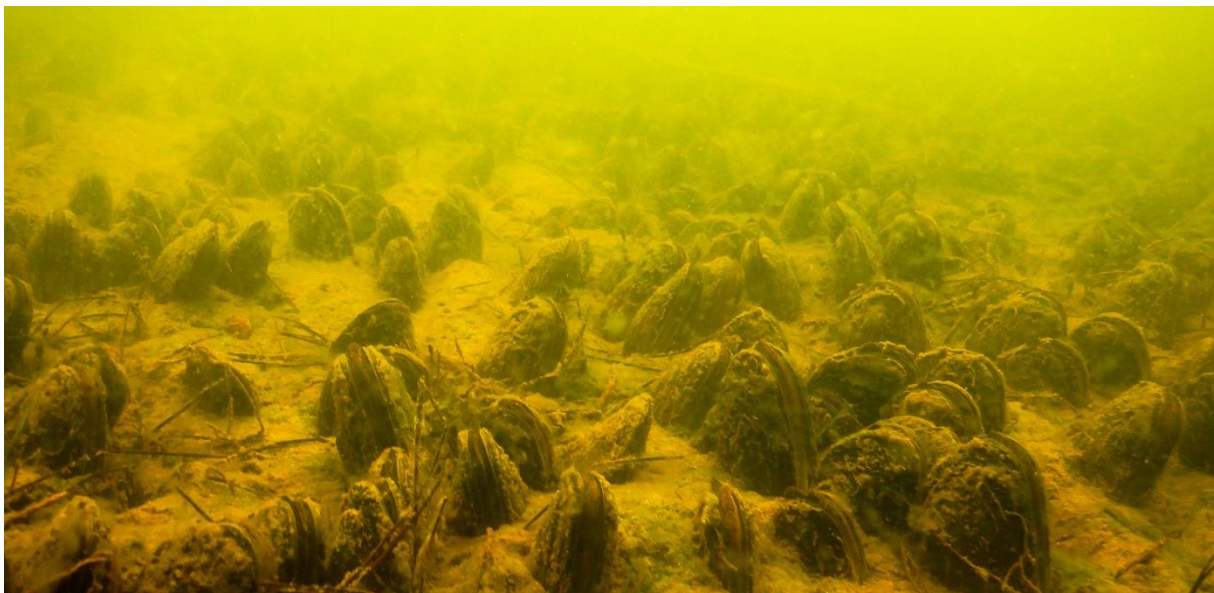
Freshwater mussels (*Echyridella menziesii*) were abundant in the 2018 survey. Leeches (*Richardsonianus mauianus*), and *Potamopyrgus antipodarum* snails were noted in some surveys but not in 2018.

Freshwater mussels in Lake Rotokawau. (Photo: Tracey Burton, 19 September 2018).

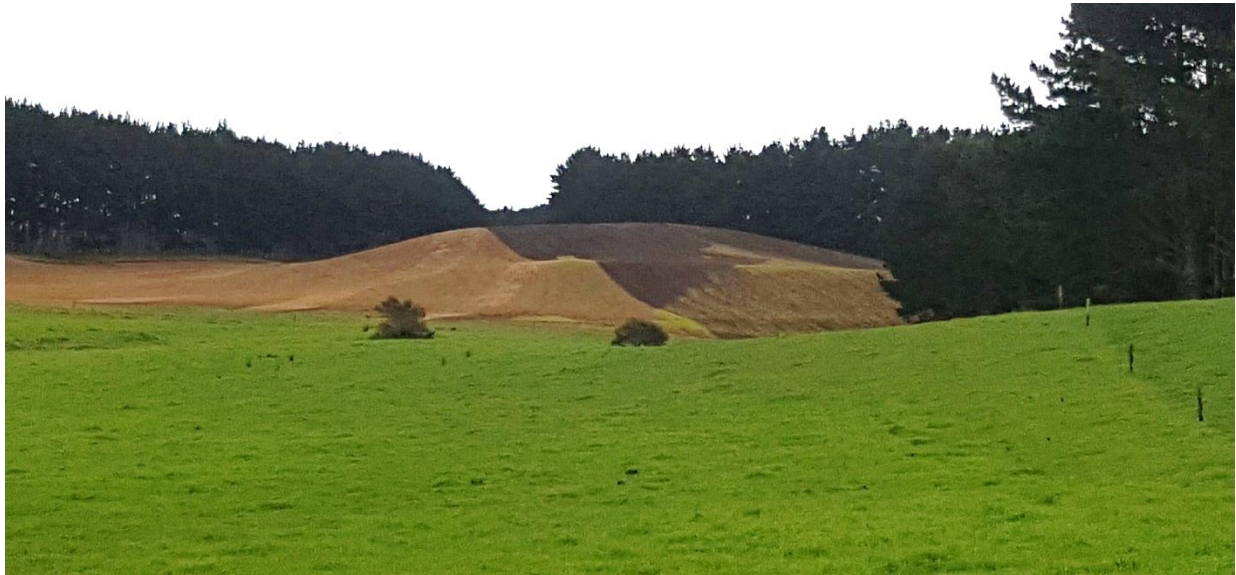
Submerged vegetation underwent a significant decline in 2018 and water quality has generally declined since 2008 (but is still mesotrophic with a 10-year median of 3.40 in 2019), with nutrient enrichment most likely relating to farming activities in the catchment. A paddock adjacent to the lake was devegetated at the time of the 2018 survey and fertiliser application may have contributed additional nutrients to Rotokawau (L. Forester, NRC, pers. comm.).

Paddock adjacent to Rotokawau (to the north (right)). Run off from the bare earth is likely to run into the lake. (Photo: Paul Champion 19 September 2018).

Livestock access to parts of this lake could also affect water quality through direct nutrient addition, and damage to emergent and wetland vegetation that currently buffer the northern part of the lake from land-based nutrient sources.

Understanding the drivers for the water quality decline is critical to sustaining the outstanding ecology of this lake. Fencing and riparian retirement are advocated for this lake to reduce nutrient addition from erosion of the catchment and direct livestock access.
