Remotely piloted aircraft system (RPAS) survey and habitat assessment of Ruakaka Estuary

Griffiths R, Eyre R, Bamford N, Umuroa N, Brotherhood B, Jolly M, Sharp-Heward J, 2019. Remotely piloted aircraft survey (RPAS) and habitat assessment of Ruakaka Estuary. Northland Regional Council, Whangārei, pp46.

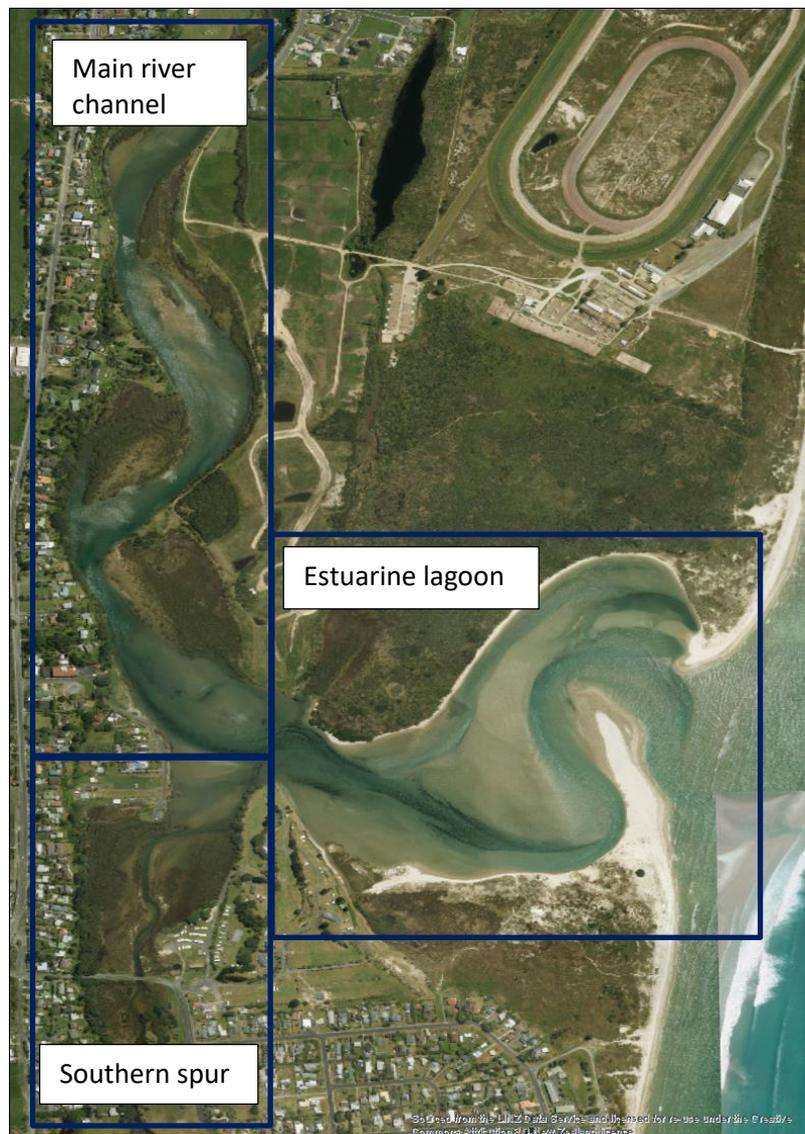
Figure 1. Aerial view of Ruakaka Estuary.

Ruakaka Estuary is a drowned river valley system located on Northland’s east coast. The Estuary comprises a main river channel, which meanders north to south, an outer lagoon and a southern spur (Figure 1).

The main Ruakaka River channel is bordered by narrow sand and mud flats with fringing mangroves and saltmarsh habitat. The outer lagoon comprises shifting sand bars and channels, with a sand spit at the entrance to the estuary. There are narrow sand flats on the northern shore and a larger sand flat on the southern shore. The southern spur comprises a shallow channel that meanders south to north. The channel is boarded by sand flats, saltmarsh and mangrove habitat, with a more expansive sand flat, at the northern end, where the spur joins the main river channel.

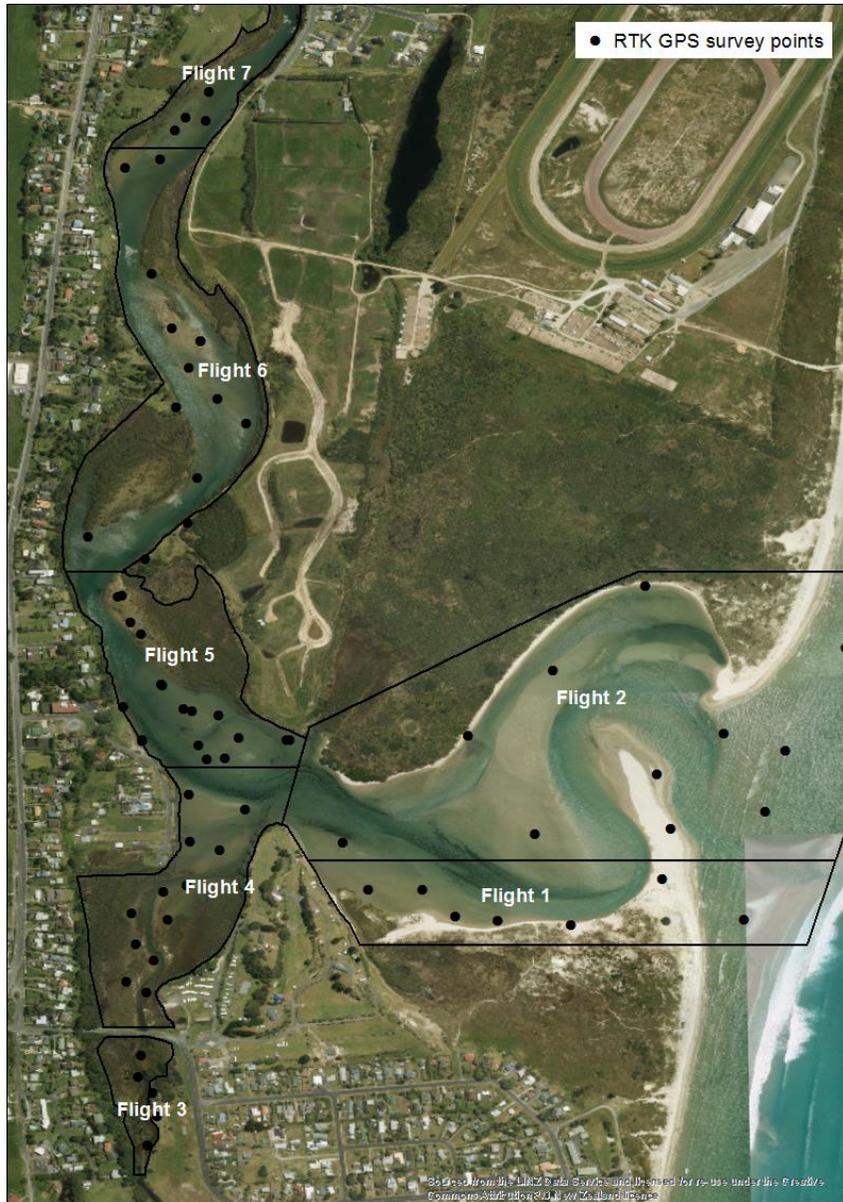
Figure 2. Flight zones and RTK GPS survey points.

A Trimble R10 RTK GNSS system was used to collect 71 ground control points (GCPs) (Figure 2) for georeferencing and correcting the elevation data produced in DroneDeploy. The base was positioned over LINZ benchmark BDDM at Princes Road, Ruakaka (a 4th order mark) and the rover was used to collect a measurement to a second known LINZ control point to verify the location of the base. GCPs were then collected throughout the estuary, on flat uniform surfaces. They were marked with a cross on the ground and the centre of each GCP was surveyed with the rover. At each GCP, three GPS measurements were recorded and these were then averaged.

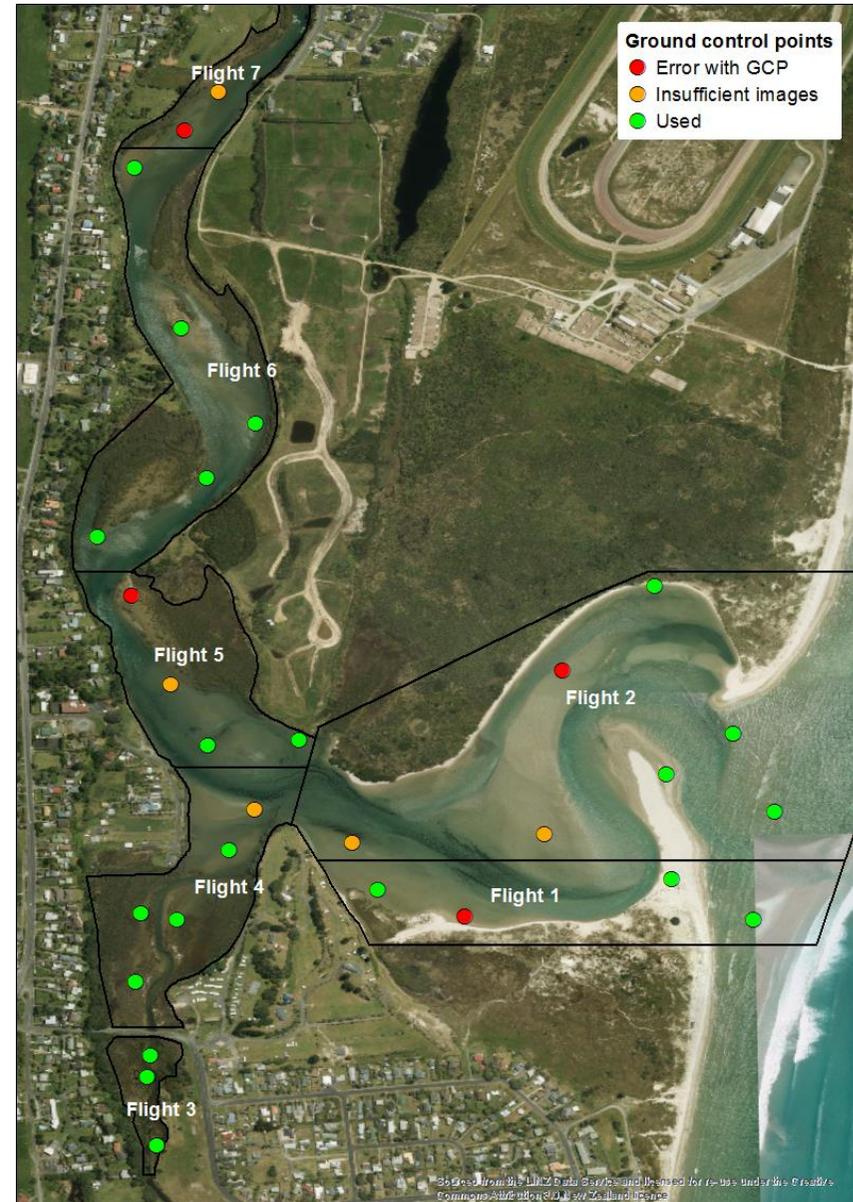
Figure 3. Ground Control Points uploaded to DroneDeploy.

In total 71 GCPs were collected. As DroneDeploy only allows for up to 30 GCPs to be used in processing the remaining RTK GPS survey points were utilised as check points.

DroneDeploy recommends that GCPs are located at least 15m from the edge of the planned flight path and 15m away from water. GCPs located too close to the perimeter of the flight path are likely to be

captured in less images collected by the RPAS (each GCP needs to be visible in at least three images to be used for processing). Unfortunately, due to the shape of some parts of the estuary, it was not always possible to place GCPs 15m away from a water body or the perimeter of the flight plan.

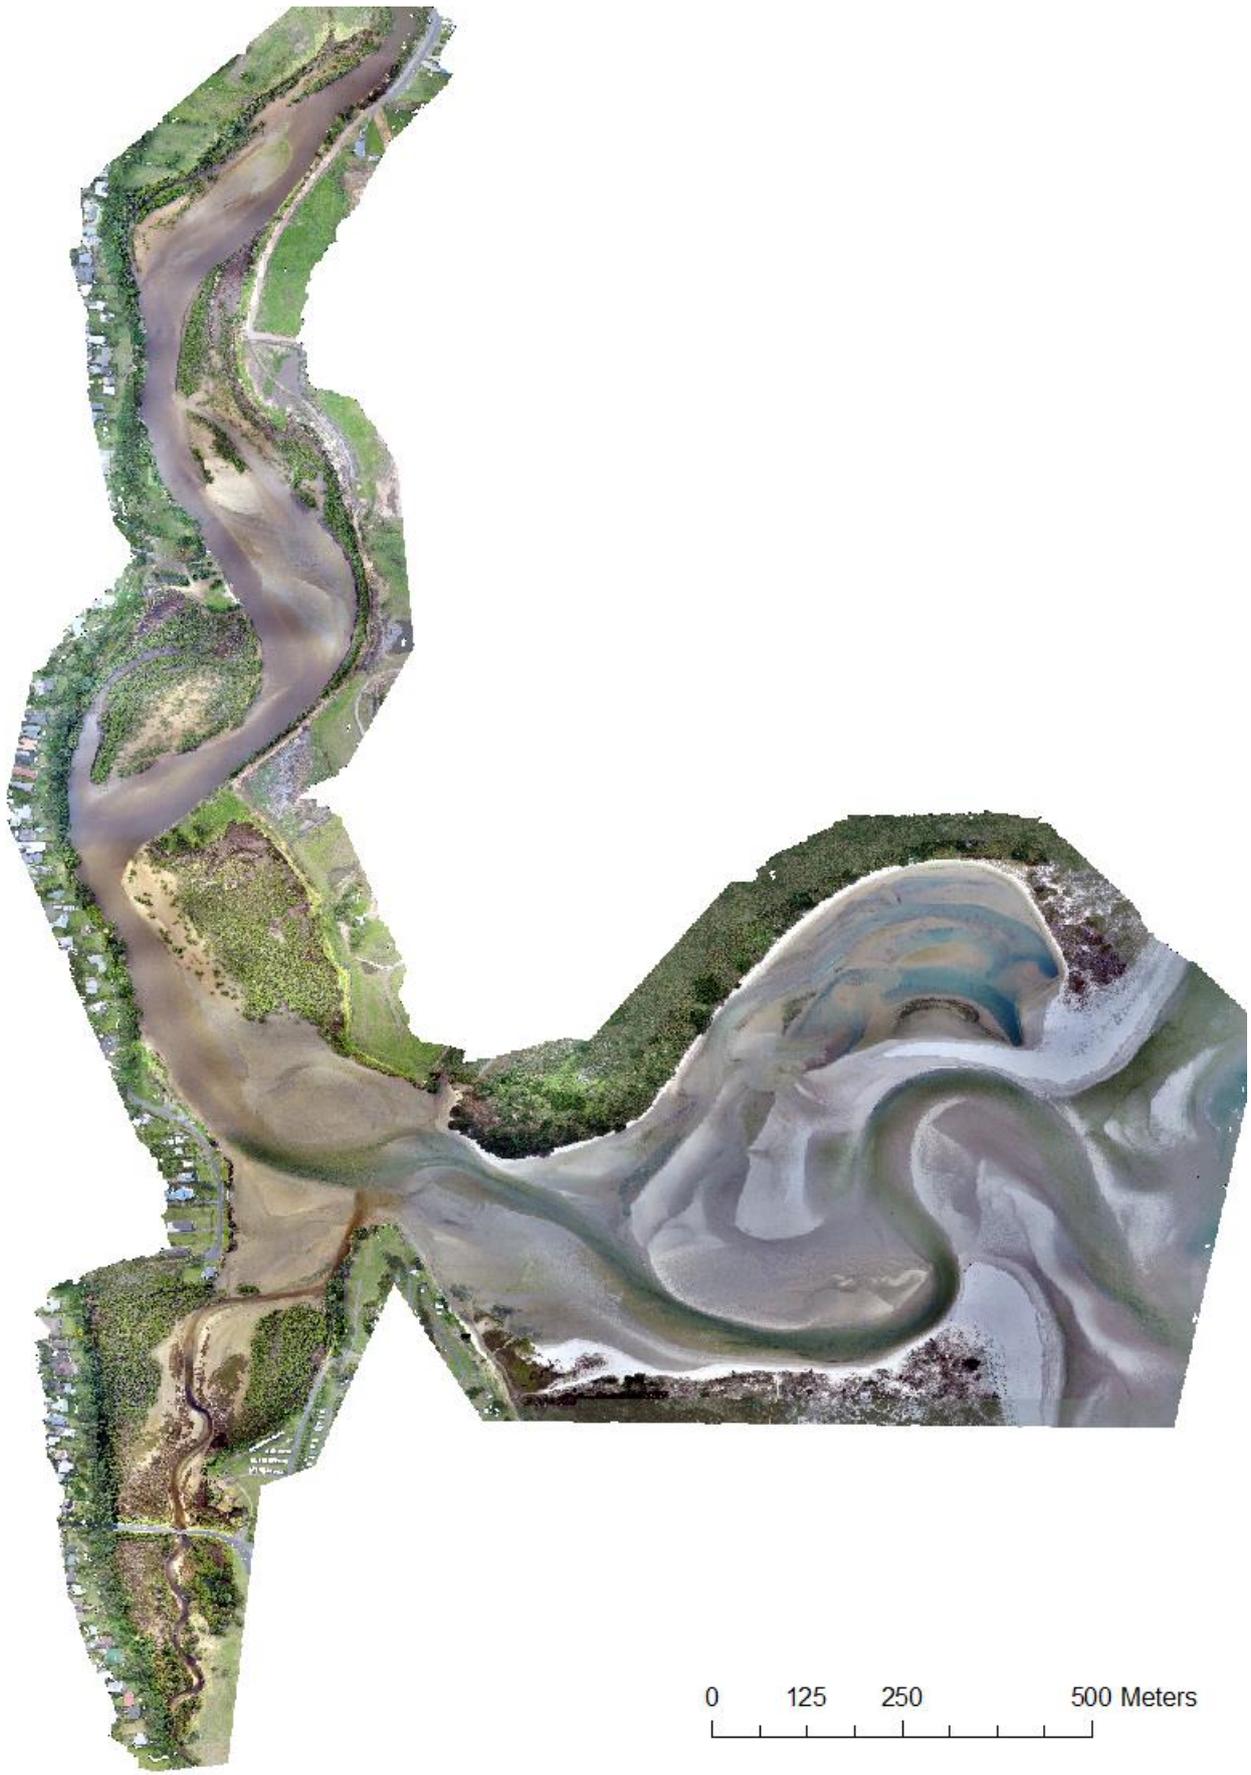
Figure 4. Orthomosaic GeoTiff of Ruakaka Estuary.

After processing an orthomosaic GeoTiff, a digital elevation model (DEM) GeoTiff and a contour shapefile, with a resolution of 0.25m, was exported from DroneDeploy.

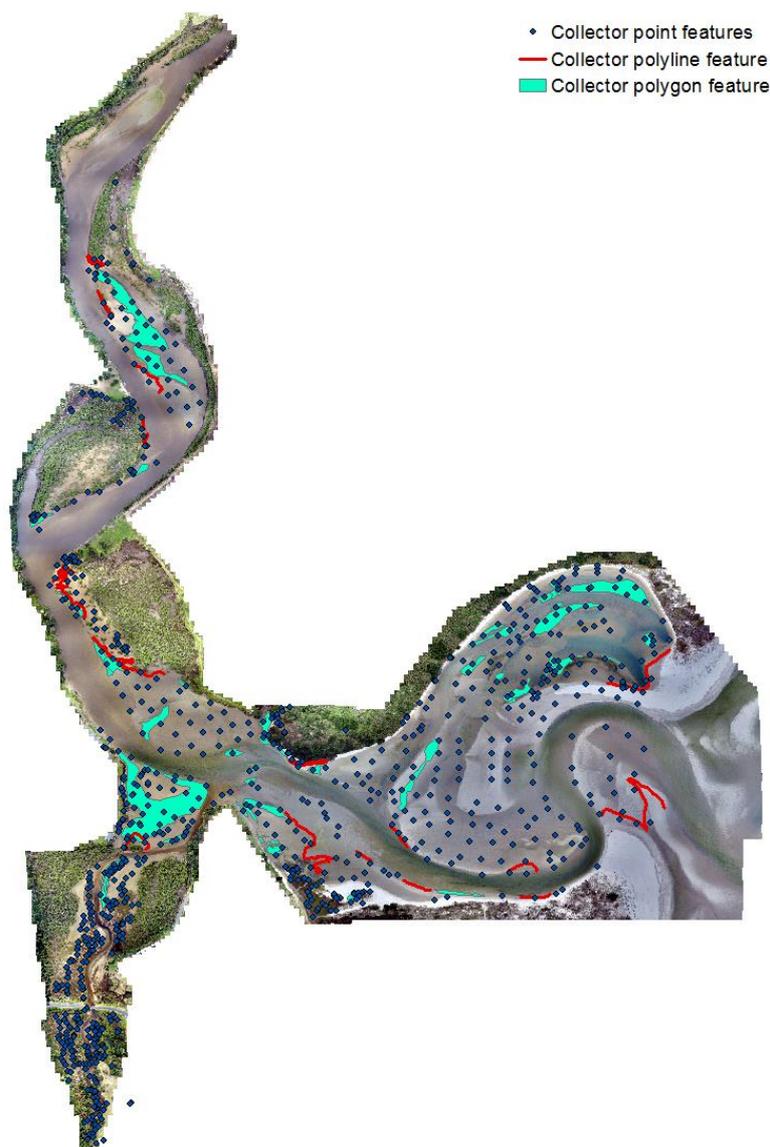
Figure 8. Substrate and habitat features collected in Ruakaka Estuary.

A total of 998 point features, 62 polygons and 32 line features were recorded in the Collector app and uploaded into ArcMap (Figure 8). The northern section of the main river channel was not surveyed due to difficulties accessing the western bank of the river channel resulting in most of flight zone 7 not being covered by the survey. Several other areas could not be easily accessed and therefore were not surveyed. In particular, an area of saltmarsh habitat behind thick mangrove forest on the eastern bank of the river channel could not be easily accessed. The total area mapped in this study was 460,262m². The total area that could not be classified was 6,901m², which is about 1.5% of the total surveyed area. A further 6,082m² which is about 1.3% of the total surveyed area, was classified as saltmarsh using the orthomosaic GeoTiff but was not surveyed, so was not classified at the level of structural class or dominant cover.

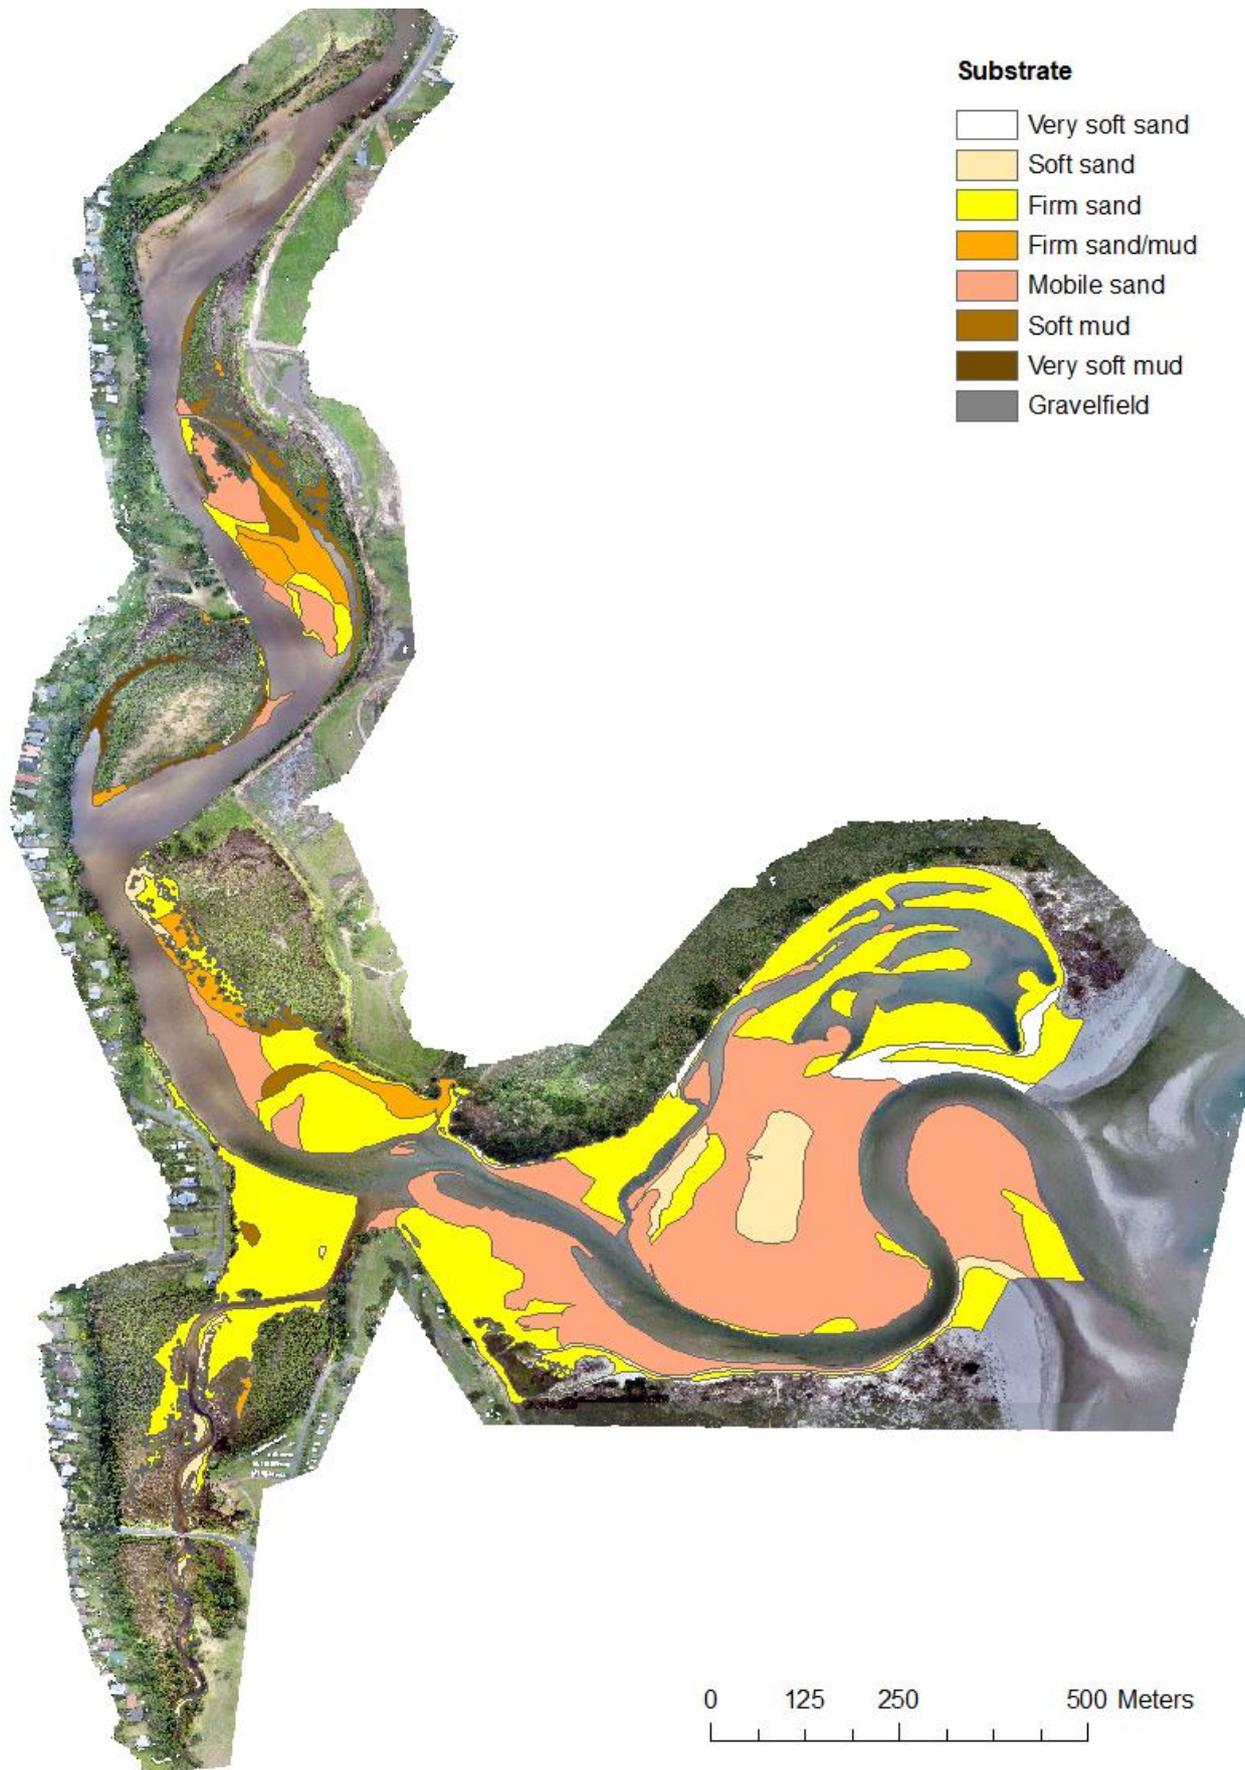
Figure 9. Substrate classes recorded in Ruakaka Estuary.

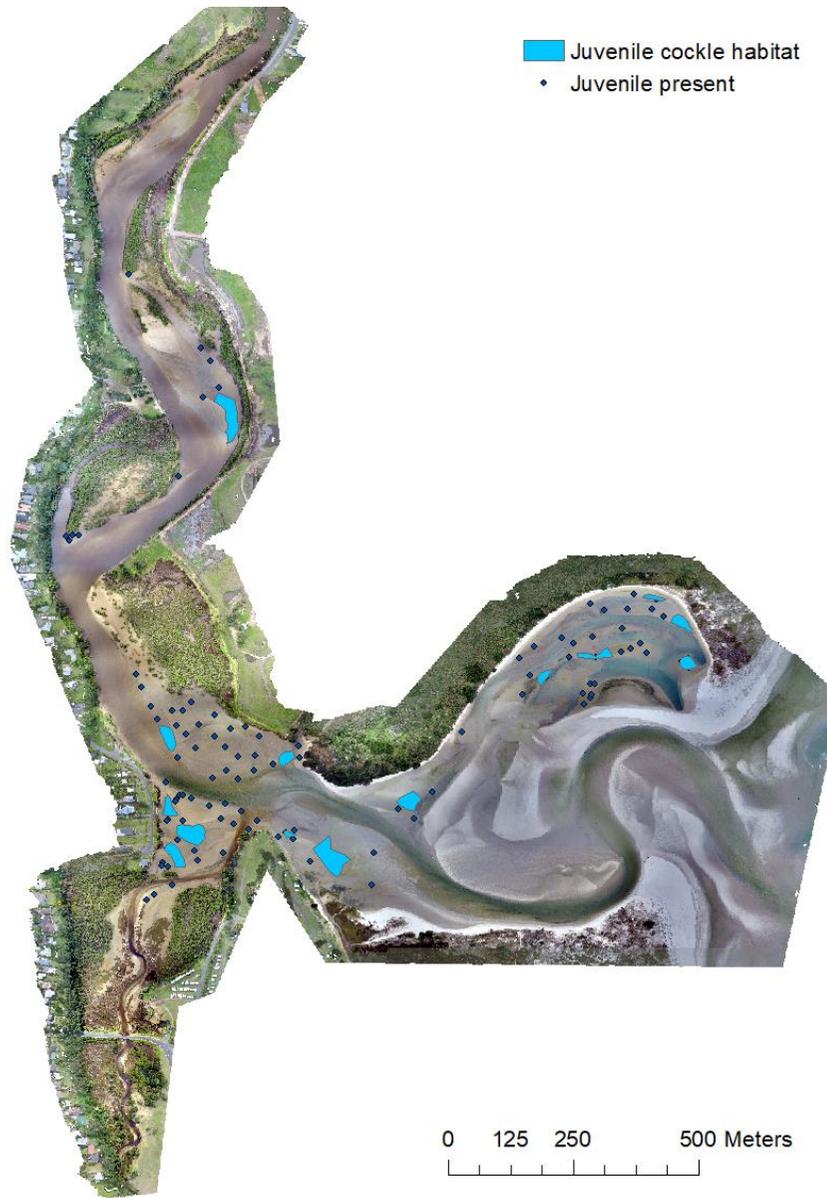
Figure 10. Juvenile cockle habitat in Ruakaka Estuary.

Cockles were present at 174 points throughout the estuary. Juvenile cockles were present at 126 points and the threshold for juvenile cockle habitat was reached at 29 points (Figure 10). Juvenile cockle habitat covered an area of 1,152 m² but there was some overlap with adult habitat (Figure 10 & 11). Adult cockles were present at 132 sites and the thresholds for adult cockle habitat (low and high density) was reached at 68 points (Figure 11). Adult habitat covered 39,314m² (Table 7), which represents approximately 12% of the un-vegetated area surveyed.

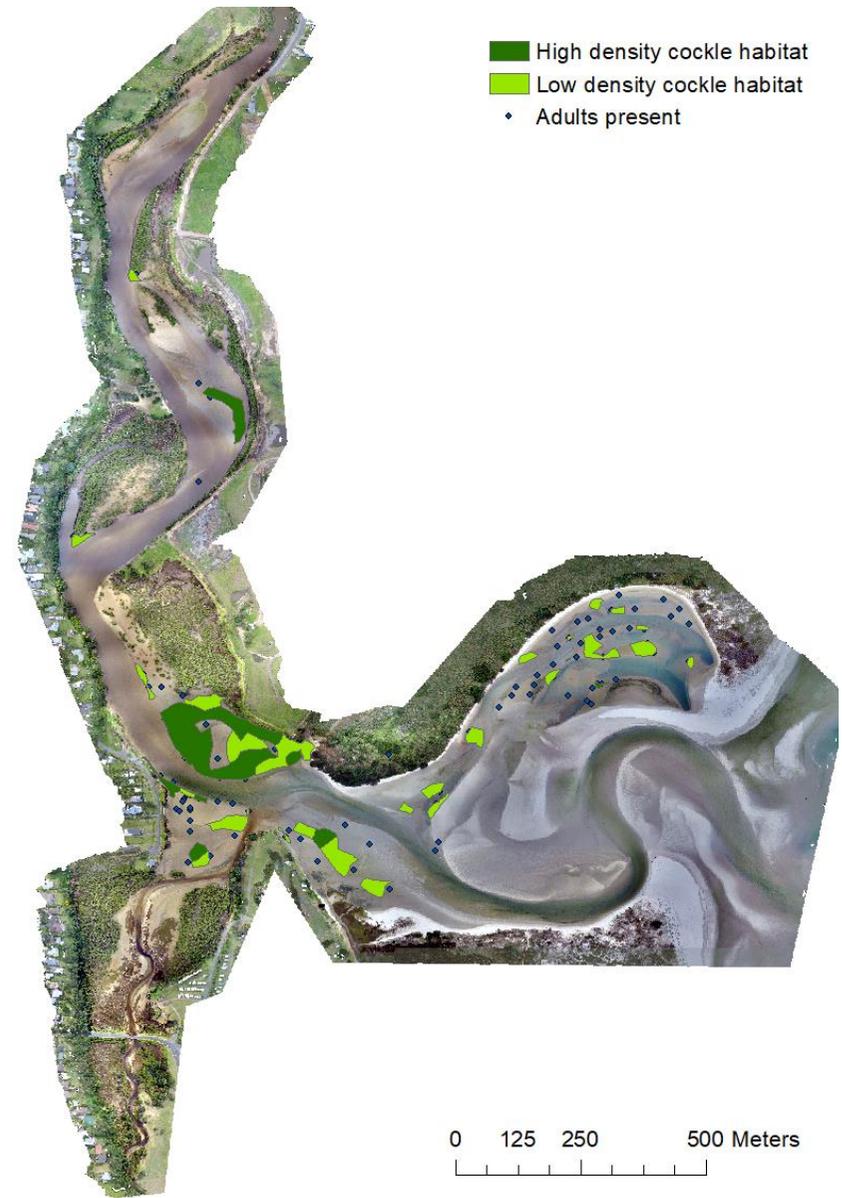
Figure 11. Adult cockle habitat in Ruakaka Estuary.

High density cockle habitat was mainly found on the larger sand flat at the southern end of the main river channel section of the estuary (Figure 11). Another area of high density habitat was found on sand/mud flats on the eastern bank of the channel further up the river and on the large sand flat at the northern end of the southern spur. In the lagoon, low and high density cockle habitat was found on the southern sand flat, with patches of low density habitat found on the sand flats and sand banks along the northern edge of the lagoon (Figure 11).

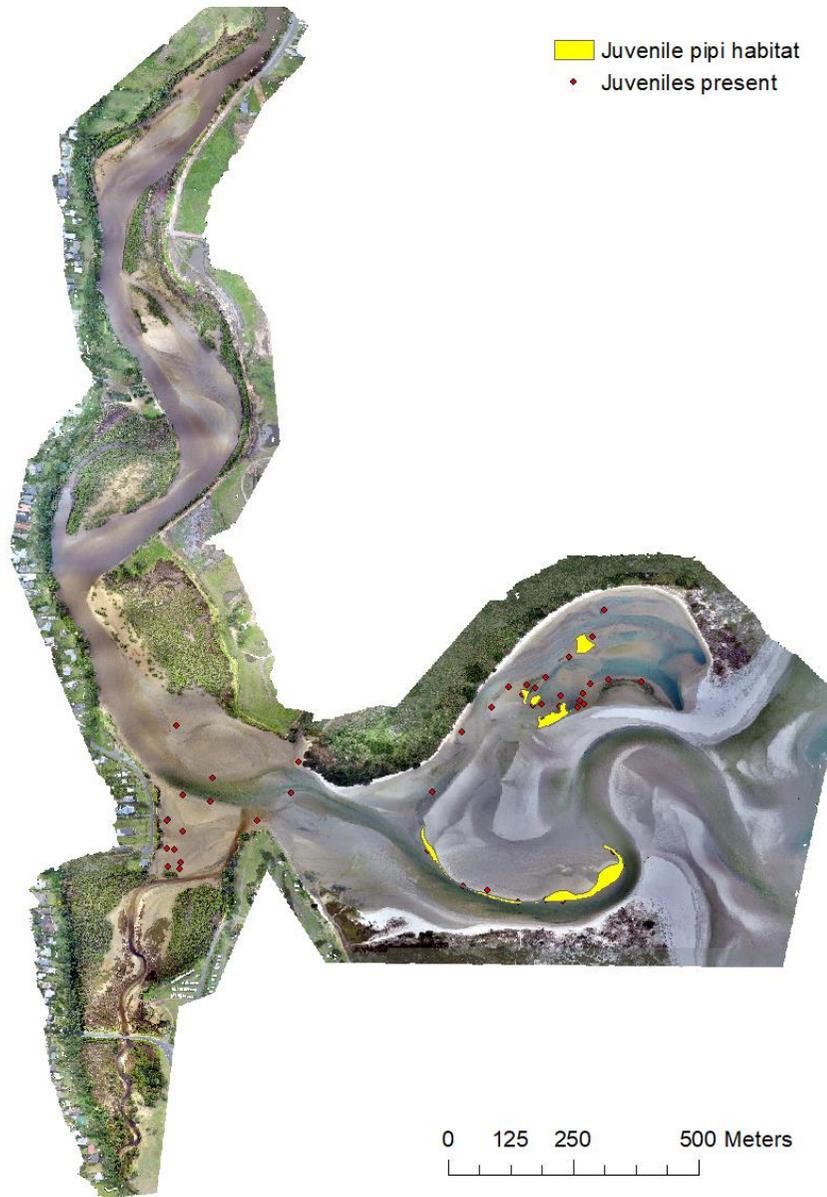
Figure 12. Juvenile pipi habitat in Ruakaka Estuary.

Pipi were recorded at 96 points. Juvenile pipi were present at 52 points and the density threshold for juvenile habitat was reached at 10 points (Figure 12). The mapped juvenile pipi habitat covered 6,156m² (Table 9, Figure 12). Adult pipi were present at 64 points and the thresholds for adult pipi habitat (low and high density) were reached at 20 points (Figure 13). The mapped adult pipi habitat covered an area of 8,286m², which is approximately 2.5% of the un-vegetated area surveyed (Table 9).

Juvenile pipi habitat was found exclusively in the lagoon section of the bay, in low lying areas adjacent to channels (Figure 12). High density pipi habitat was found exclusively in the lagoon area of the estuary, adjacent to channels (Figure 14). Low density pipi habitat was recorded in the lagoon and on sand flats at the lower end of the southern end of the River channel (Figure 13).

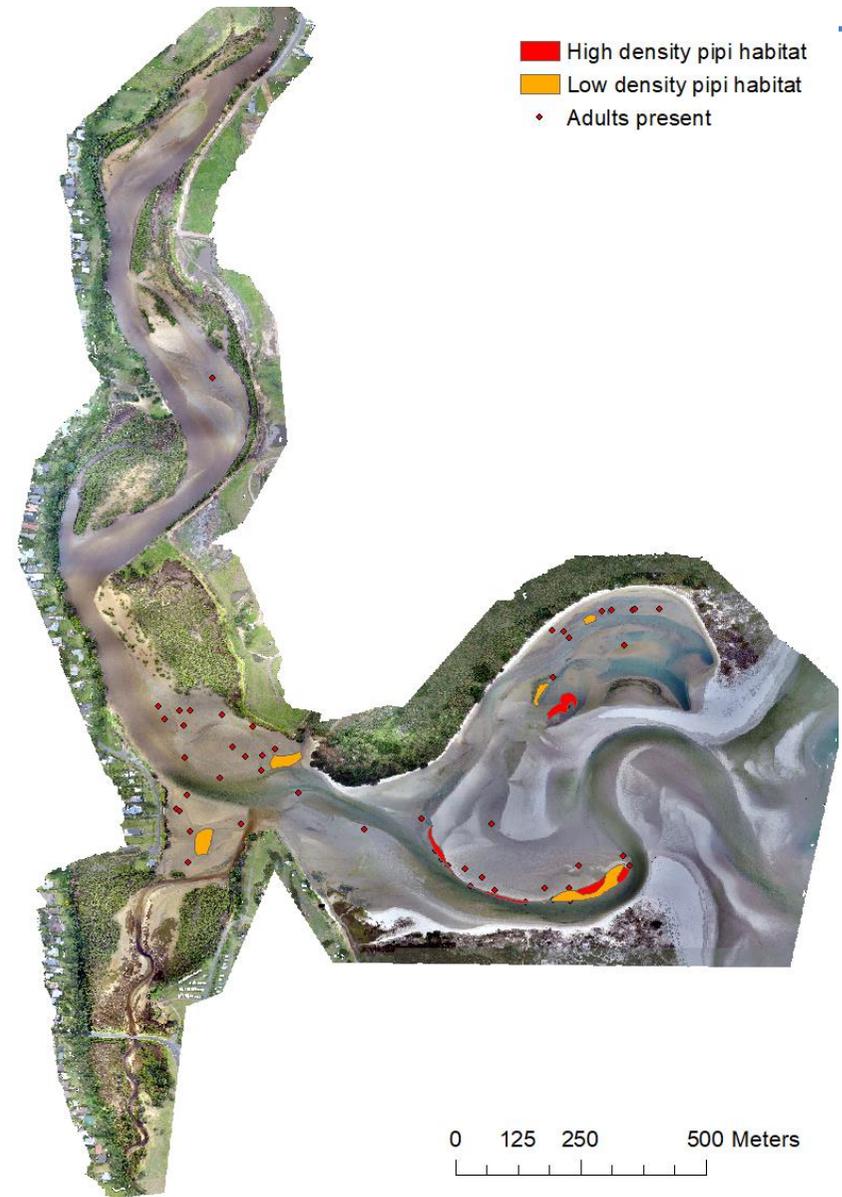
Figure 13. Adult pipi habitat in Ruakaka Estuary.

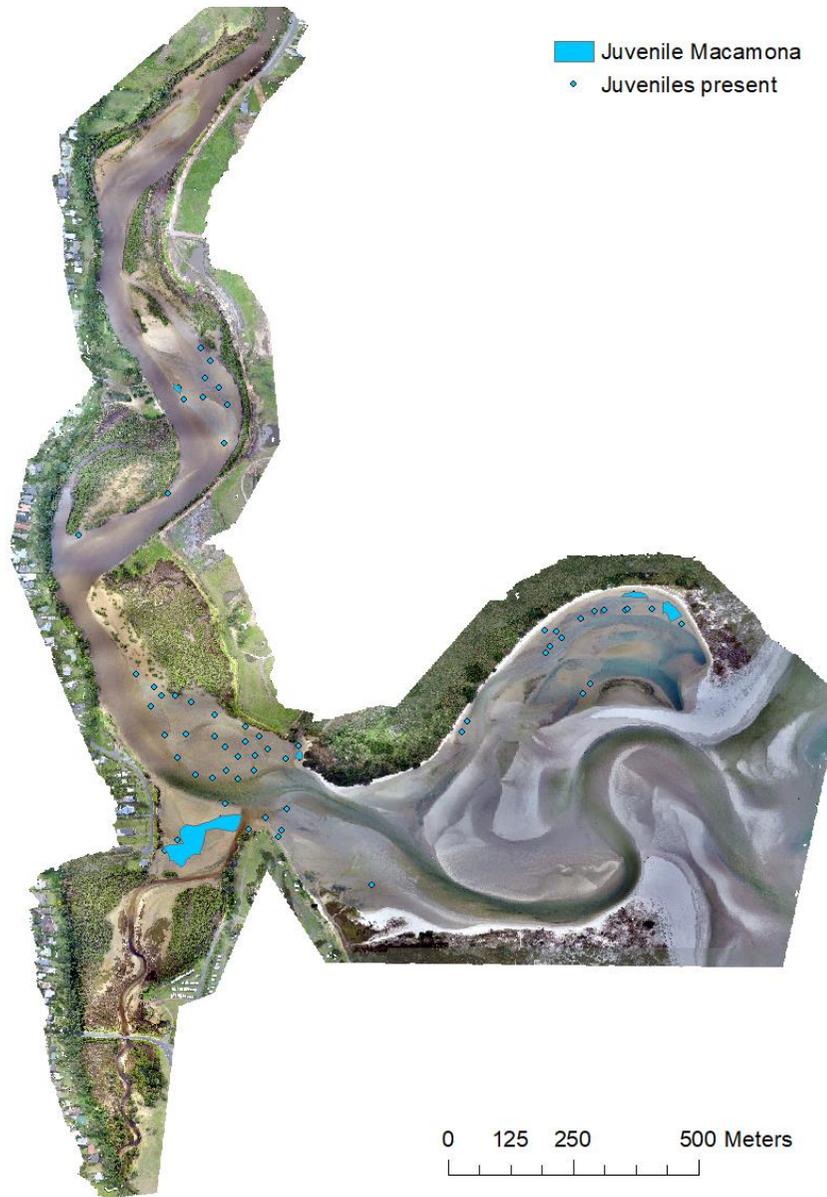
Figure 14. Juvenile *Macomona liliiana* habitat in Ruakaka Estuary.

Macomona liliiana were present at 116 points in the estuary. Juvenile *Macomona liliiana* were present at 73 points but the threshold for juvenile habitat was only reached at 11 points (Figure 14). The habitat covered 5,807 m² but there was some overlap with adult habitat (Table 11, Figure 14 & 15). Adult *Macomona liliiana* were present at 106 points and the density threshold for *Macomona liliiana* habitat was only reached at 16 points (Figure 15). The mapped *Macomona liliiana* habitat covered an area of 16,335.8m² which is about 5% of the un-vegetated area surveyed (Table 11 & Figure 15).

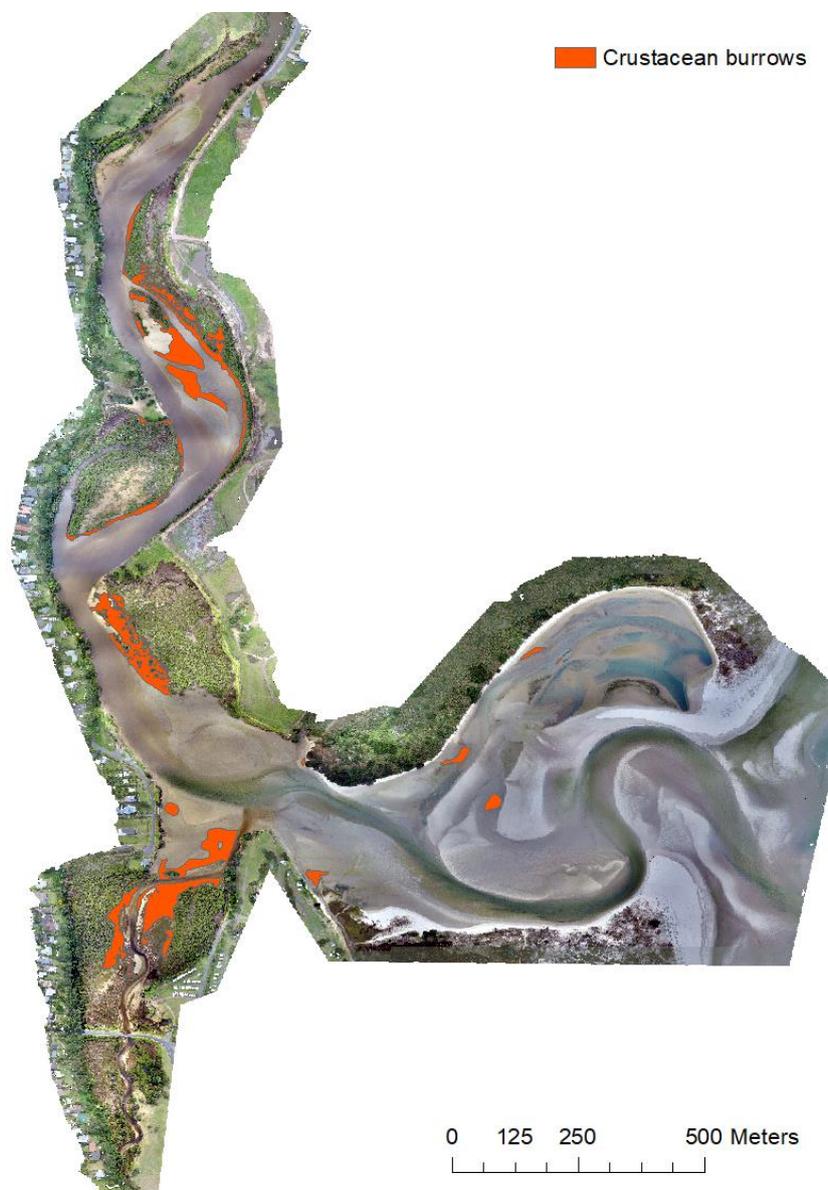
Figure 16. Crustacean burrow habitat in Ruakaka Estuary.

Crustacean burrows were recorded at 101 sites and covered an area of 36,666.1m², which represents 11% of the un-vegetated area surveyed (Figure 16). The actual area of crustacean habitat in Ruakaka Estuary is likely to be much larger as crustacean burrows were regularly recorded at vegetated sites, including areas of rushland, herbfields and mangrove forest, but in this study fauna within saltmarsh or mangrove habitat was not mapped.

The largest areas of crustacean burrows were found adjacent to mangrove and saltmarsh habitat in the main river channel and the southern spur (Figure 16). Relatively large areas were also observed on the sand flats at the northern end of the southern spur and on a sand flat towards the northern end of the river channel. In addition, four smaller areas of crustacean burrows were found in the lagoon section of the estuary (Figure 16).

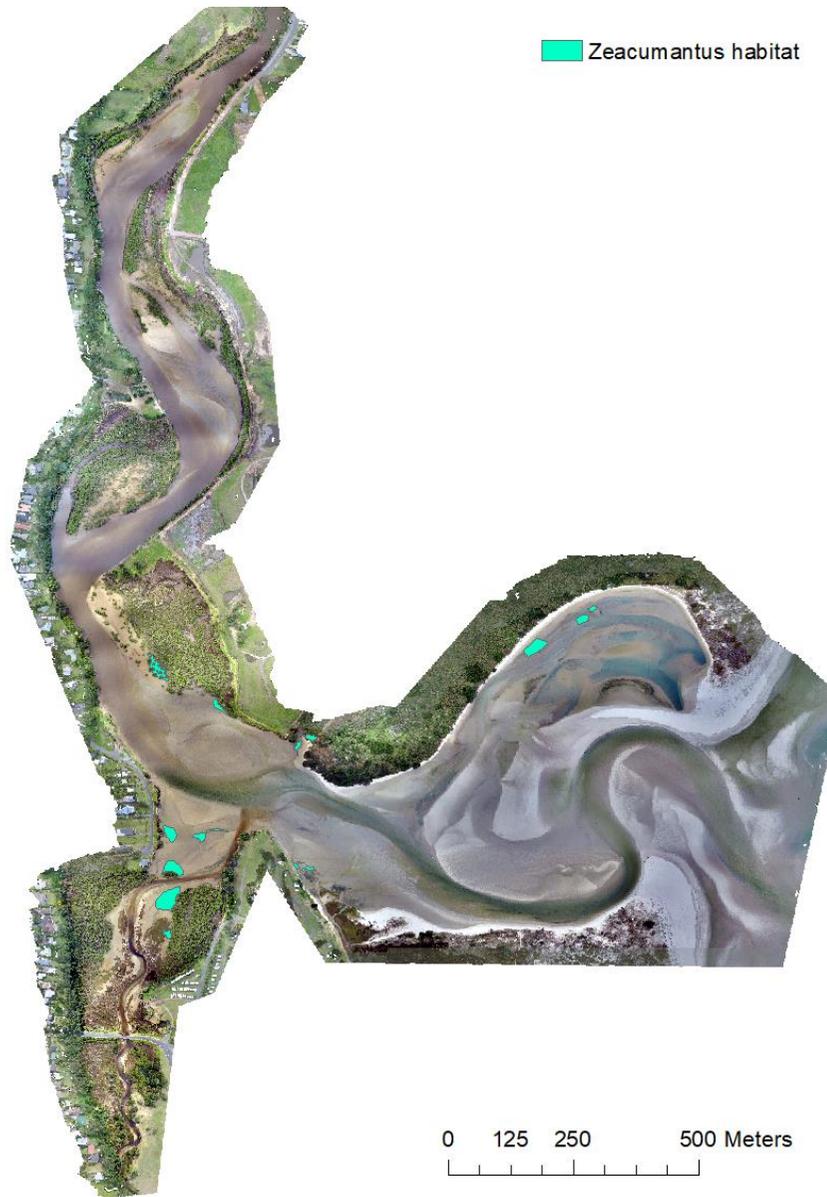
Figure 17. *Zeacumantus lutulentus* habitat in Ruakaka Estuary.

Small pockets of *Zeacumantus lutulentus* were found throughout the estuary and covered an area of 6,034.3m², which is approximately 1.8% of the un-vegetated area surveyed (Figure 17). 72% of *Zeacumantus lutulentus* observations were recorded on firm sand, with observations also occurring on firm sand/mud (14%) and soft mud (14%). The elevation data indicated that *Zeacumantus lutulentus* habitat was recorded from 0.17m below mean level to 1.37m above mean sea level (Table 14).

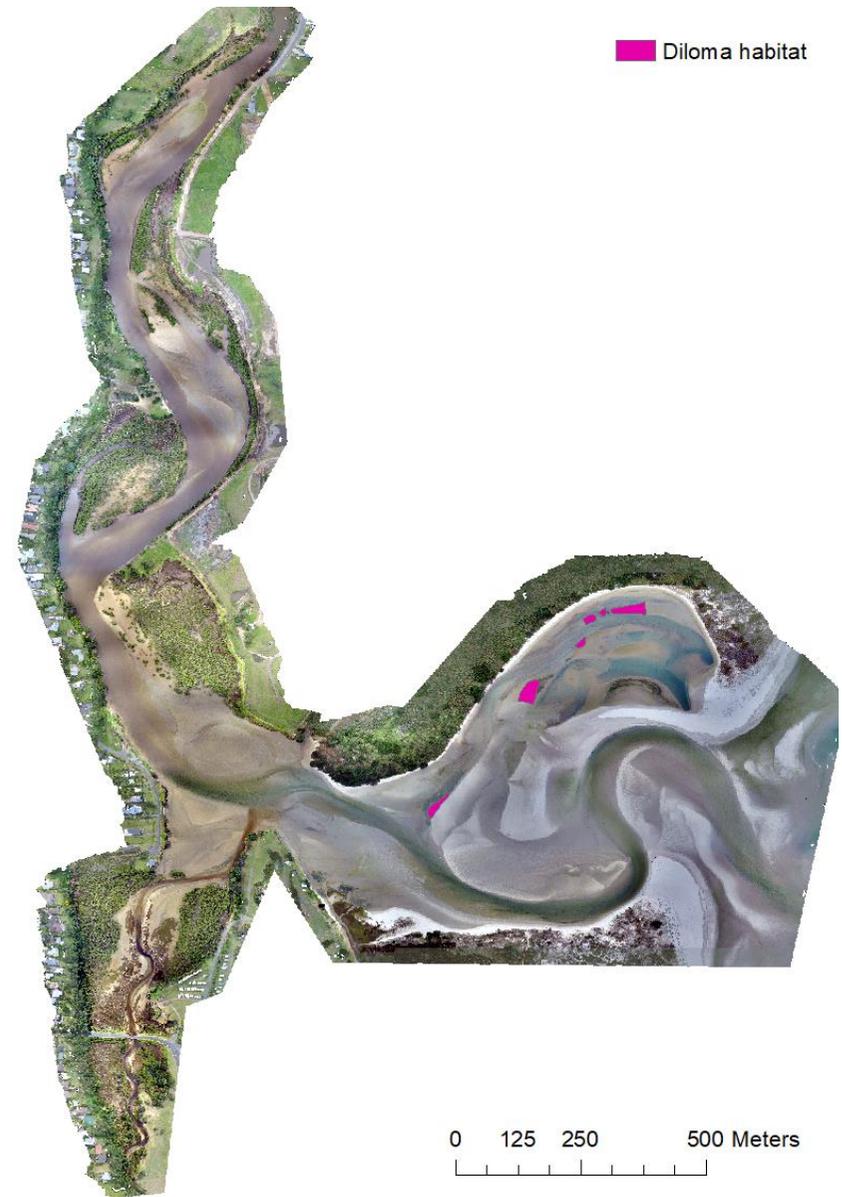
Figure 18. *Diloma subrostratum* habitat in Ruakaka Estuary.

Diloma subrostratum covered an area of 3,425.0m², which is approximately 1% of the un-vegetated area surveyed. All of the *Diloma subrostratum* habitat mapped in this study was on sand banks in the northern area of the lagoon section of the estuary (Figure 18).

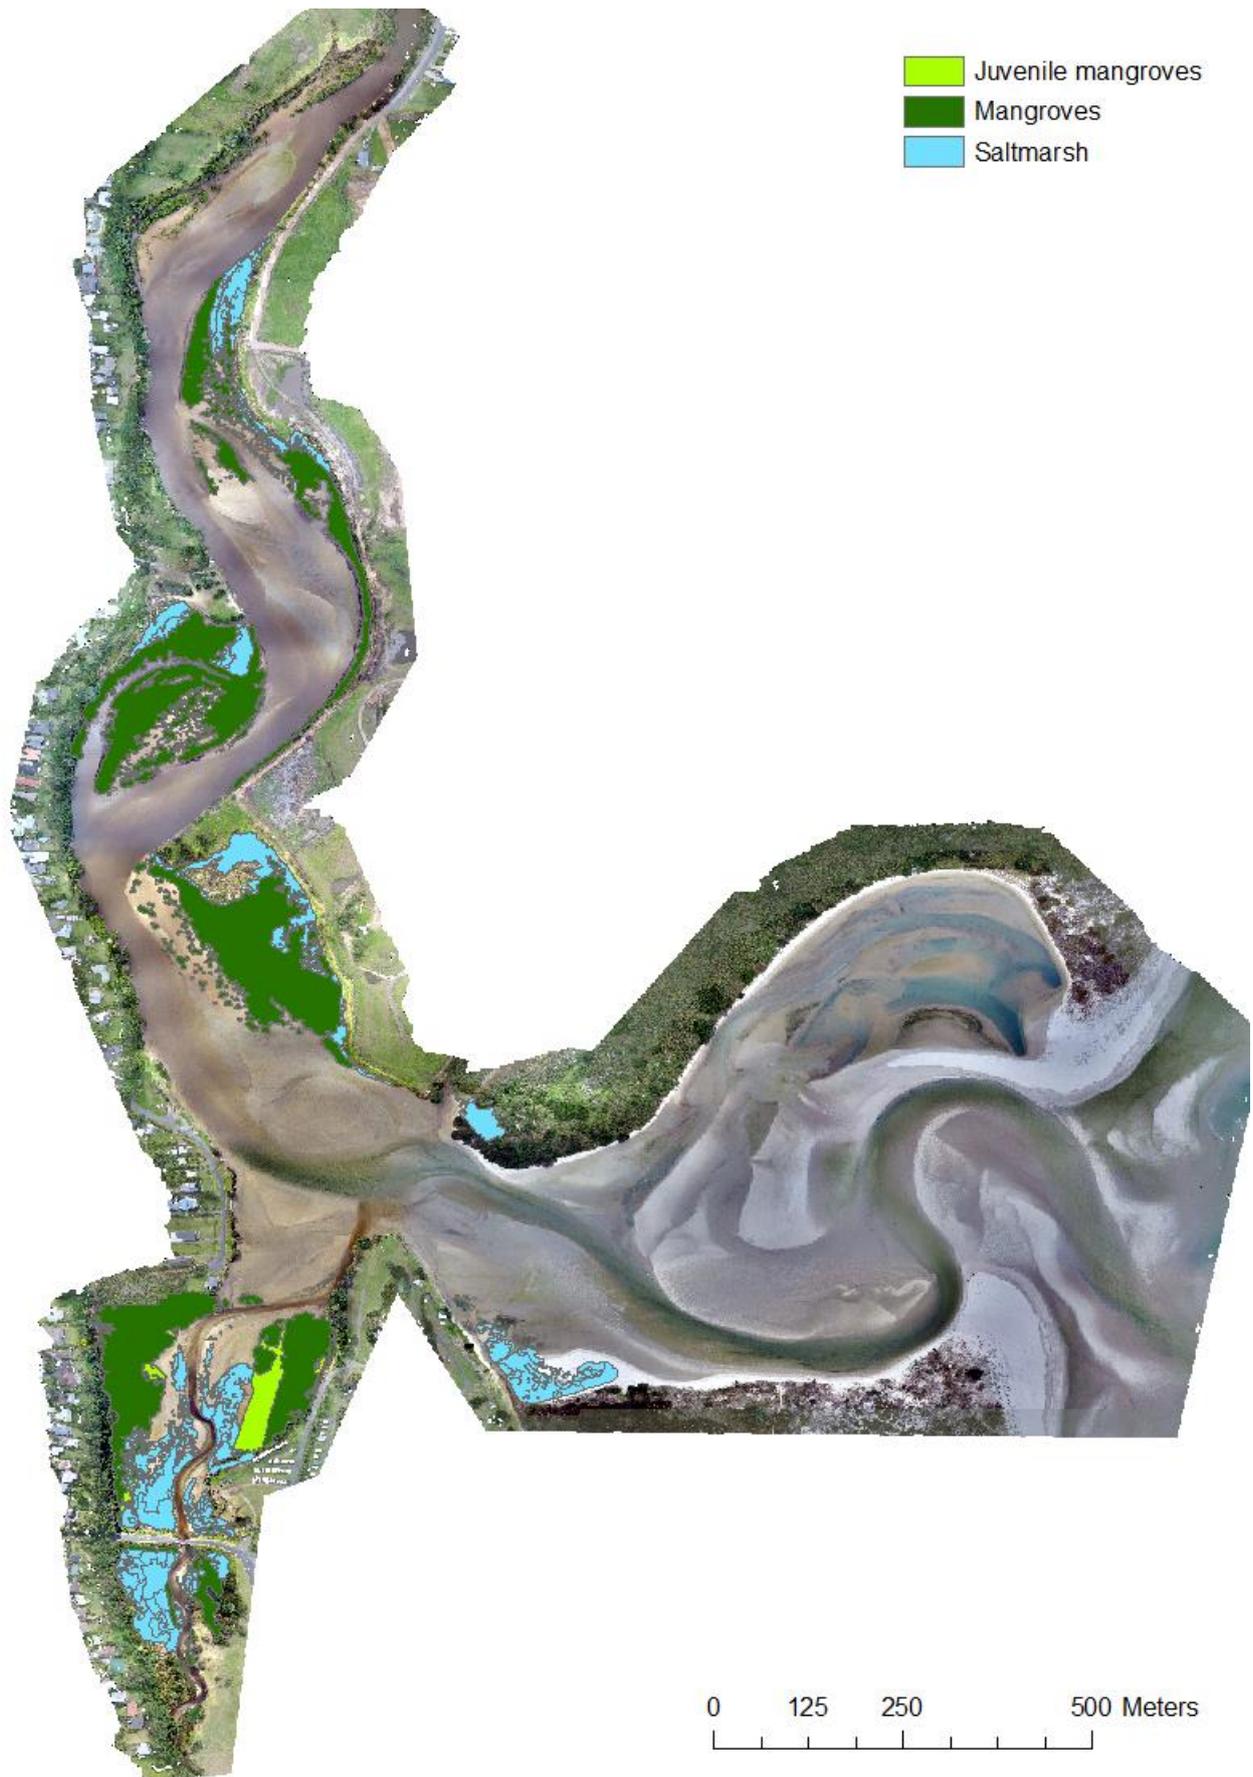
Figure 19. Mangrove and saltmarsh habitat recorded in Ruakaka Estuary.

The southern spur consisted of a sizeable saltmarsh/mangrove complex (Figure 19, 20, & 21) and three large mangrove saltmarsh habitats were also identified in the main river channel section of the estuary (Figure 22, 23 & 24). Unfortunately, the saltmarsh in the lower portion of this section was not surveyed as it is inaccessible from the estuary (Figure 24). One saltmarsh habitat was mapped on the southern shore of the outer lagoon section (Figure 25). Another saltmarsh complex was identified on the northern shore of the lagoon, but this area was not fully captured by the aerial image and was not surveyed (Figure 26).
