Remotely piloted aircraft system (RPAS) survey and habitat assessment of Ruakaka Estuary

Griffiths R, Eyre R, Bamford N, Umuroa N, Brotherhood B, Jolly M, Sharp-Heward J, 2019. Remotely piloted aircraft survey (RPAS) and habitat assessment of Ruakaka Estuary. Northland Regional Council, Whangārei, pp46.

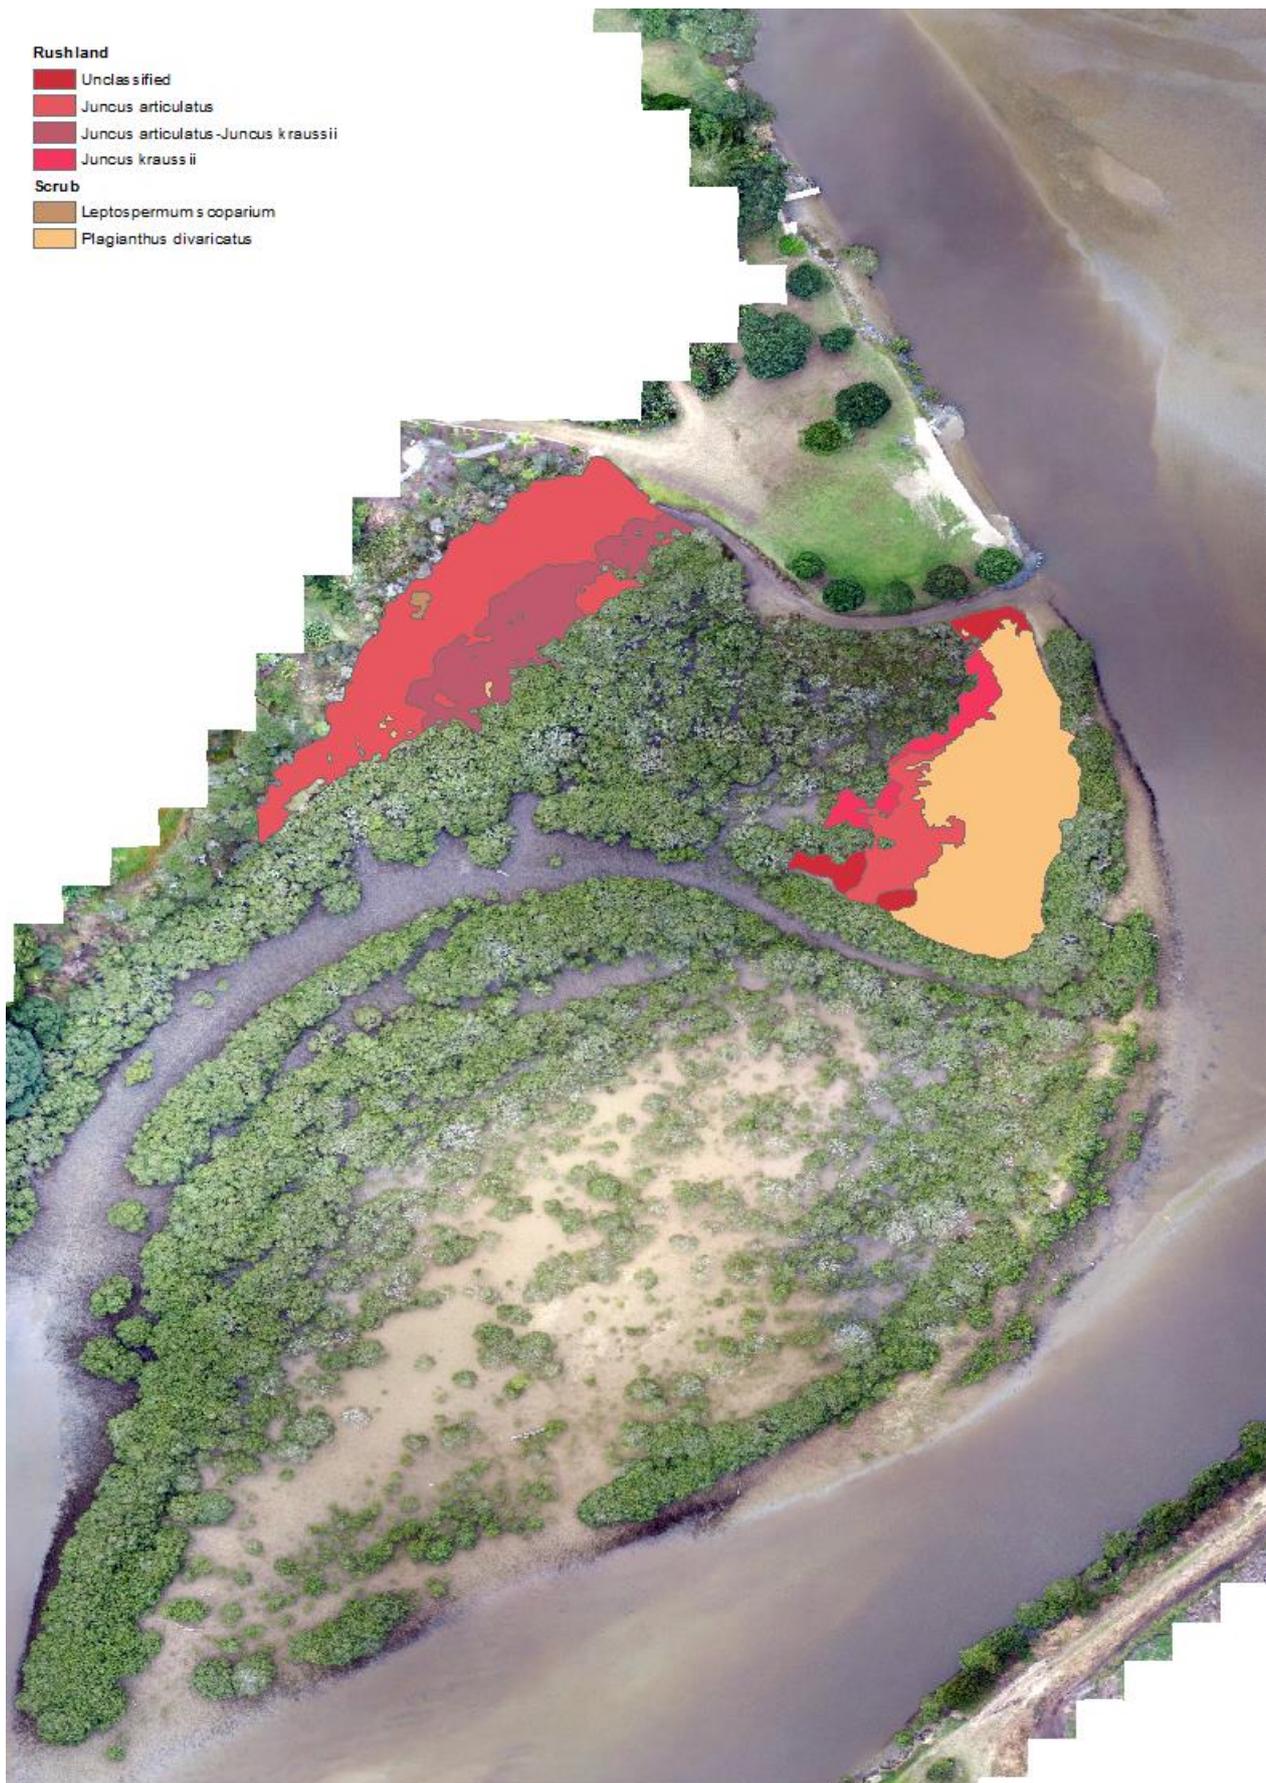
Figure 23. Saltmarsh habitat on the western bank of the main river channel.

The southern spur consisted of a sizeable saltmarsh/mangrove complex (Figure 19, 20, & 21) and three large mangrove saltmarsh habitats were also identified in the main river channel section of the estuary (Figure 22, 23 & 24). Unfortunately, the saltmarsh in the lower portion of this section was not surveyed as it is inaccessible from the estuary (Figure 24). One saltmarsh habitat was mapped on the southern shore of the outer lagoon section (Figure 25). Another saltmarsh complex was identified on the northern shore of the lagoon, but this area was not fully captured by the aerial image and was not surveyed (Figure 26).

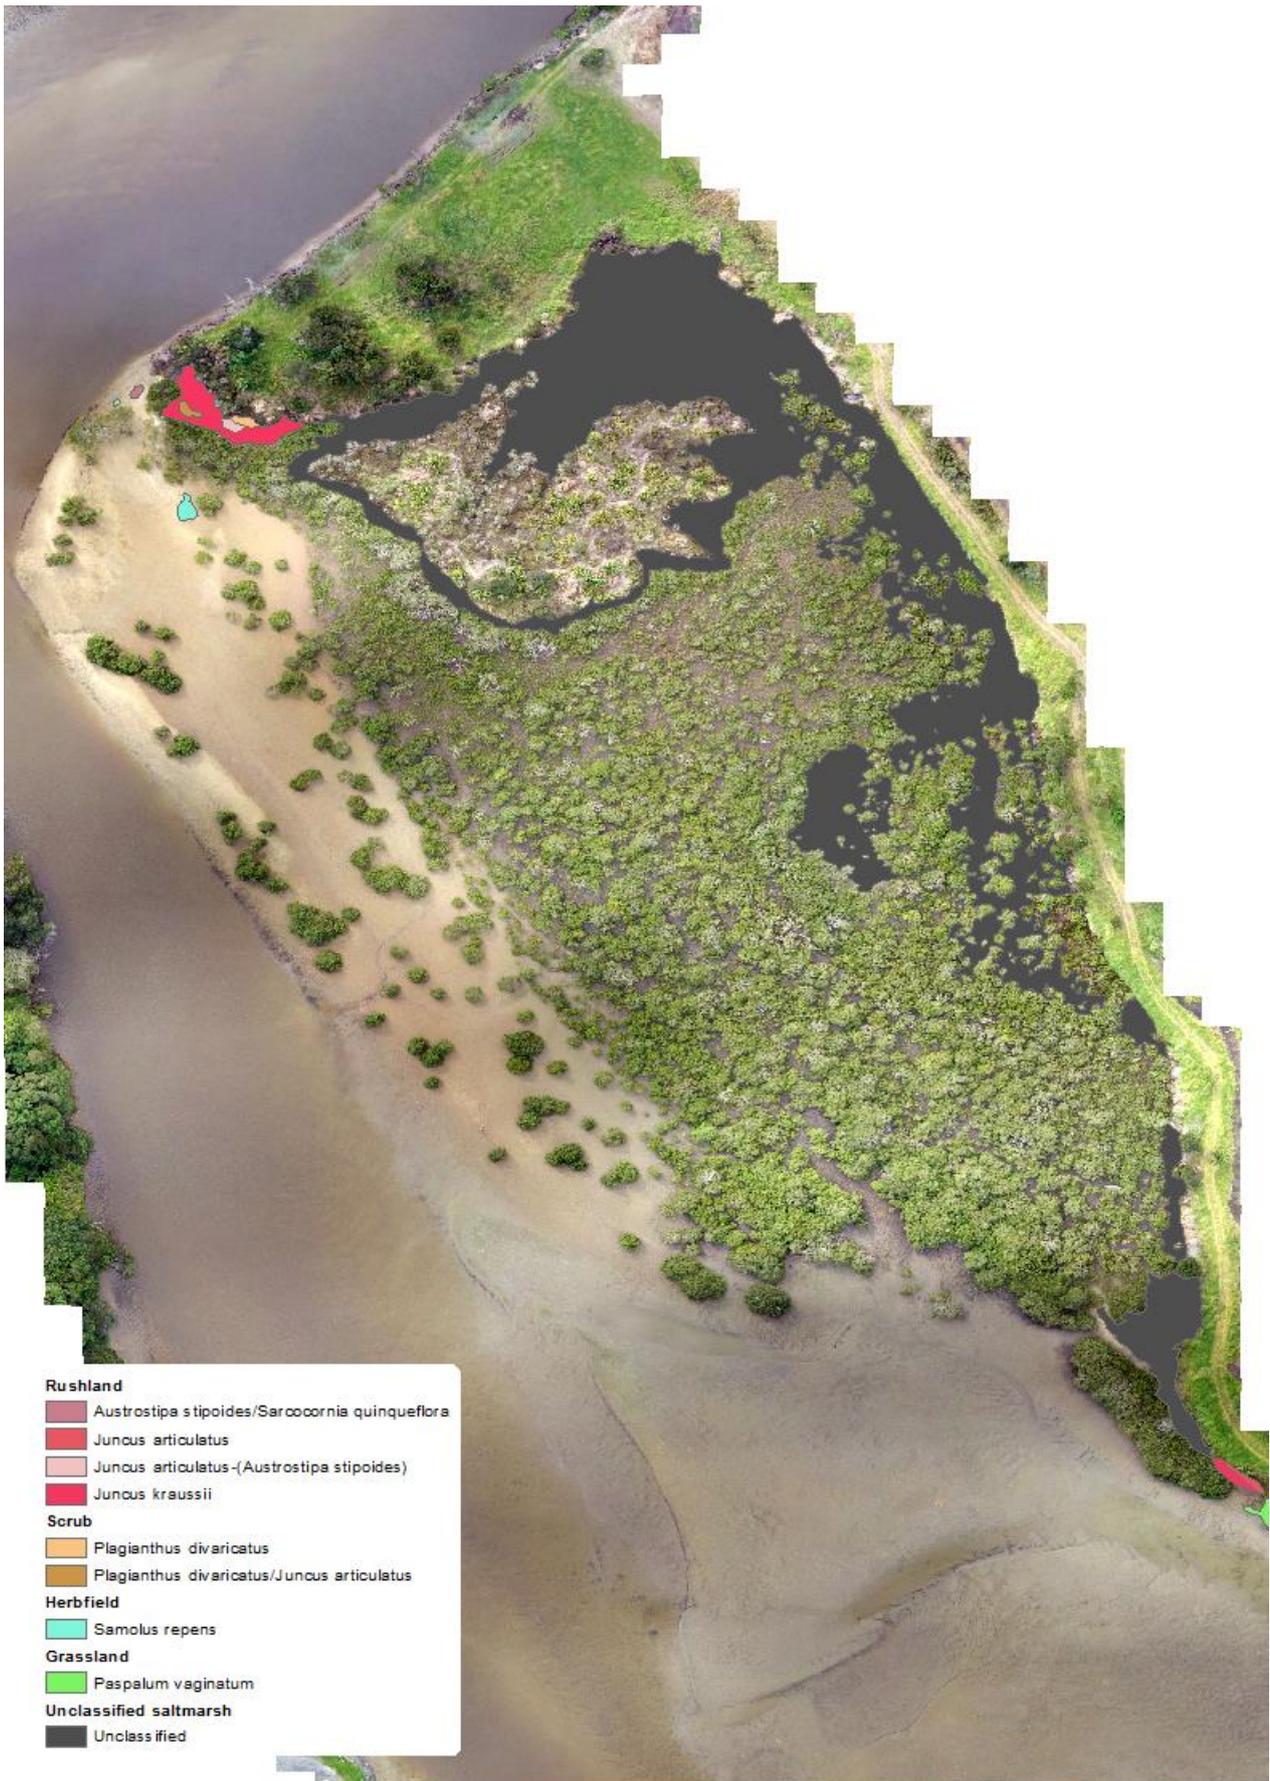
Figure 24. Saltmarsh habitat towards the south of the river channel.

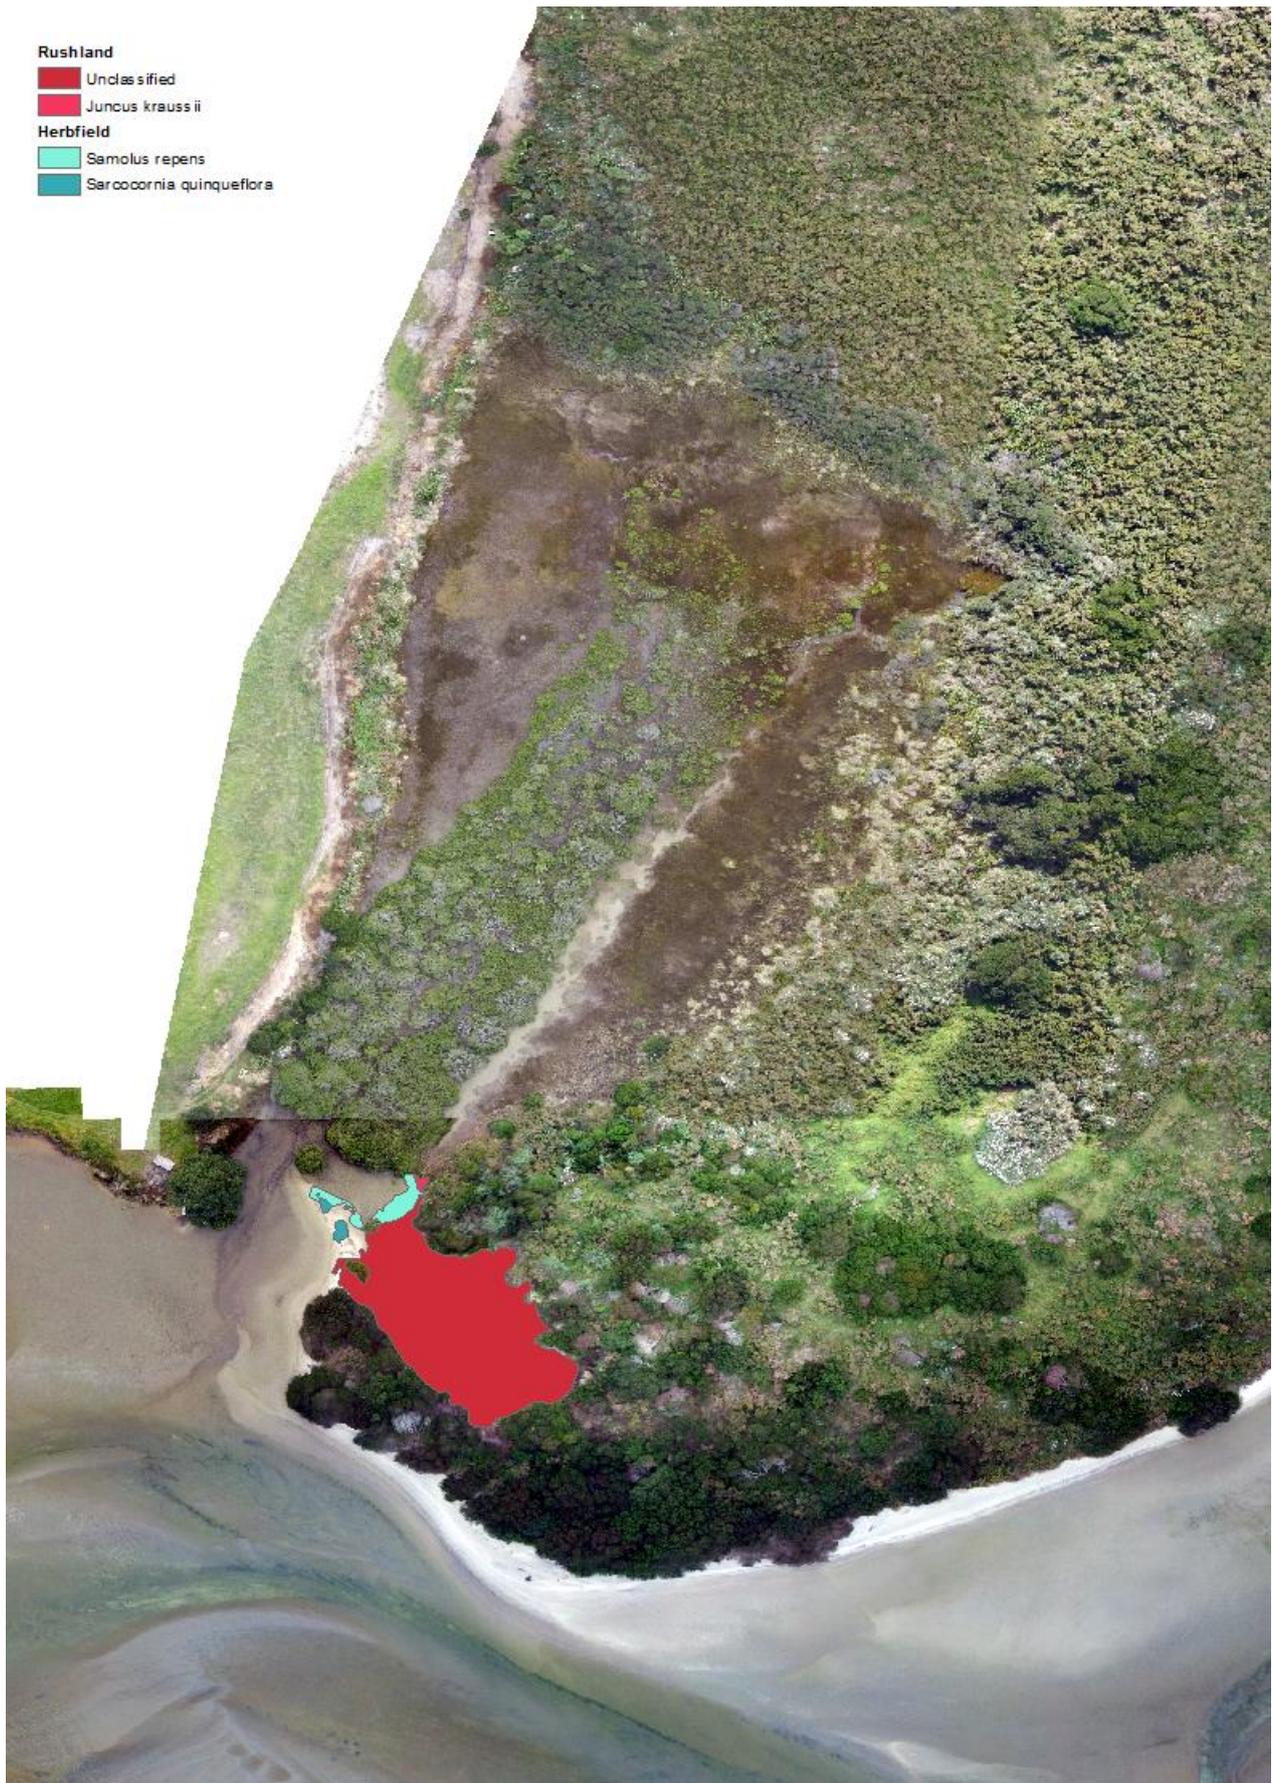
Figure 26. Unmapped saltmarsh habitat on the northern shore of the lagoon section of the estuary.
