3.27 Lake Wahakari (Aupouri), NRC Lake No. 35; surveyed in 2005 and 2008.

3.28 Lake Waihopo (Aupouri), NRC Lake No. 78; surveyed in 2006 and 2009.

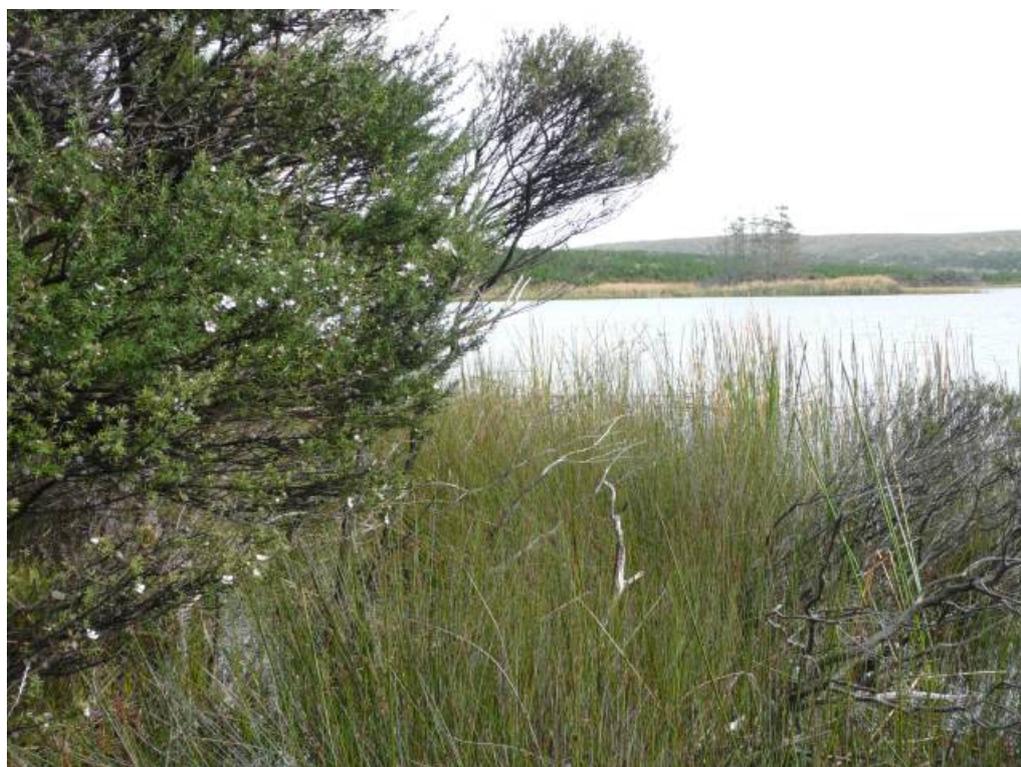
Plate: Lake Wahakari.

<p>Summary</p> <p><i>Overall ranking</i></p> <p>Outstanding: Good emergent and submerged vegetation with numerous endangered biota. Pest plants and fish present, possible water quality decline.</p> <p><i>Threats</i></p> <p>Introduction of invasive species.</p> <p><i>Management recommendations</i></p> <p>As access to this water body is now severely restricted, annual surveillance for pest plants should be discontinued. Lake condition monitoring every 5 years.</p>

Most of the lake margins have beds of emergent species of up to 10 m wide. The dominant emergent species were *Eleocharis sphacelata*, *Apodasmia similis*, *Baumea juncea*, *B. arthrophylla*, *B. articulata* and *Typha orientalis* growing from the lake margin to 2.6 m depth. *Baumea rubiginosa* was noted as emergent in the south eastern bay during the 2008 survey.

Turf communities were sparse due to extensive and dense emergent beds. The nationally threatened species *Utricularia australis* was relocated at one site and *Isolepis fluitans* (Plate below) was found in three locations. This included two profiles, amongst *E. sphacelata* beds and also amongst *Apodasmia similis* at the south eastern bay. Charophytes (mostly *Chara fibrosa*, *C. australis*, and *Nitella* aff. *cristata*) were found from the edge of emergent communities to a maximum depth of ~3 m in 3 profiles. Below this, the pondweed, *Potamogeton ochreatus* formed scattered low density growths (~ 0.5 m tall) to 5.7 m. *Utricularia gibba* had recently spread to this lake (since 2004). It was restricted to the emergent vegetation zone to a maximum depth of 1.5 m, occasionally with high covers of 50-75%.

An assessment of lake condition at 5 yearly intervals is recommended.

Annual monitoring of water quality should be undertaken to determine the extent of nutrient enrichment.

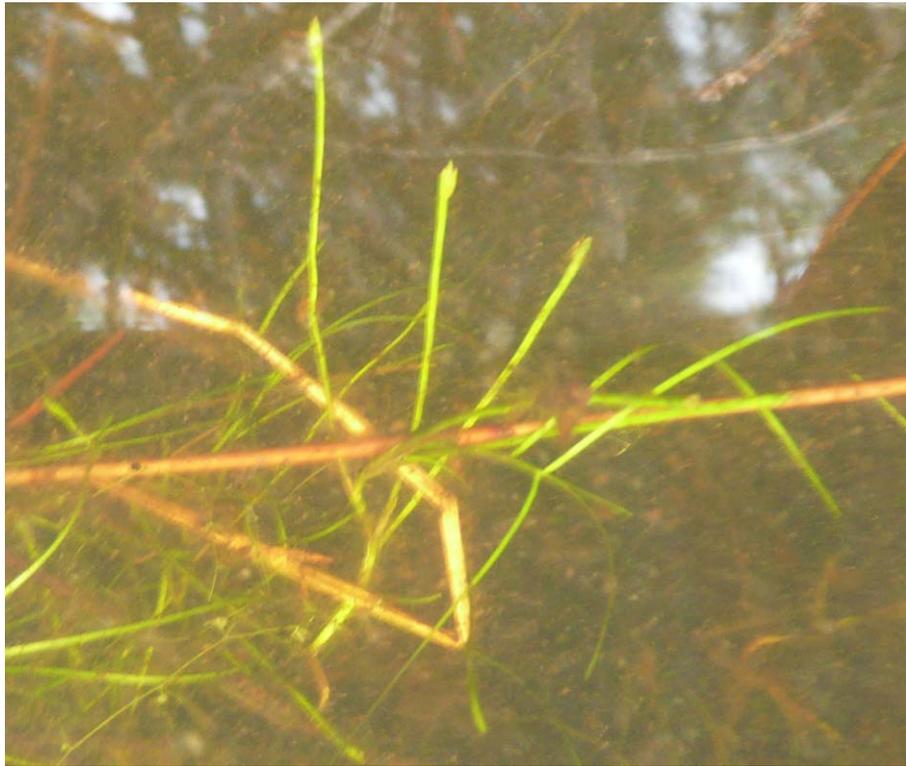
Plate: *Isolepis fluitans*

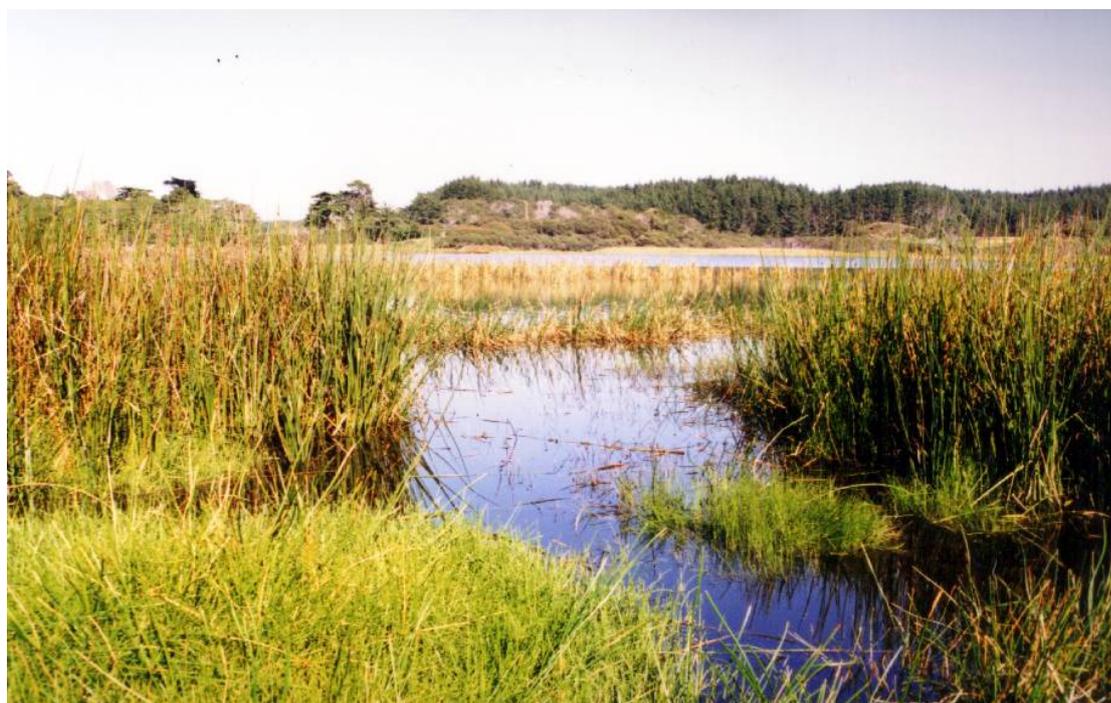
Plate: Lake Waihopo from the boat access point, note the extensive emergent vegetation.

Much of the lake (70%) is occupied by large beds of emergent species, up to 50 m wide. The dominant emergent is *Eleocharis sphacelata* growing from the lake margin to 1.8 m, with other species including *E. acuta*, *Baumea articulata*, *B. juncea*, *B. rubiginosa*, *Isolepis prolifer* and *Typha orientalis* all common. The regionally significant maru (*Sparganium subglobosum*) was noted in the peaty marginal vegetation. The nationally threatened *Thelypteris confluens* is reported from this lake. A large population of another nationally threatened fern *Cyclosorus interruptus* was found in 2006.

Carry out lake condition monitoring every 5 years.

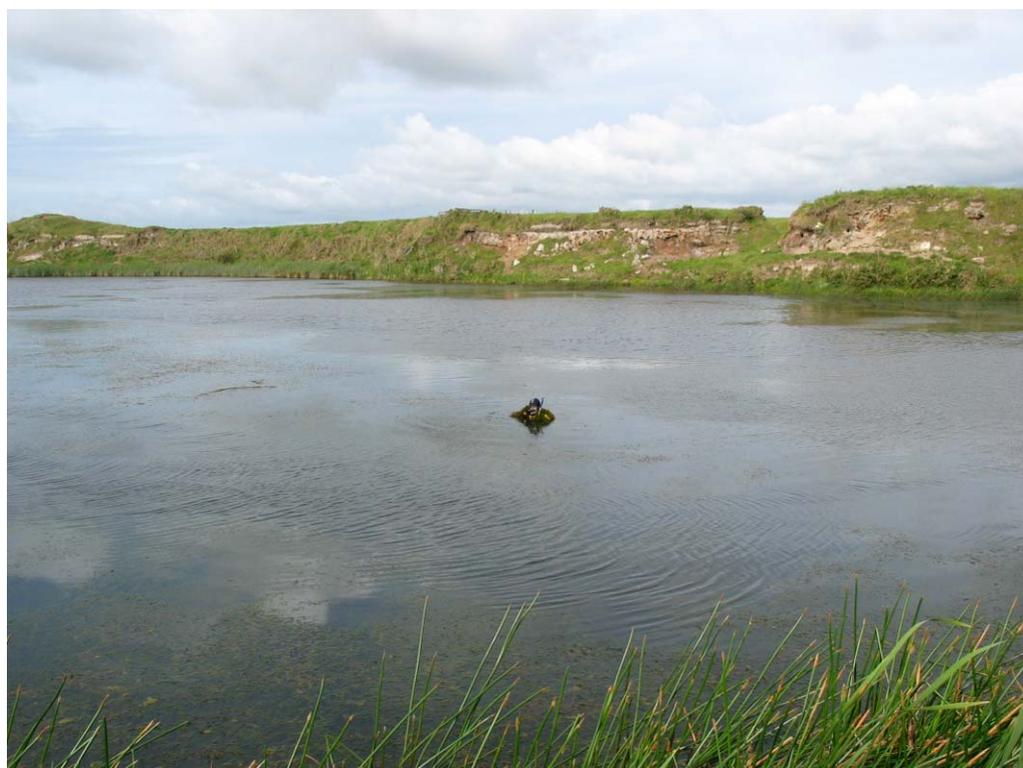
Plate: Lake Waimimiha North showing surface-reaching beds of *Ceratophyllum demersum* (bottom left) on the margin of emergent vegetation.

The submerged vegetation was dominated by surface-reaching (~ 2 m tall) beds of *Ceratophyllum demersum* covering the entire lake outside of the emergent beds.

The worst invasive submerged weed *C. demersum* completely dominated the lake. Alligator weed (*Alternanthera philoxeroides*) was found further downstream and possibly could occupy the open lakeward edges of *T. orientalis* dominated emergent vegetation in the future.

No monitoring is recommended.

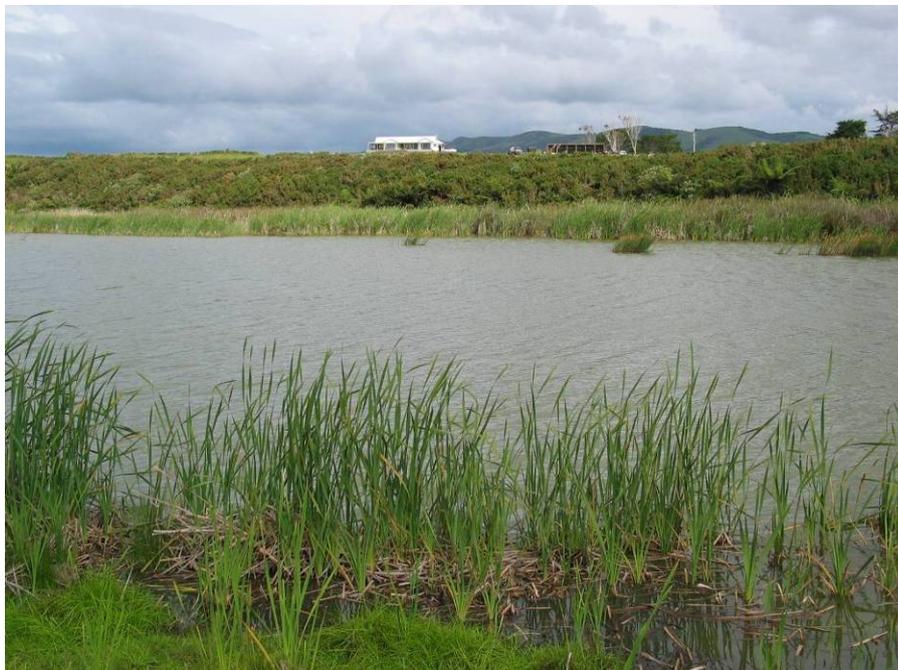
Plate: Lake Waimimiha South showing margin of emergent vegetation. Note the green tinge to the water indicating an algal bloom.

No investigation of submerged vegetation was attempted due to possibly toxic algal blooms, however development of plants with such restricted clarity is unlikely.

Poor water clarity would restrict the development of submerged vegetation. Alligator weed (*Alternanthera philoxeroides*) was found further downstream and possibly could occupy the open lakeward edges of *T. orientalis* dominated emergent vegetation in the future.

No monitoring is recommended.

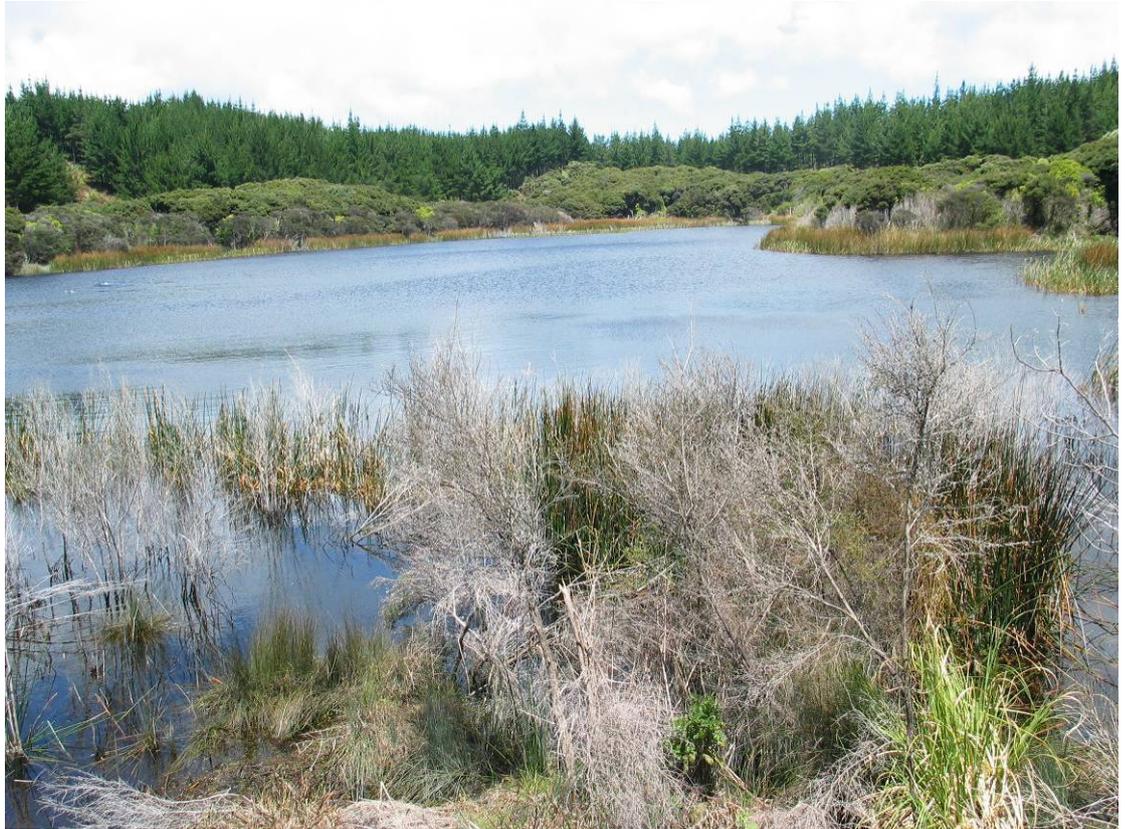
Plate: Lake Waipara showing the margin of scrub vegetation with pine forestry behind this. Note the narrow emergent zone.

The lake was ringed by a narrow (2 to 5 m wide) emergent band of *Baumea articulata* (edge to 0.5 m deep) and *Eleocharis sphacelata* (0.5 to 2 m deep).

Lake condition monitoring every 5 years.

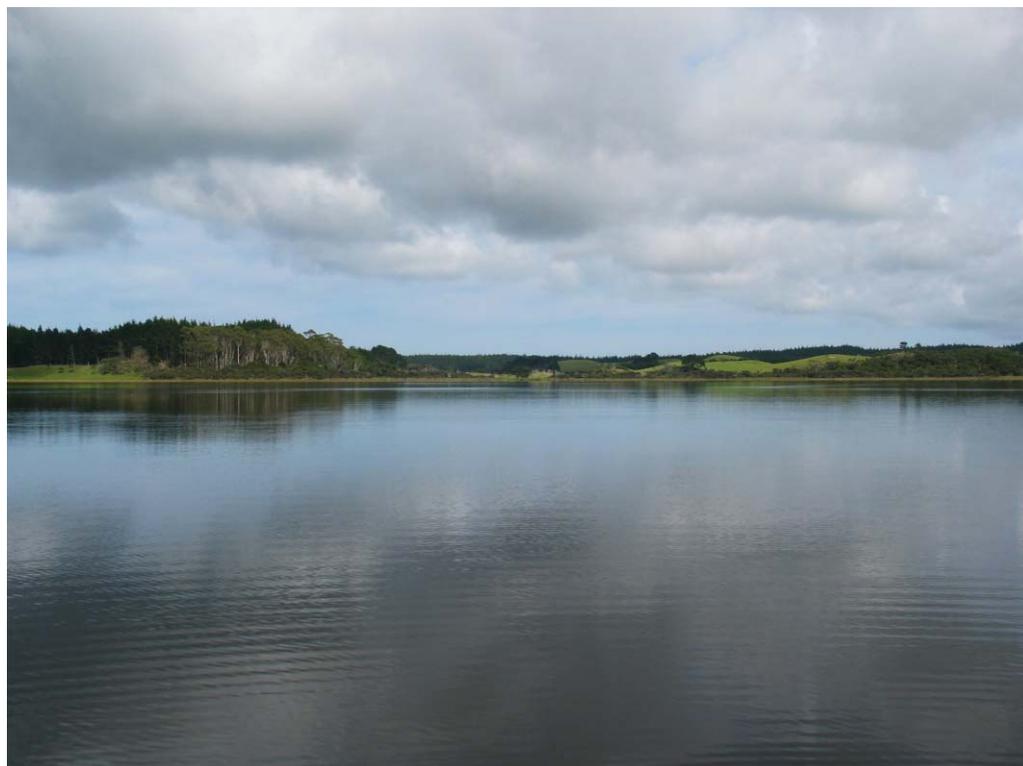
Plate: Lake Waiparera.

Moderate to High: Submerged vegetation sparse with invasive species (weeds and fish) present, but good water bird habitat and threatened fish present.

Moderate impacts from *Egeria densa*, *Lagarosiphon major*, *Utricularia gibba* and alligator weed. *Gambusia* and goldfish present, rudd were recorded. Margins fenced, lake is nutrient enriched.

The alien invasive alligator weed (*Alternanthera philoxeroides*) formed floating mats on the south western shore and appeared to be well established around the southern part of this lake.

The lake may provide a source of pest plants and fish to other water bodies. Signage and possible weed control in the vicinity of the boat ramp are suggested.

Lake condition monitoring every 5 years.

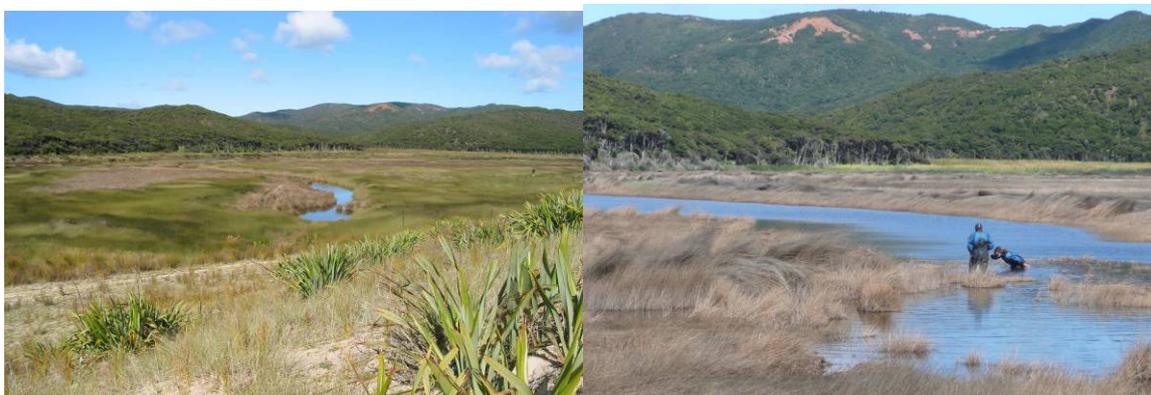
Plate 1: LEFT 2007 showing the east end of Waitahora Lagoon, showing a saline influenced wetland dominated by the green oioi (*Apodasmia similis*) and brown sea rush (*Juncus kraussii* var. *australiensis*), RIGHT 2009 showing a closer of the same area but with the oioi impacted by saltwater intrusion.

Most of the lagoon was saline with no submerged vegetation. However, some sparse vegetation (5-25% cover) was noted in 2007 in the upper channels (as shown in Plate 1). Species present included *Ruppia polycarpa*, *Triglochin striata*, *Mimulus repens* and a charophyte in the genus *Lamprothamnium*. All these species are typical from brackish areas, although the first of these plants is also relatively common in freshwater lakes. Prior to the 2007 survey one species of *Lamprothamnium* (*L. macropogon*) was recorded from the southern North Island, the South Island and Chatham (Rekohu) Island, with the northernmost record from the Whakaki Lagoon near Wairoa (Hawkes Bay). The Waitahora Lagoon plant appears to be a different species (M. de Winton pers. comm.) and has been planted to grow on to enable its identification. In 2009 the *Lamprothamnium* site had recently been affected by a saline intrusion and no submerged plants were found and surrounding rushes / sedges were brown. A channel closer to the freshwater wetland supported *Utricularia australis* growing over dead rushes / sedges.

Carry out 5 - year ecological condition monitoring.

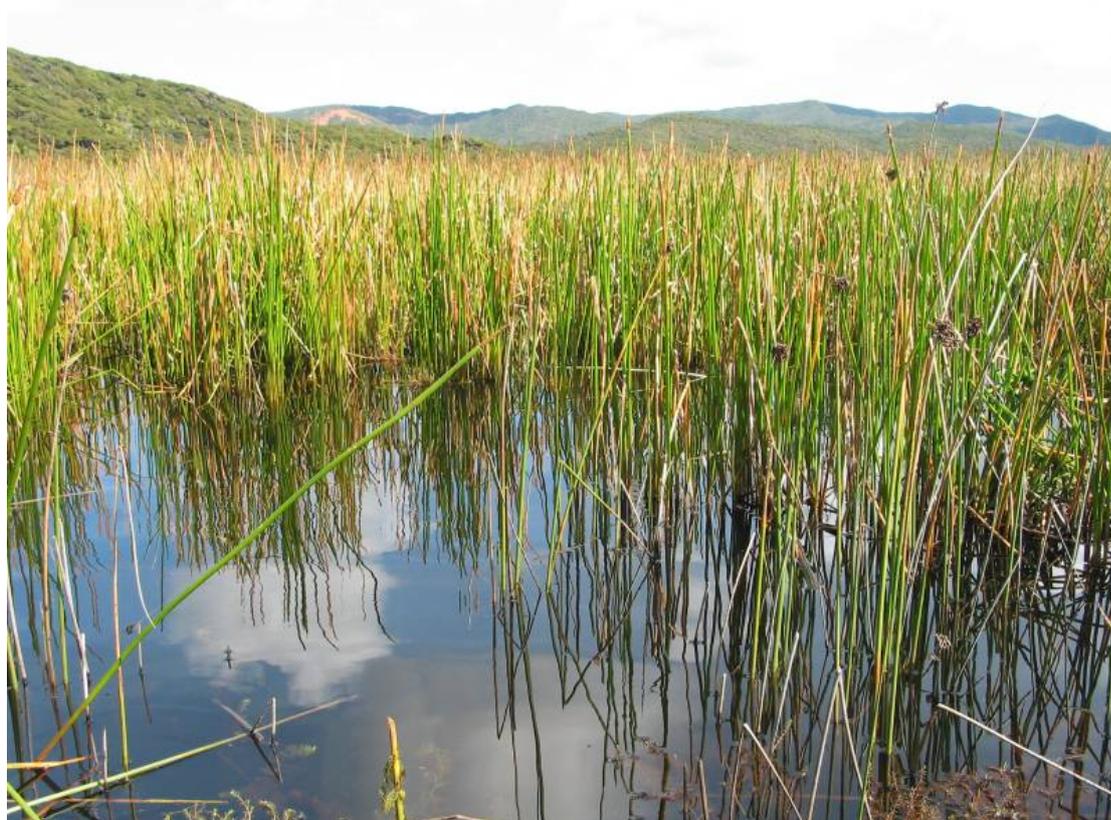
Plate 2: Freshwater lake, east of Waitahora Lagoon dominated by *Eleocharis sphacelata*.

Ecological condition monitoring every 5 years.

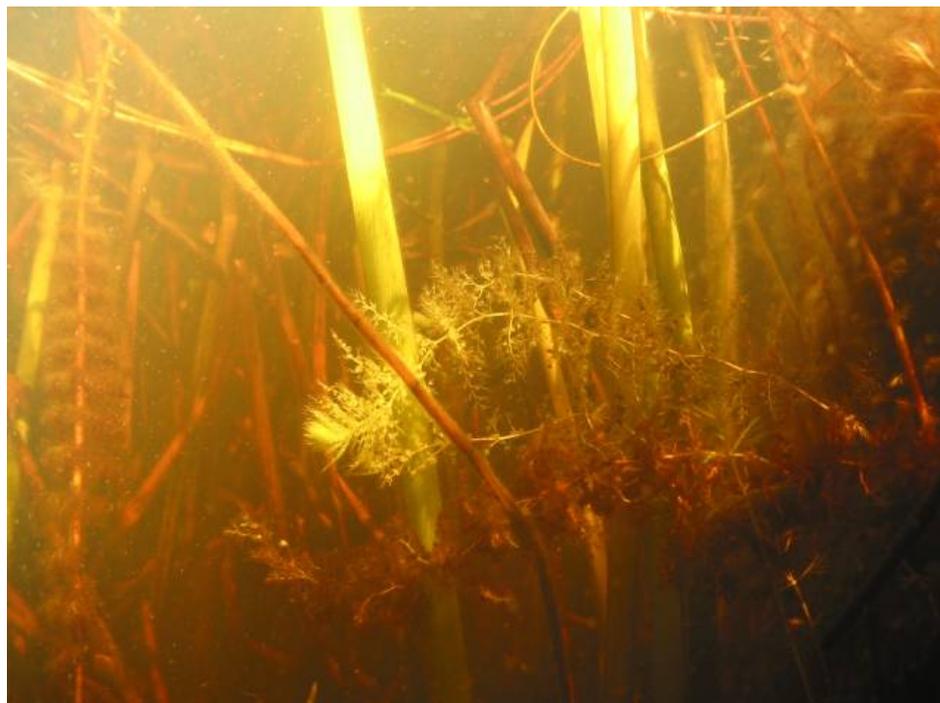
In 2007, open areas of water had some *Chara australis* and *C. fibrosa*, with pondweeds (*P. cheesemanii* and *P. ochreatus*), the milfoil *Myriophyllum propinquum* and the introduced swamp lily (*Ottelia ovalifolia*). The nationally endangered *Utricularia australis* was commonly found (Plate 3). The introduced water purslane (*Ludwigia palustris*) was found at the margin of the lake.

Plate 3: Freshwater lake east of Waitahora Lagoon with the endangered bladderwort (*Utricularia australis* – centre) and the milfoil *Myriophyllum propinquum* (left and right) in open water amongst the culms of *Eleocharis sphacelata* (centre background).

Ten year ecological condition monitoring.

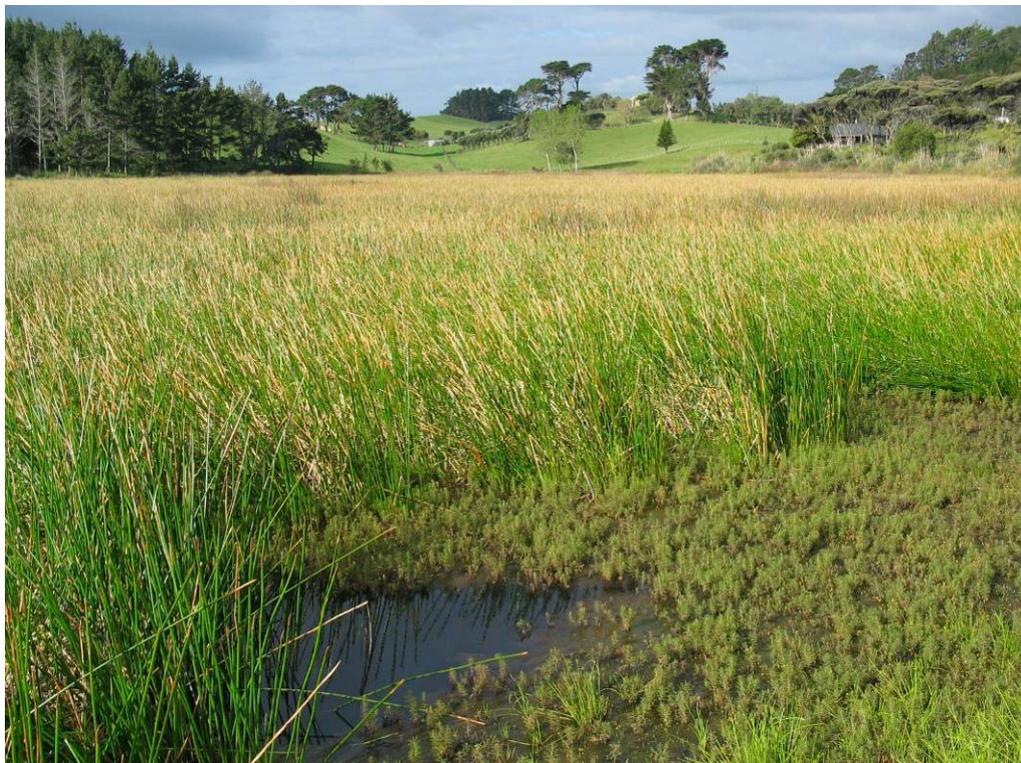
Plate: West Coast Road Lake showing emergent dominated water body with the endangered *Myriophyllum robustum* (bottom right) 2005, though not present in 2007.

Approximately 90% of the lake was covered with dense emergent vegetation dominated by *Eleocharis sphacelata* with local patches of the taller *Baumea articulata*. In 2005 the nationally endangered *Myriophyllum robustum*, a sprawling emergent species, was restricted to areas of open water amongst the taller sedges (see plate). However when visited in 2007 these plants could not be found, with sedges occupying the area in which *Myriophyllum robustum* formally occurred.

Lake condition monitoring every 5 years.

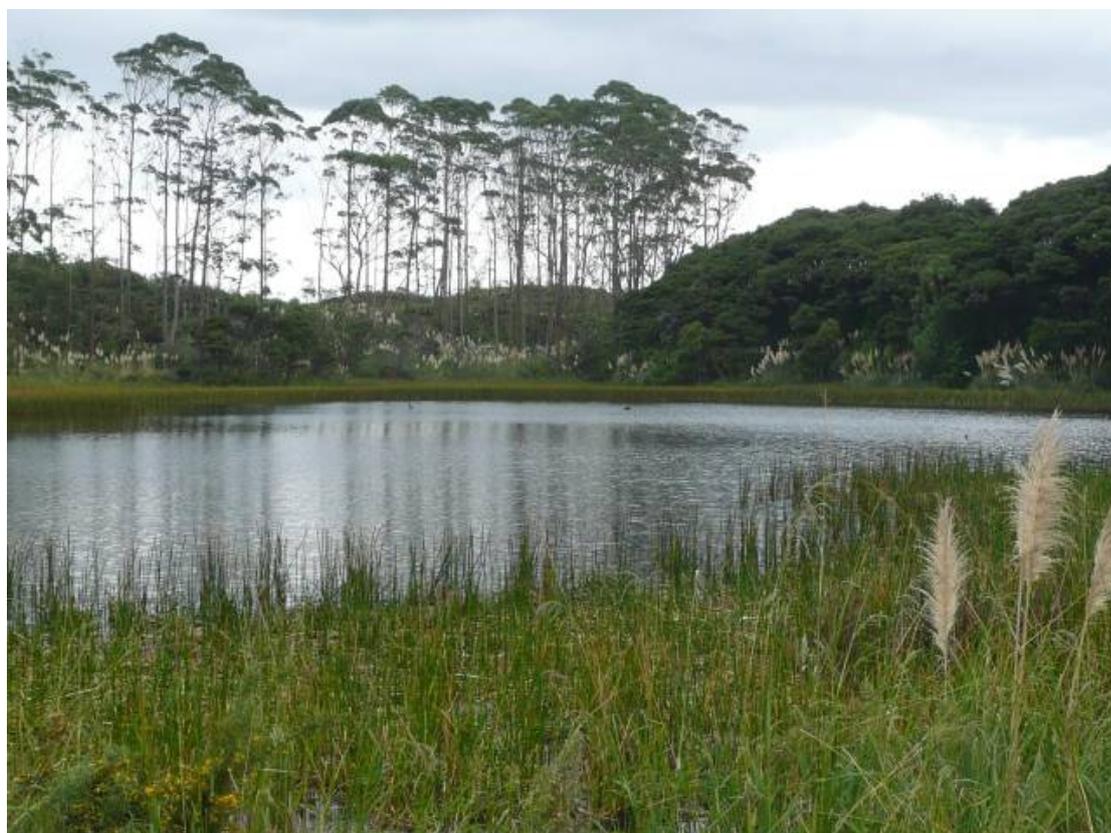
Plate: Lake Yelavich, a dune lake within plantation pine forestry

Lake Yelavich (1614575E, 6132392N) is about 3 ha in area. The lake was heavily tannin stained, but not turbid with visibility of around 1 m. The lake lies in a scrub and pine plantation catchment. Access was through Juken Nissho Ltd. forestry roads.

This is a good example of a shallow tannin-stained lake, with intact fringe of emergents and no livestock access. An assessment of lake condition at 5 yearly intervals is recommended.
