3.9 Lake Little Gem, near Ngatu (Aupouri) NRC Lake No. 123; surveyed in 2007.

3.10 Mini Lake (Split Lake) (Aupouri), NRC Lake No. 130; surveyed in 2005.

3.11 Morehurehu (Aupouri), NRC Lake No. 32; surveyed in 2006 and 2009.

3.12 Morehurehu South (Aupouri), NRC Lake No. 36; surveyed in 2006.

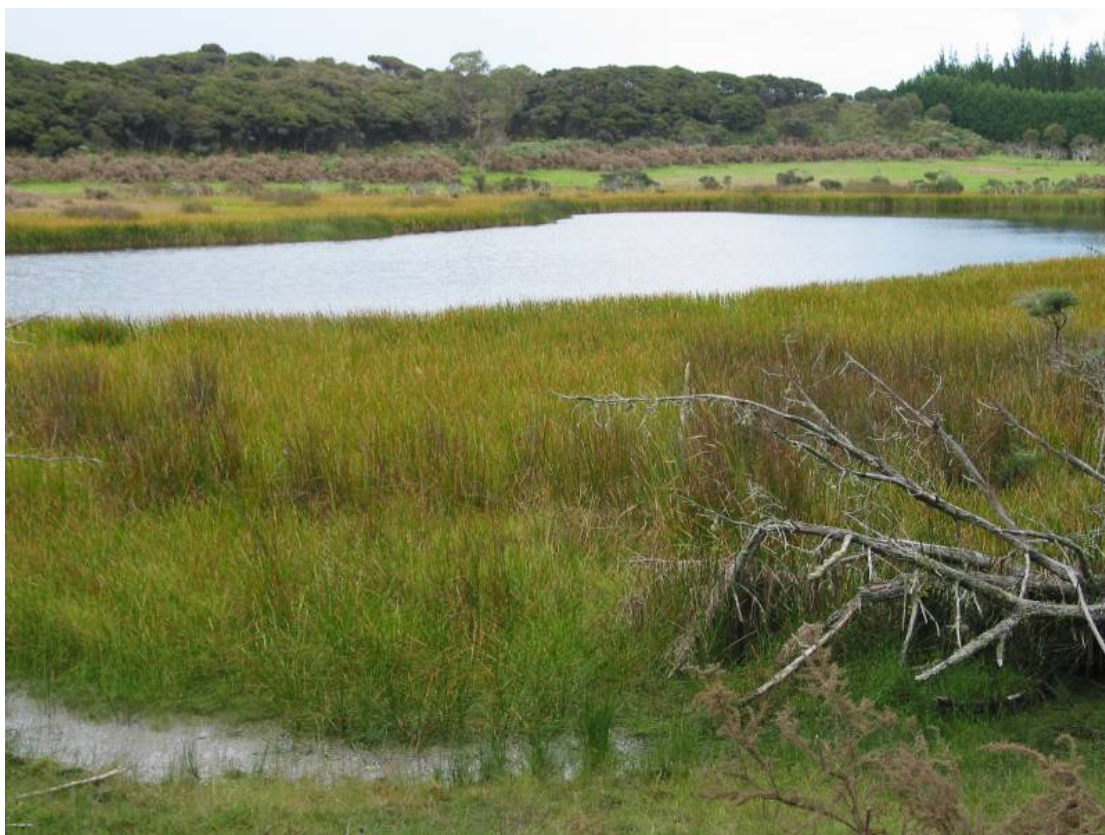
Plate 1: Lake Little Gem viewed from the north-western access point.

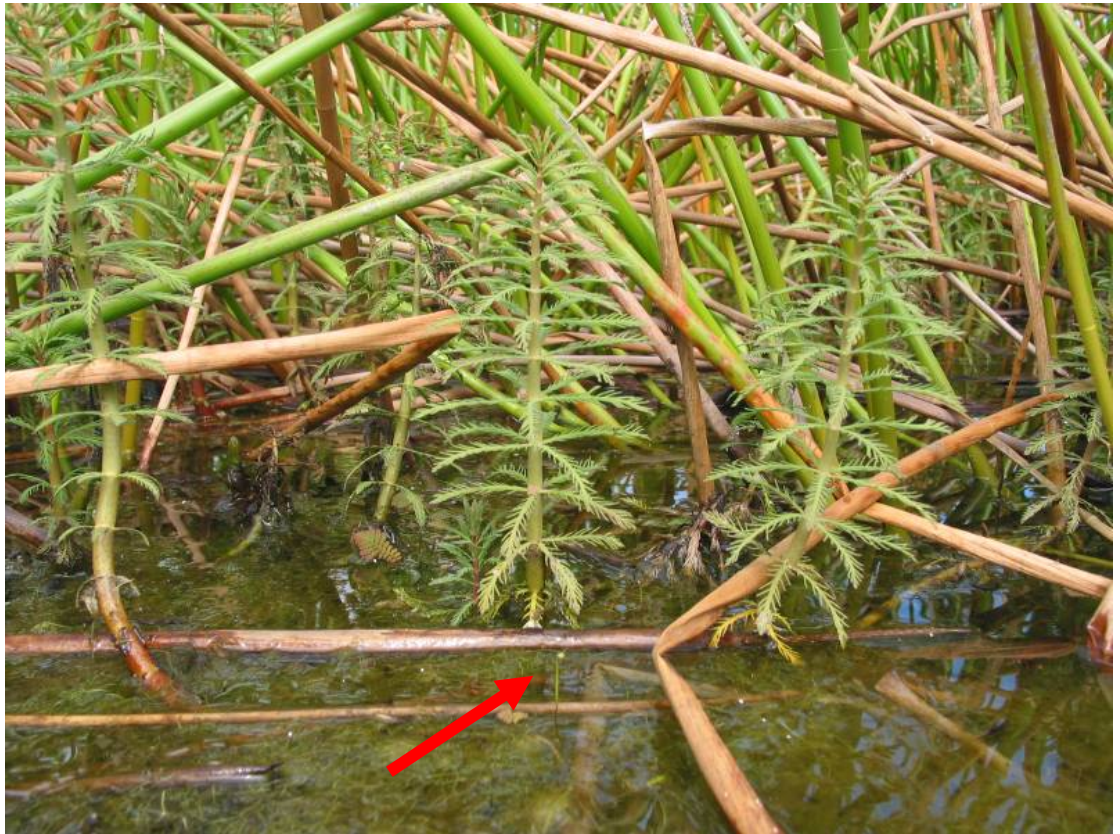
Plate 2: The nationally threatened *Myriophyllum robustum* growing amongst the emergent sedge *Eleocharis sphacelata* in Lake Little Gem in about 0.5 m of water. Note the dense mat of the invasive *Utricularia gibba* with lone small flower stalk (red arrow).

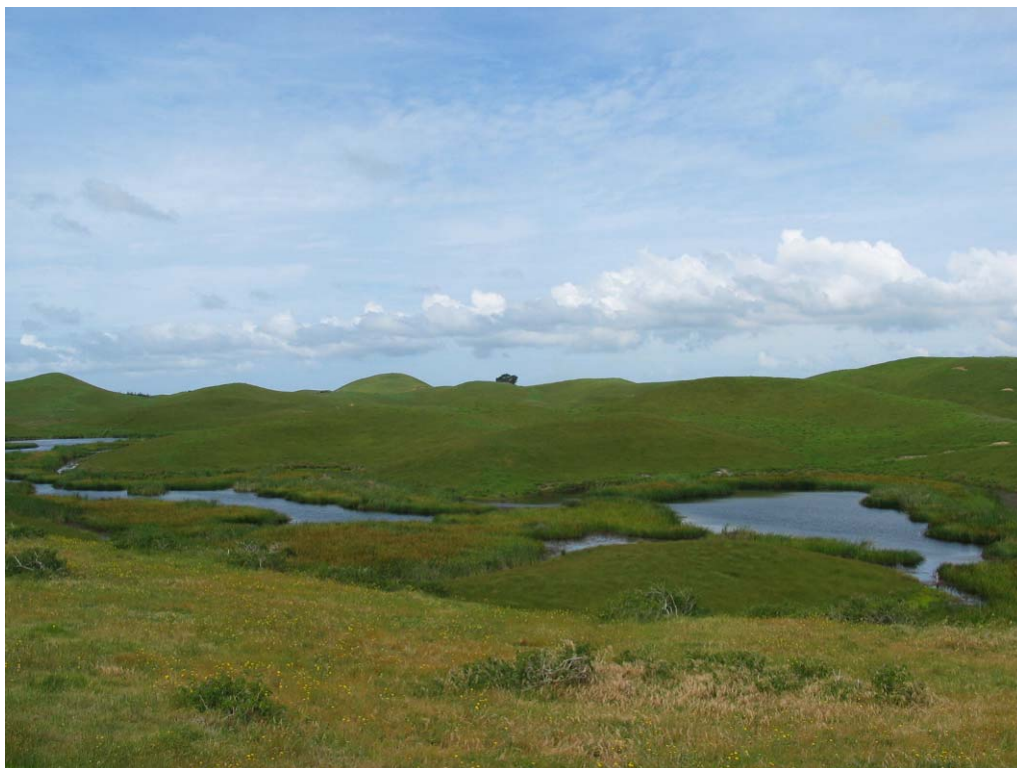
Plate: Mini Lake, set in pasture, showing the narrow ribbon-like nature of the lake with large emergent beds of raupo (*Typha orientalis*) and kuta (*Eleocharis sphacelata*).

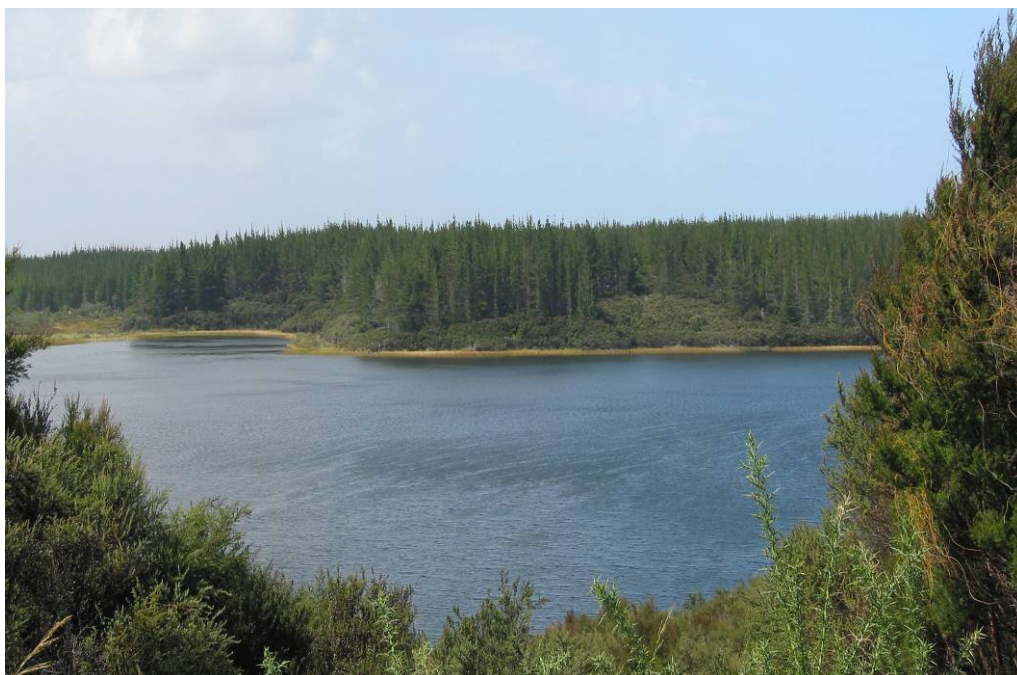
Plate: Morehurehu set in plantation pine, with extensive emergent beds.

Leaving the zone of scrub would offer some buffer for the lake from nutrient additions associated with logging activities. Lake condition monitoring every 5 years.

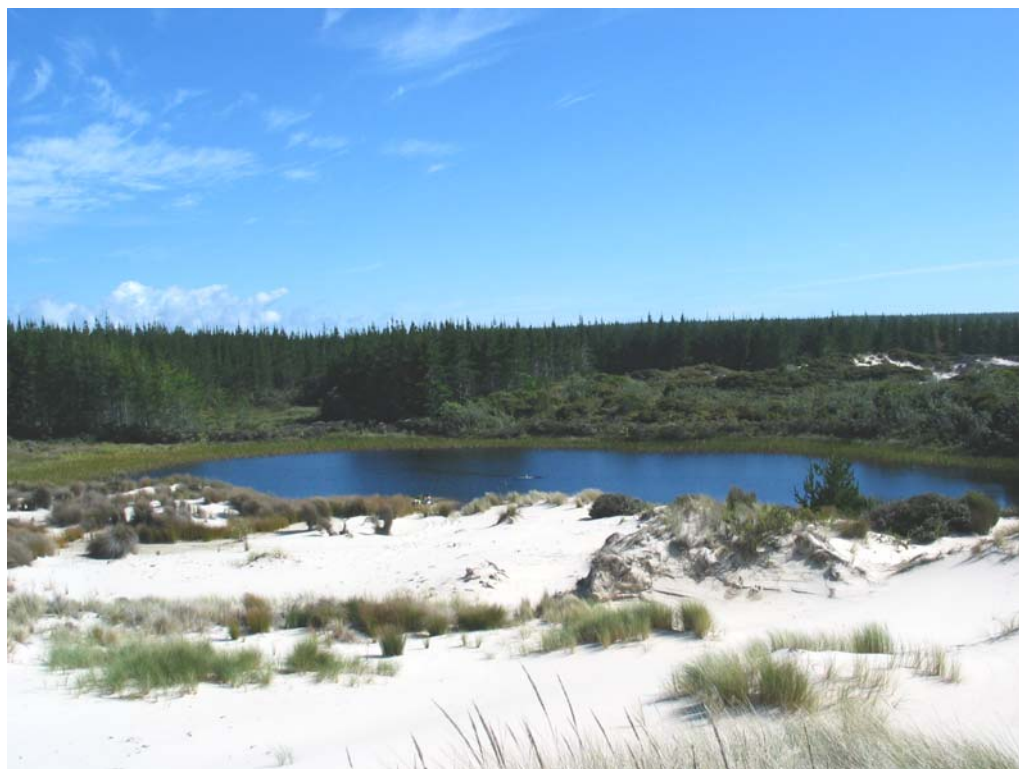
Plate: Morehurehu South, a coastal dune lake set in mobile sand dunes, scrub and pine plantation forestry.

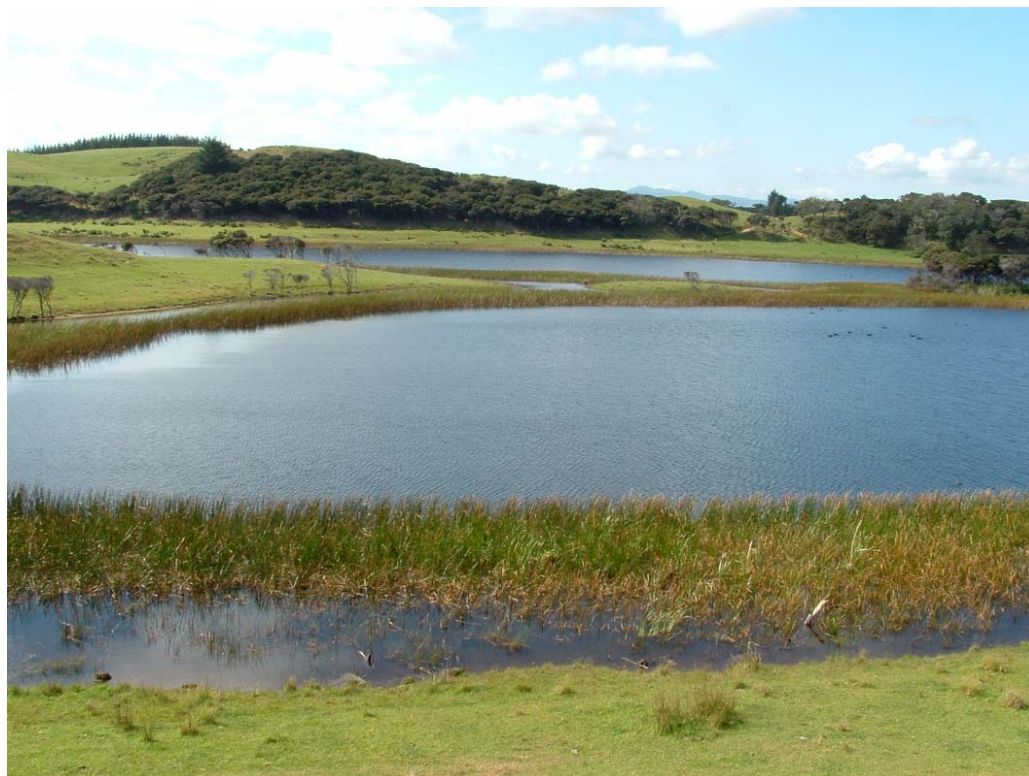
Plate: Ngakapua South Basin looking towards the North Basin separated by a bed of emergent kuta (*Eleocharis sphacelata*). Note the grazing impacts confining emergent vegetation to deeper water.

Fencing of lake edge is recommended. Lake condition monitoring should be undertaken at 5 yearly intervals.

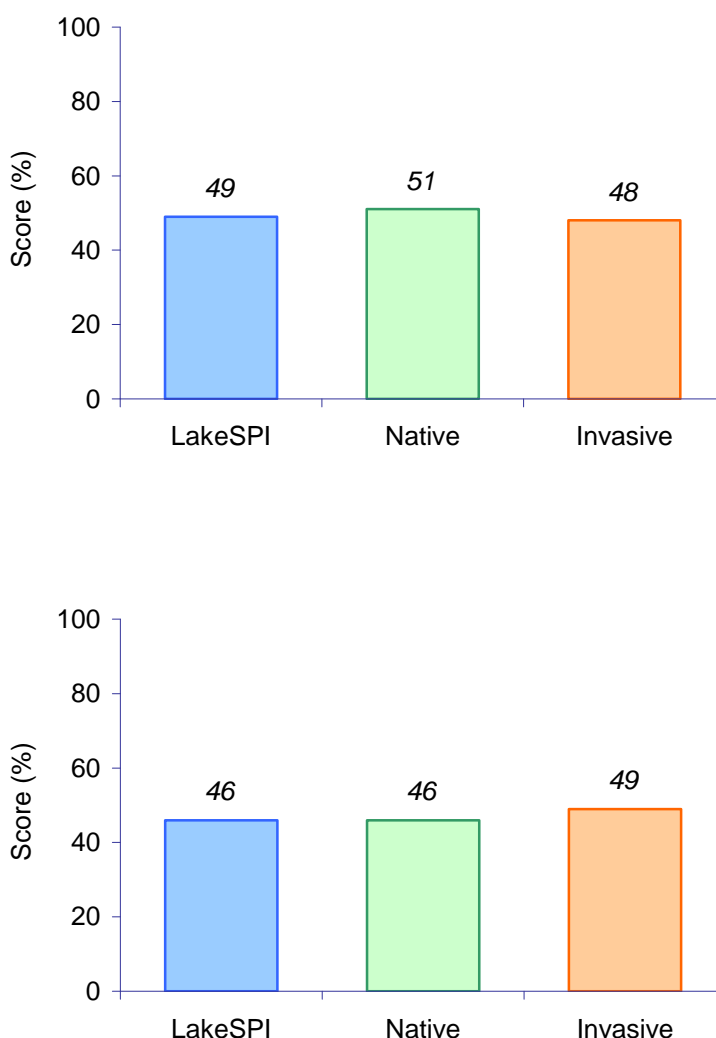
Figure: LakeSPI Index as % of potential score, Native Condition Index, and Invasive Impact Index (from left to right) for North Basin (Top) and South Basin (Bottom).

A moderately low LakeSPI score of 49% for the North Basin and 46% for the South Basin, which reflects the limited depth extent of native vegetation and the significant presence of *U. gibba*.

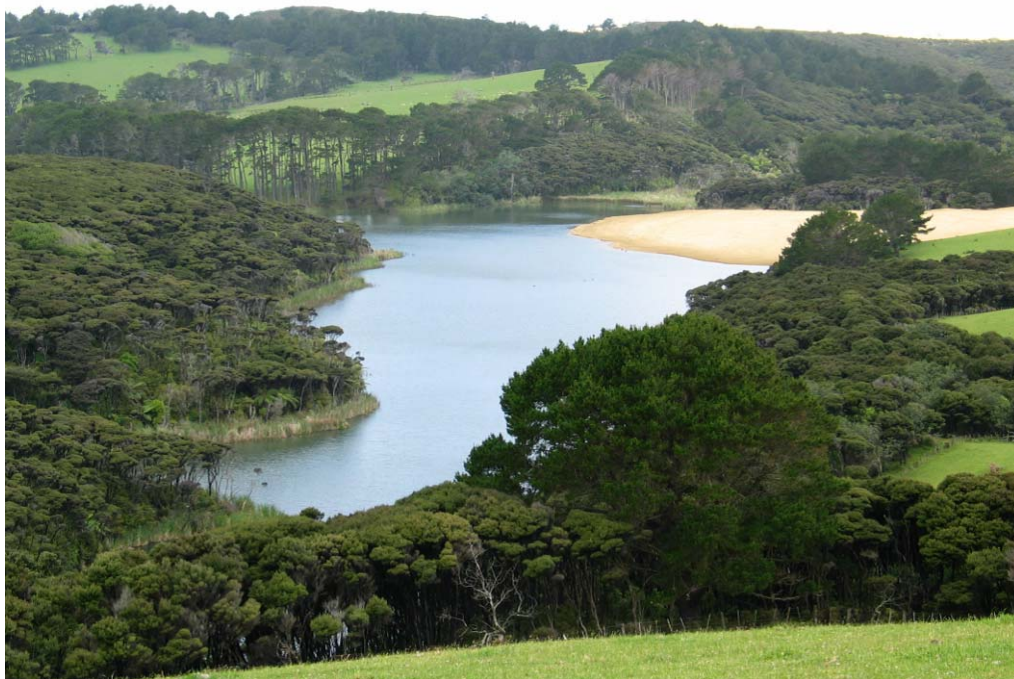
Plate: Lake Ngakeketa showing steep scrub catchment, mobile dune (right) with outlet behind this.

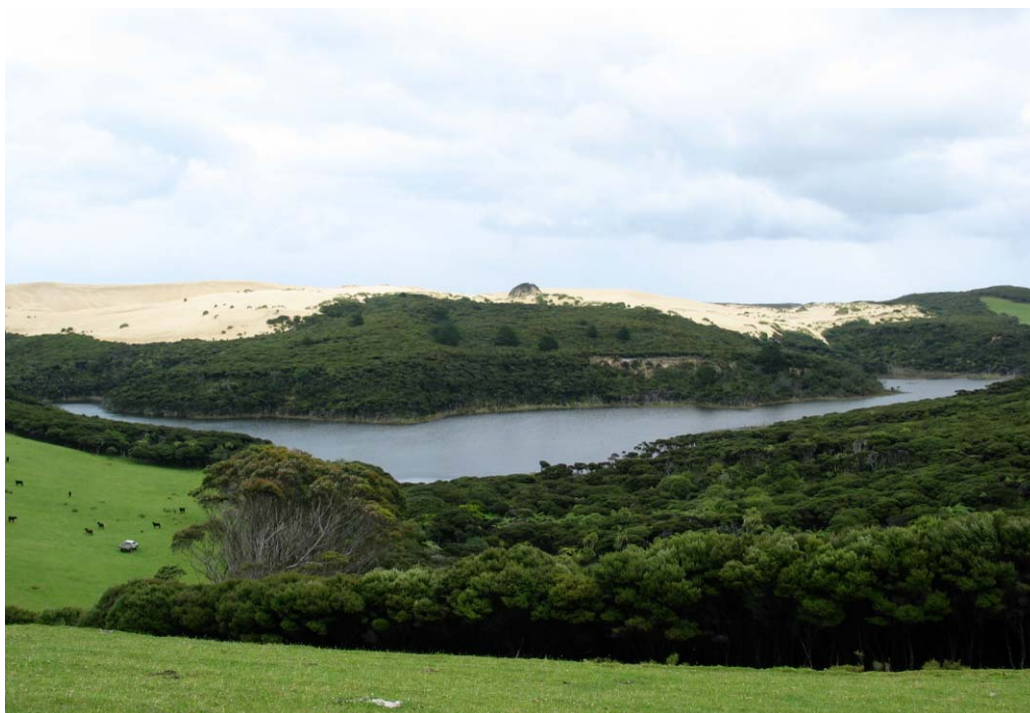
Plate: Lake north of Lake Ngakeketa (head of Te Paki Stream), showing the forested surrounds, with pasture and mobile dunes also in the catchment.

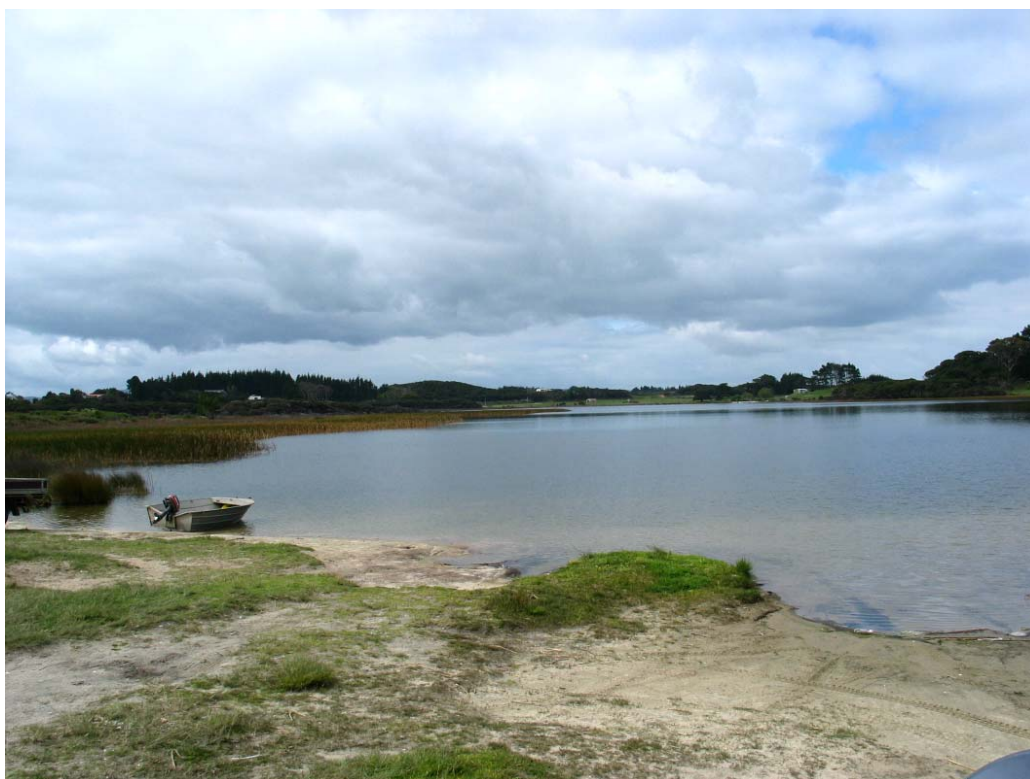
Plate 1: Lake Ngatu from the northern boat ramp.

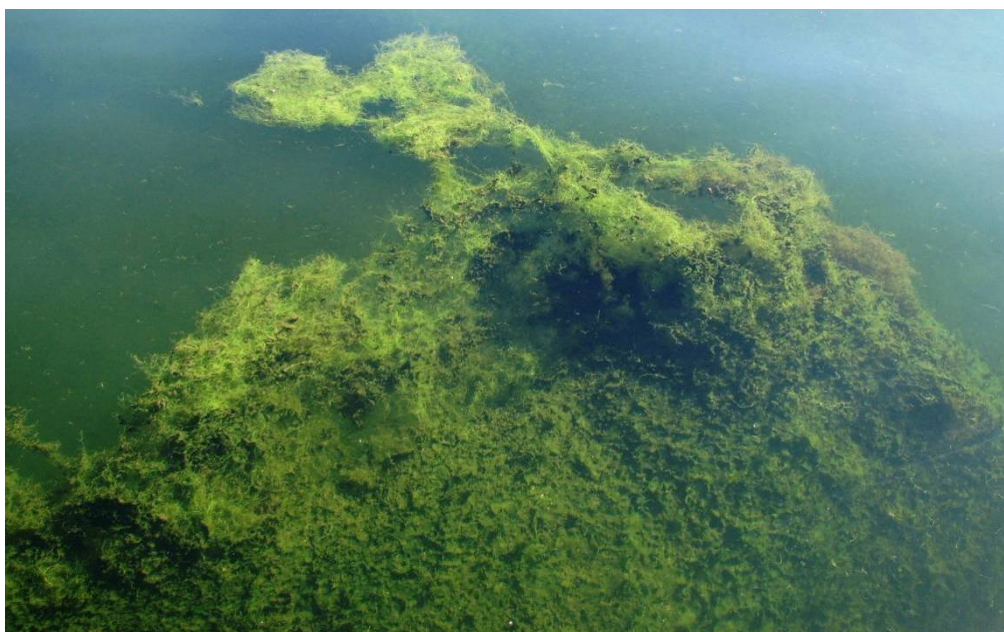
Plate 2: Lake Ngatu, *Utricularia gibba*, an invasive plant pictured in autumn lifting off the bottom and rafting on the surface (photo Kevin Matthews 30 May 2007).

A herbicide trial using endothall to evaluate the feasibility of eradication of *L. major* (and possible control of *U. gibba*) is proposed for Lake Ngatu. Charophyte species are tolerant of this herbicide.

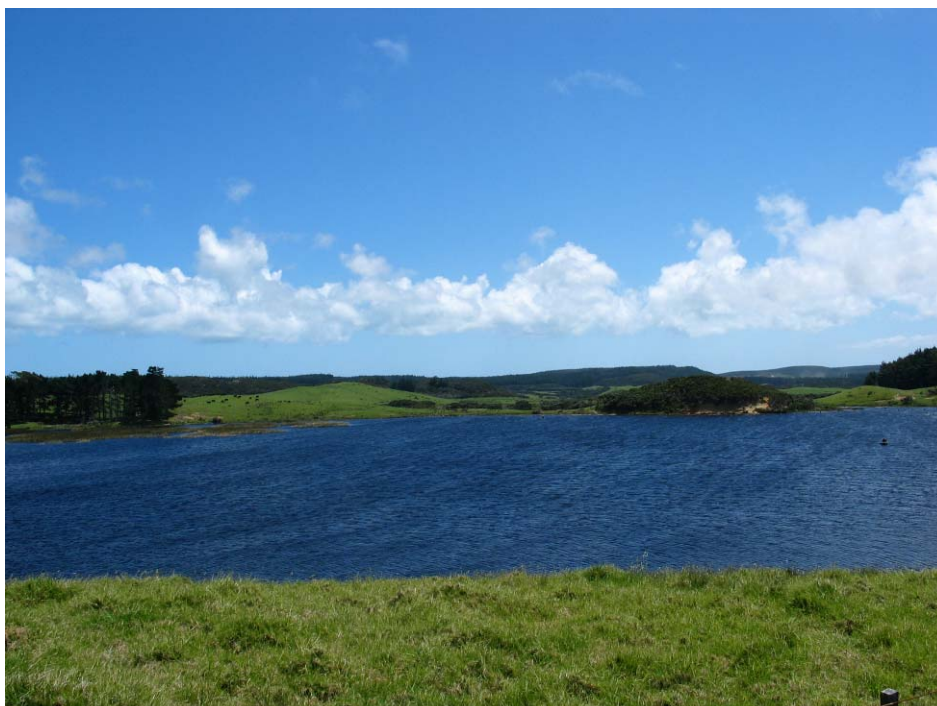
Plate: Lake Ngatuwhete with a mostly pasture catchment, note the beds of emergent vegetation dominated by kuta (*Eleocharis sphacelata*) (middle left).
