NORTHLAND FRESHWATER BATHING SITES

WATER QUALITY MONITORING SUMMER 2003-04

Prepared by Nathaniel Wilson
NRC Monitoring Department

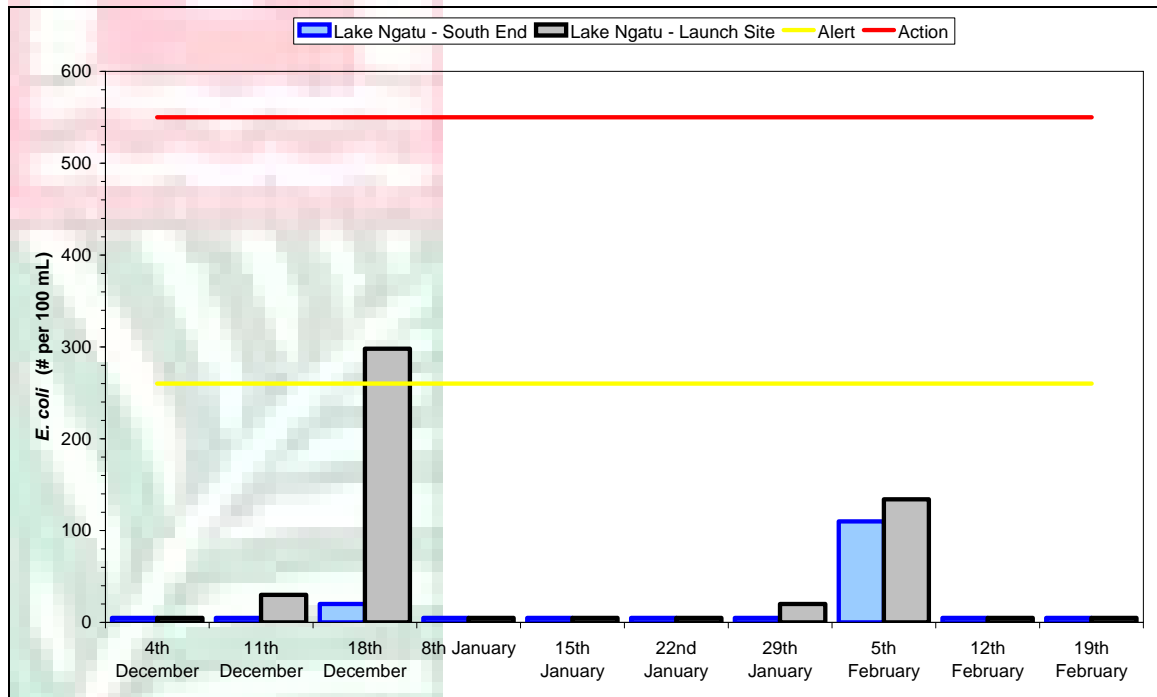
Figure 2 Results from the 2003-04 freshwater recreational contact study for Lake Ngatu

As is obvious from Table 6 (above), and Figure 2 (below), the bacteriological water quality of Lake Ngatu was excellent for the bulk of the sampling period. There were two 'spikes', one in December, and another at the beginning of February.

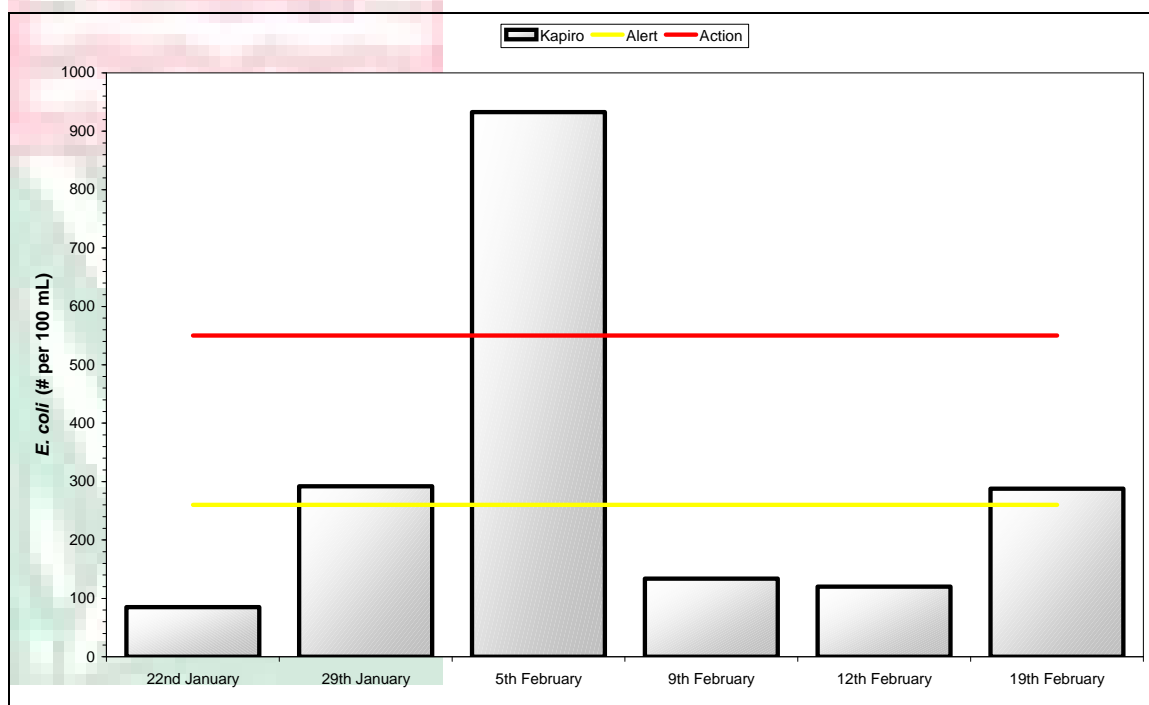
Figure 12 Results for the Kapiro Stream over the 2003-04 summer. Sample data from the 9th of February courtesy of the FNDC

With only six samples collected, and no historic data, it is premature to read anything into the results of the 2003-04 survey (Results presented as Table 11). Samples exceeded the action guidelines once, at the beginning of February, and two samples contained *E. coli* above the alert (260 *E. coli* per 100 mL) threshold (Figure 12). 95th percentiles using the hazen method require at least 10 data points, and therefore could not be calculated for the Kapiro Stream.

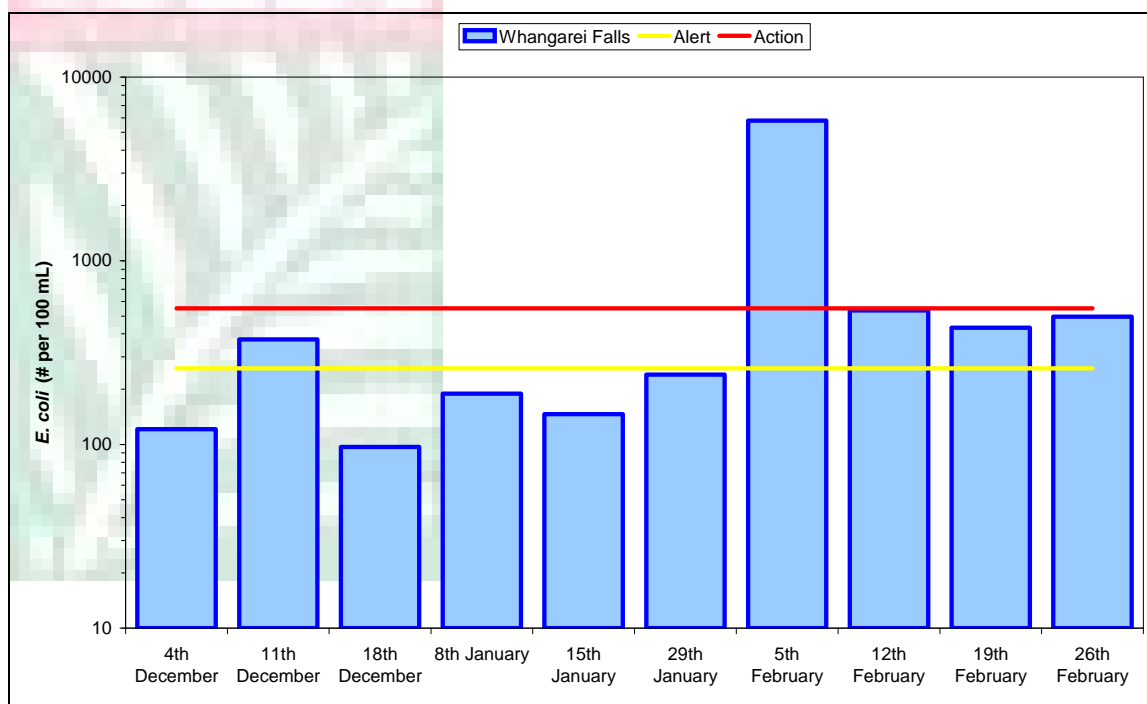
Figure 18 Results for the Whangarei Falls over the 2003-04 summer.

According to Table 14, the water quality of the Waitaua Stream at the Whangarei Falls was marginally better than average, with only one breach of the 550 *E. coli* per 100 mL action threshold. Overall, *E. coli* populations were higher in the Waitaua Stream than at most sites around Northland, with a median above the 260 *E. coli* per 100 mL alert guidelines. As shown in Figure 18, water quality at the site was variable throughout the summer, but generally worse after the spike on the 5th of February.

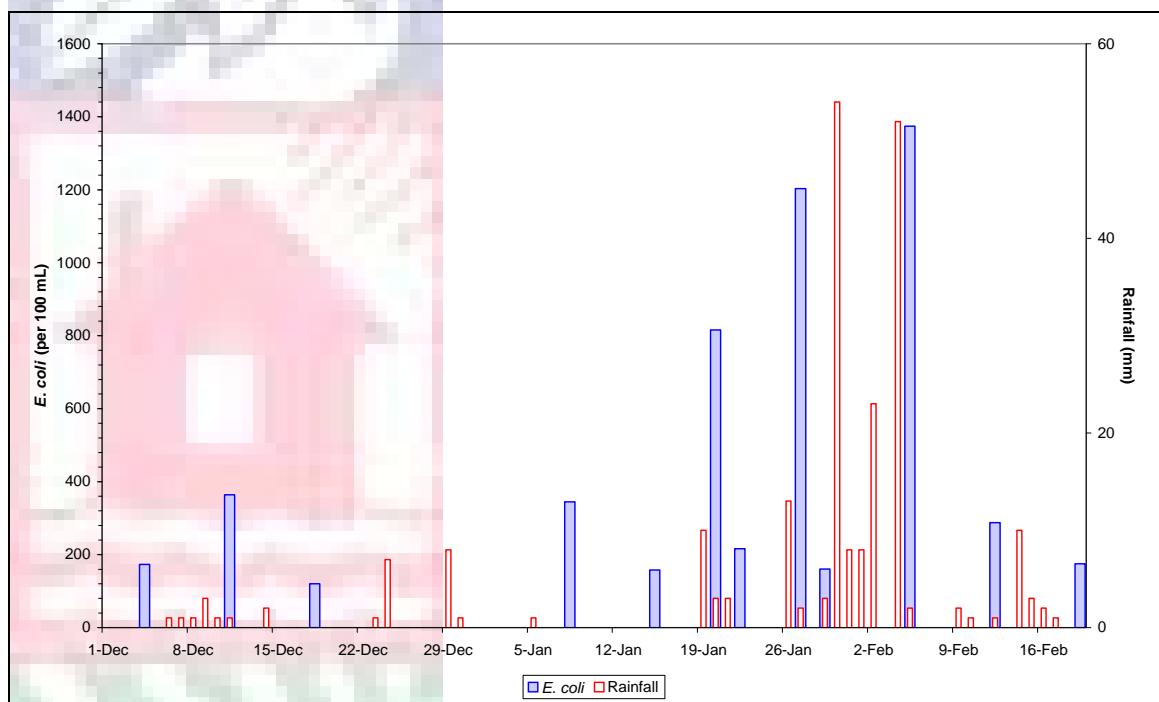
Figure 21 Rainfall and *E. coli* results for the Raumanga Stream

It appears that the Raumanga takes a couple of days to flush. Elevated *E. coli* results on the 8th of January for example, appears to have been caused by rain falling on the 5th, and similar circumstances could explain the levels observed on the 12th of February. An unexpected drop on the 19th of February may be due to the bulk of the *E. coli* having already been flushed through, as the most significant rainfall preceding it occurred on the 14th (five days earlier).

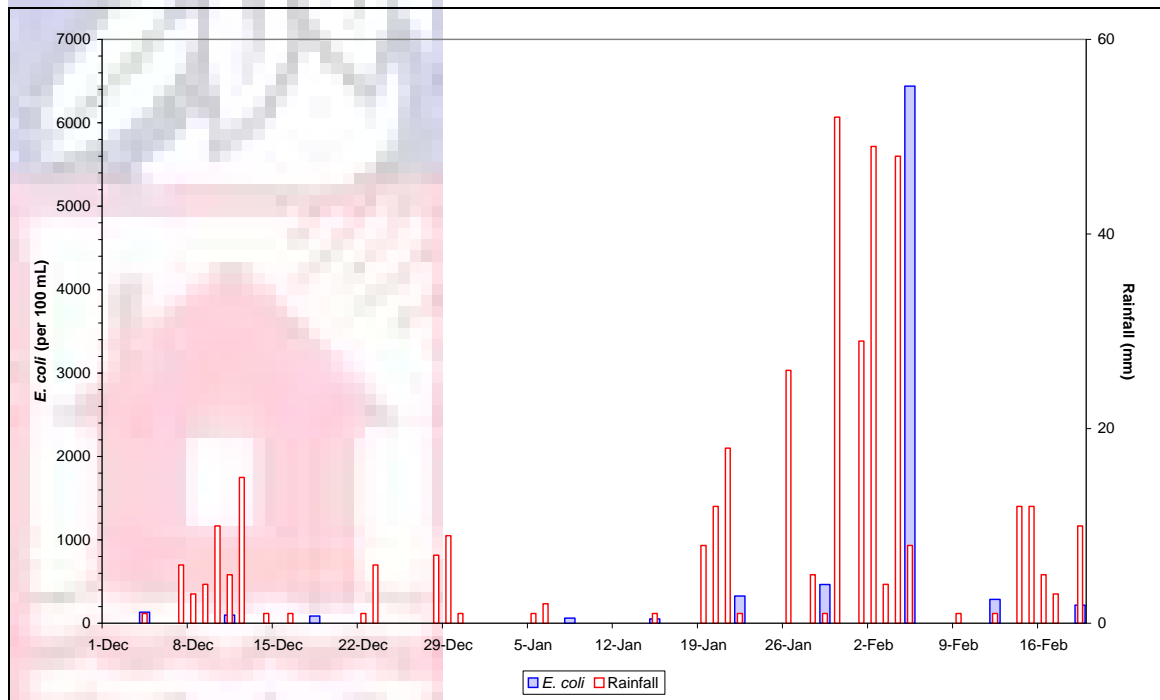
Figure 23 Rainfall and *E. coli* data for the Mangakahia River below the Tokiri Marae

Rainfall appears to have caused the elevated *E. coli* detected in samples from the end of January through to the beginning of February, as shown in Figure 23. However, there is no clear correlation between *E. coli* and rainfall overall.

Sustained rainfall at the beginning of December did not cause an elevation of *E. coli*, and in fact, *E. coli* levels at the site were lower than in the sample collected a week earlier. A similar phenomenon occurred at the end of the summer, where *E. coli* continued to decline after the spike on the 5th February, even though sustained rainfall occurred between the 12th and 19th of that month.

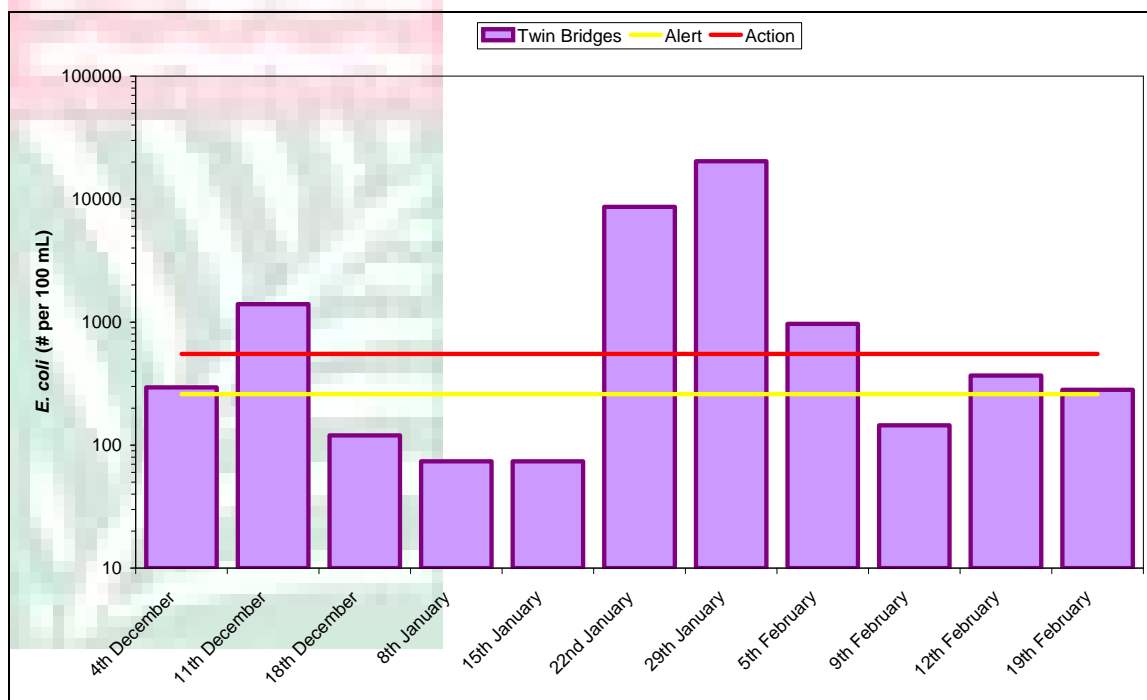
Figure 24 Results at the Twin Bridges site over the 2003-04 summer

The Twin Bridges site is one of the more pleasant sites to sample over summer, however water quality was exceptionally poor over the 2003-04 period. As listed in Table 17, water quality was worse than average across the board, and the 95th percentile for the summer was almost unbelievably high. Of particular concern were the results from the 22nd and 29th of January, at which *E. coli* were measured in the tens of thousands (Figure 24), suggesting the presence of an upstream source of contamination that requires urgent attention.

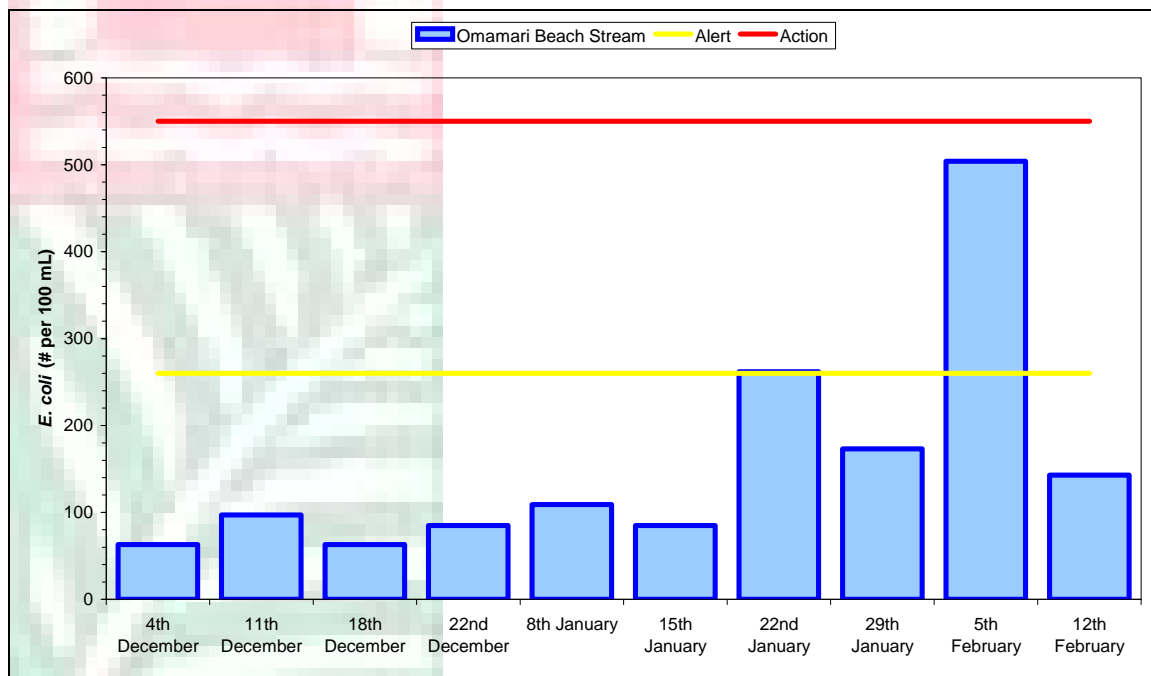
Figure 28 2003-04 results for the Omamari Beach Stream

The results presented as Table 19 and Figure 28 show that water quality was excellent at the site with two exceptions. *E. coli* on the 22nd of January just broke the alert threshold of 260 *E. coli* per 100 mL (262 *E. coli* per 100 mL, and approached the action threshold of 550 per 100 mL at the beginning of February.

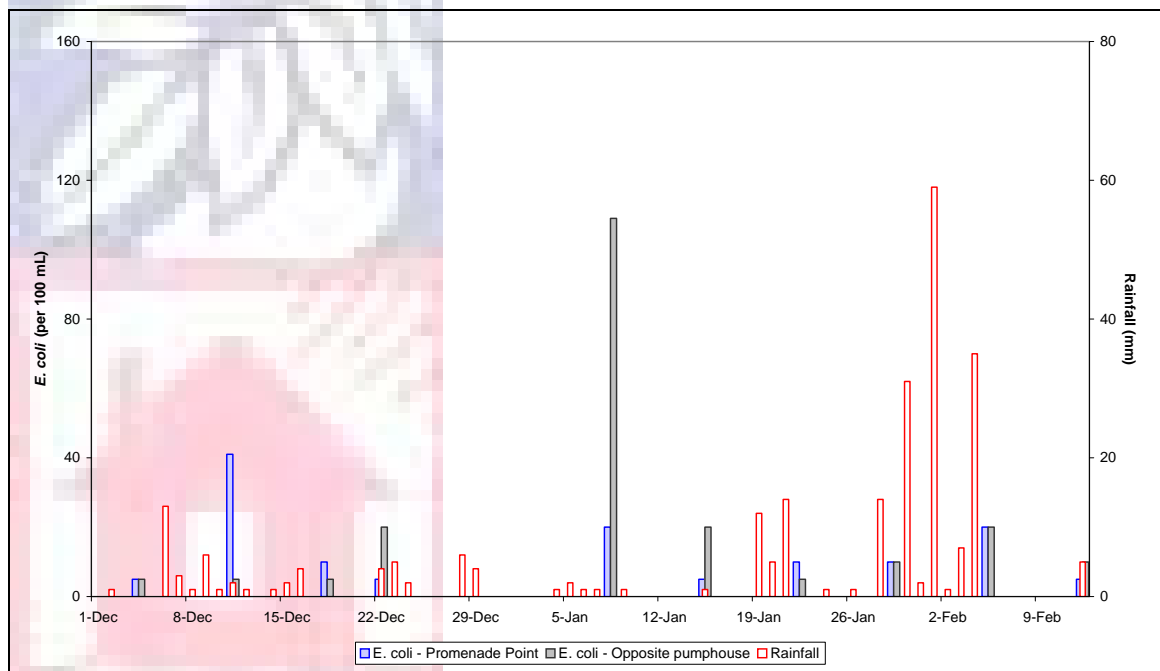
Figure 31 Rainfall and *E. coli* data for Lake Taharoa

There is no obvious link between rainfall and *E. coli* levels at Lake Taharoa. As shown in Figure 31, very little rain fell before the spike recorded on the 8th of January, while prolonged rain had little effect, based on samples from the 5th of February. Isolating the cause for the spike is not possible, and could be anything from a contaminated sample through to birds defecating at the sampling site. Whatever the reason, when 109 *E. coli* per 100 mL constitutes a “spike”, the implication is that people have not affected the health of Lake Taharoa at all (in terms of bacteriological quality at least).
