## Central and East Northland

Uretiti Sand Quarry Lake (East Northland), NRC Lake No. 247B

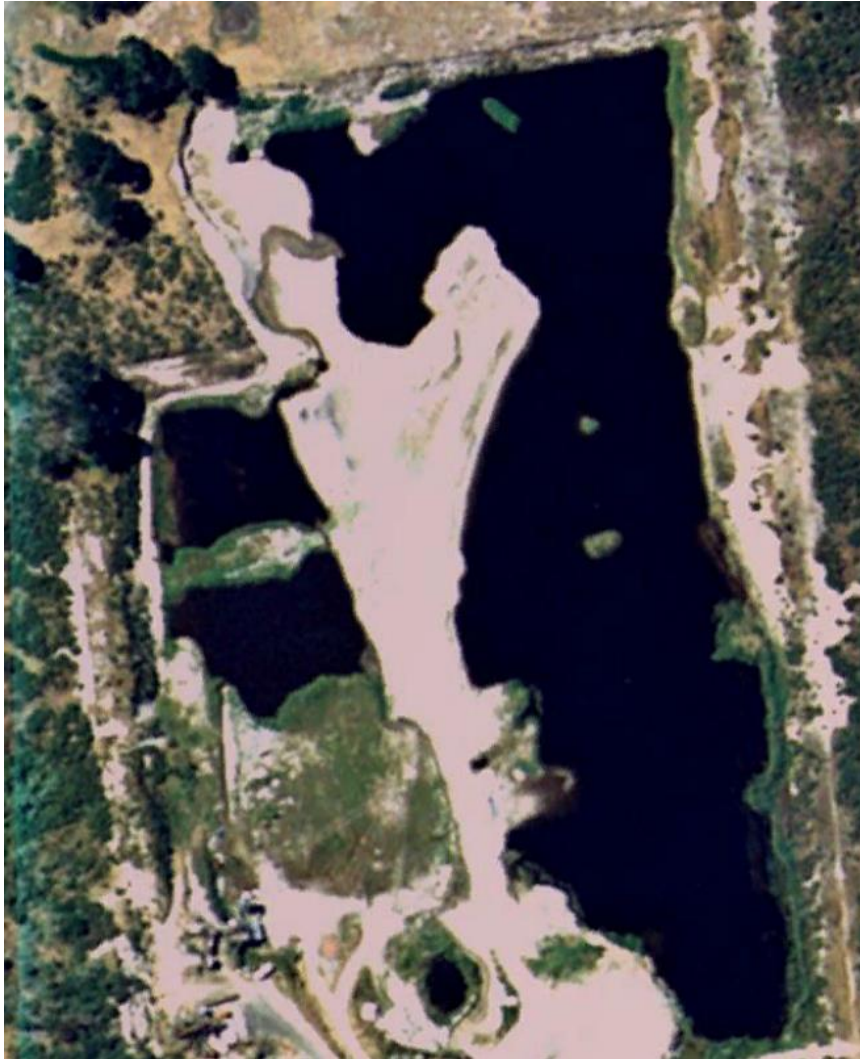
Uretiti Sand Quarry Lake.

A 3 ha sand quarry lake (1731340E, 6023215N) adjacent to State Highway 1. The depth was not determined but is likely to be in excess of 5 m. Access was through private, with a track leading to the southern shore.

Limited emergent vegetation was found, with *Juncus pallidus*, *Typha orientalis* and *Ludwigia palustris* recorded. The introduced invasive alligator weed (*Alternanthera philoxeroides*) was locally established.

No monitoring.
