Northland rivers & streams

Habitat Assessment

2011-2012

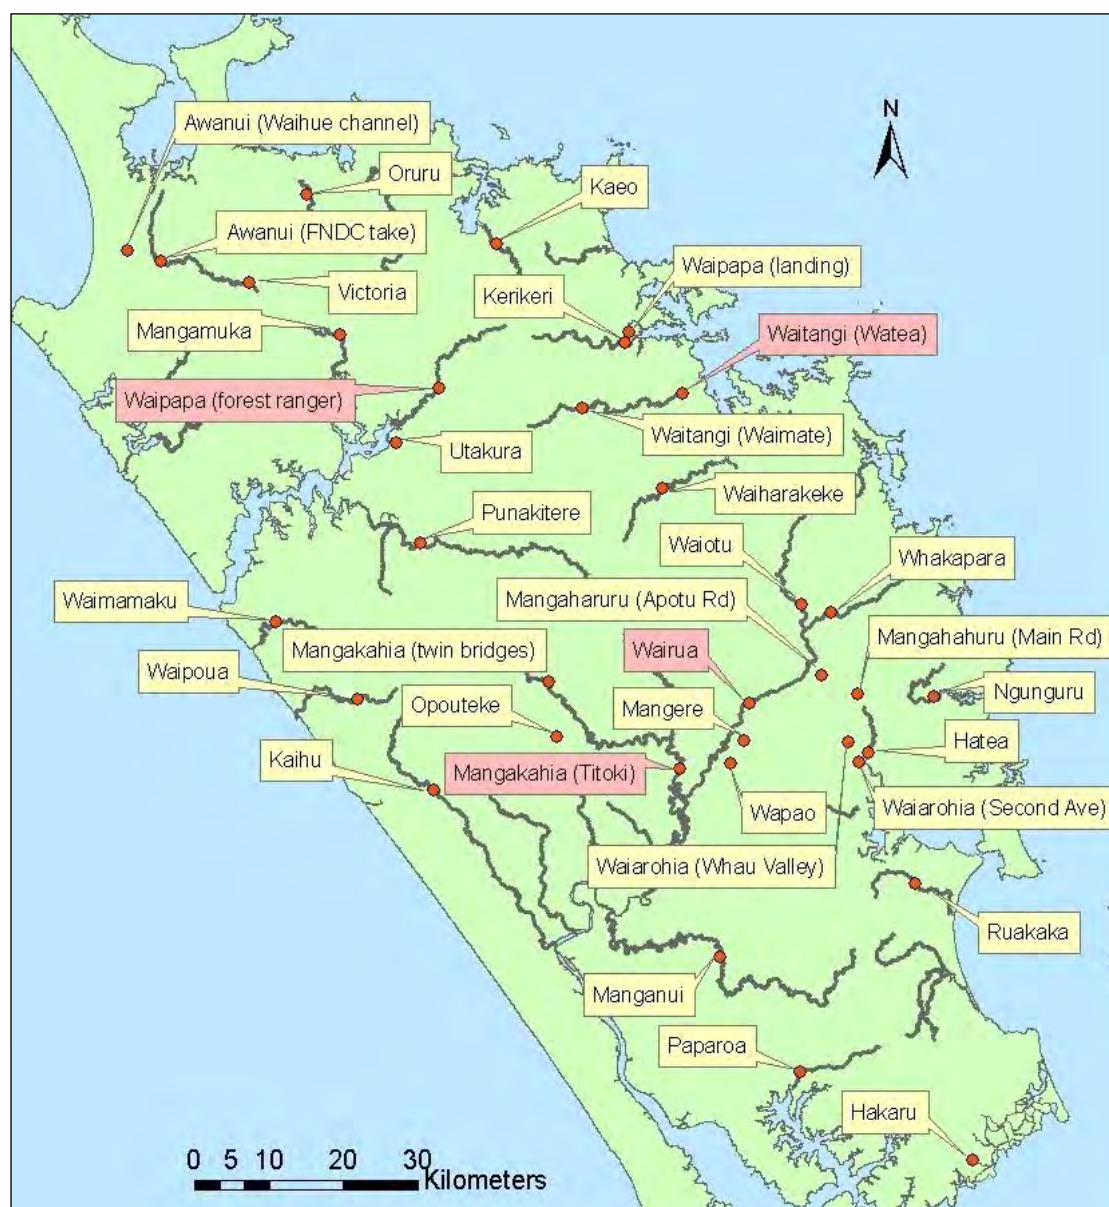
The sites assessed by the Council are those included in the Regional River Water Quality Monitoring Network (RWQMN). There are currently 35 sites in the network; 31 of which are monitored by the Council and four by the National Institute of Water and Atmospheric Research (NIWA) (shown in pink in Figure 1).

Figure 1: Map showing the 35 Regional Water Quality Monitoring Network sites (National River Water Quality Network sites in pink)

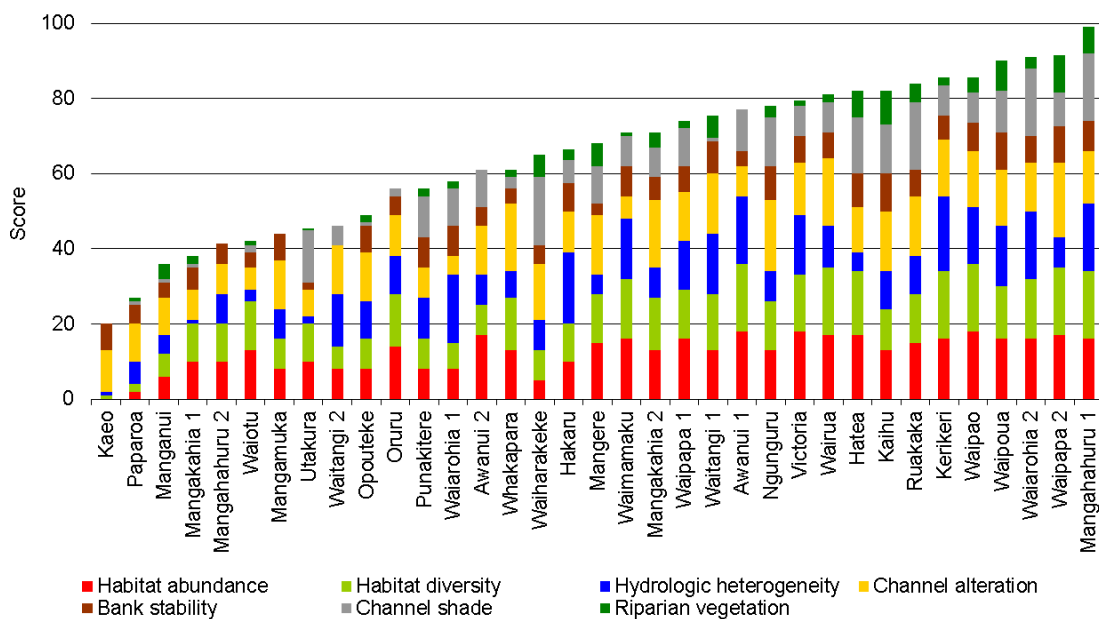
Figure 5: Habitat quality scores 2010

Figure 5 shows total habitat quality scores, broken down into component parts, for all sites assessed in 2010. Sites are ranked from lowest score (poorest habitat) to highest score (best habitat).

The two sites with best habitat quality in 2010 were Mangahahuru 1 (99) and Waipapa 2 (91.5). The two sites with the poorest habitat quality were Kaoe (20) and Paparoa (27).

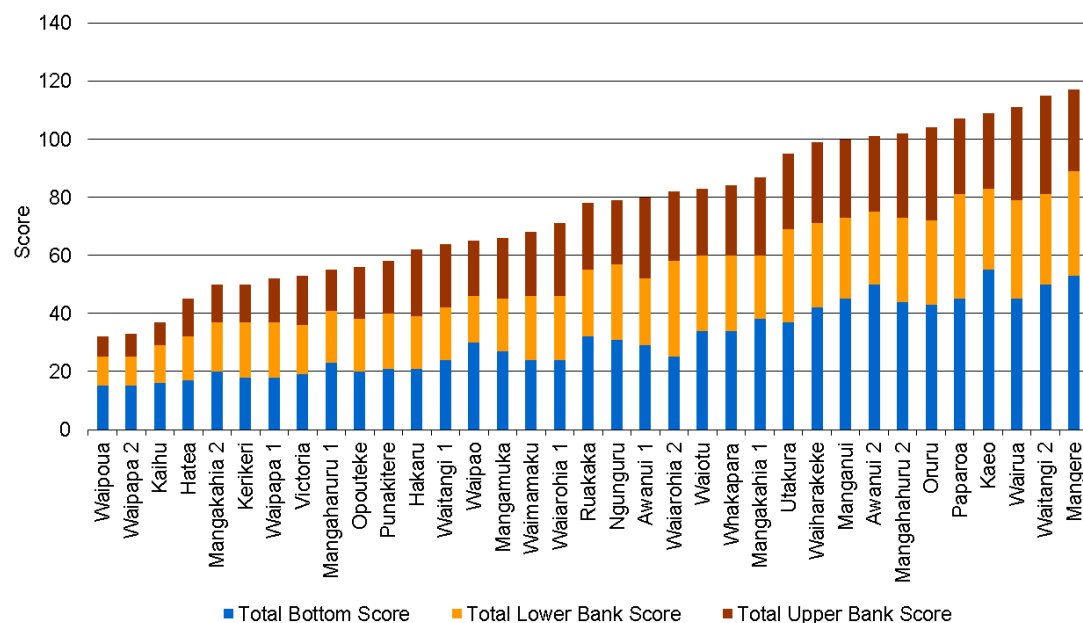
Figure 7: Pfankuch stability index scores 2012

Figure 7 shows the total Pfankuch stability score, broken down into bottom, lower bank and upper bank scores, for all sites assessed in 2012. Sites are ranked from lowest score (most stable habitat) to highest score (least stable habitat).

The three most stable sites in 2012 were Waipoua (32), Waipapa 2 (33) and Kaihu (37). In comparison, the three most stable sites in 2010 were Kaihu (43), Waipoua (47) and Hatea (50). Waipapa 2 was the eighth most stable site in 2010 with a score of 65 suggesting it has become more stable over the past two years. Kaihu was the third most stable site in 2012 with a score of 37 and also appears more stable in 2012. The Hatea River was the fourth most stable site in 2012 with a score of 45. It is worth noting that in the summer of 2010 Northland received less rainfall than in 2012, so it is likely the improvements in stability were a result of differences in surveyor's judgement, rather than any real change in stability.

The three least stable sites in 2012 were Mangere (117), Waitangi 2 (115) and Wairua (111). In comparison, the three least stable sites in 2010 were Waitangi 2 (128), Paparoa (122) and Waiharakeke (112). Wairua and Mangere could not be graded in 2010 and so a comparison between years cannot be made. Paparoa was the fifth least stable site in 2012 with a score of 107 and Waiharakeke was the tenth least stable site in 2012 with a score of 99.

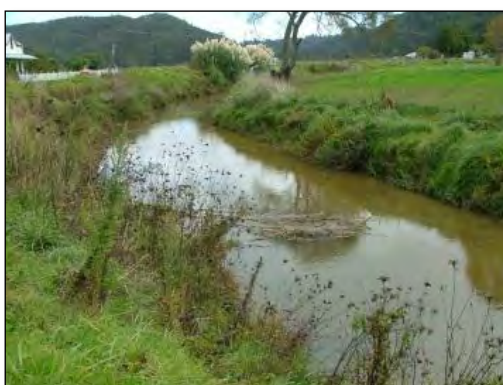
The Kaeo River site is characterised by a soft bottom constituted by sediment including silt and/or sand, a quasi inexistent riparian canopy cover, and a surrounding land-use dominated by pastoral activity as illustrated in Photo 3. The river is subject to frequent flooding, and bank erosion and deposition. Some parts of the Kaeo River – excluding the sampling site – are also open to livestock, which together with the flood and erosion problems impact on habitat quality. The site grade has fallen from marginal to poor in the last five years.

In regards to habitat stability Kaeo has had fair stability from 2008 to 2012 since it improved from 2007 (poor stability). This may have been influenced by channel stabilisation work that was undertaken on the river for flood prevention purposes. Habitat quality will take longer to recover than channel stability and may not improve unless riparian fencing and planting is undertaken to reduce the effect of livestock on river banks, riparian vegetation and therefore water quality.

Photo 3: Kaeo River, upstream view

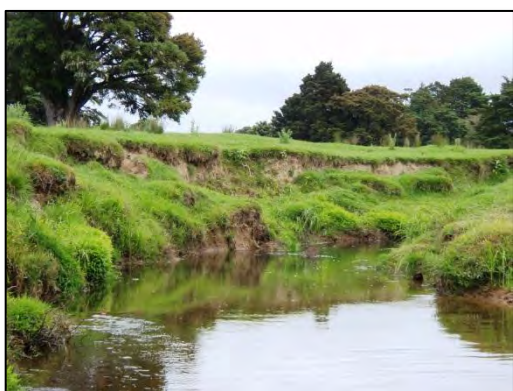
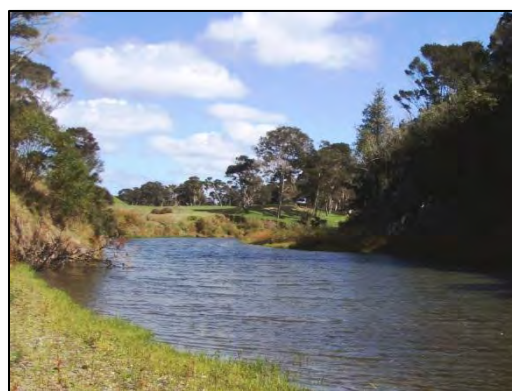
In terms of physical characteristics obvious differences between the sites also occur as illustrated in Photo 4 and Photo 5 below. Unlike the upstream site, Waitangi 1 is characterised by a mixed bottom constituted by soft material including silt and sand but also hard material including cobble, boulder and bedrock. The surrounding land-use is lifestyle, riparian canopy cover is average and livestock do not have access to the river. The MCI score difference suggests degradation has occurred between the two sites. Water quality trend analysis (available in a separate report in early 2013) – found that phosphorus levels are increasing in the river. This could be explained by on going sediment discharges from a large slip higher up in the catchment and bank erosion. Despite this the site has been moving from marginal to sub-optimal habitat quality. Habitat stability at Watea is also different from the upstream site as the river bed and banks are composed of more stable material and are less prone to degradation.

Photo 4: Waitangi (2) River at Waimate

Photo 5: Waitangi (1) River at Watea

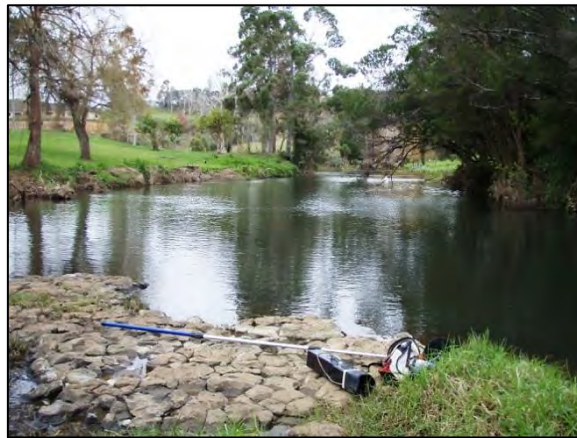
The river channel is characterised by a hard bottom of bedrock, boulders and cobbles. The surrounding land-use is a mix of native scrub, lifestyle and urban areas, and there is no livestock accessing the river. Riparian canopy cover is average as illustrated in Photo 6 below. A combination of poor hydrologic heterogeneity (lack of different habitat types, e.g. pools, riffles runs, etc.), aquatic habitat diversity and abundance and average riparian canopy cover could explain the low MCI score in 2012. Furthermore, the site is located at the bottom of the catchment meaning that water quality is likely to be poorer.

This site has remained within the good stability grade since it was first assessed in 2008.

Photo 6: Waipapa Stream at Waipapa Landing Bridge, upstream view

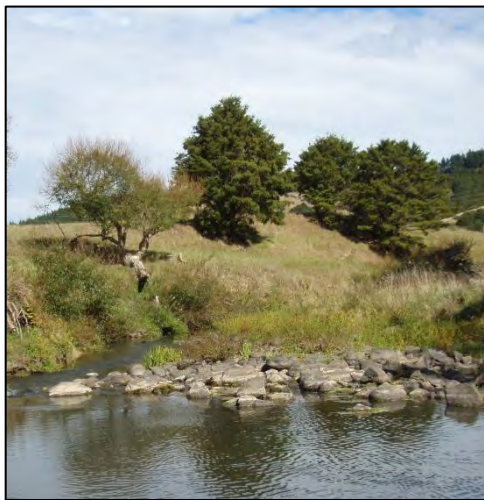
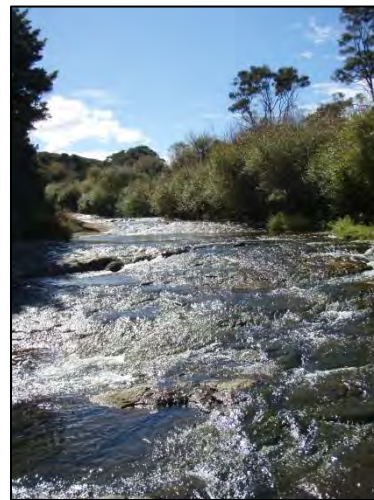
The river channel is characterised by a hard bottom of bedrock, boulders and cobbles. The surrounding land-use is a mix of plantation forest and pastoral activity, livestock have access to the river and riparian canopy cover is average (Photo 7 & Photo 8). Interestingly this site presents good hydrologic heterogeneity, aquatic habitat diversity and abundance which should support the development of a healthy macroinvertebrate community. However, other water quality indicators such as nutrients and sediment have negatively affected the MCI score.

The Hakaru River site has been moving from a sub-optimal to a marginal habitat quality between 2008 and 2010 and was again assessed with a sub-optimal habitat quality in 2012. Regarding its stability, it has always remained within the good stability grade since it was first assessed in 2008.

Photo 7: Hakaru River

Photo 8: Hakaru River, upstream view

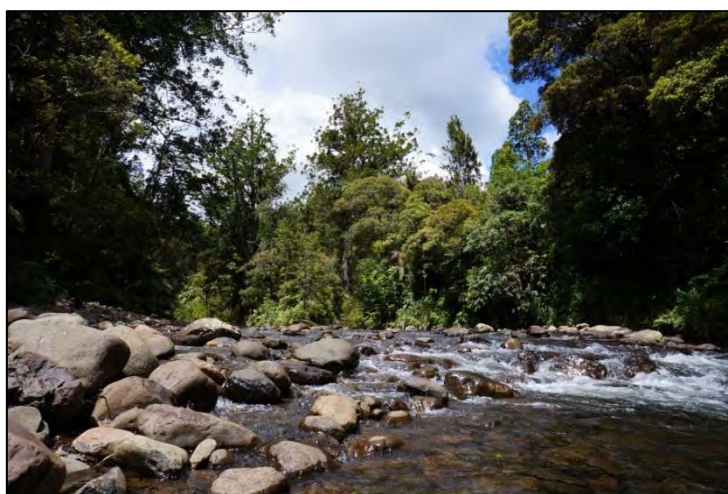
This river channel is characterised by a hard bottom of bedrock, boulders and cobbles. The surrounding land-use is dominated by native forest including Kauri trees, livestock do not have access to the river and riparian canopy cover is excellent (Photo 9). The Waipoua River is considered a reference, or “control” site in Northland as it is the closest site to a natural state, i.e. pristine, without human modification.

The Waipoua River has remained within the sub-optimal/optimal habitat quality grade since it was first assessed in 2005. Its stability has also remained within the good to excellent grade since 2005.

Photo 9: Waipoua River, upstream view
