DETAILED SITE INVESTIGATION AND GEOTECHNICAL ASSESSMENT [HW]

Geoenvironmental Appraisal

1 Richard Street, Opuia

Doug's Opuia Boat Yard Limited

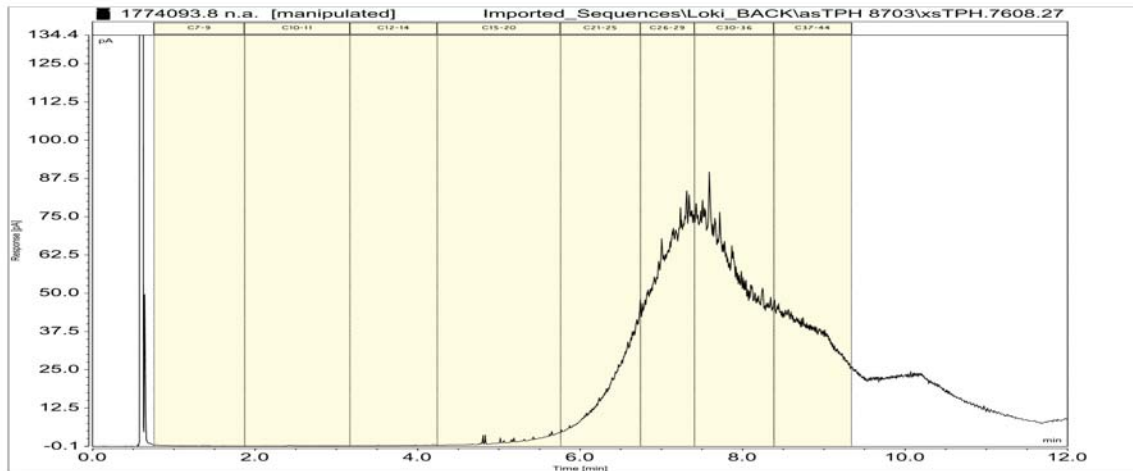
1774093.8
17 115-ES8 09-May-2017 10:30 am
Client Chromatogram for TPH by FID

Two samples recorded elevated concentrations of PAHs above the relevant SCS derived from Toxic Equivalence Factors (TEFs). These samples included ES8 at the site of localised staining at the winch and ES15 between the winch and existing boat shed structure. In comparison to the TPH chromatogram for sample ES8 (presented within Appendix H), a lubricating oil product of approximate SAE-30 grade can be identified. This is in line with the localised, historic applications to the winch and ground surface staining.
