# River water quality and ecology in Northland

State and trends 2007-2011

Putting Northland first

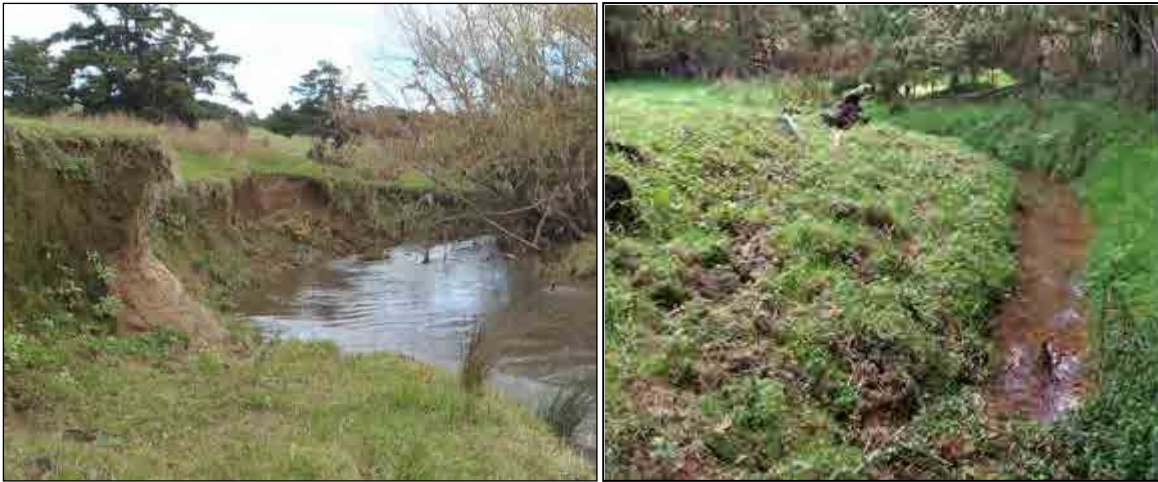
**Figure 14: Slumping banks and pugging of stream banks by cattle increase sediment loads at the Waitangi River, Waimate Road site (left) and a tributary of the Mangahuru River (right).**

When compared to the ANZECC guidelines for turbidity, eighteen (50%) of the 36 RWQMN sites failed the guideline (Table 4). Likewise all upland forest sites and lowland forest sites and 63% of all lowland rural sites had visual clarity below the national median (Table 6). The majority of these sites are located in areas where the underlying geology is deeply weathered soft sediments and very prone to erosion. The unstable nature of the geology combined with Northland's high rainfall means that many of the region's rivers are more vulnerable to erosion issues brought about by human activities than in other areas of New Zealand. Land clearance, wetland drainage and poor land management practices have resulted in a substantial increase in sediment loads to waterways compared to rivers in a natural state. Many rivers in Northland are deeply incised with unstable banks which frequently slump sediment into the river channel. These bank slumping blocks can 'bleed' fine sediment even at low flows, reducing visual water clarity and impacting in-channel habitat for aquatic animals (R Davies-Colley, pers comm. 12 March 2014). This process is exacerbated by livestock access, which causes pugging and accelerated erosion (Figure 14).

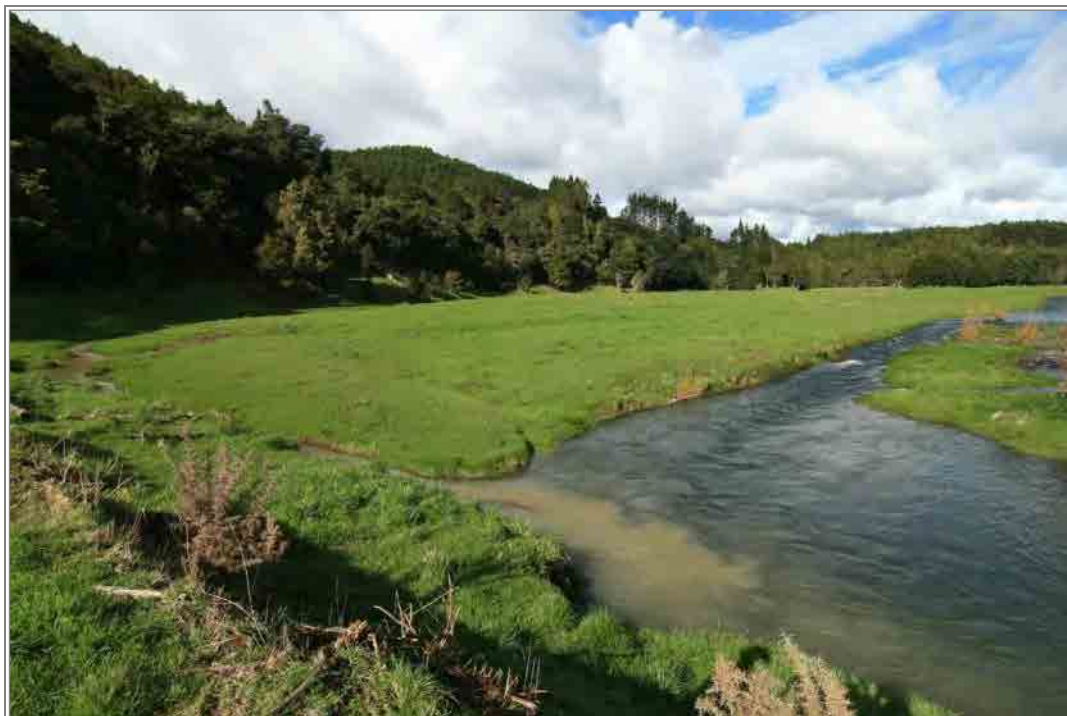
**Figure 15: Sediment running out of a harvested forest catchment into the Opouteke River.**

Runoff from earthworks and forestry harvesting are also known to increase sediment loads to rivers with the effects of these activities potentially more extreme due to Northland's seasonal rainfall and layer clay soils. Fine sediment causes degradation of aquatic habitat for invertebrates and fish, smothering food sources, reducing habitat availability and impacting on the hunting ability of visual feeders (Clapcott *et al.* 2011). Although there is insufficient data to assess the status of the fish fauna at these locations, all sites with poor visual clarity and higher levels of deposited sediment had correspondingly degraded macroinvertebrate communities.

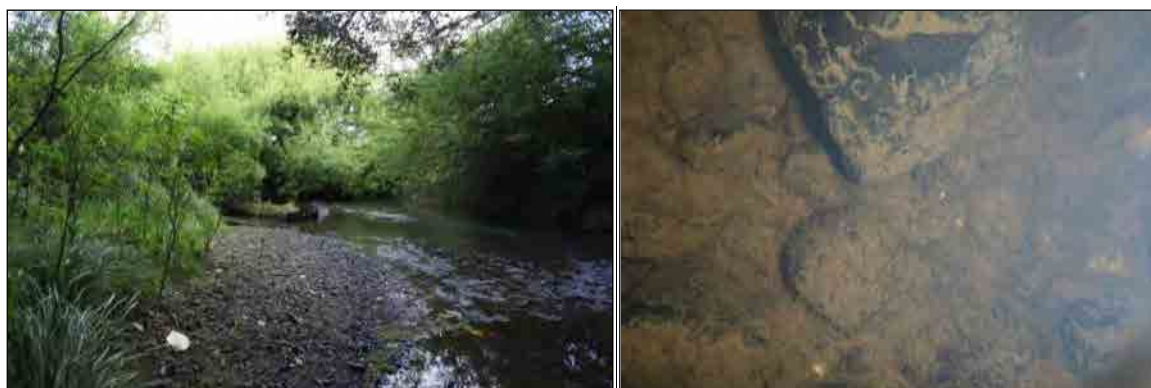
**Figure 16: High sediment deposition and low light conditions under riparian shade vegetation can restrict periphyton growth [Ruakaka at Flyger Road].**

The occurrence of elevated nutrient levels (particularly nitrogen) is associated with nuisance periphyton growth that can degrade ecosystem health and other instream values such as contact recreation and aesthetics (Kilroy *et al.* 2008). Periphyton records for the Northland region are limited but the data which is available confirms that corresponding with low nitrogen levels, most RWQMN sites tend to have low algal biomass, well below the guidelines for 'clean water' macroinvertebrates (Biggs 2000). Those sites with elevated nutrient levels have no periphyton data due to the muddy substrate being unsuitable for periphyton growth. The exception is Ruakaka at Flyger Road which historically has low levels of periphyton growth. However this site is within a bush remnant with low light conditions and poor visual clarity which is likely to be limiting periphyton growth (Figure 7).

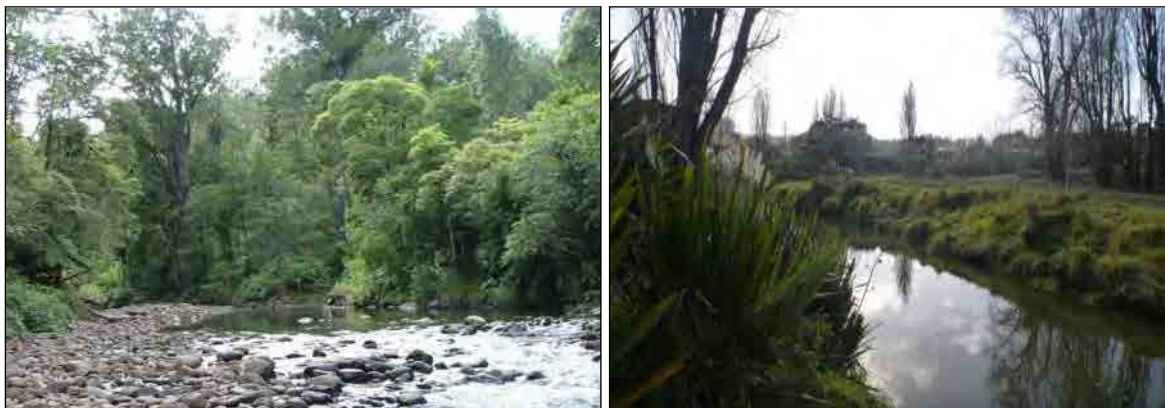
**Figure 20: Waipoua River (left) has good quality habitat and a correspondingly good MCI. The Paparoa River (right) is channelised with poor habitat quality and a poor MCI.**

Habitat quality, along with water quality, is strongly aligned with ecosystem health. Where there is a diverse habitat available with a variety of flow types (runs riffles and pools) and good quality riparian vegetation/cover, there tends to be high ecological health (MacGibbon and Tipa 2001) and a diverse, healthy macroinvertebrate population (Stark 2011). For example the Waipoua Forest at SH12 has optimal habitat with stable, dense native riparian margins, a variety of habitat types and an excellent Macroinvertebrate Community Index (MCI). The Paparoa at Walking Bridge, on the other hand, has marginal habitat, no cover/shade, unstable banks, is channelised with very little habitat diversity and has a poor MCI score (Figure 20). Good riparian cover also provides shade, limiting periphyton cover and restricting temperatures in hot summer months. The maximum spot temperature reading at Waipoua between 2007 and 2011 was 19.9°C compared to 24.3°C at Paparoa, close to the critical 25°C upper limit for many fish and invertebrate species.

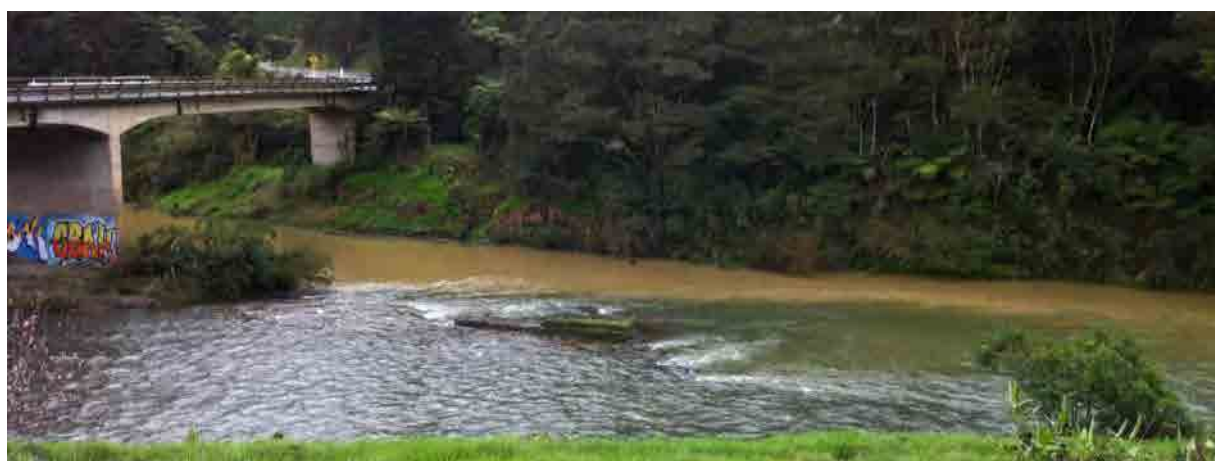
**Sediment flowing into the Mangakahia from the Awaroa River (a catchment where there has been recent pine harvesting)**

The habitat assessment is inconsistent with the WQI scoring the site as sub-optimal. The surrounding land use is native and exotic forest, there is a high level of shading from native cover (40%) and livestock do not have access to the site. However, the banks are unstable, and there is evidence of quite high sediment loads, with much of the substrate being made up of silt/sand which is likely to be associated, at least in part, with forest harvesting.

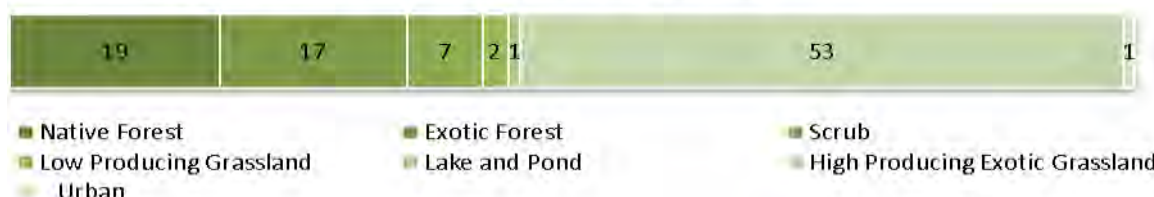
#### Percent land use upstream of Punakitere a Taheke (32541)

The Punakitere River originates from a wetland to the southwest of Kaikohe and is a major tributary of the Waima River (which flows into the Hokianga Harbour). The catchment is predominantly agricultural land use with an underlying geology of soft sediments.

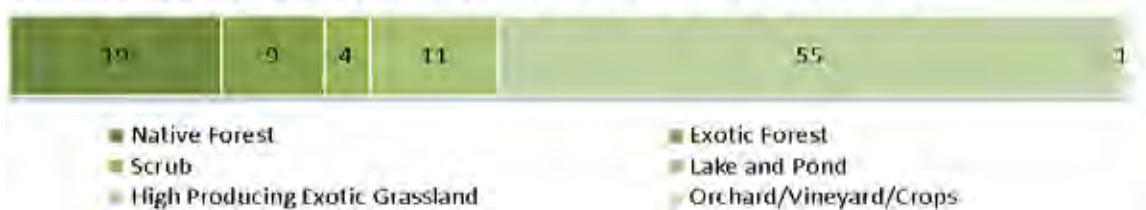
**Percent land use upstream of Utakura @ Okaka Road Bridge (11693Ha.)**

The Utakura River is fed by Lake Omapere, to the north of Kaikohe, and flows west into the Waihou River arm of the Hokianga Harbour. The catchment is dominated by farmland with areas of native forest, pine forest and manuka scrub.
