Ruakākā Solar Park Development

Ecological Effects Assessment
Prepared for Meridian Energy Limited

28 August 2023

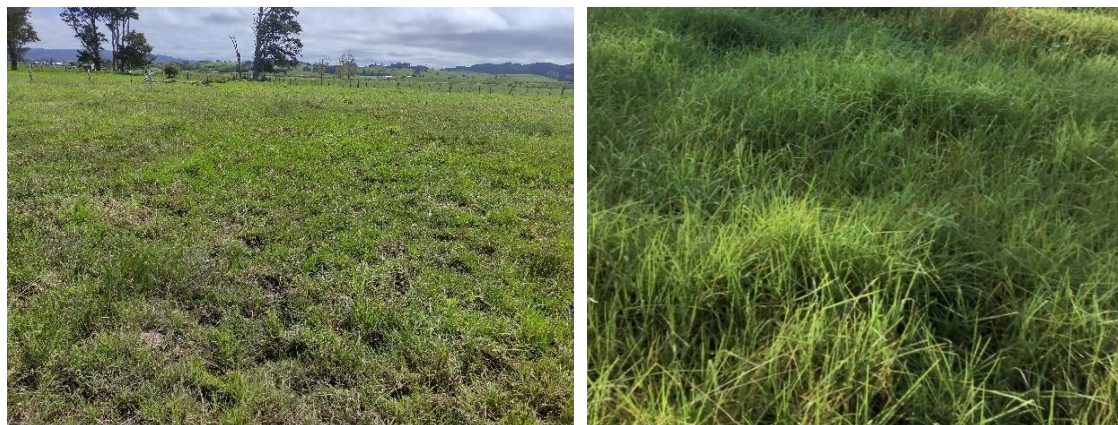
Figure 3: Grazed exotic pasture in Site 3, typical of all grazed grassland areas, and kikuyu dominated grass sward in Site 1A in May 2022

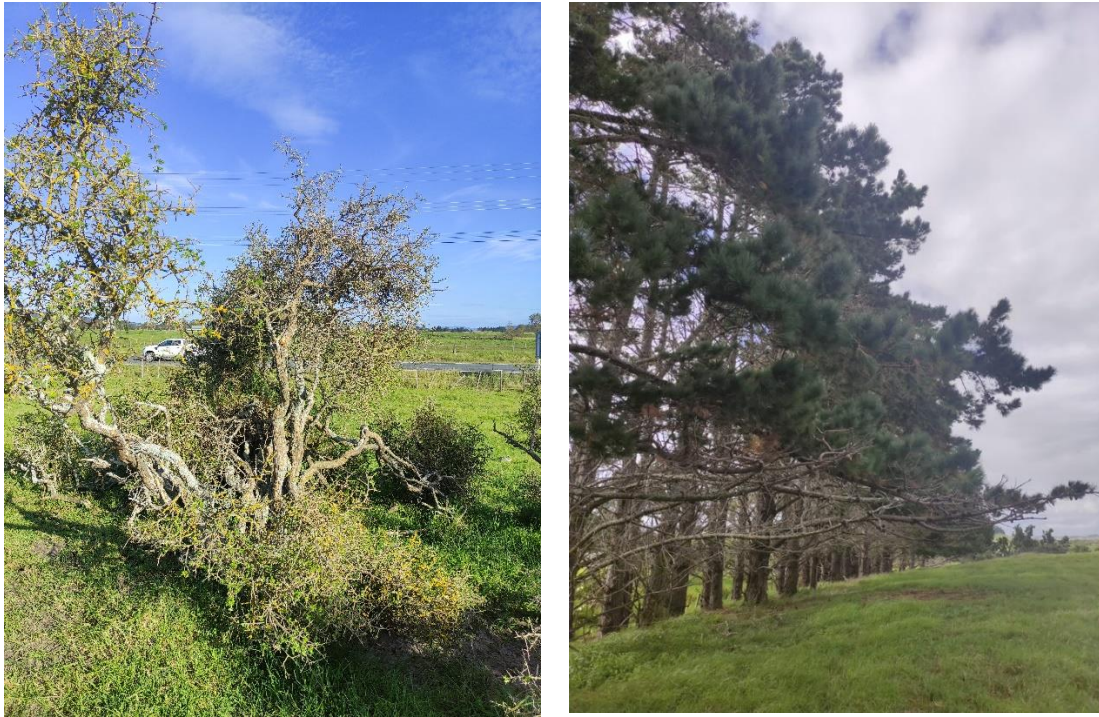
Figure 4: Patch of boxthorn on Site 1B (left) and pine shelterbelt found at Northern corner of site 2 (right).

Small patches of exotic scrub are found throughout the sites, mostly dominated by gorse (*Ulex europaeus*) and boxthorn (*Lycium ferocissimum*) (Figure 4). Within Site 3, scrub borders drainage channels to the south of the site, and around a constructed farm pond to the east of the site. Kanuka (*Kunzea ericoides*), manuka (*Leptospermum scoparium*), harakeke (*Phormium tenax*) and gorse are the main species present, with kikuyu (*Cenchrus clandestinum*) as the dominant ground cover. A stand of large (>20m) pines and patch of sparse gorse scrub is present at the northern end of site 2. Invasive species found within scrub patches, predominantly within Site 1A but also ungrazed areas of Site 1B, 1C and 2, include arum lily, madeira vine, Sydney golden wattle and black wattle.

A mature pine shelterbelt is found between Site 1A and 1B and on the northern corner on Site 2 (Figure 4).

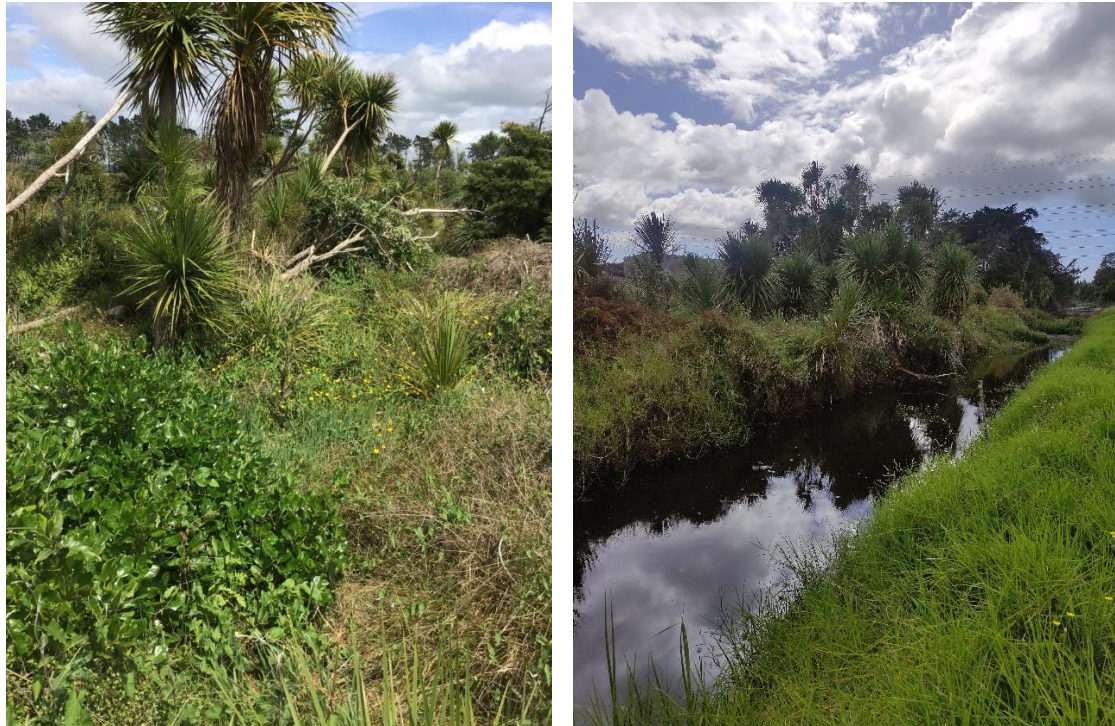
Figure 7: Mix of native and exotic riparian vegetation on northern side of Bercich Drain in Site 1A.

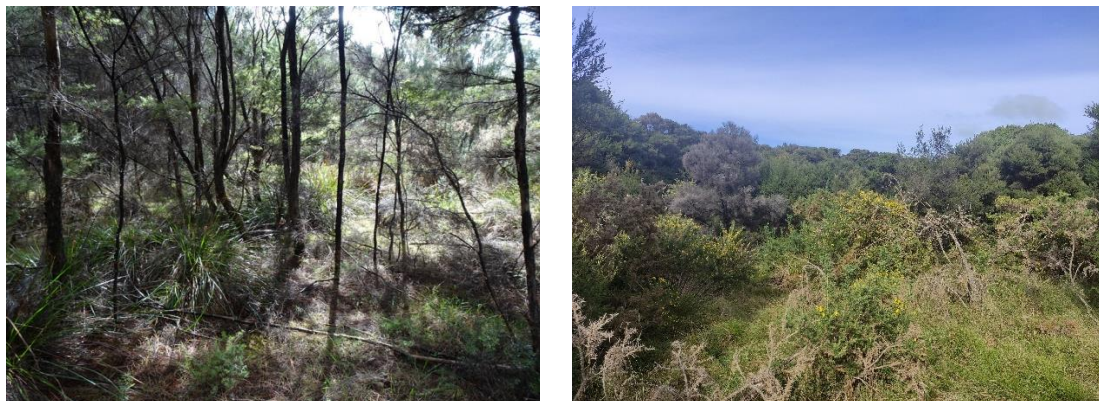
Figure 8: Kanuka (*Kunzea ericoides*) dominated shrubland on Site 1A, showing sparse understorey (left) and transition from kanuka to gorse shrubland (right).

K. ericoides (5 – 8m tall) forms an open canopy with minimal understorey (Figure 8), and a ground cover of meadow rice grass (*Microlaena stipoides*) and bracken (*Pteridium esculentum*). The bush margin is fairly well-defined, with an abrupt transition to gorse-woolly nightshade scrub on the landward side.

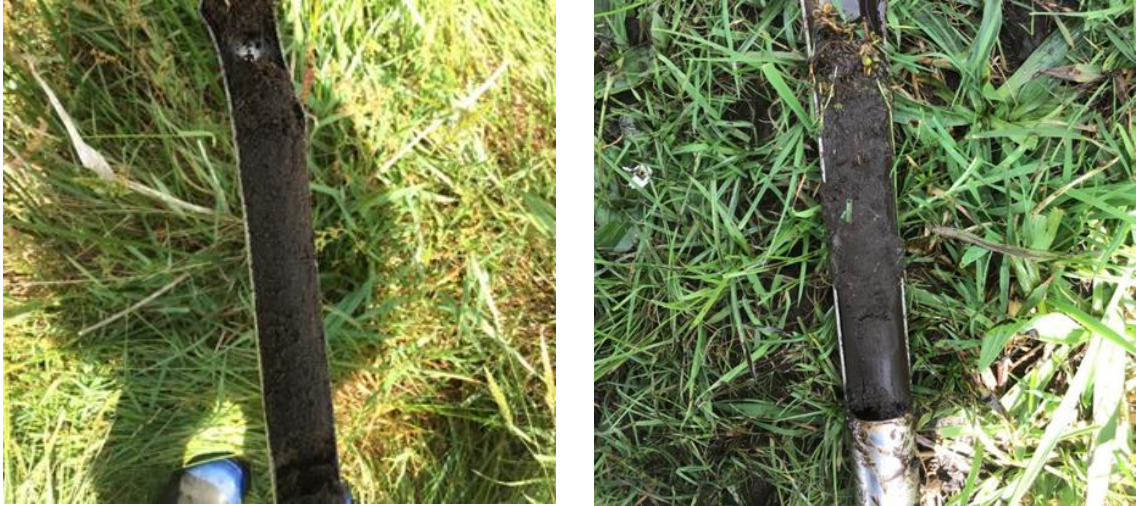
Figure 9: Soil core samples taken on Site 1 in October 2021, showing peat and sand composition

Ground conditions on site 1 consisted of topsoil (from 0.05 m to 0.4 m), peaty sand (from 0.1 m to 0.4 m) (Figure 9) and sand (from 0.1 m to 1.5 m). While the soils on Sites 2 and 3 were characterised by approximately 20-30 cm of topsoil over 10 -15 cm of peaty sands, with saturated peaty soils present to the surface in low-lying depressions in November 2022 (Figure 10).

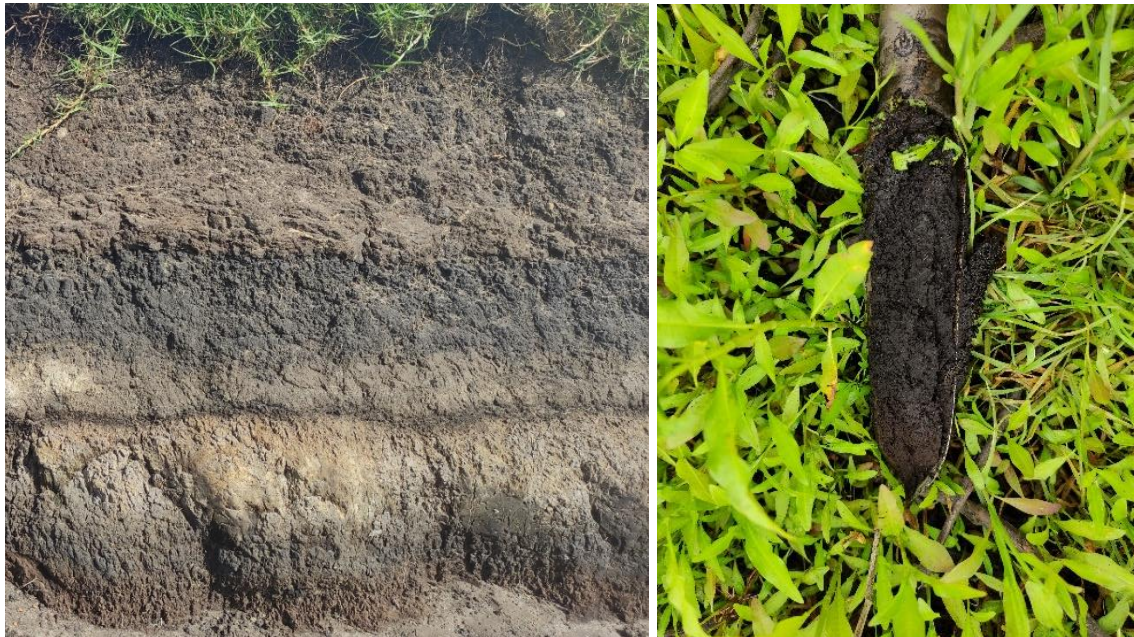
Figure 10: Soil profile on Site 2 (left) and soil core from low-lying depression in site 2, showing peat composition (right).

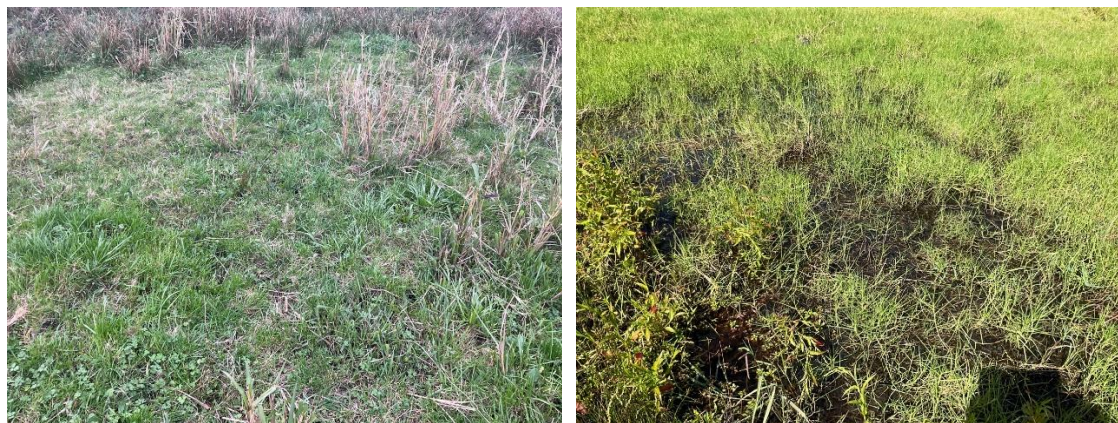
Figure 11: Pasture dominated areas; in Site 1C in June 2022 (left) and in Site 1B in March 2023 (right).

species, such as rye grass, kikuyu and clover (Figure 11). These areas failed the Dominance Test and Prevalence Index (refer to the plot data in Appendix 5), and therefore are not wetlands. These areas are shown as exotic grassland in Figures 6 and 7.

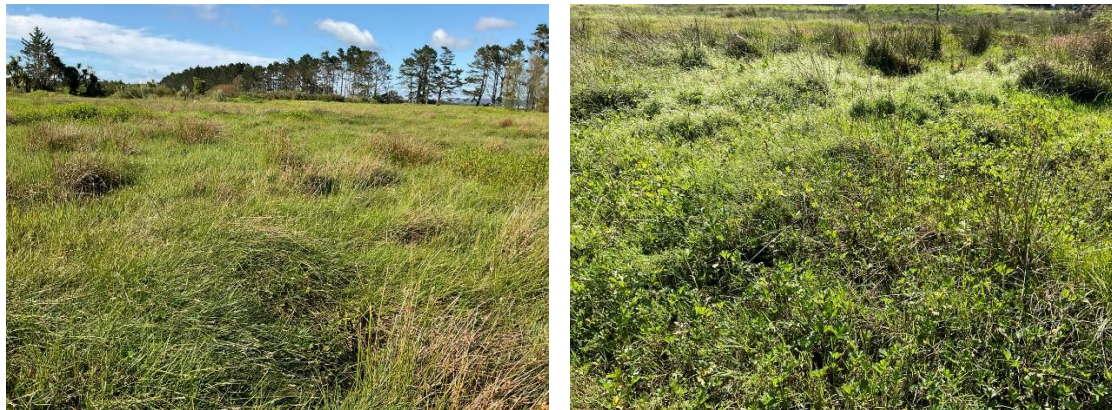
Figure 14: Broom sedge dominated area in Site 1A in March 2023 (left) and creeping buttercup and marsh bedstraw dominated area in March 2023 (right).

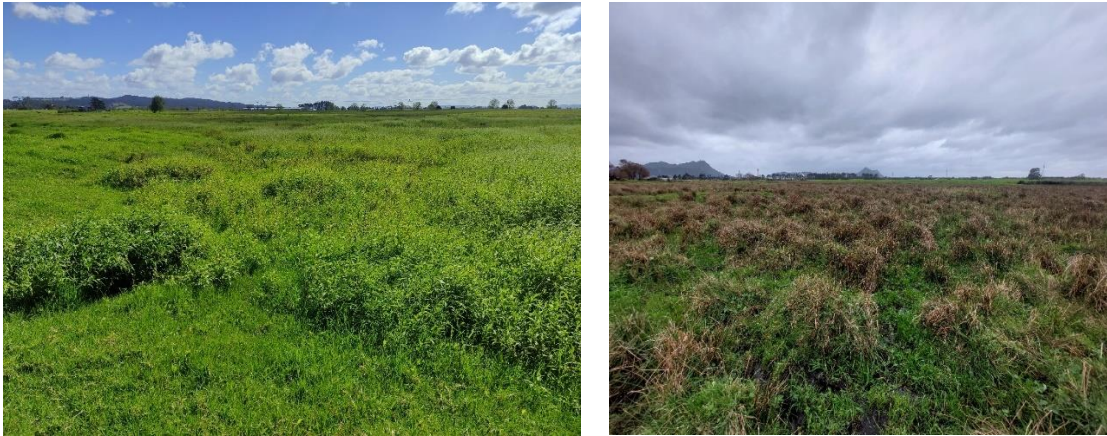
Figure 15. Water pepper dominated wetland in Site 1B in March 2023 (left) and soft rush, mercer grass and creeping buttercup wetland in Site 1C in June 2022 (right)

The exotic wetlands in Site 1B were typically dominated by water pepper and/or mercer grass, whereas in Site 1C they were mostly dominated by soft rush and mercer grass with localised patches of water pepper (Figure 15). The water table was at or above ground surface in June 2022 and March 2023, with water pooling and severe pugging throughout low relief areas.

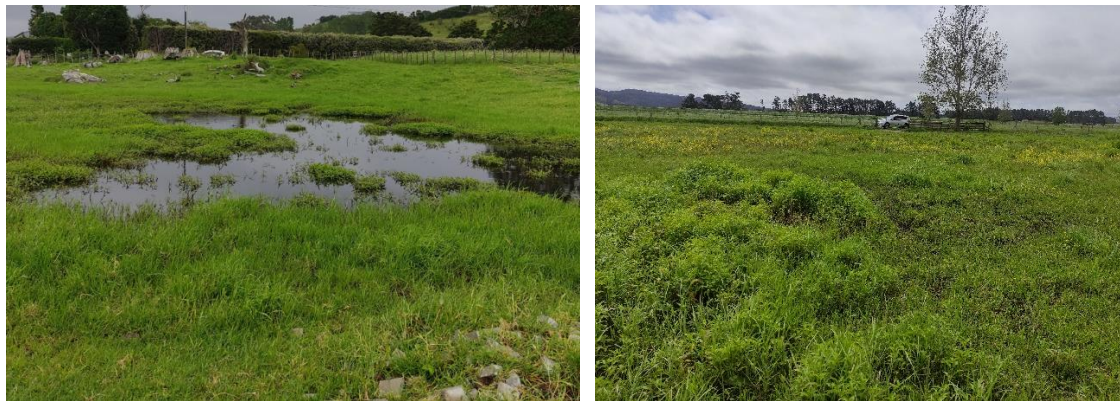
Figure 16: Small water pepper dominated wetlands typical of wetland features present on Sites 2 and 3.

There were very few wetland features in Sites 2 and 3 (Figure 13). Found in low-lying depressions, they were all small, ranging in size from 30 to 570 m² and had either shallow water (< 30 cm deep) or saturated soil (Figure 16). They were mostly dominated by water pepper, with a mix of other exotic hydrophytic species present, such as Yorkshire fog, creeping buttercup, mercer grass, alligator weed (*Alternanthera philoxeroides*), water starwort (*Callitriche stagnalis*) and umbrella sedge.

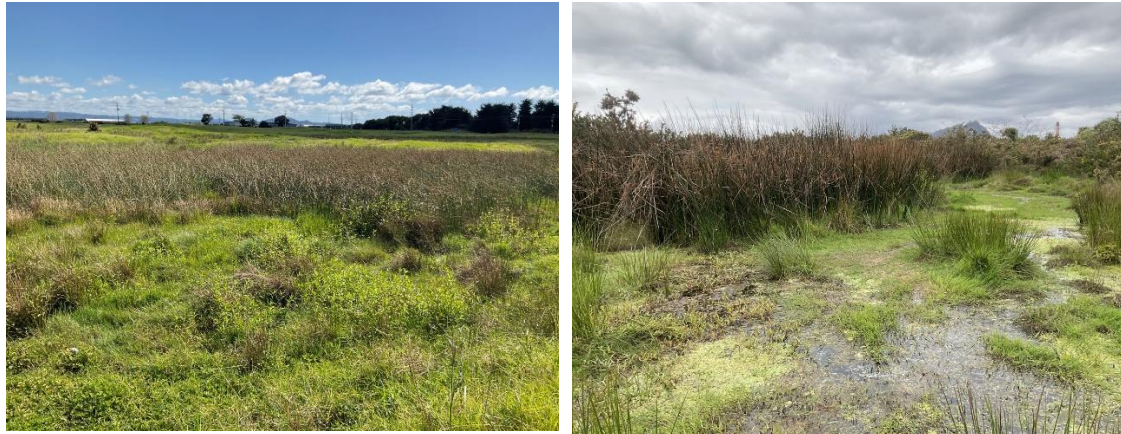
Figure 17: Kuawa patch near the BESS platform (left) and jointed twig rush patch near the kanuka stand (right).

The vegetation included large patches of rautahi (*Carex lesssoniana*), jointed twig rush (*Machaerina articulata*), baumea and kuawa, ranging in size from ~50 to 400 m². None of these species is threatened (de Lange et al., 2018).

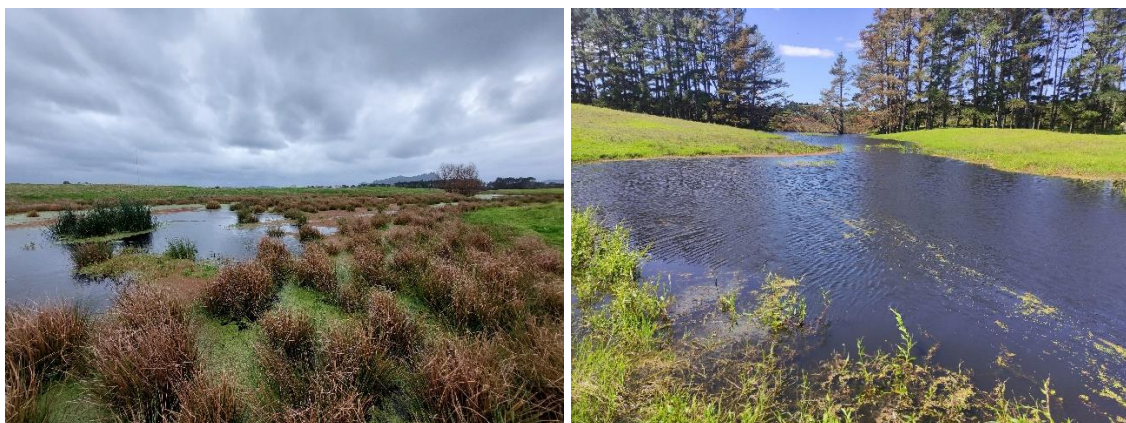
Figure 18. Area of open water pond habitat in Site 1C in June 2022 (left) and in Site 1B in March 2023 (right).

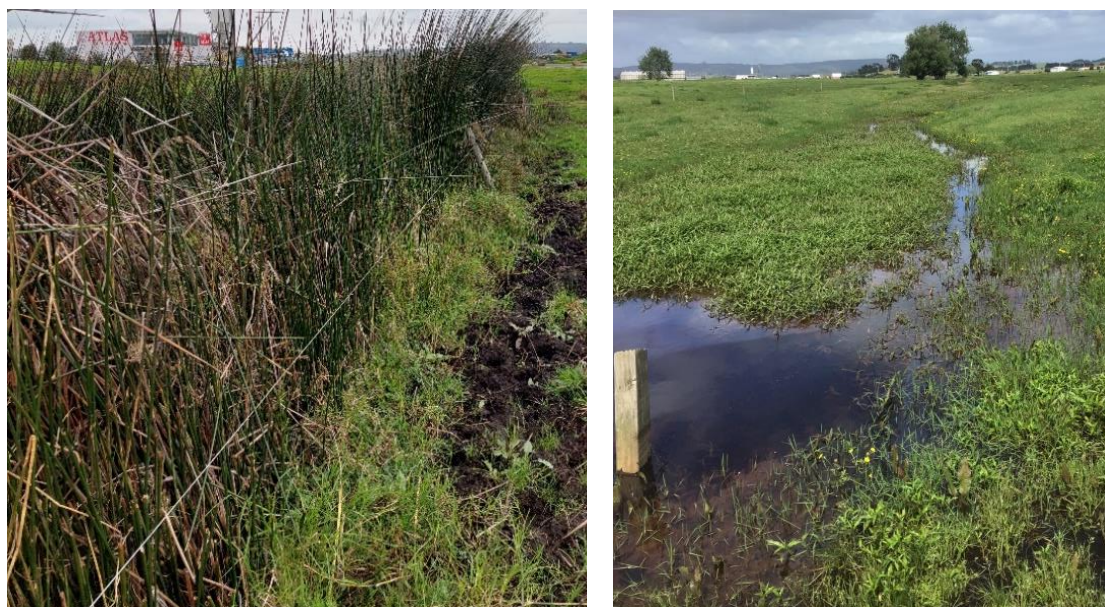
Figure 19: Kuawa patch in Bercich Drain in Site 1C (left) and water pepper and willow weed dominated reach through Site 1B and part of Site 1C (right).

Both Bercich Drain and the Unnamed Drain are soft-bottomed and macrophyte dominated, although they are likely to have vegetation cleared at times, to maintain drainage and prevent flooding. Both are straight narrow channels with reasonably shallow slow-flowing water (50 cm – 1 m deep). The width of Bercich Drain ranges from 4 - 5 m and the width of the Unnamed Drain varies from 2 – 2.5 m. The water was observed to be peat stained and turbid in both drains on most site visits.

Bercich Drain had a habitat quality score of 41.5 in Site 1A and 29 in Sites 1B and 1C. The Unnamed Drain had habitat quality score of 37.5. This indicates that these two watercourses have fair (moderate) quality and availability of habitat for freshwater invertebrates and fish in their current state.

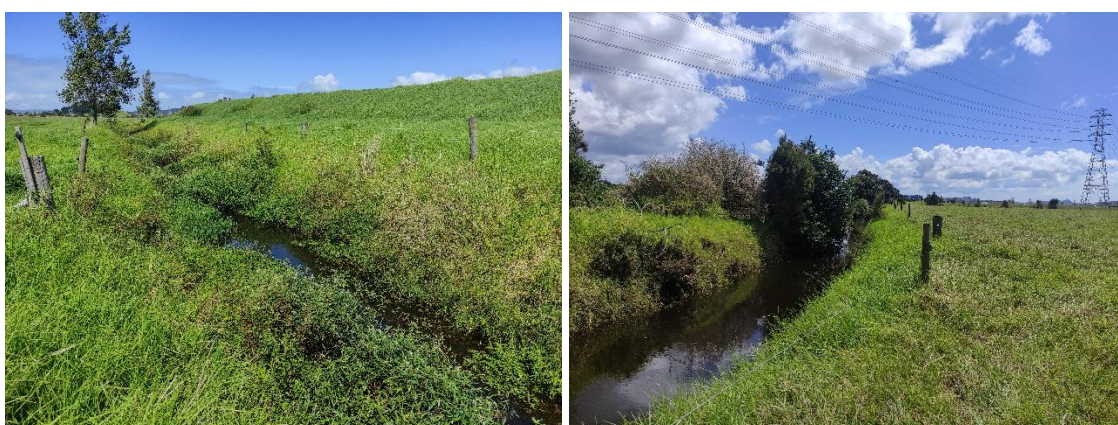
Figure 20: Northern end of the Unnamed Drain, showing macrophyte cover (left) and southern end of Unnamed Drain as it leaves the property, and flows under McCathie Road (right)

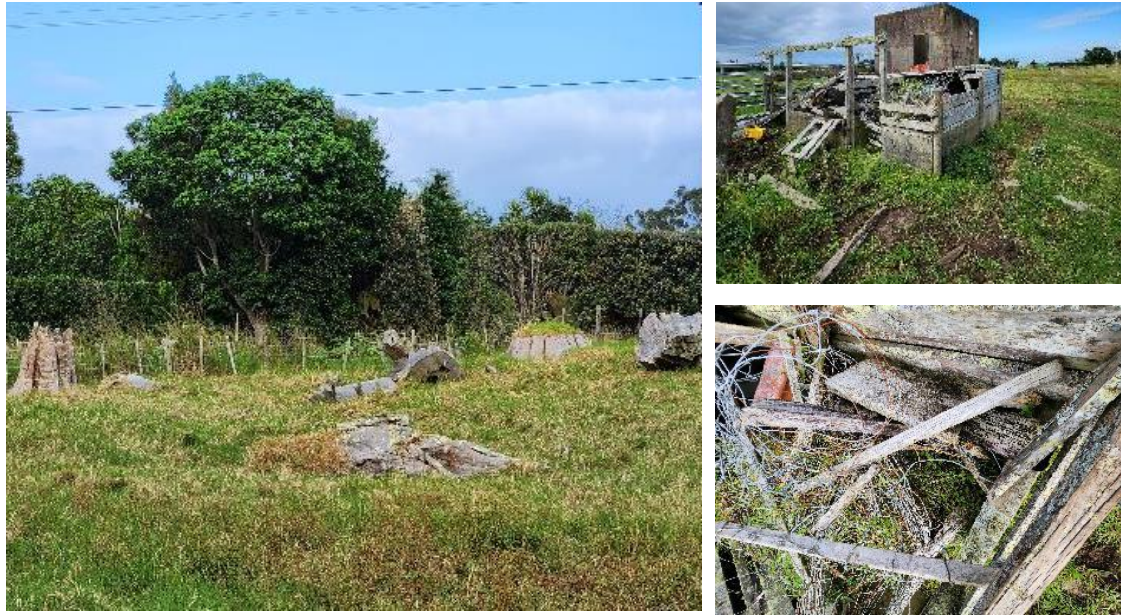
Figure 21: Felled pine debris left in-situ in Site 2, to break down provides good quality habitat to skinks if present (left) and old farm structure with rank weeds and rotting panels of wood that may offer habitat to copper skinks if present (right)

Site 2 is dominated by grazed pasture but also comprises areas of rank grassland, shelterbelts, occasional individual native trees, and some wetlands. A large patch of gorse shrubland is present in the northern end of the site, as well as around site boundaries. Woody debris from previously felled pine trees is present in the southern section of the site adjacent to McCathie Road, and an old-disestablished shed with rank weeds and broken, rotting timbers also provide potential complex habitat for skinks if present (Figure 21).

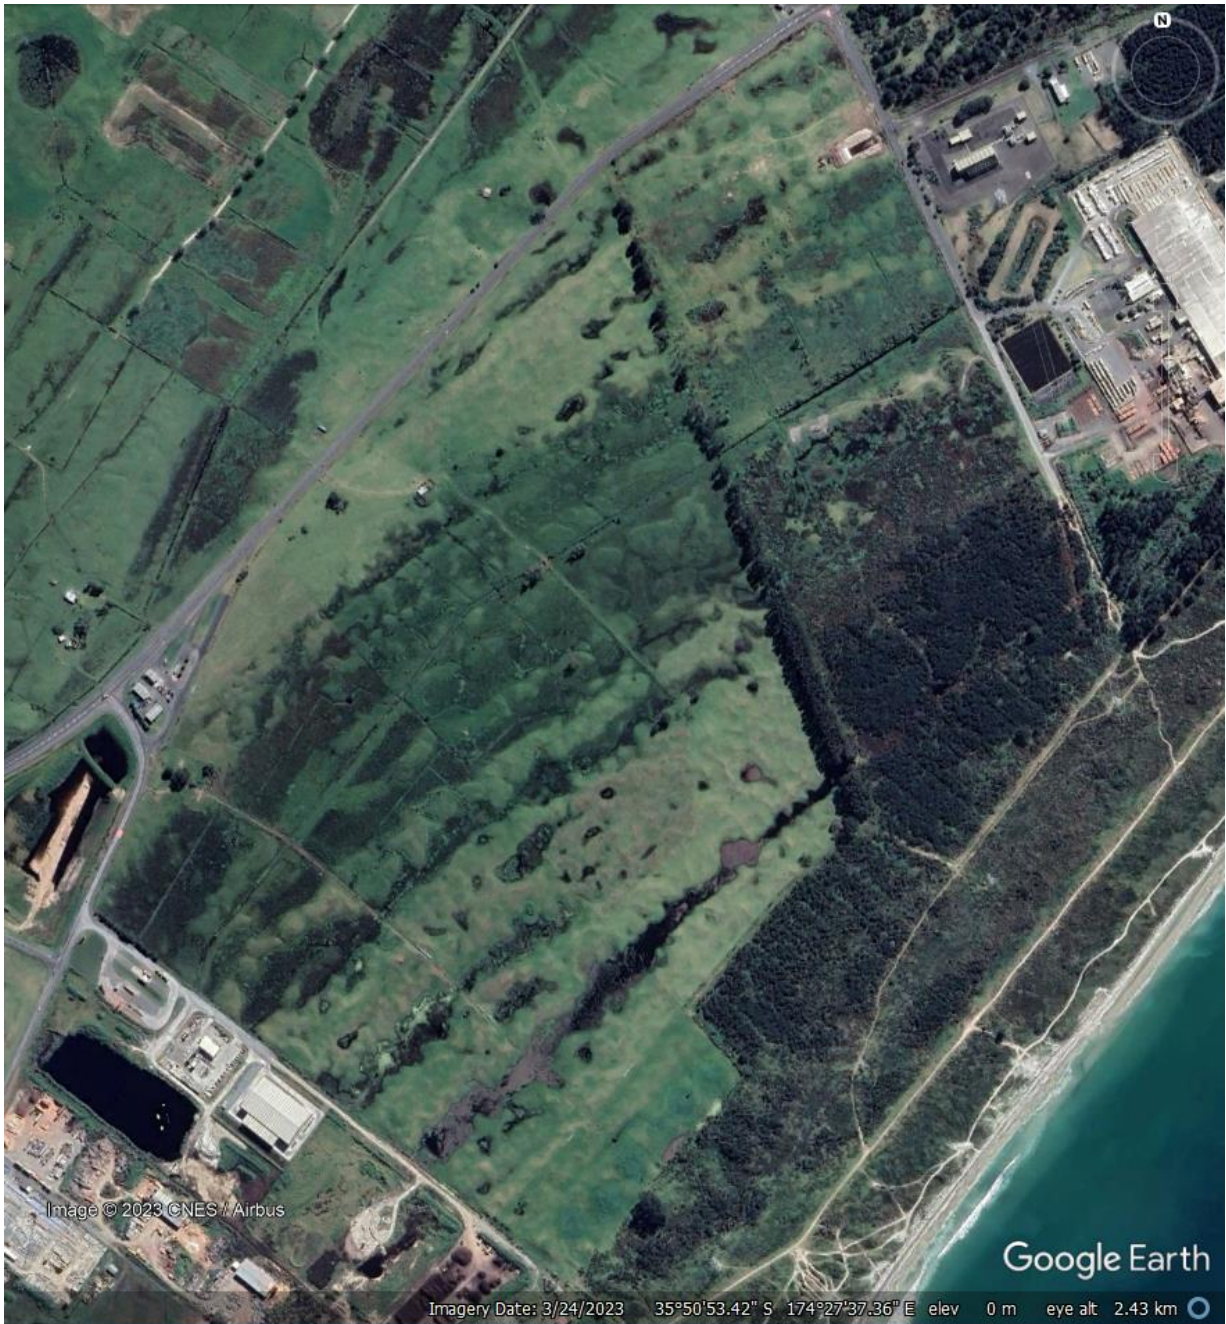
Figure 30: Most recent satellite imagery of Site 1, dated 24 March 2023. Source: Google Earth.

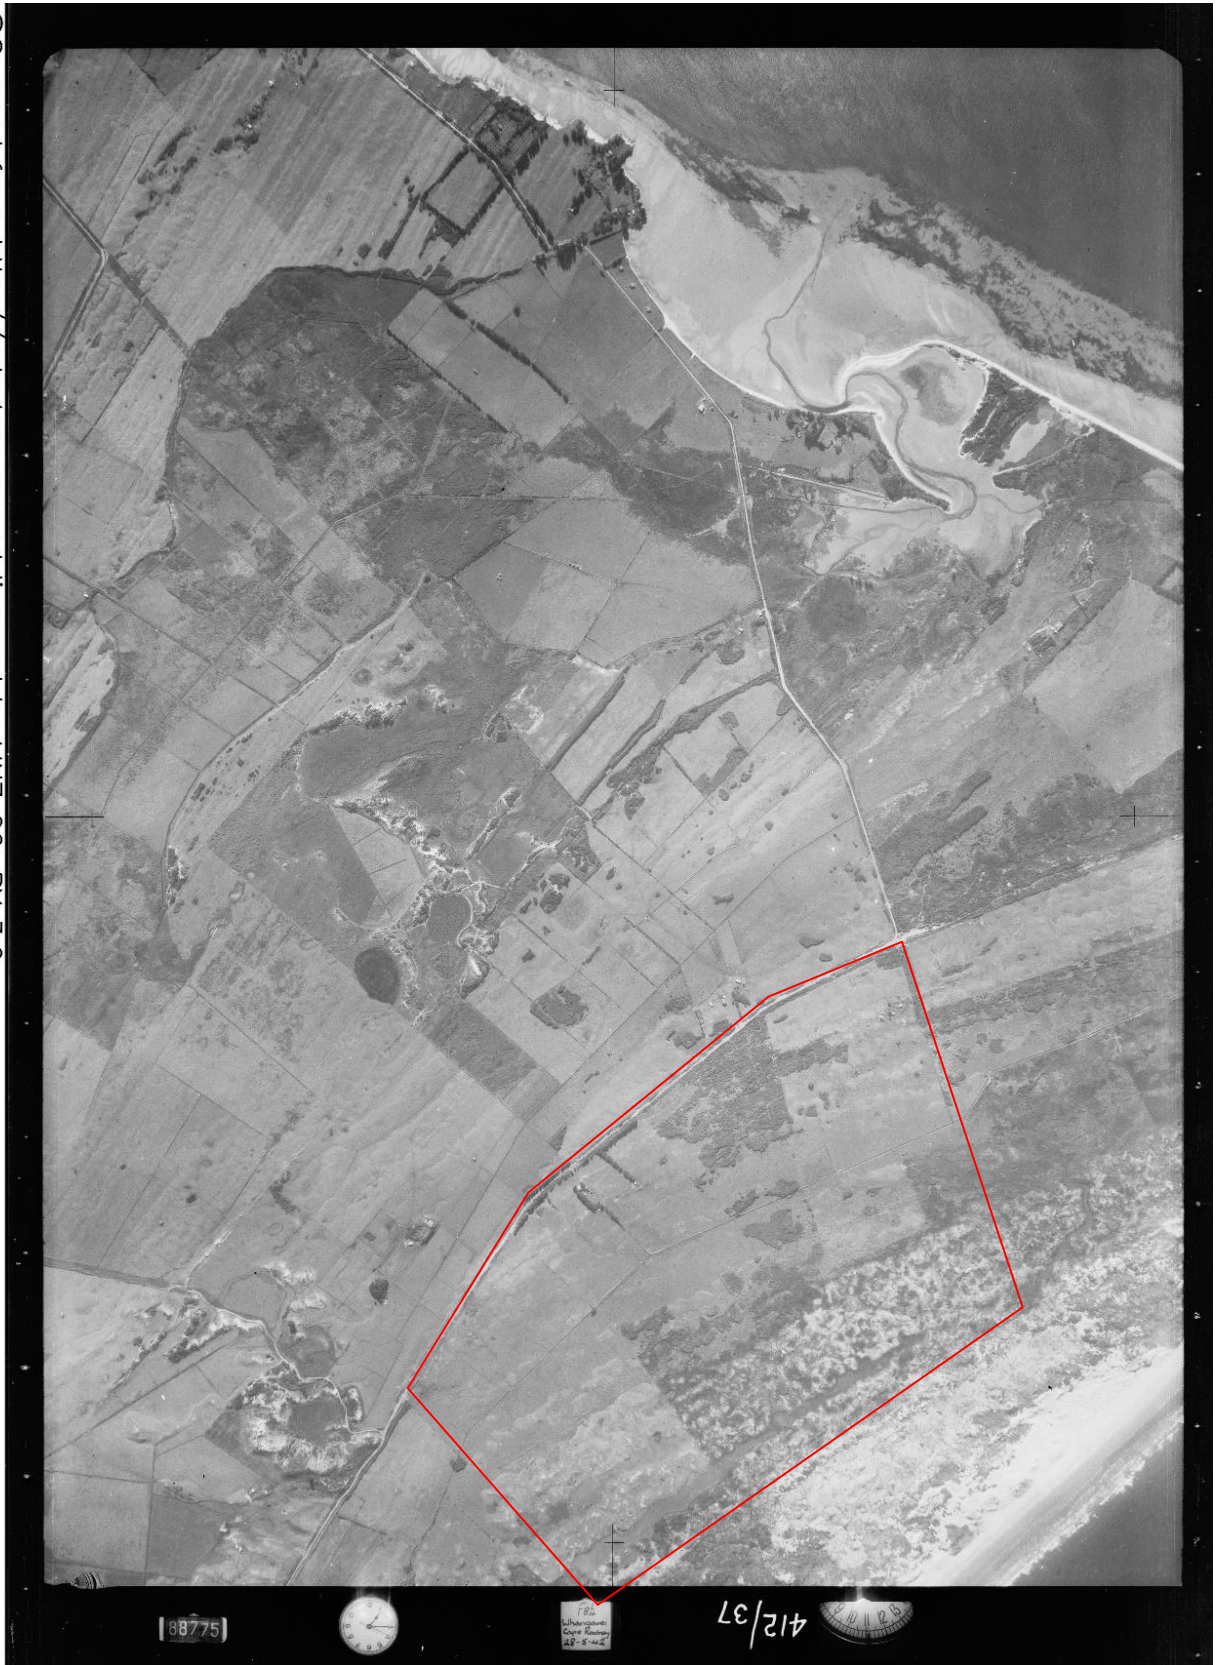
Figure 32: Aerial imagery of Marsden Point area, collected on 28 May 1942. Approximate Site 1 boundary shown in red. Source: Retrolens.nz.

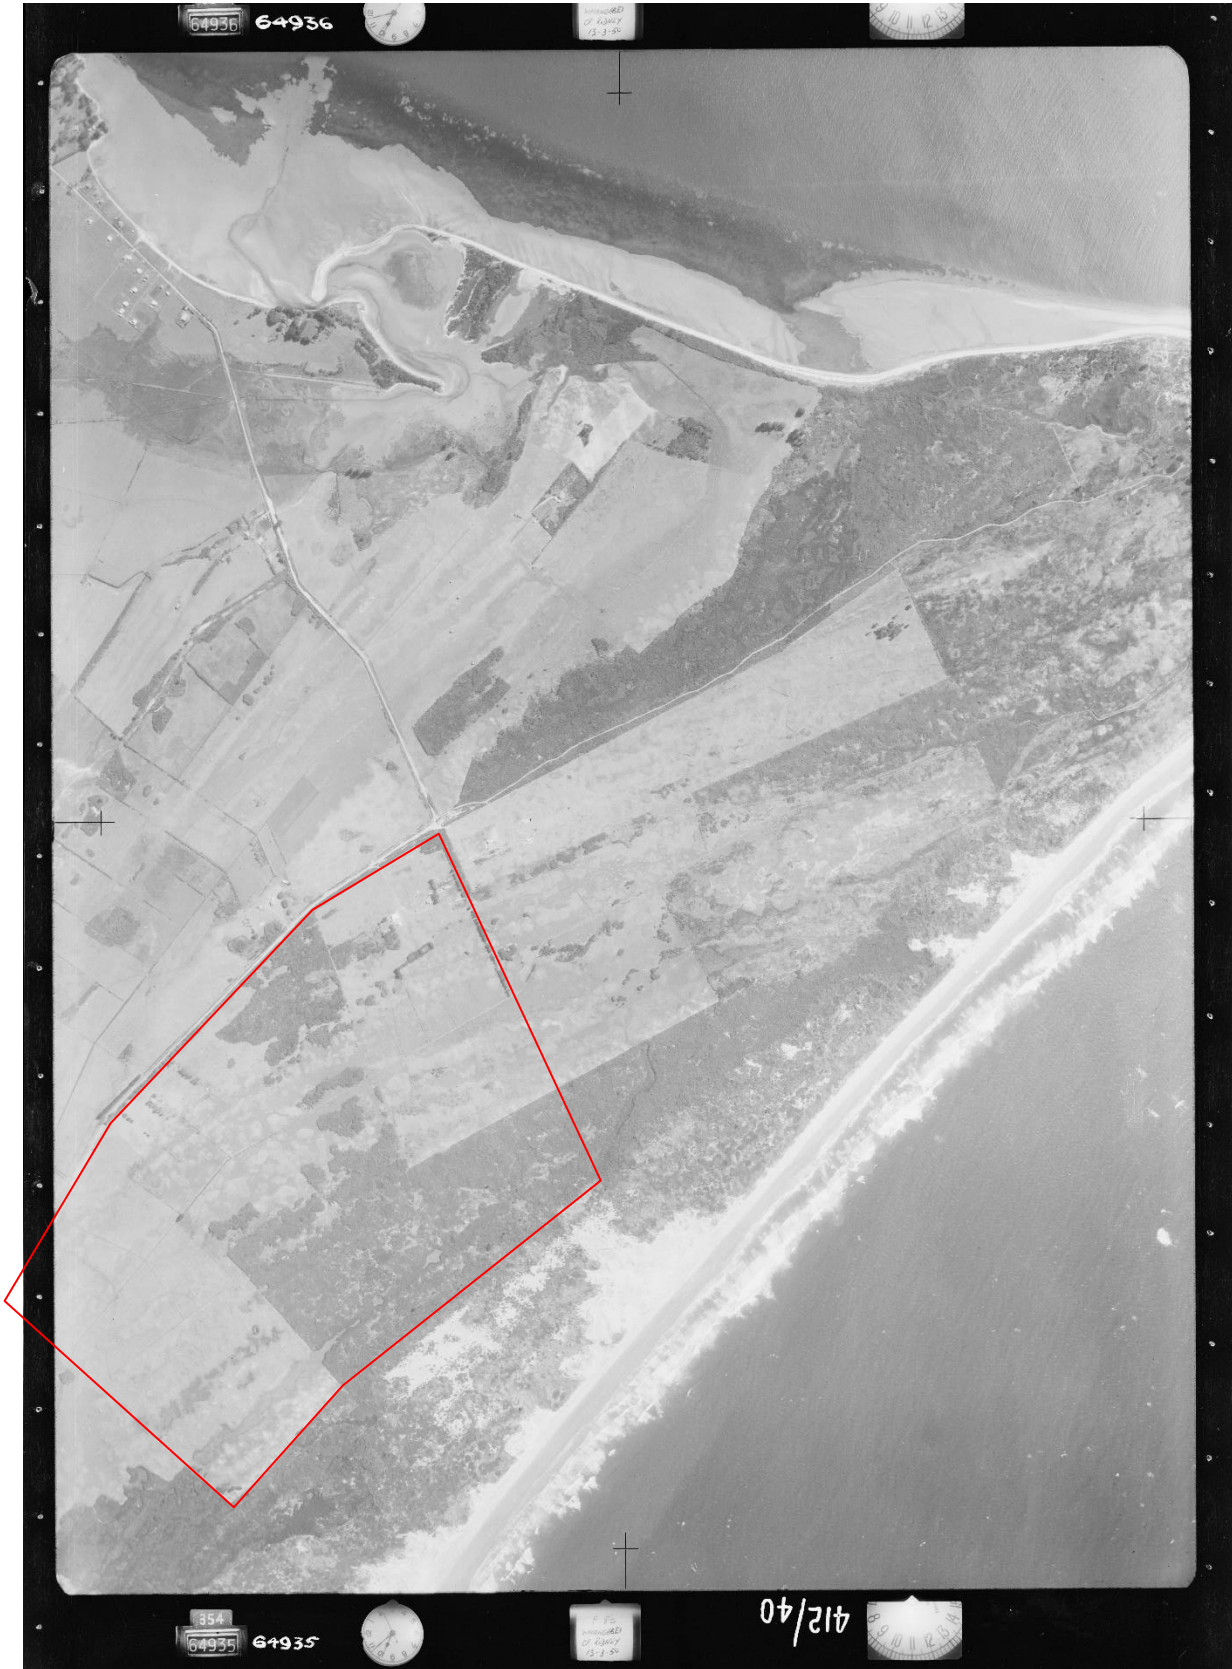
Figure 33: Aerial imagery of Marsden Point area, collected on 13 March 1950. Approximate Site 1 boundary shown in red. Source: Retrolens.nz

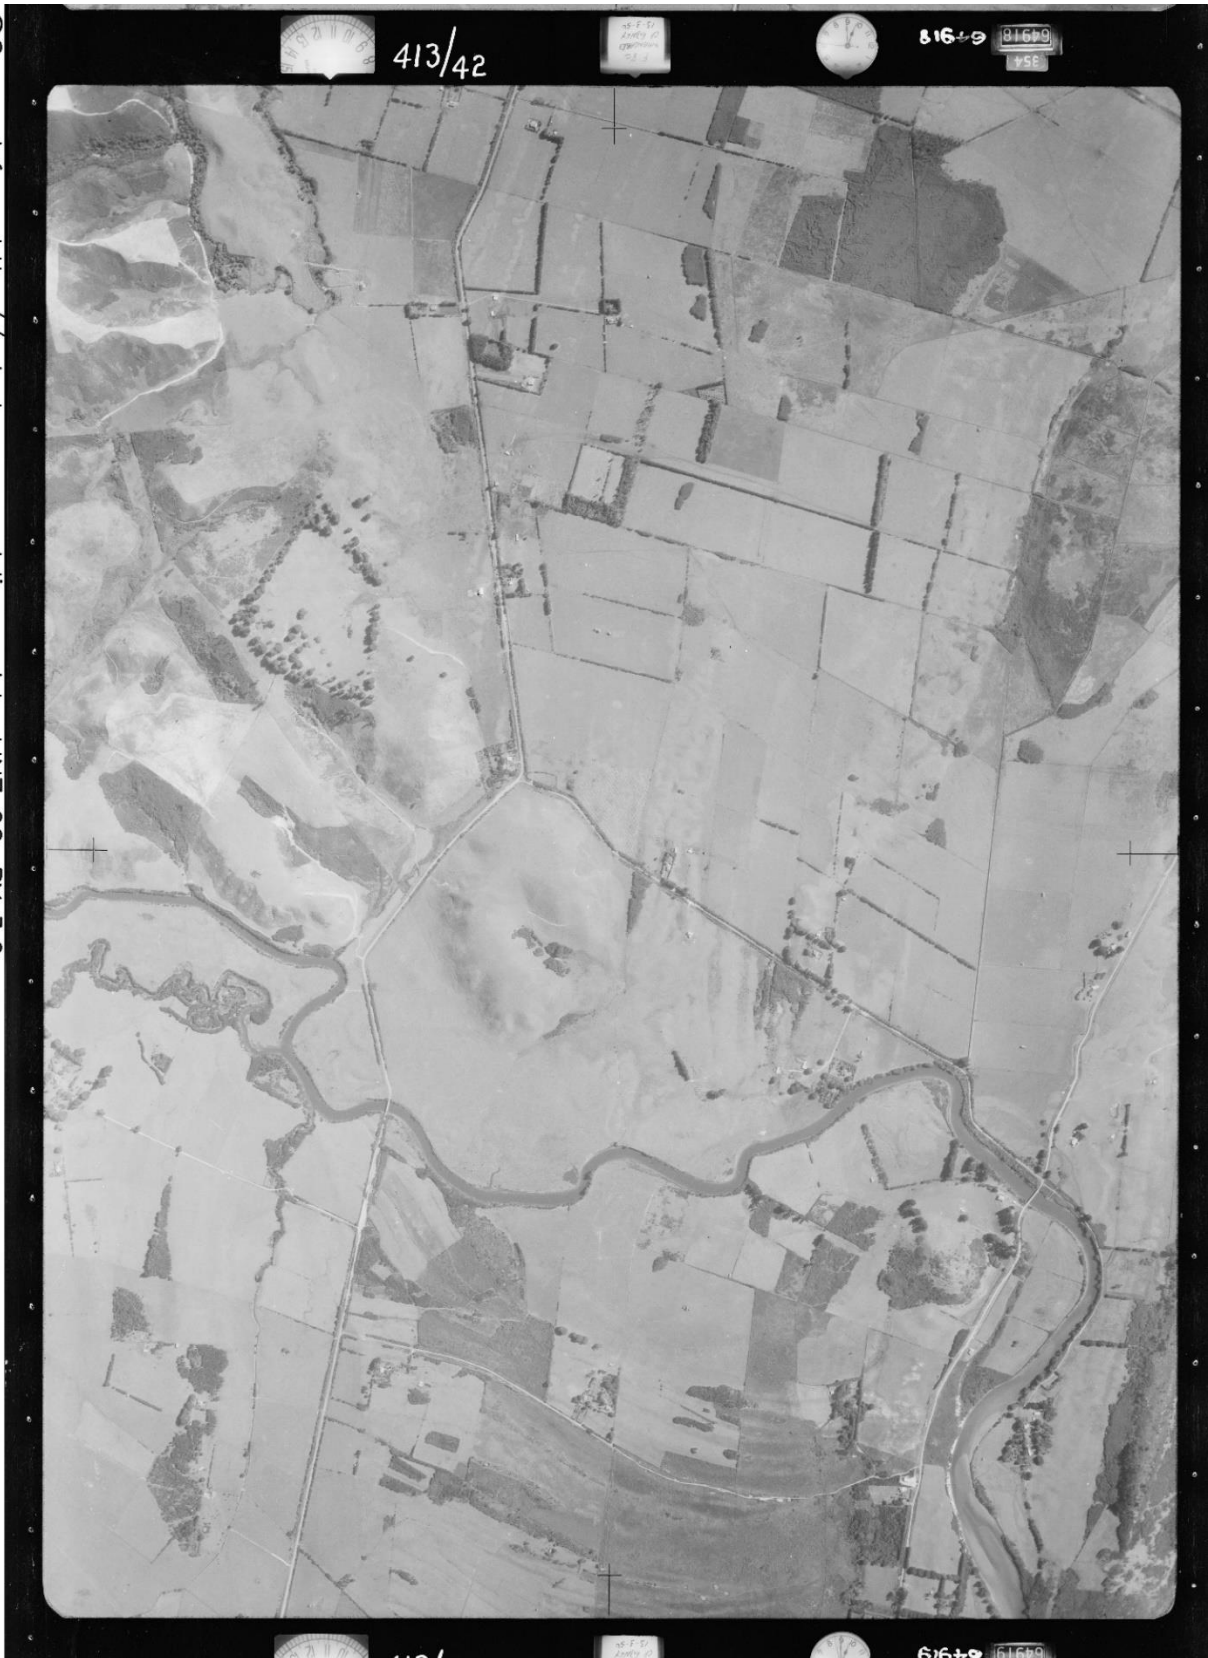
Figure 34: Aerial imagery of Marsden Point area, in location of Sites 2 and 3, collected on 13 March 1950. Source: Retrolens.nz
