## Poutō Peninsula

Wairere (Poutō), NRC Lake No. 339 & Round Hill Lake 2.

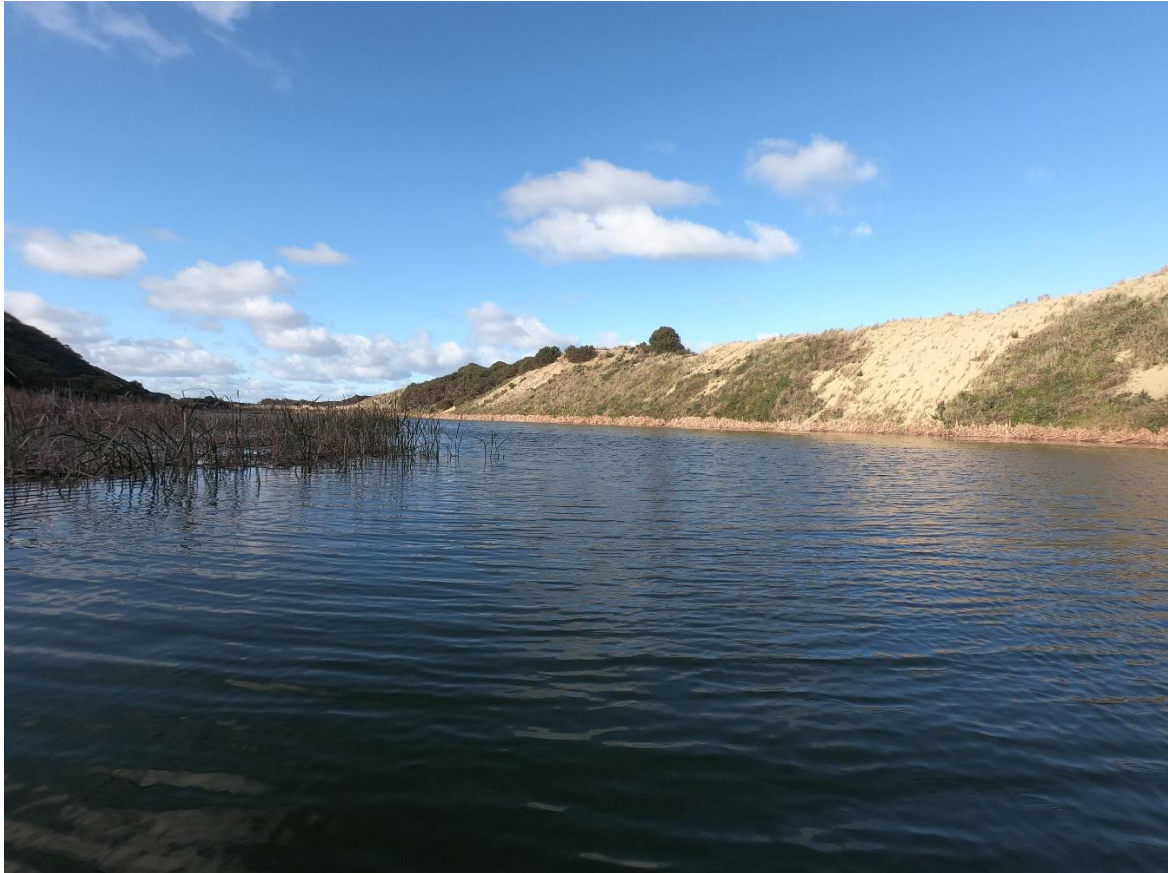
**Lake Wairere** south end showing the mobile dune on the western shore (Photo: Daniel Clements 12 August 2022).

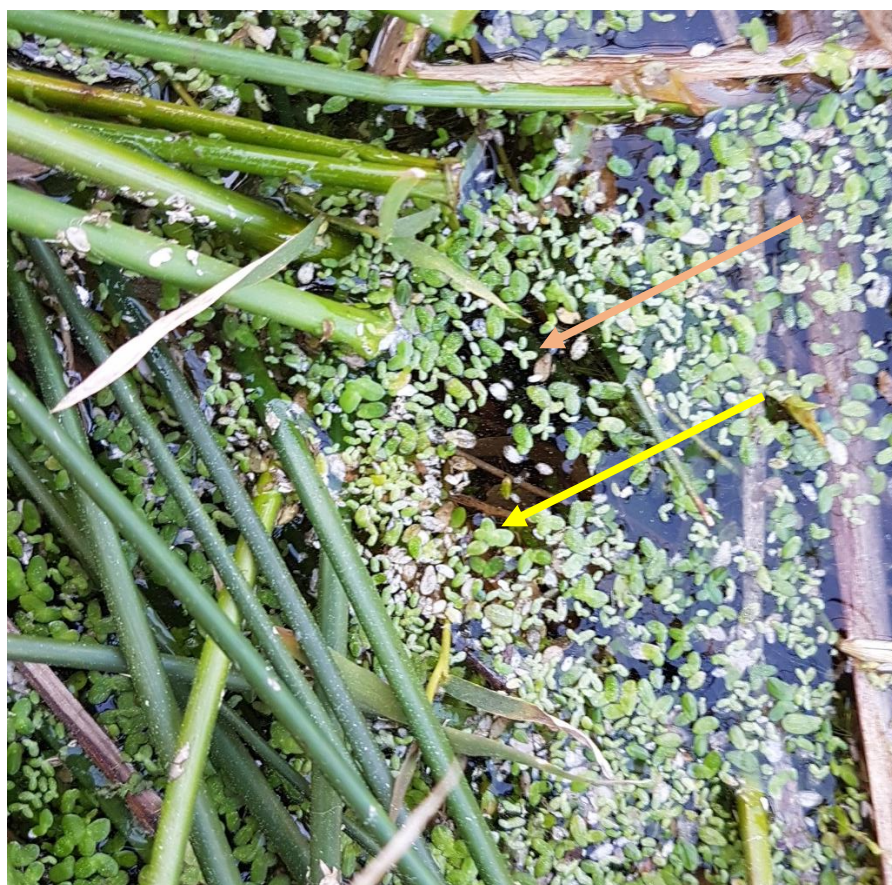
A small duckweed was found associated with *Lemna disperma* in the marginal emergent vegetation of Round Hill Lake 2. It is possibly *Lemna perpusilla*, a species not previously recorded in New Zealand, probably naturally introduced.

The two duckweeds *Lemna disperma* (yellow arrow) and *Lemna perpusilla* (orange arrow) in the marginal emergent vegetation of Round Hill Lake 2 (Photo: Paul Champion 12 August 2022).

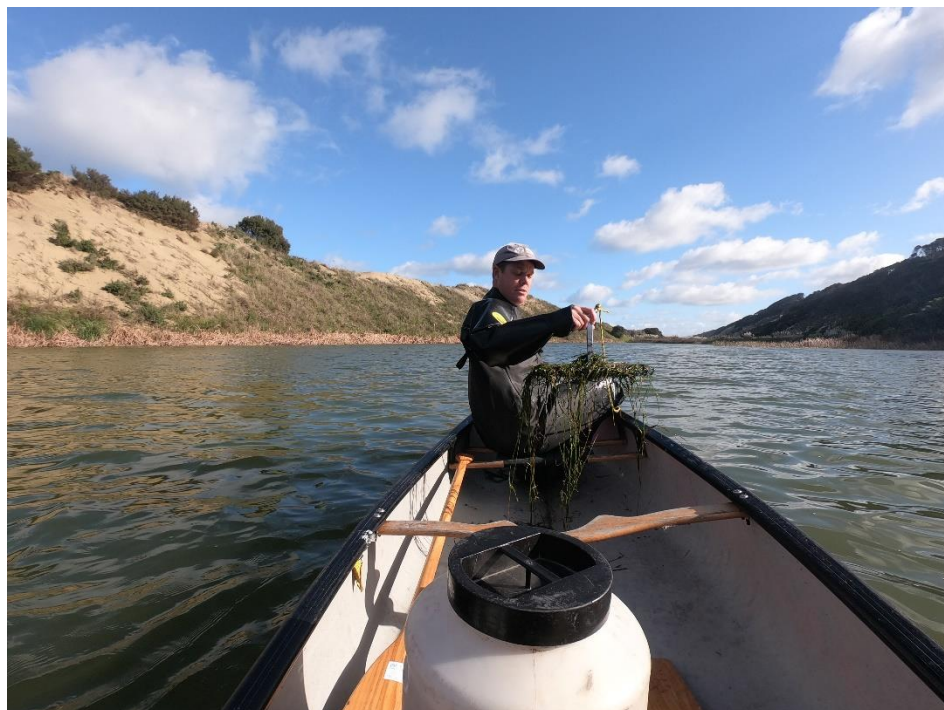
The 2022 survey was conducted by snorkelling, rake and sonar. In Lake Wairere and Round Hill Lake 2, species recorded (in order of abundance) were *Chara australis*, *C. globularis*, *Potamogeton ochreatus*, *Myriophyllum triphyllum*, *Utricularia gibba* and *P. cheesemanii*. Scattered plants were recorded from 1.8 to 4.5 m depth in Lake Wairere and to 2.4 m in Round Hill Lake 2. Similar species were found in 2014, with *C. globularis* also recorded.

**Lake Wairere**, examining the submerged vegetation sampled using a rake (Photo: Aleki Taumoepeau 12 August 2022).
