# Waipū Estuary SEA assessment 2021

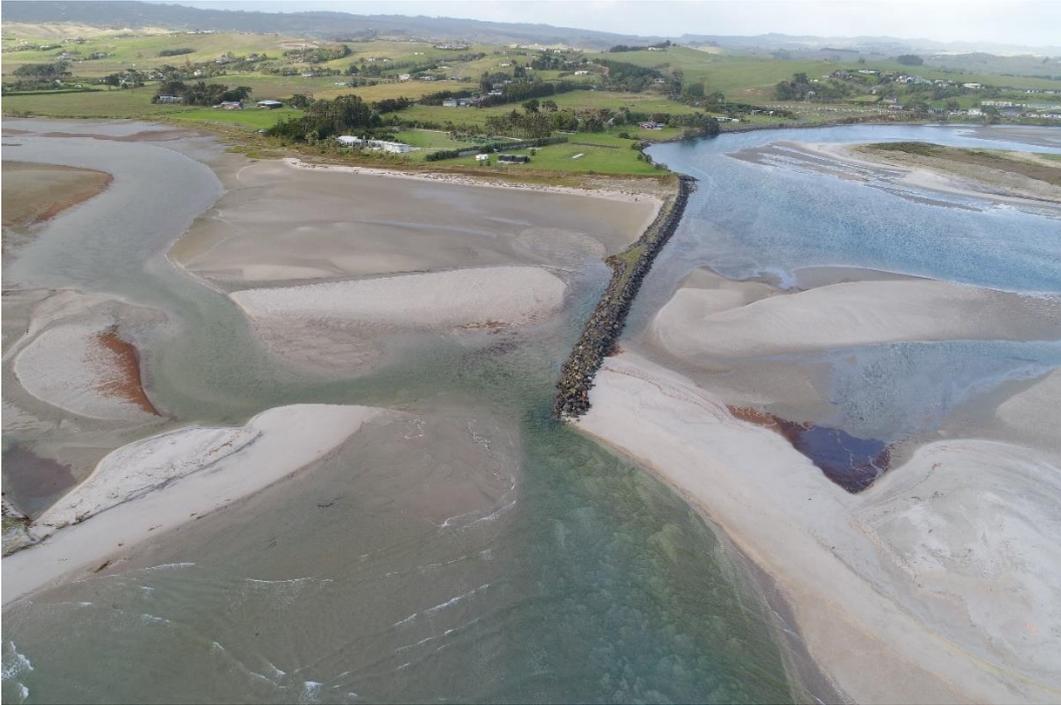
**Figure 4.** The rock groyne at the entrance to the Waipū Estuary.

Within the estuary there are only three consented activities or structures. The most significant of these is a rock groyne (Figures 4 and 5) near the mouth of the estuary. The other consents are for a stormwater discharge from a residential subdivision into the Waipū River and for a rock revetment and stormwater outlet at Hamon Road (Figure 6).

At some time prior to 1900, a channel was cut through the dunes to the sea and a wooden groyne constructed to stabilise the river mouth at its current general location. This was primarily for navigation purposes and for the protection of farmland adjacent to the old river channel. This wooden groyne deteriorated over time and the river mouth migrated to a more southerly position. In 1957, the mouth of the Waipū River was again cut through at its current position. The wooden structure was dismantled at this time and a 300m rock structure was built to replace it (Figures 4 and 5). This structure was approved at its current extent by the Northland Harbour Board (NHB) in 1967 and the NHB maintained the groyne until the organisation was dissolved in 1989. The primary purpose of the groyne is to constrain the river mouth to its current location, providing better access for small vessels and erosion protection. The groyne is likely to have restricted water flow and exchange between the river channel and the southern lagoon area of the estuary and may have restricted flushing of the lagoon.

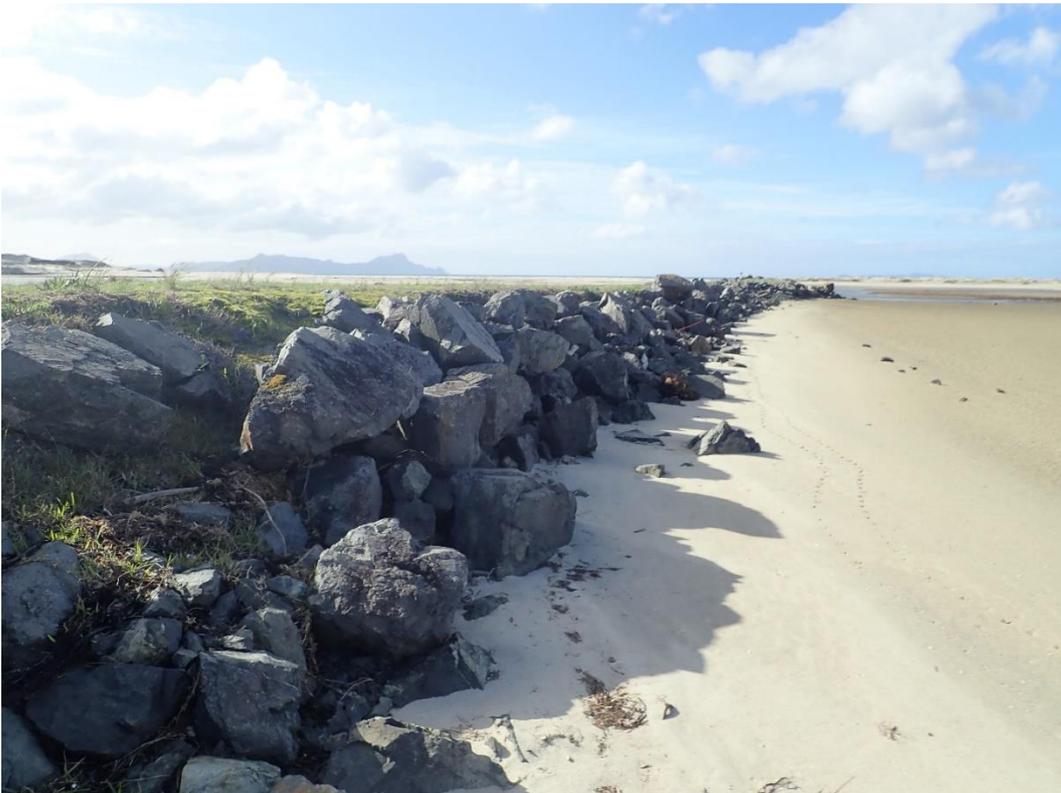
**Figure 5.** The rock groyne photographed from the Lagoon area of the Waipū Estuary.

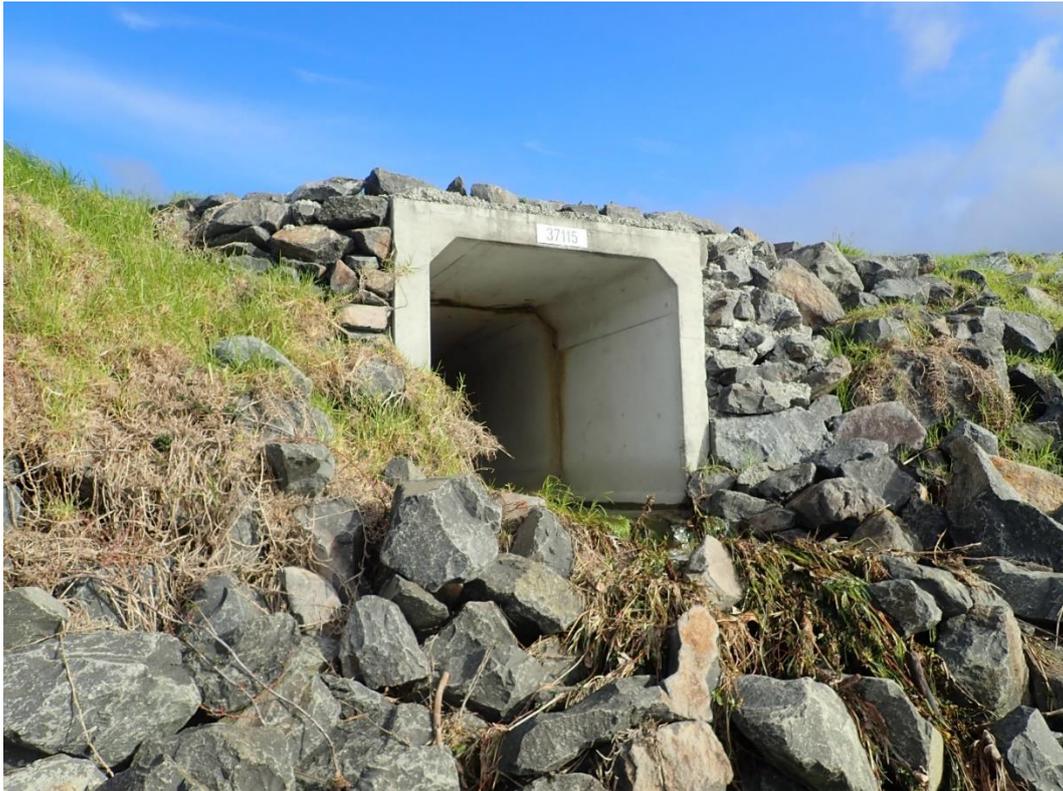
**Figure 6.** Stormwater box culvert and rock revetment in the river section of Waipū Estuary.

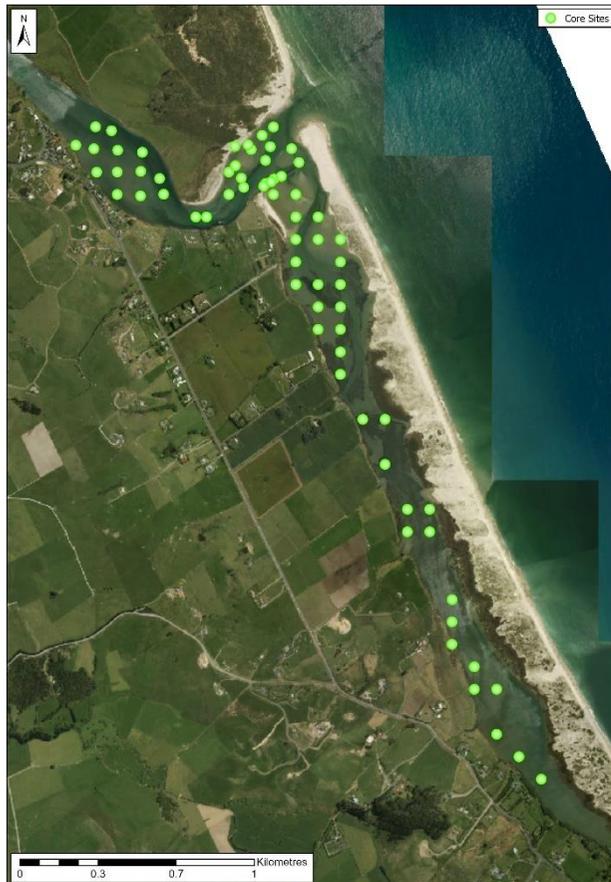
**Figure 7.** Location of shellfish core sites.

Shellfish were sampled by collecting two circular core samples (with a 150mm diameter) pushed into the substrate to a depth of 150mm, at each sampling site (Figure 7). The contents from the two cores were aggregated and passed through a 5mm aperture sieve. All hū ai/cockles (*Austrovenus stutchburyi*), hanikura/wedge shell (*Macamona liliana*) and kōkota/pipi (*Paphies australis*) retained on the sieve were identified and counted. A photograph was also taken of all the individuals at each site, using a specially adapted 20L bucket, which had a hole drilled through the lid and an indent to match the sampler's phone's camera. This ensured that each photograph was taken at the same height and centred in the middle of the bucket (Figure 10). These photographs were analysed using Photoblique v2.0.122, which allows the user to set the spatial scale of the photographs using a reference photograph with a ruler in the bottom of the bucket and then measure the shell length of each individual shellfish (Figure 10). The shell length measurements made using Photoblique were exported as a csv and used to calculate the number of juveniles and adults, and to estimate the biomass of hū ai/cockles. Hū ai/cockles 15mm or greater in shell length, kōkota/pipi 18mm or greater and hanikura/wedge shell 30mm or greater were classified as adults.

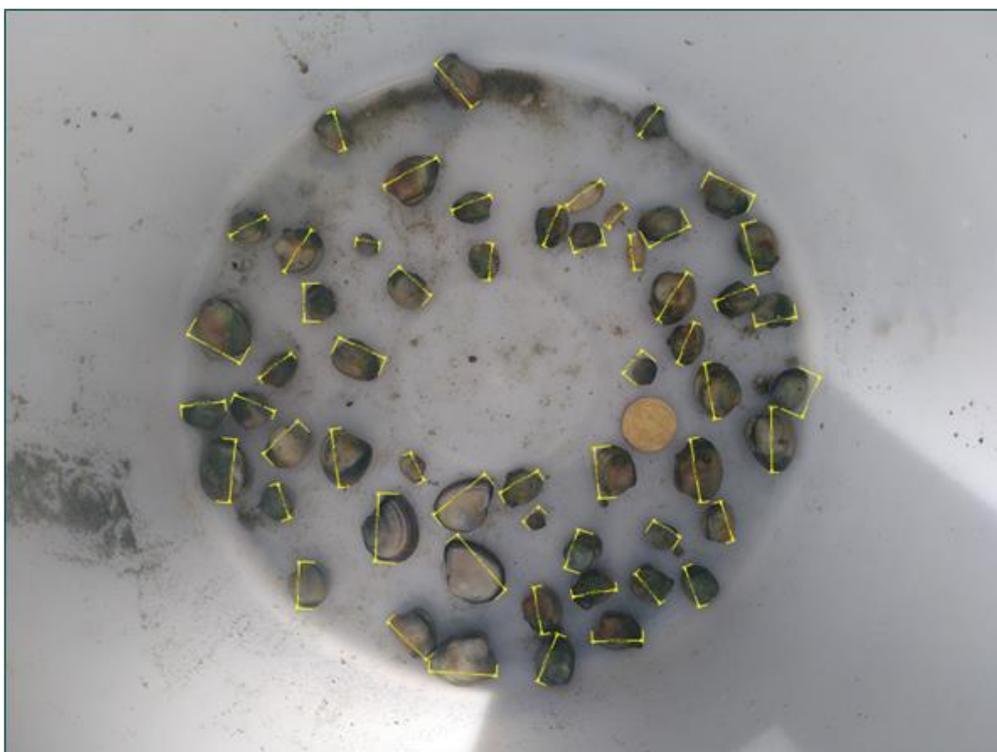
**Figure 10.** Shellfish measurements using Photoblique v2.0.122.

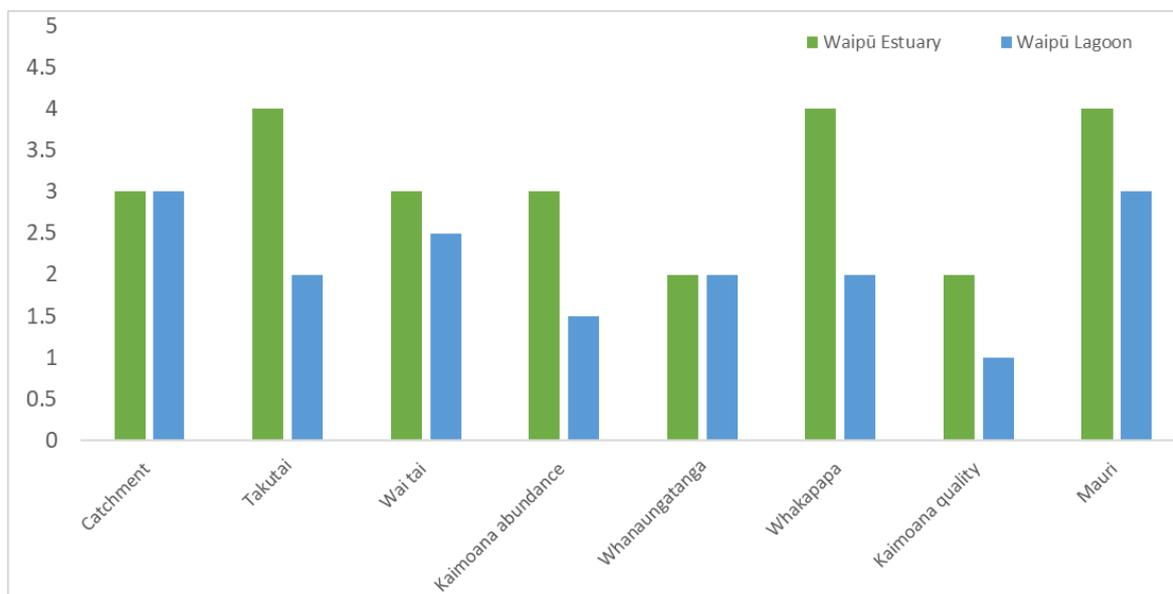
The mauri at the lagoon is similar to the estuary, but slightly lower due to a subtle, but different felt sense. It is still a beautiful place riddled with wildlife, but at the time of the survey, the mauri had been impacted by the presence of the groyne and the hau of the site was less apparent.

**Figure 11.** Takutai health analysis results from Waipū Estuary SEA (Patuharakeke Taiao unit, 2021).

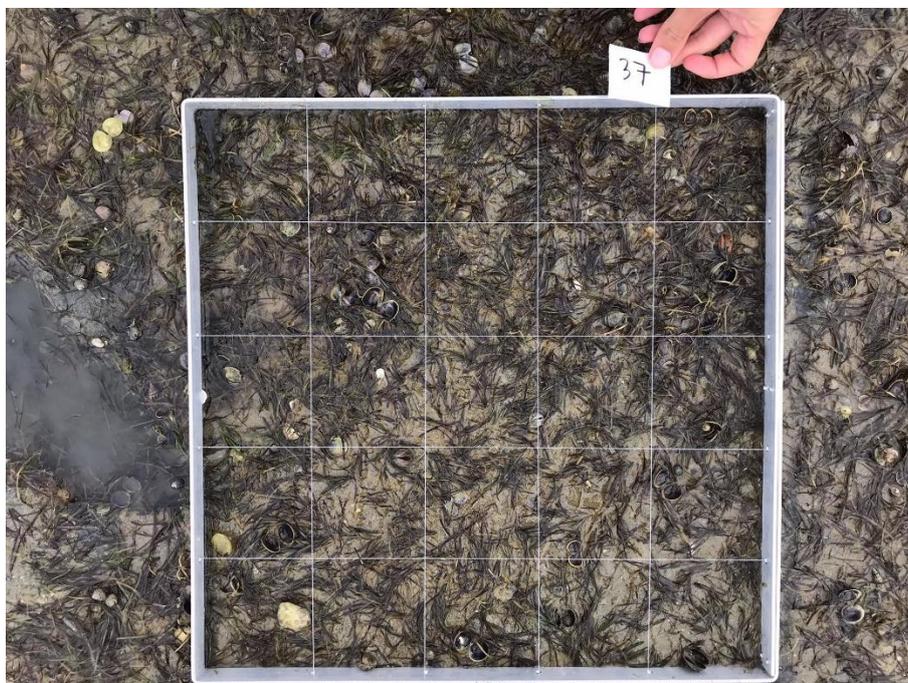
Seagrass was recorded at 16 quadrat stations in the lagoon (Figures 12 & 14) and large areas of seagrass were observed during the site visits. No seagrass was recorded or observed in the river area of the estuary (Figure 14).

**Figure 12.** Seagrass observed in one of the quadrat samples in Waipū Estuary.

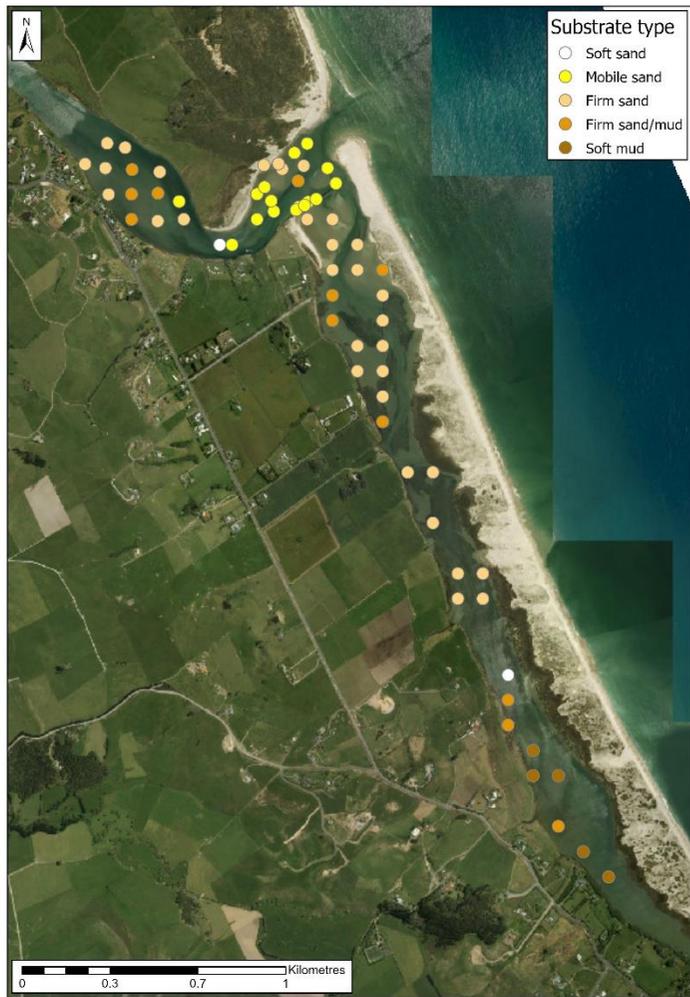
Substrate in the river area of the estuary was predominately firm sand and firm sand/mud upstream of the first bend of the river. In the more dynamic area near the mouth of the estuary the substrate comprised mainly mobile sand (Figure 13). In the lagoon area of the estuary the substrate was predominately firm sand and firm sand/mud with an area of soft mud found towards the southern end of the lagoon (Figure 13).

Figure 13. Substrate type recorded at quadrat sample site in Wāipū Estuary.

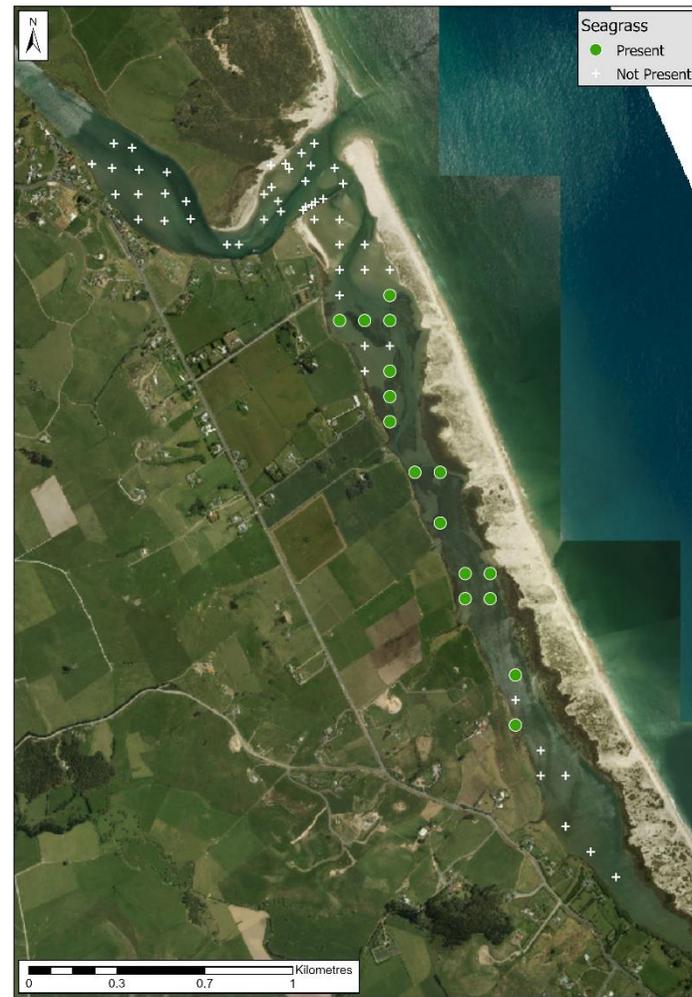
Figure 14. Seagrass habitat recorded at quadrat sample site in Wāipū Estuary.

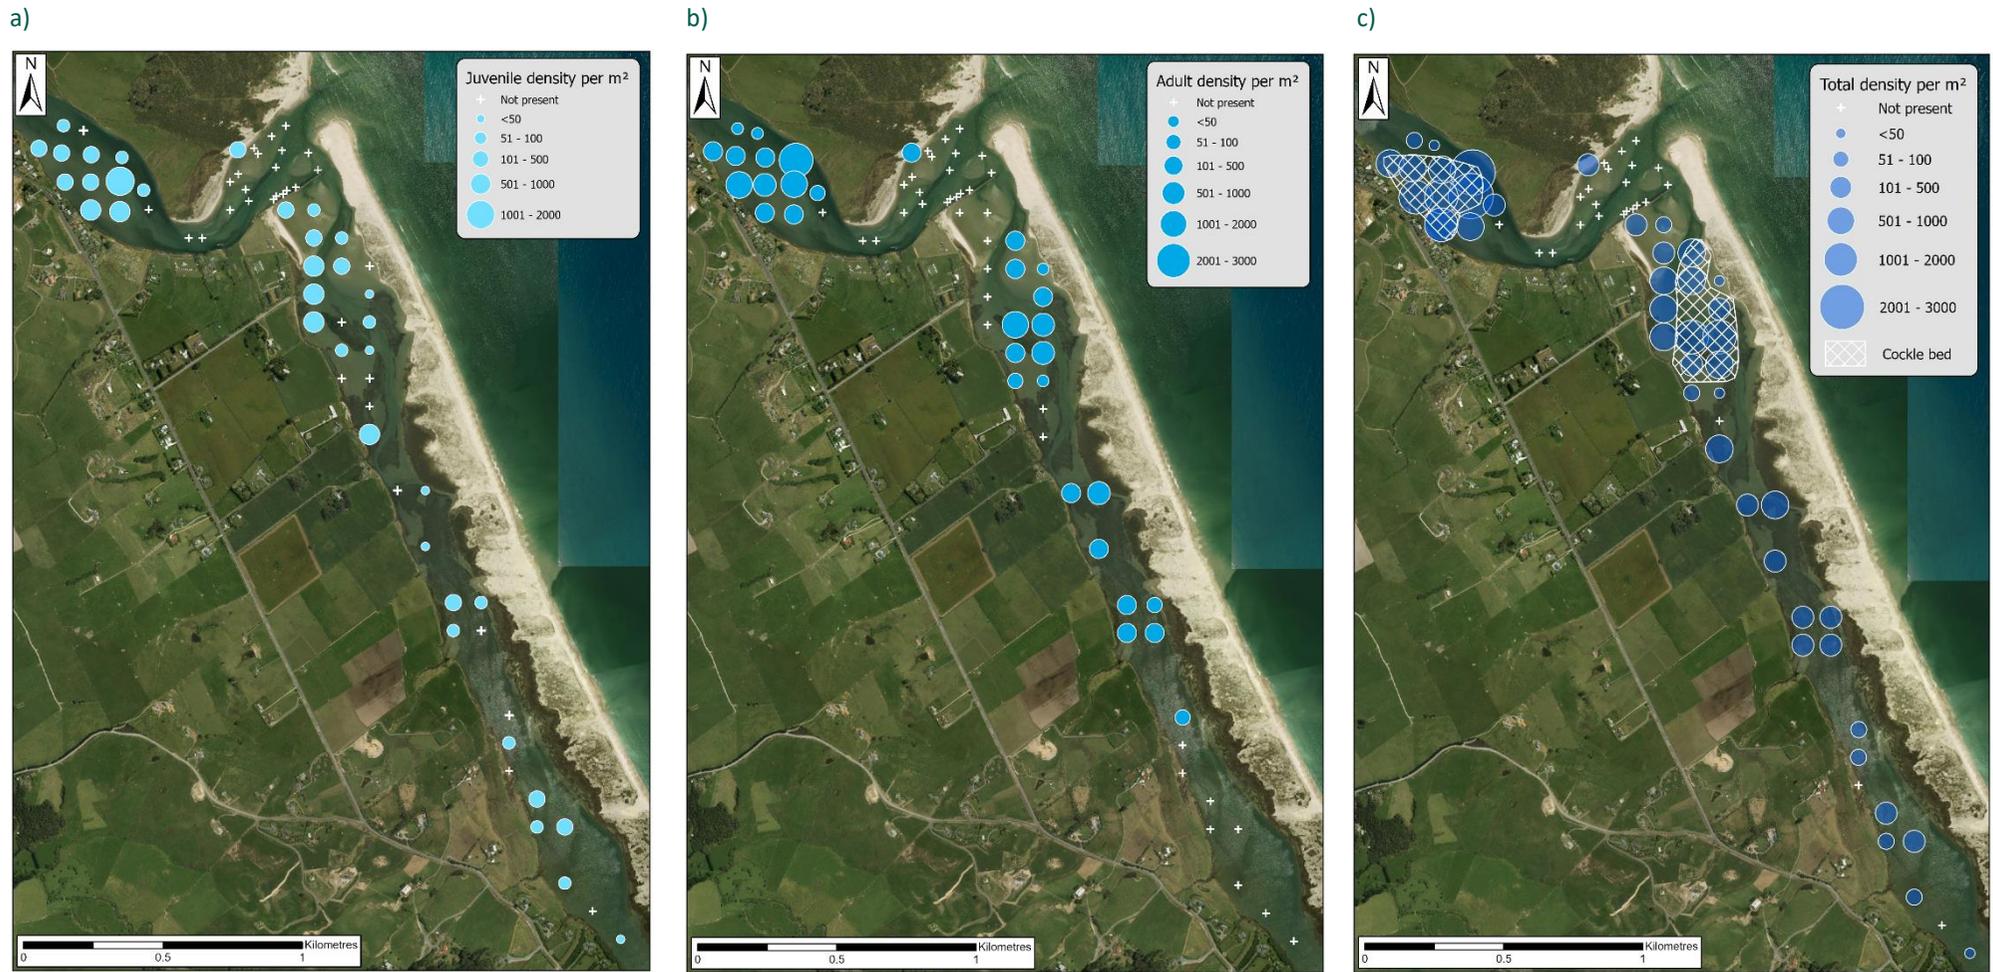
Hū ai were quite widely distributed throughout the lagoon although the highest densities were found in the northern area of the lagoon (Figure 15). In the river section of the estuary, hū ai were almost exclusively located upstream of the first bend on intertidal sand flat. Two hū ai beds, where the adult density exceeded 226 individuals per m<sup>2</sup>, were identified (Figure 15), one in the river section and one in the lagoon. The population of the bed in the river section of the estuary was estimated to be 90.21 and the population of the bed identified in the lagoon section was estimated to be 63 million (Table 5). There is a relatively high standard error associated with these estimated due to the small sample sizes.

Figure 15. Hū ai (*Austrovenus stutchburyi*) density in Wāipū Estuary. a) juvenile density, b) adult density, c) total density.

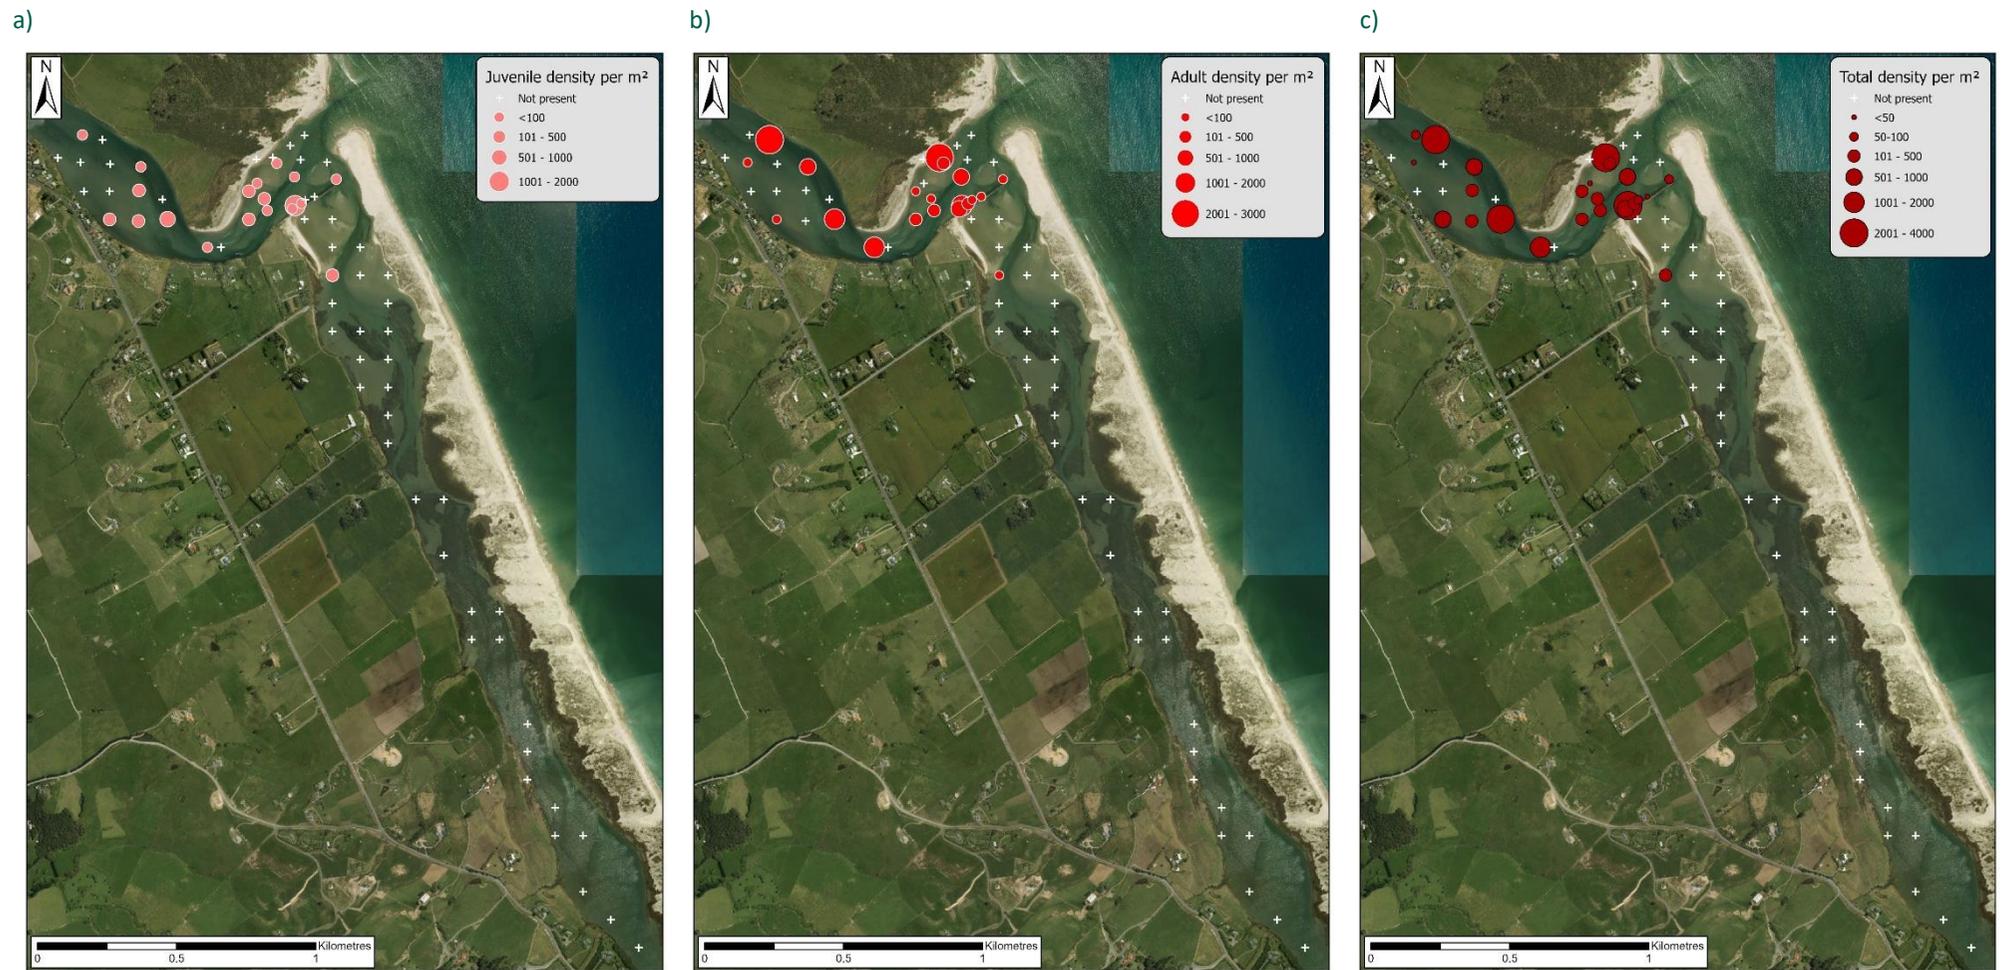
Kōkota were found at 24 sites in the river section of the estuary but only at one site in the lagoon (Figure 16). Juvenile kōkota were widespread through the river section of the estuary, but adult Kōkota were only found in high abundances within the river channel. Although adult kōkota were found in densities that exceeded 226 individuals per m<sup>2</sup> at 10 sites, which is sufficient to be classified as kōkota habitat, no obvious kōkota bed was identified (Figure 16).

Figure 16. Kōkota (*Paphies australis*) density in Waipū Estuary. a) juvenile density, b) adult density, c) total density.

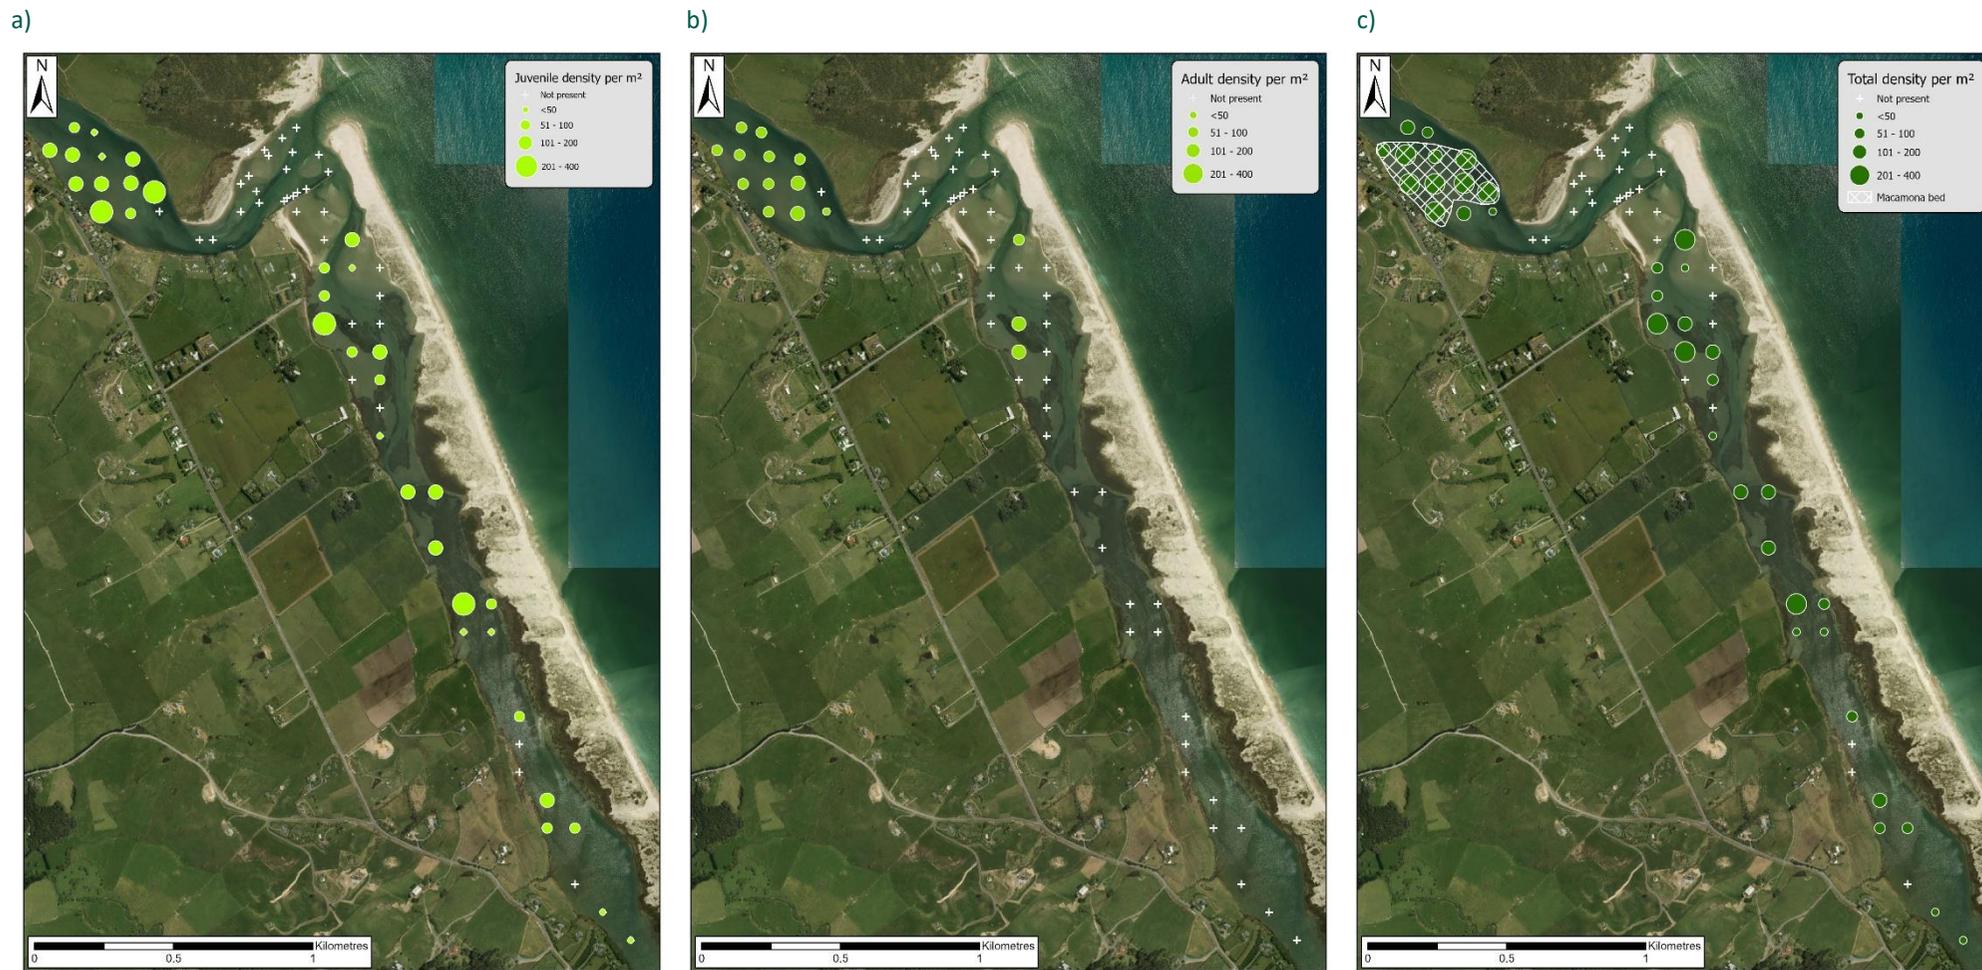
Hanikura were found at 36 sites in the estuary (Figure 17). Juvenile hanikura were widely distributed throughout the lagoon (23 sites), but adult hanikura were only found at three sites, all towards the northern end of the lagoon. In the river section of the estuary, juvenile and adult hanikura were only found upstream of the first bend on the intertidal sand flat.

Although adult hanikura (shell length  $\geq 30\text{mm}$ ) were not found in sufficient density to be classified as hanikura habitat, juvenile and adult hanikura combined were found in sufficient densities at eight sites, in the river section of the estuary, to be classified as hanikura habitat (Figure 17). The total population of Hanikura in this bed was estimated to be 20.63 million (Table 6).

Figure 17. Hanikura (*Macamona*) density in Waipū Estuary. a) juvenile density, b) adult density, c) total density.

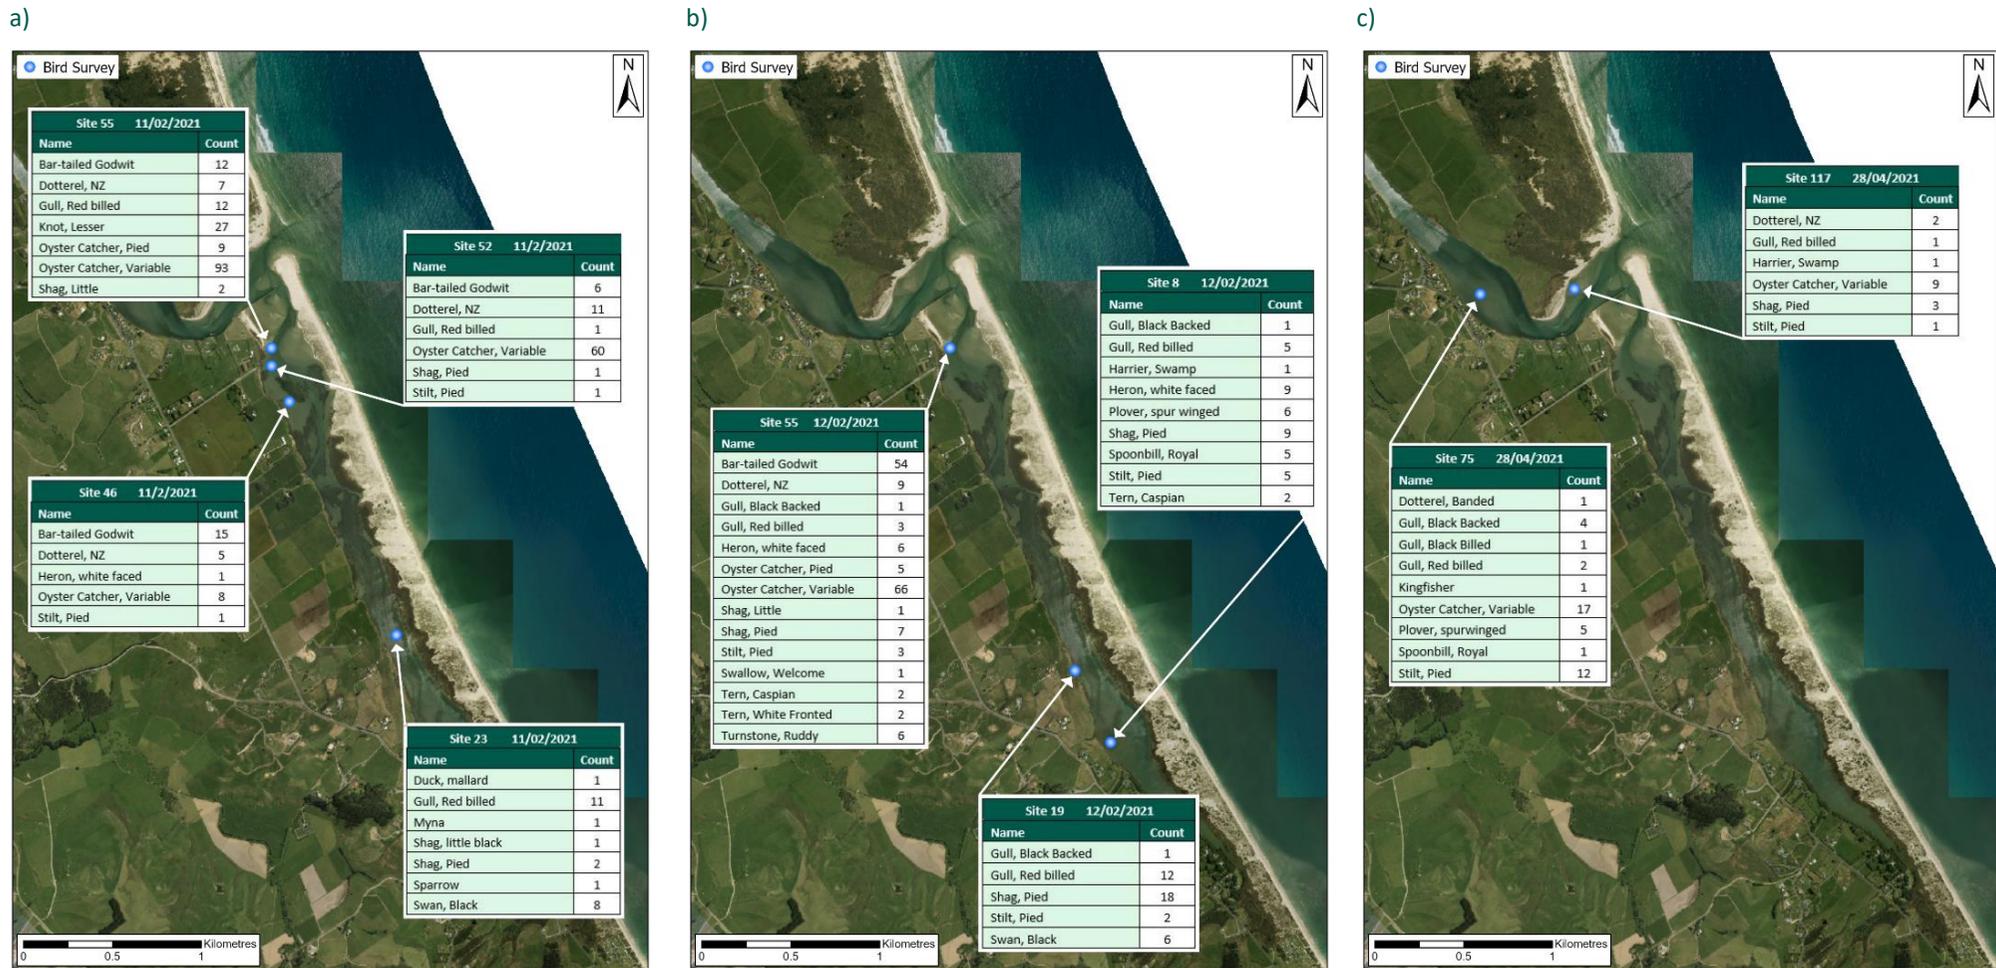
The variable oyster catcher (*Haematopus unicolor*) was the most abundant species across all sites (Figure 18) with the red-billed gulls (*Larus novaehollandiae*) and pied stilt (*Himantopus Himantopus*) also present at most sites. In contrast, the banded dotterel (*Charadrius bicinctus*) and the sacred kingfisher (*Todiramphus sanctus*) were only found at one site each. Individuals were concentrated at sites 52, 55, and 75, with 449 or 74.5% of all individuals recorded at these sites.

Figure 18. Bird survey data recorded in Wāipū Estuary on a) 11 February 2021 b) 12 February 2021 and c) 28 April 2021.
