1 Langs Beach

Coastal Erosion Hazard Assessment

Langs Beach

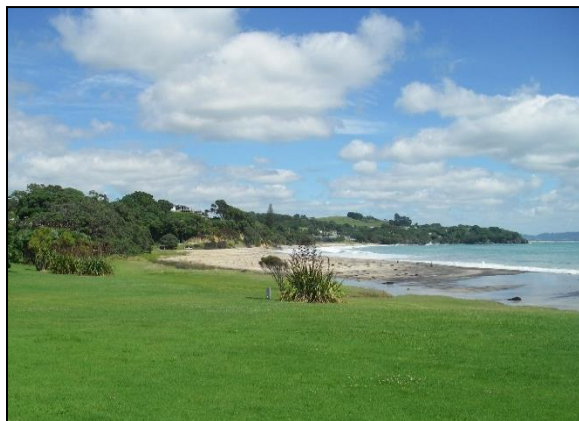
Site Photograph A (low lying southern backshore)

The next 500 m section of shoreline is unconsolidated beach situated between two streams. Both streams have an effect on the shoreline position. The southern stream is often blocked by the beach berm forming a lagoon and meandering channel that causes some backshore erosion. A rock reef exists at the northern end of this cell which is located approximately 25 m offshore.

The central 300 m of shoreline comprises soft cliff (cell 1D). A medium to fine sandy beach exists along the site that has a berm width of approximately 5 to 10 m above the high tide line. Another stream mouth exists at the southern end of this cell where the topography transitions from the cliff shoreline to a low lying backshore area. This low lying area is approximately 450 m long and the stream channel flows between the edge of the shoreline bank and an intertidal spit.

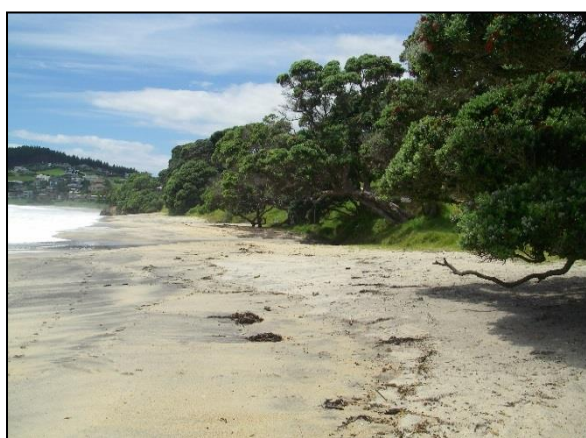
Site Photograph B (central cliff area)

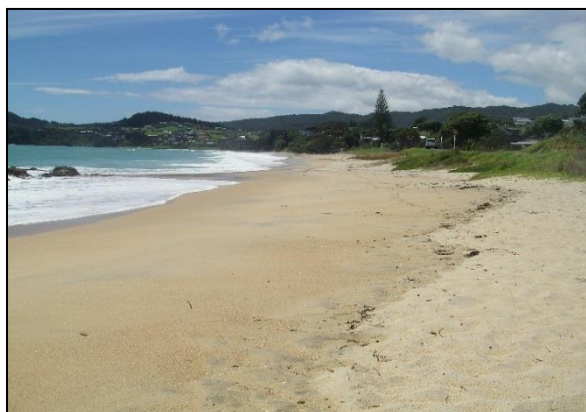
Site Photograph C (northern beach)

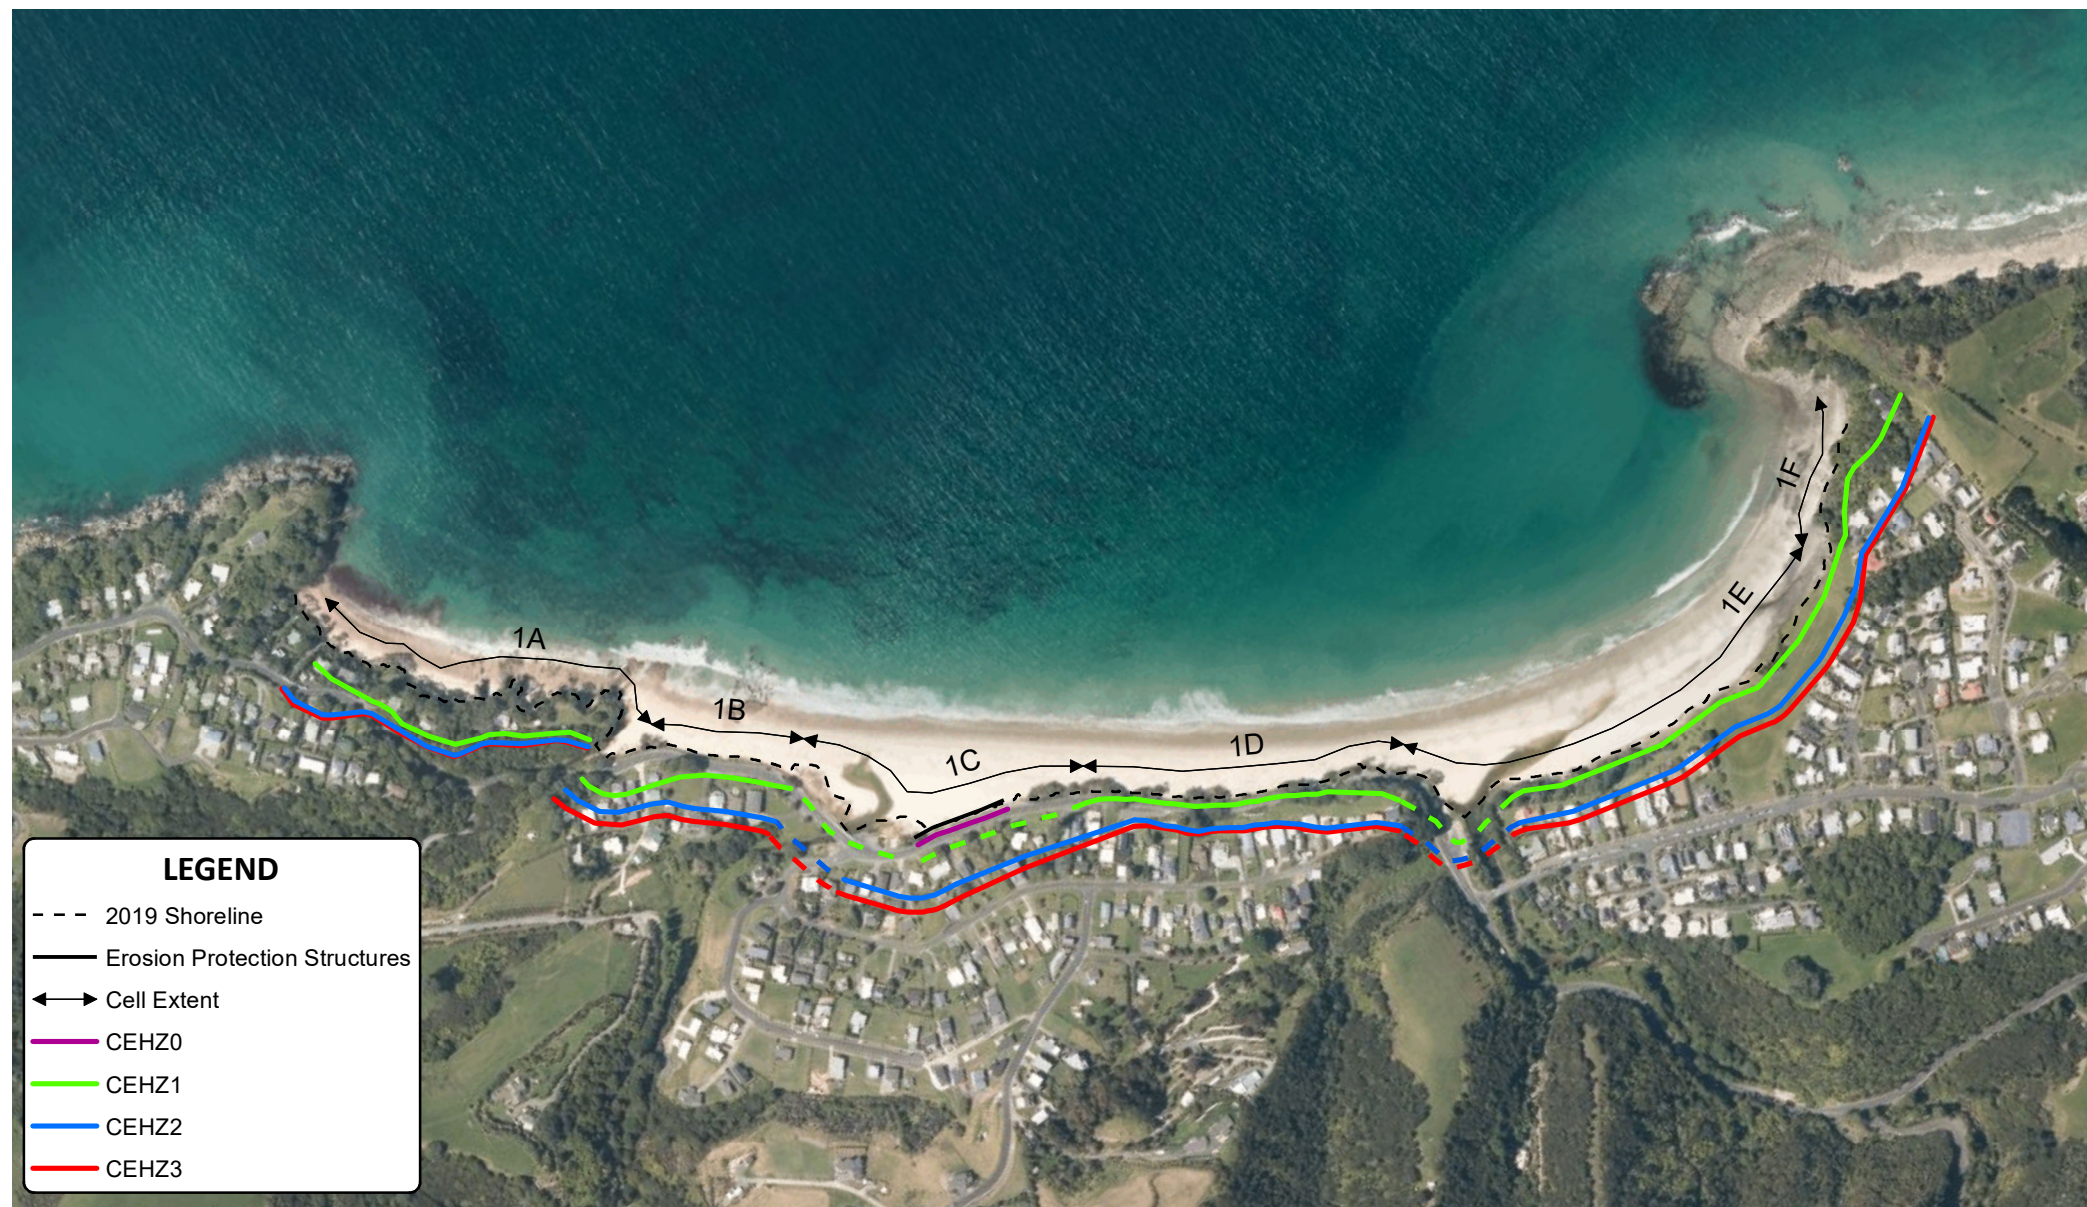
Figure 1-7

Notes: Dashed CEHZ indicates greater uncertainty around stream mouths and backshore topography.
Northland 0.4m Rural Aerial Photos (2014-2016).

Histograms of individual components and resultant CEHZ distances using a Monte Carlo technique are shown in Figure 1-1 to Figure 1-6. Coastal Erosion Hazard Zone widths are presented within Table 1-2, Table 1-3 and Table 1-4 and mapped in Figure 1-7.

CEHZ1 lines range from 15 to 24 m for the beaches, CEHZ2 values range from 40 to 60 m and CEHZ3 values range from 50 to 74 m. The CEHZ1 value for cell 1E has been adjusted from 12 m to a minimum value of 15 m.

Hazard lines are generally based on these values, although uncertainties remain around the

stream mouths where fluvial processes occur. These lines have been dashed to reflect this.
