Report

Taumarere Modelling and Calibration Report

12 OCTOBER 2012

Prepared for Northland Regional Councl 36 Water Street Whangarei 0140

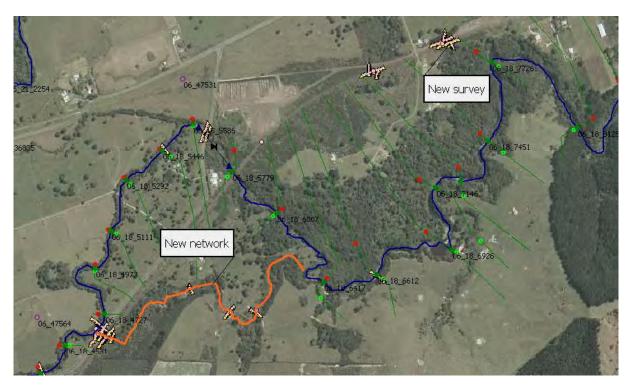
Figure 1-2: Model extension and example of new survey for Taumarere catchment model; Intersection of Pukapu Road and Otiria Road

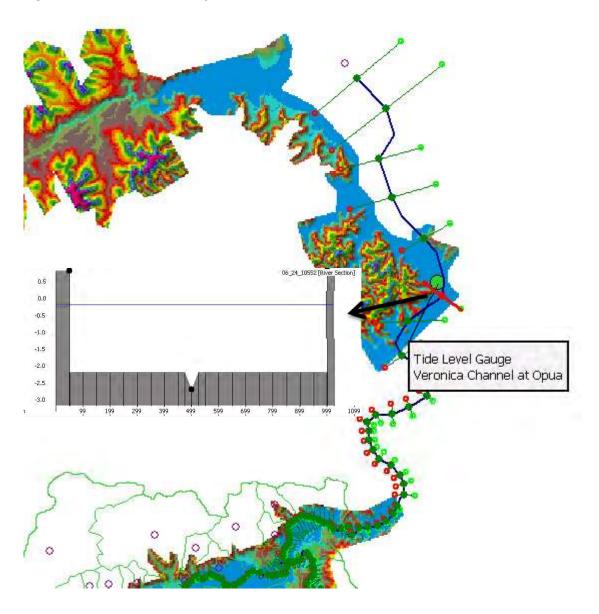
Figure 3-1: Veronica Channel previous model cross section

Despite the correct downstream configuration, the river mouth of Kawakawa River is not contained in the LiDAR information, and the cross sections on the estuary were found to be critical in extreme events, where its current capacity seems to delay the discharge of the flow into the sea. For that reason model improvements were made in the estuary, estimating the missing section area in the cross sections and locating the tidal boundary close to the actual location of the tide gauge. Figure 3-1 shows the previous model cross section at a location outside of the LiDAR. Cross sections in the previous model in this area were considered to be rectangular with a small slot at the bottom; the width and depth were arbitrary and in some areas they seem too wide or too short compared with the aerial photograph. For the new model the limited LiDAR around the estuary and the aerial images were used to estimate the width of the estuary at this location. That width was used to estimate an area of flow to be distributed along the cross section. Even though they remain as assumptions, this approach is more realistic as the final cross sections properly describe contractions and expansions along the estuary that might be important in big events. Figure 3-2 shows the new estuary extent and an example of a modified cross section in this area.

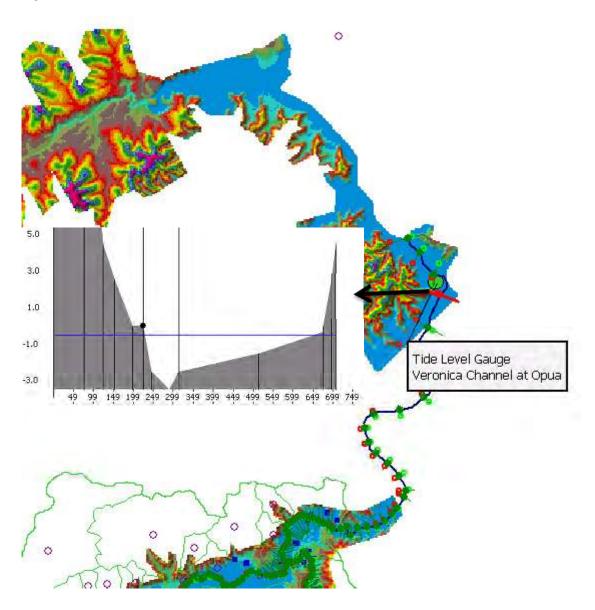
Figure 3-2: Veronica Channel modified model cross section

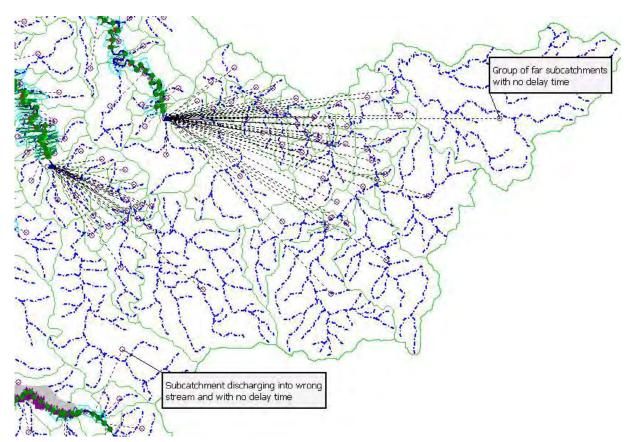
It was discovered that many of the points of discharge to the network were not well defined. There were many situations where sub-catchments were located a great distance from their discharge point to the network. This would not pose a problem if they were connected to the river system at the proper point, with the appropriate delay time. There were two issues noted. The first issue was that a few sub-catchments were not connected to the river network at the correct point. The second issue was more serious as many sub-catchments that had long travel times (time of concentration) to the network did not have any time delay incorporated into their nodes. These particular sub-catchments discharged their runoff directly to the river network immediately after the runoff was generated. This was the case for most of the sub-catchments that were connected to the network from significant distances, therefore the time of delay is not negligible. Without the inclusion of the time of delay, the routing of the flow from these sub-catchments incorrectly impacted the modelling of the network and compromised the calibration.

Figure 3-3 shows an example of this situation. The problem was corrected by using the ARC TP108 formulation to estimate a time of delay for each sub-catchment based on the stream link. This calculation was conducted by using GIS tools based on the long profiles of the missing streams and differences in elevations.

Figure 3-3: Example of issues in previous sub-catchment connections (Upper catchment of Tirohanga and Waiomio streams)

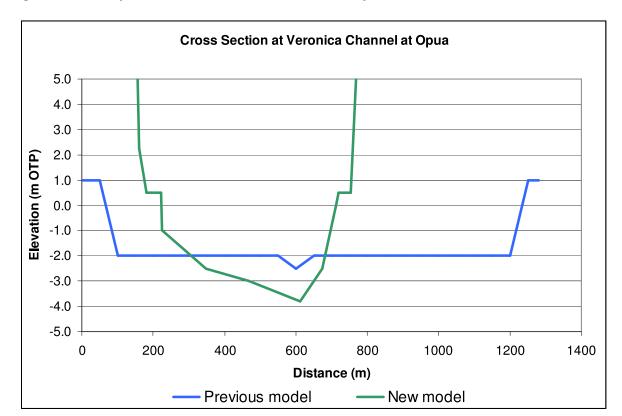
Figure 3-4: Example of correction of cross section at estuary

Cross sections were corrected along the lower 10.0 kilometres of the model extent from the tide level boundary condition at Veronica Channel at Opua station.

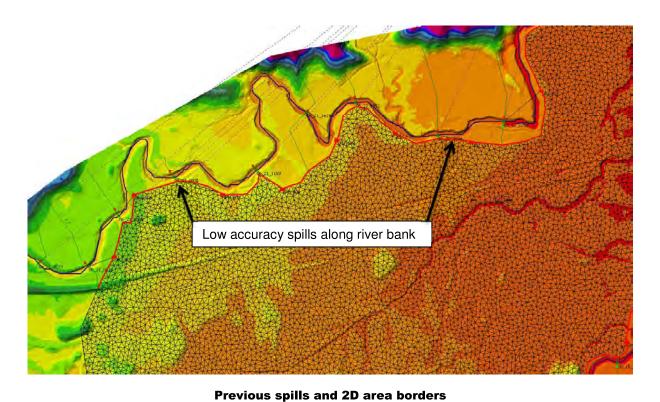
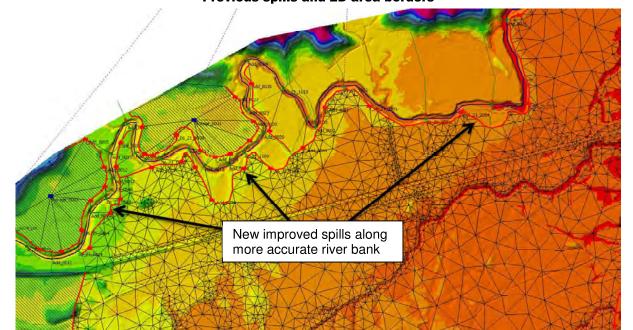
Figure 3-5 Example of spill corrections at Orauta stream; Otiria Road at Orauta settlement

Corrected spills and 2D area borders

The scope of this project included the extension and modification of some critical 2D areas. This involved modification of the spills connecting the river with the respective 2D areas. However, in many areas where 2D modifications were not required, spills were represented poorly. These spills typically did not follow the banks along the river or their section resolution was so poor that it incurred an inaccuracy in the solution of the flows spilt over 2D Areas. The example below shows a set of spills that were defined with low accuracy, and spilling a large amount of water from the Orauta stream upstream of Otiria into the 2D area that would cross the flood plains and discharge into Waiharakeke river reach to the south.

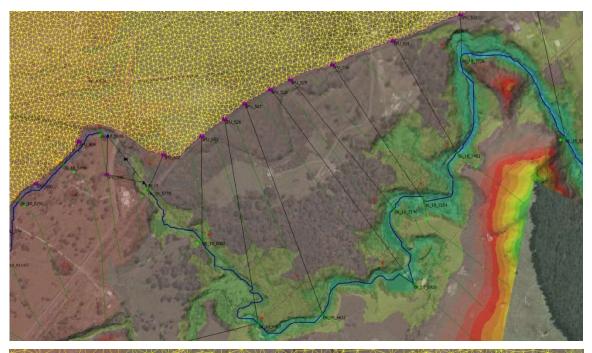
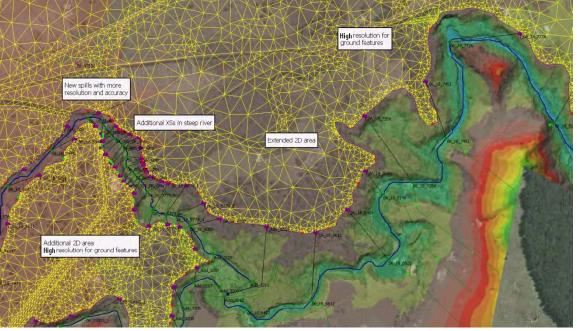
Figure 3-6 Example of previous and improved 2D mesh; Waiharakeke river downstream of Pokapu road

The resolution of the previous model's 2D polygons was sufficient to provide only a rough description of the flood plains. Break lines and better resolution in many areas were required in order to meet requirements of calibration. Additional 2D areas were also added to assure a good description of the flooding in terms of flood extents, overland flow paths and representative storage capacities. Other areas were reduced in resolution as they were either in high lands or flat flood plains.

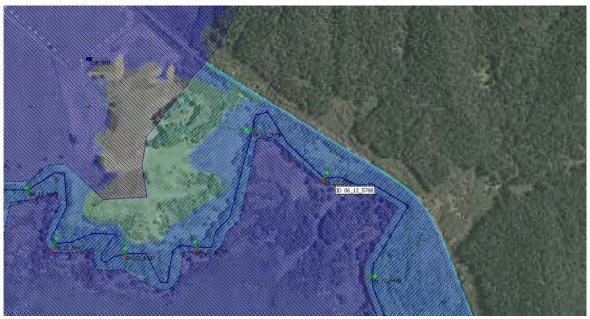
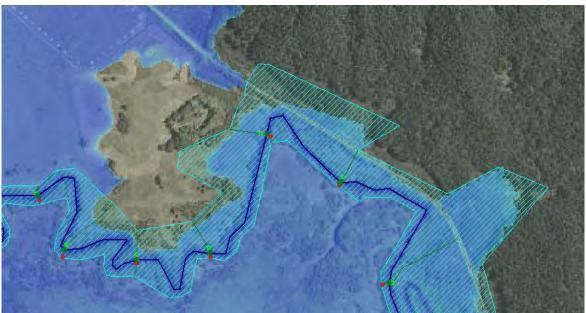
Figure 3-7 Example if flood compartment corrections; Taikirau Stream between Pokapu and Pokere settlements

Flood compartments were corrected, extended or created in areas where more detail was required. Extension of the flood compartment alone is advisable when the storage of the flooded area is not important; otherwise a storage unit was generally added together with the extended flood compartment.

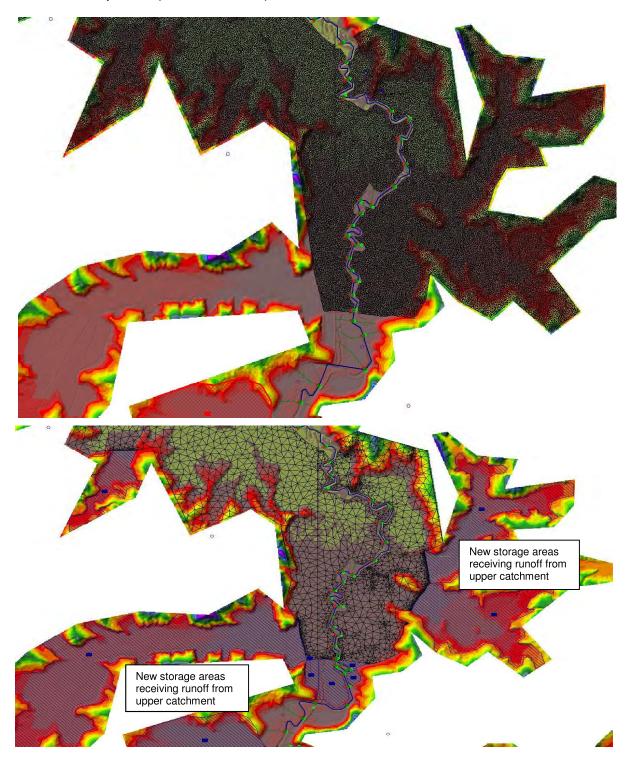
Figure 3-8 Example of additional storage areas connected to 2D to assist runoff; Taikirau Stream at Kupa Road (Pokere settlement)

In the previous model many sub-catchments were found to be draining directly to the main stream even though there were important flood plain storage areas that they should have drained to before reaching the river. This had to be corrected in order to get a good fit for the calibration, especially in the Taumarere catchment where the inclusion of natural storage areas was critical for accurate representation of reality. The newly calibrated 2012 model has 72 additional storage areas covering more than 13km². This improved the flood plain areas and the routing of the water between subcatchments and rivers.

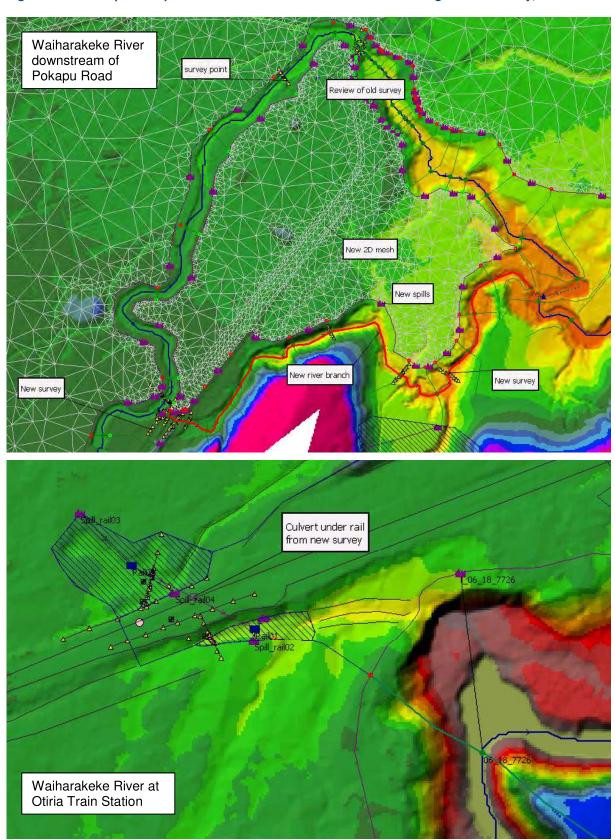
Figure 3-9 Example of improved extension of the 1D and 2D models using the new survey;

Figure 3-9 shows an example where the 1D river network was improved and extended using new survey information.

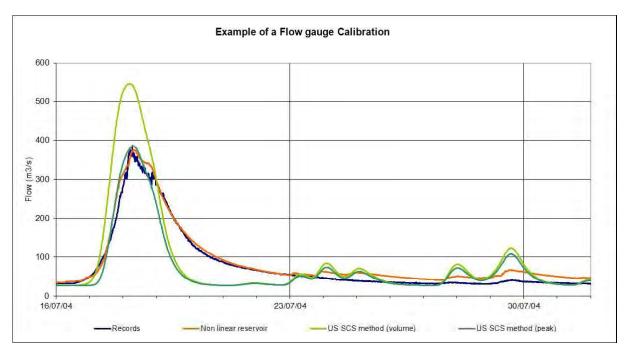
The following figure 3-10 shows a comparison between the US SCS method (applied to calibrated peak flows and flow volumes separately) and the Non Linear method (calibrated both peak and volumes). This example is for the Rangitaiki River catchment in New Zealand. The figure shows that the non-linear reservoir method appeared to be more capable of fitting both volume and peaks for this large catchment.

Figure 3-10 Example of a flow gauge calibration using different hydrological models

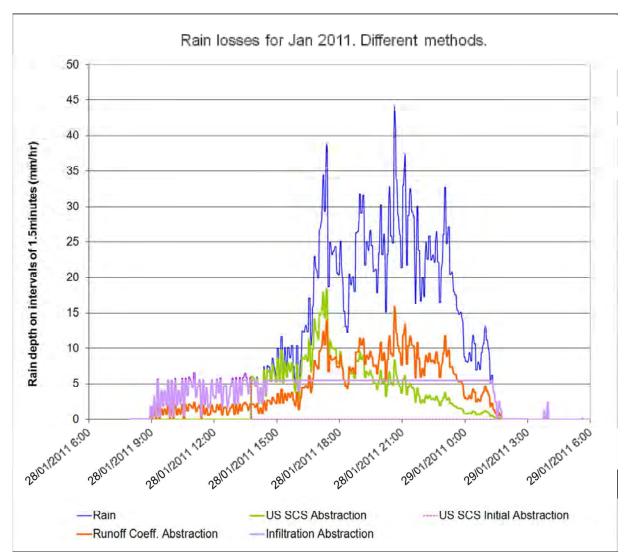
- Non-Linear Reservoir (NLR) with a constant infiltration rate (depth) estimated from a record volume balance (in Figure 3-11 as the Infiltration Abstraction curve)
- NLR with a variable infiltration rate. To estimate the rainfall losses, the US SCS method was used
 to estimate the total losses and initial abstractions over the calibration storm for each subcatchment, based on the previous spatially distributed CN values. Then the CN values were
 adjusted with a factor to match the total rainfall losses of the NLR method with the total volume
 balance determined from the records (in Figure 3-11 same as Infiltration Abstraction, but variable
 for each sub-catchment).

- A constant runoff coefficient was applied over the rainfall. The runoff coefficient was calculated for the whole Taumarere catchment based on the volume balance done from flow records (in Figure 3-11as the Runoff Coeff. Abstraction curve).
- Finally, a preliminary model was calibrated using a constant infiltration rate, and with the Non-Linear Reservoir method with constants p=1 (linear) and K defined for each sub-catchment based on geometric features. The constants *K* and *p* were used to calculate a unit hydrograph for each sub-catchment (as explained in Section 3.6.2). The unit hydrographs were then run using the US SCS method and the previous CN values variably distributed on Taumarere catchment based on land cover and soil type (in Figure 3-11 as the US SCS Abstraction and US SCS Initial Abstraction curves).

The analysis showed that the infiltration rate resulted in an abstraction estimate that is close to the average of all tested methods, and provides enough detail for the model considering the limited amount of flow data available to calibrate. Even though the moistures conditions and rain distribution

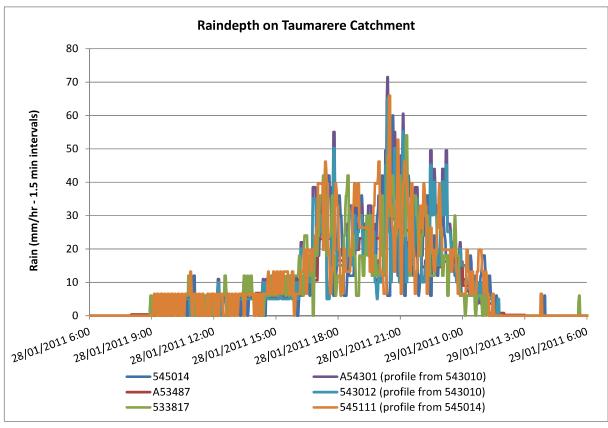
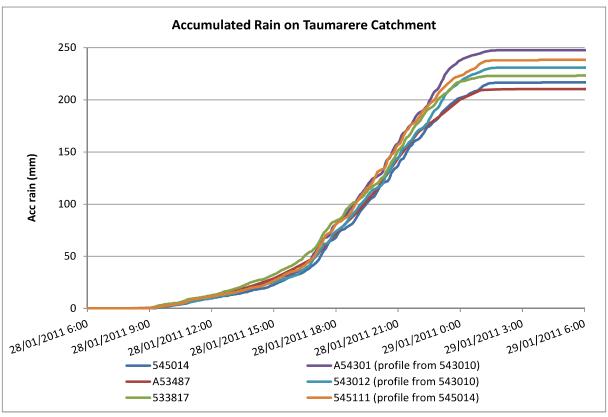
Figure 4-2 Distributed and accumulated rain for the calibration event

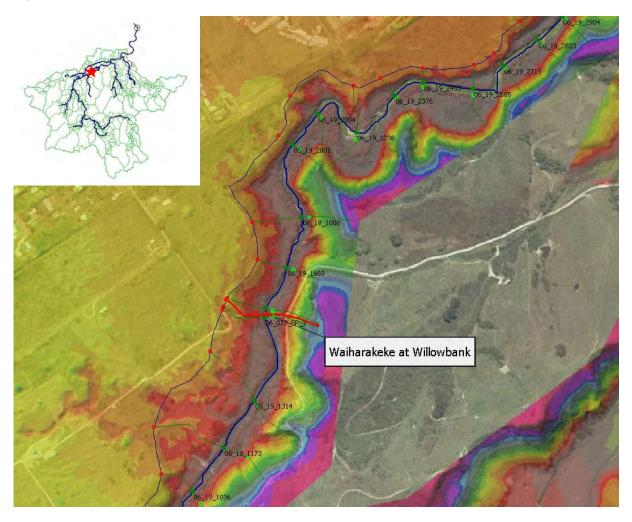
Figure 4-3 Waiharakeke at Willowbank station

The catchment draining to the Willowbank station is approximately 230 km², or 52% of the total Taumarere catchment.

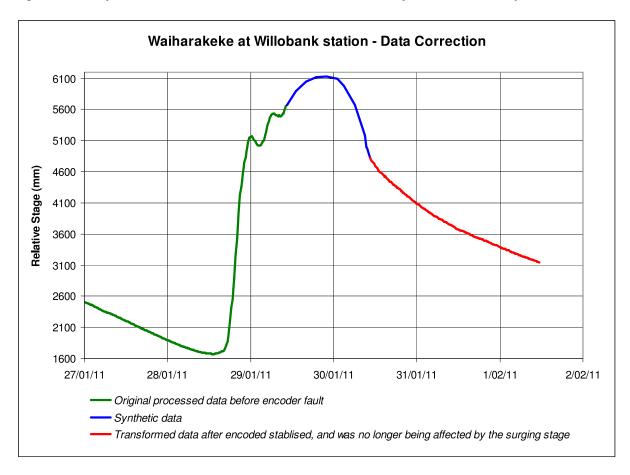
During the storm of January 2011 this recorder malfunctioned from 29/01/2011at 10:30 to 30/01/2011 at 9:30, when the maximum flows occurred. The peak stage at the gauge site was surveyed post event at 15.226m OTP (6126mm SG), which is only 450mm above the level that the recorder started malfunctioning. NRC hydrologists then processed this information and adjusted the records generating a synthetic data for the peak. Figure 4-4 shows the completed adjusted record series.

Figure 4-4 Adjusted records for Waiharakeke at Willobank, with Synthetic data at the peak

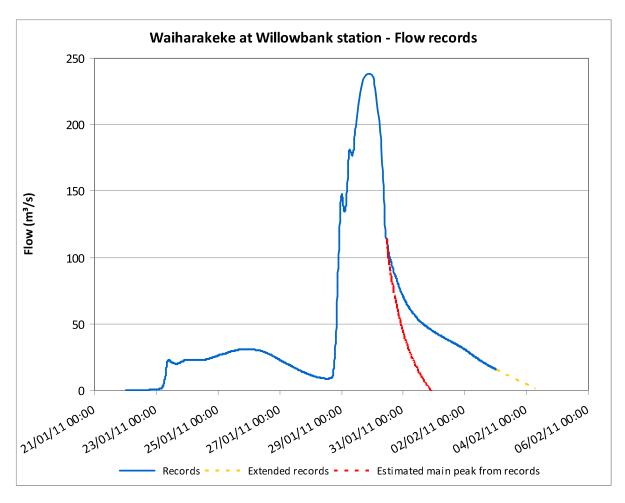
contained within it, it was determined to be necessary to exclude a portion of the Willowbank hydrograph tail from calibration (refer to Figure 4-5). The reason for the exclusion is due to an uncertainty of the rate and amount of infiltration for the catchment. The runoff coefficient of 0.73 corresponds to the overall flood volume, considering the totality of the tail. The value of 0.55 considers mainly the fast response of the hydrograph, with a shorter tail.

The runoff coefficient range translates to infiltration rates of 7.5mm/hr (RC=0.55) and 4.3mm/hr (RC=0.73) respectively. Figure 4-5 shows the flow records from Willowbank and the volume estimations related to the tail of the hydrograph.

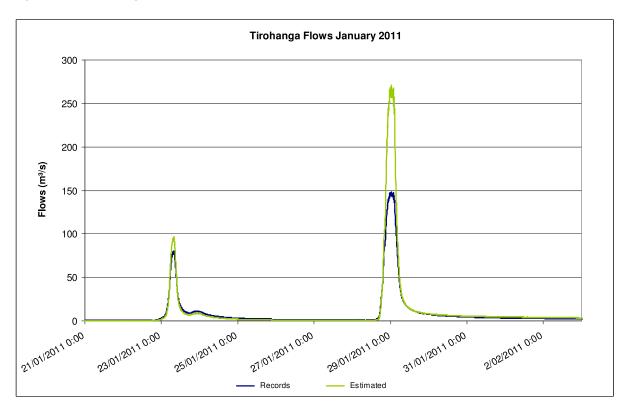
Figure 4-7 Tirohanga below Old Mill; estimated and recorded flow

flows for the peak. Figure 4-6 and Figure 4-7 shows the record rating curves and the flow records against the estimations. This new flow series provides a second guide for the calibration of this gauge. The runoff coefficient calculated based on the new flow series is 0.56 which seems more correct (equivalent to an infiltration of 5.5 mm/hr). In addition, a runoff discharge of up to approximately 5 m³/s/km² is the expected range for a 50-yr ARI event in Northland. This provided further justification for the rating curve modification.

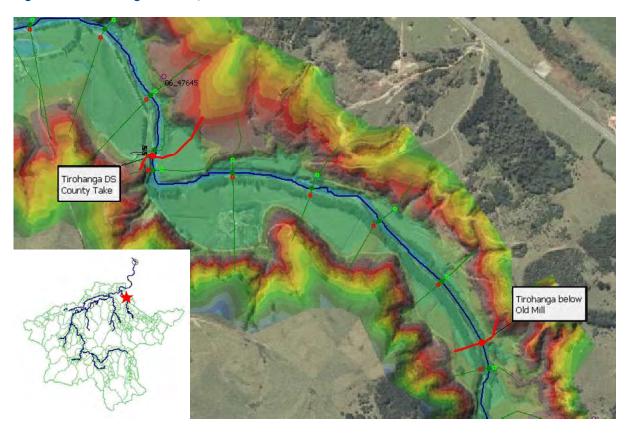
Figure 4-8 Tirohanga stations; location

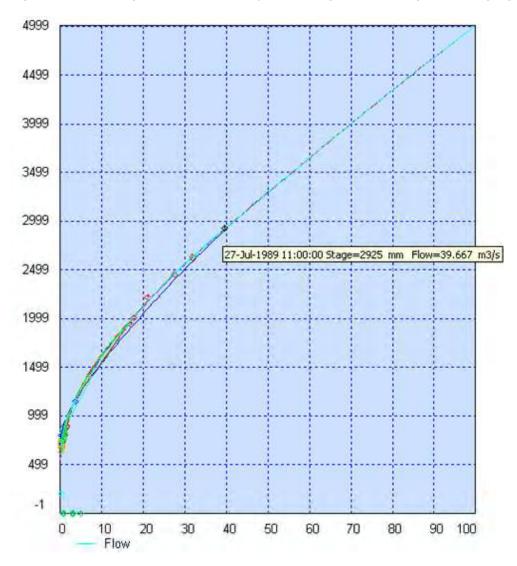
Figure 4-9 Tirohanga downstream County Take; rating curve showing maximum gauging at site

Located 1 km downstream of the station, Tirohanga below Old Mill, this is an abandoned gauge that does not have any records for the storm of January 2011. It has a rating curve, however, with an unknown datum level. This station was anticipated to be more reliable in terms of high flow predictions; however, the rating curve is only available for flows up to $100 \, \mathrm{m}^3 / \mathrm{s}$, and the last flow measurement was taken below $40 \, \mathrm{m}^3 / \mathrm{s}$. With such limited information this rating curve is not very useful. Calibration results have been graphed against the rating curve using an estimated datum. Analysis involving this gauge was not considered further in the evaluated calibration performance. Figure 4-9 shows the available rating curve for Tirohanga downstream of County Take. Section 5.3 shows model results at this site.

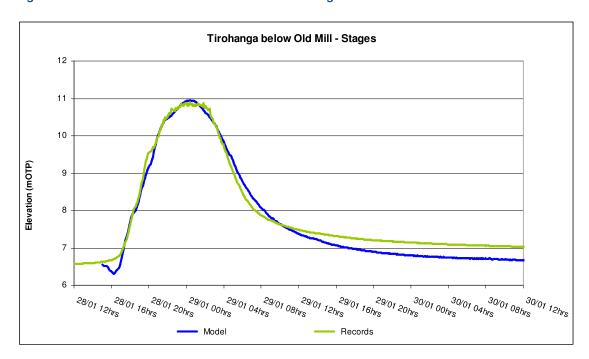
Figure 5-1 Measured and modelled levels at Tirohanga blow Old Mill station

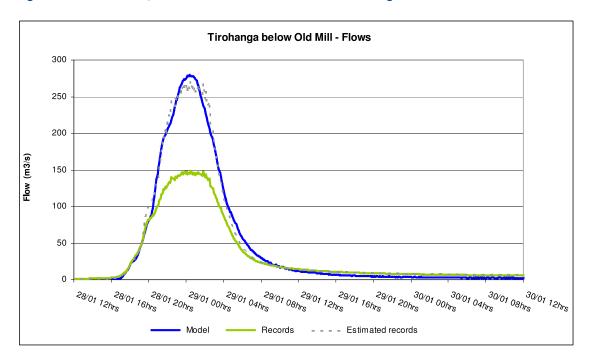
Figure 5-2 Measured, estimated and modelled flows at Tirohanga blow Old Mill station

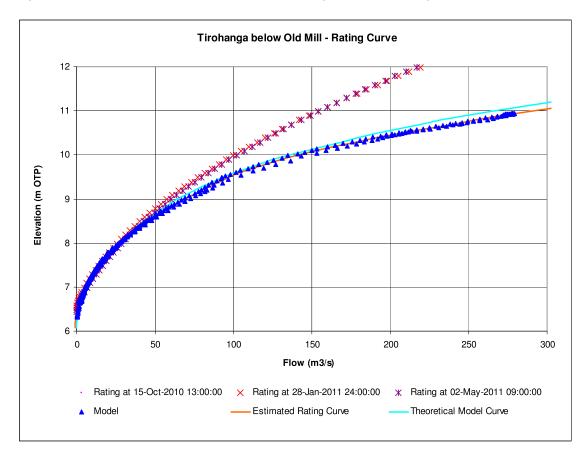
Figure 5-3 Measured, estimated and modelled rating curve in Tirohanga below Old Mill

Figure 5-3 shows the rating curves of the gauge at Tirohanga below Old Mill. It shows three site rating curves provided by NRC and related to three different dates. The Estimated Rating Curve is explained in section 4.4.2.

The Model Curve is a plot of the actual model results. The model results would take into account that the flow might be dependant of upstream and downstream conditions, and different flow regimes that might happen during a hydrograph, calculating the flow and levels in each location as a result of the whole system interacting together.

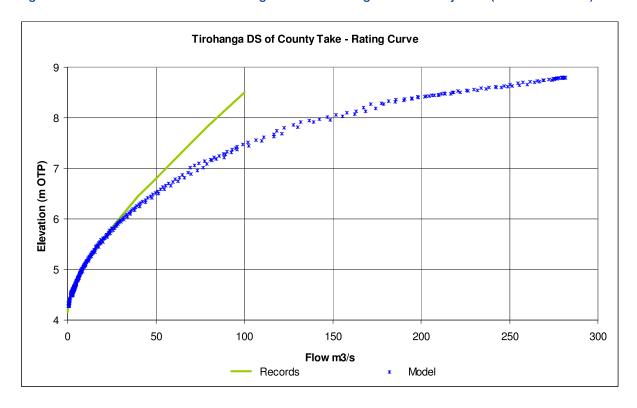
Figure 5-4 shows the rating curve of the gauge at Tirohanga DS of County Take.

Figure 5-4 Recorded and modelled rating curve at Tirohanga DS of County Take (estimated datum)

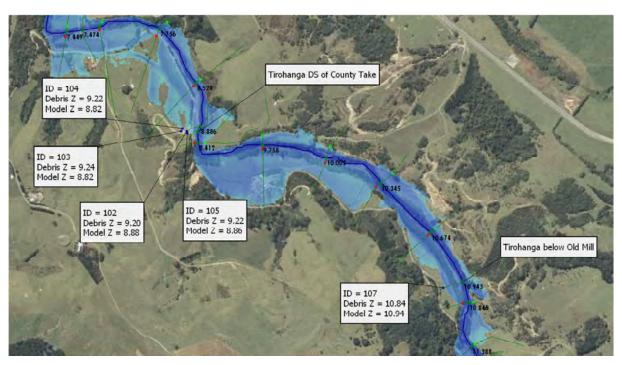
Figure 5-5 January 2011 flood levels at Tirohanga stream

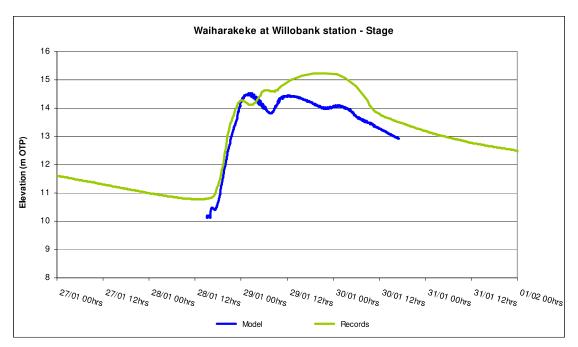
Figure 5-6 Recorded and modelled levels at Waiharakeke at Willowbank station

Figure 5-6 and Figure 5-7 show the comparison between model prediction and stage/flow records at Waiharakeke at Willowbank Station.

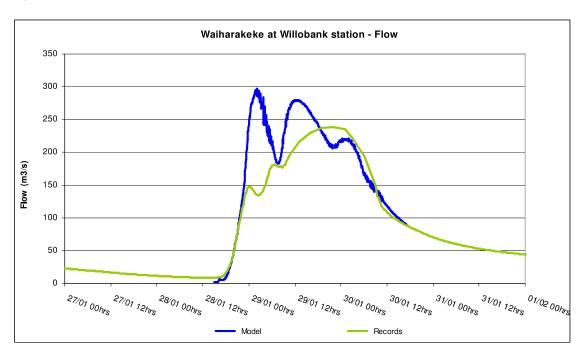
Figure 5-7 Recorded and modelled flows at Waiharakeke at Willobank station

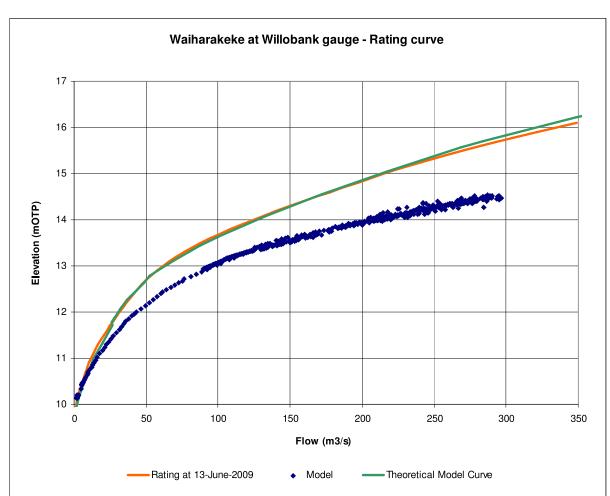
Figure 5-8 Measured, estimated and modelled rating curve at Waiharakeke at Willobank station

Figure 5-8 shows the rating curves of the gauge at Waiharakeke at Willobank. It shows one rating curve provided by NRC and related to the 13 of June of 2009.
