RECREATIONAL SWIMMING WATER QUALITY IN NORTHLAND

SUMMER 2010-11

June 2011
Northland Regional Council
Private Bag 9021
Whangarei 0140
Freephone: 0800 002 004

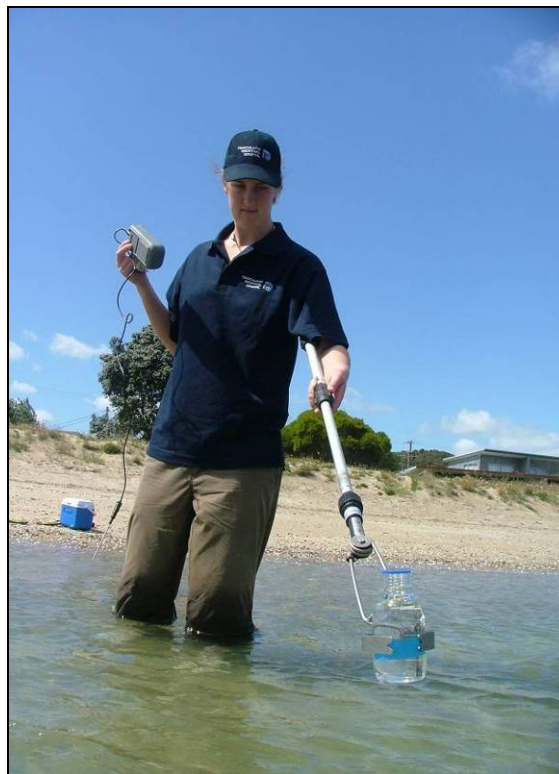
Photo: NRC staff undertaking water quality sampling

Each sample was collected following the methods in the '*Microbiological Water Quality Guidelines for Freshwater and Marine Recreational Bathing Areas*' (MfE, 2003). Coastal samples are taken from the shore using a sampling pole at about 0.5m depth, from approximately 15cm below the surface. Freshwater samples are taken at approximately 30cm below the surface, where the depth of water is approximately 1 metre. All samples are collected during daylight hours and sites are sampled in the same order each week. This ensures that, where practical, samples are collected at around the same time each week.

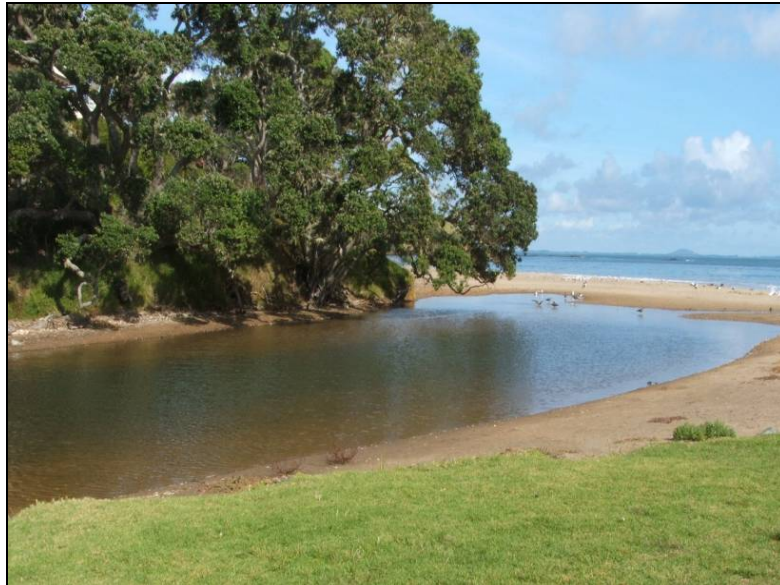
Photo: Coopers Beach stream

'Action' results from this site may, in part, relate to rainfall events or re-suspension of sediment and bacteria in the water column. However, as there is no consistent relationship between rainfall or turbidity and *E. coli*, there must also be a direct source of contamination into the stream.

Faecal source tracking on samples taken from the stream indicates that the two main sources of faecal contamination at this site are farmed ruminant and wildfowl. One sample taken in 2009 indicated a source of contamination to be dog however this source has not been detected in further samples, suggesting it was a one-off event.

The Council Land Management team has been working with land-owners in the catchment to discuss options for excluding livestock from the stream. However, the stream is the only source of drinking water for stock in the catchment and a piped water supply would need to be in place before stock could be excluded. This is a long-term project and the Council will continue to work with landowners in this area.

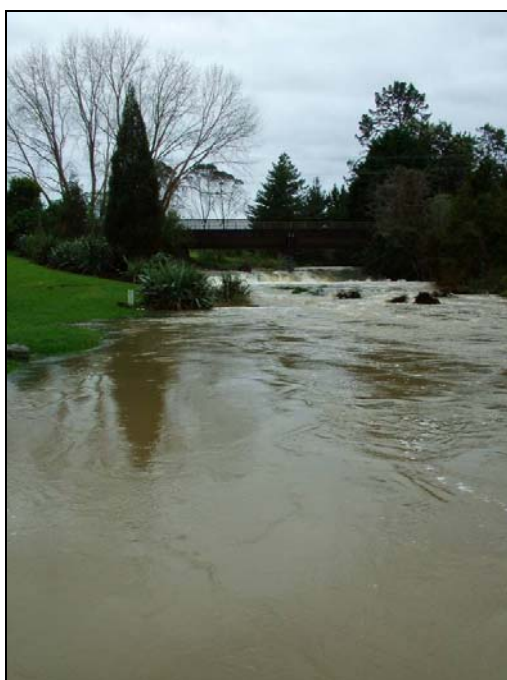
Photo: Whangarei Falls swimming hole in flood

Of the four main tributaries flowing into the Waitaua stream above Whangarei Falls, bacteria levels were found to be elevated, and generally above MfE 'Action' guideline values on three. However, the tributary with the highest *E.coli* levels was not found to be having a notable impact on bacteria levels in the Waitaua stream.

Analysis of the data for the swimming site shows that bacterial water quality is consistently poor irrespective of rainfall (25 of 43 non-compliant results since 2003 relate to rainfall). Although some 'Action' results may be related to rainfall and so rainfall runoff, there must also be a more direct source of contamination at this site, for example, stock or wildfowl in the water.

Microbial source tracking at six sites within the catchment indicated faecal contamination from both ruminant and wildfowl sources. A very weak positive marker for dogs was also found in one sample from the swimming site. No human markers were found in any of the samples.

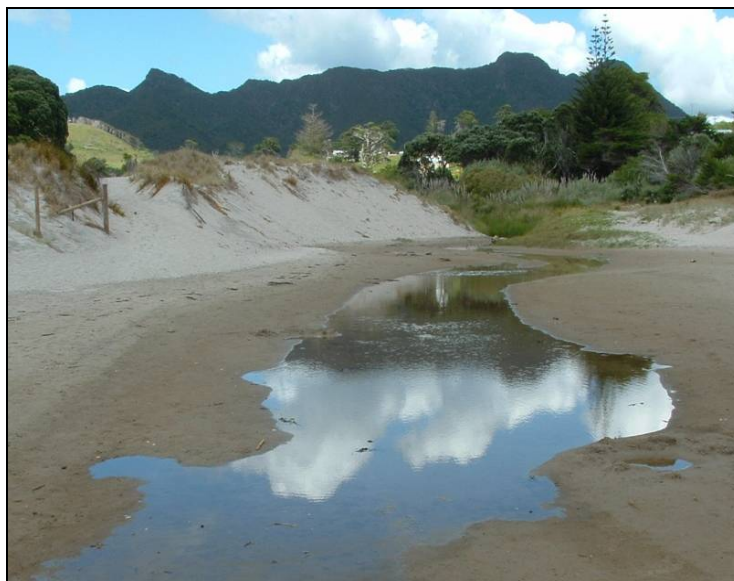
Photo: Ocean Beach Stream at low tide

bacteria and temperature. Of the 16 'Action' results recorded for the site since December 2009, six relate to turbidity >4 (the median for the site is 3.8 NTU). One of these 'Action' results is rainfall related. Preliminary analysis of the data suggests no relationship between turbidity and levels of *E. coli* at the site. Analysis of tide data for 'Action' results shows that 12 of the 'Action' results are at high or incoming tide.

Ocean Beach stream was subject to site investigation work in 2007 and 2010-11. Faecal source tracking work on samples taken from the site in 2007 showed a source of contamination to be wildfowl. Results from samples taken in 2010-11 showed two possible sources of contamination – wildfowl (most probably gulls) and humans. Two other weak markers were found in 2010-11 – ruminant and dog.

Although human sterols were found in two samples taken from this site, no PCR markers for humans were found. This could be because the source of pollution is from a small number of individuals, or that the human source of pollution is partially treated.

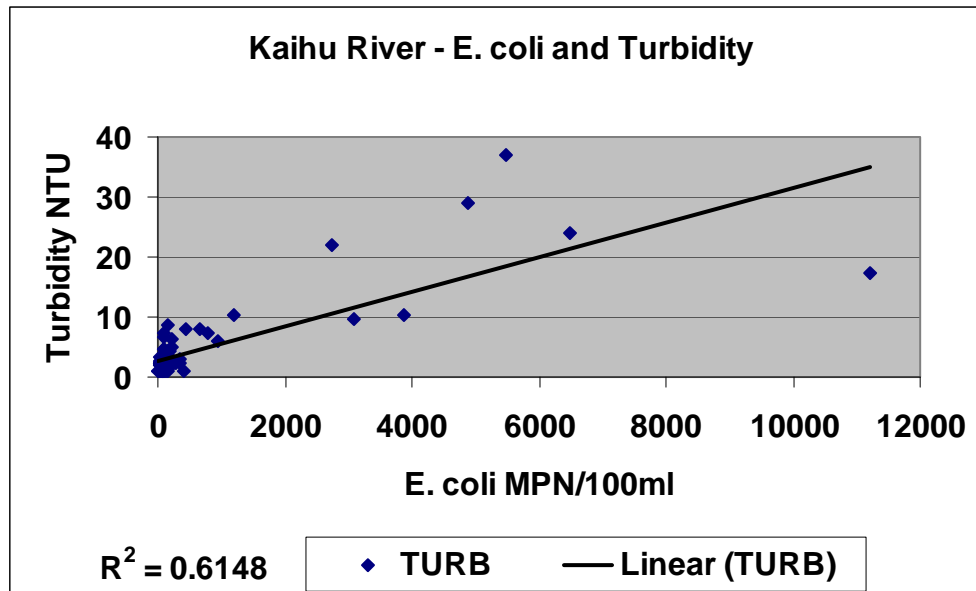
Graph 1: Turbidity and *E. coli* data for the Kaihu River

Since February 2002, there have been a total of 19 'Action' results recorded for this site. All 19 of these results relate to rainfall events. Preliminary analysis of the data shows that there is a relationship between turbidity and *E. coli* at this site, as seen in graph 1 below. All 19 'Action' results correspond to elevated levels of turbidity in the river, which is generally in response to rainfall events.

Results from faecal source tracking at this site in 2010-11 indicate that the source of contamination at this site is ruminants. The upstream catchment is pastoral with areas of native bush. It is most likely that contamination at this site is the result of rainfall runoff carrying contaminants off farmland into the river, although there have also been incidents of direct discharge of farm dairy effluent into a tributary of the river in the upper catchment.

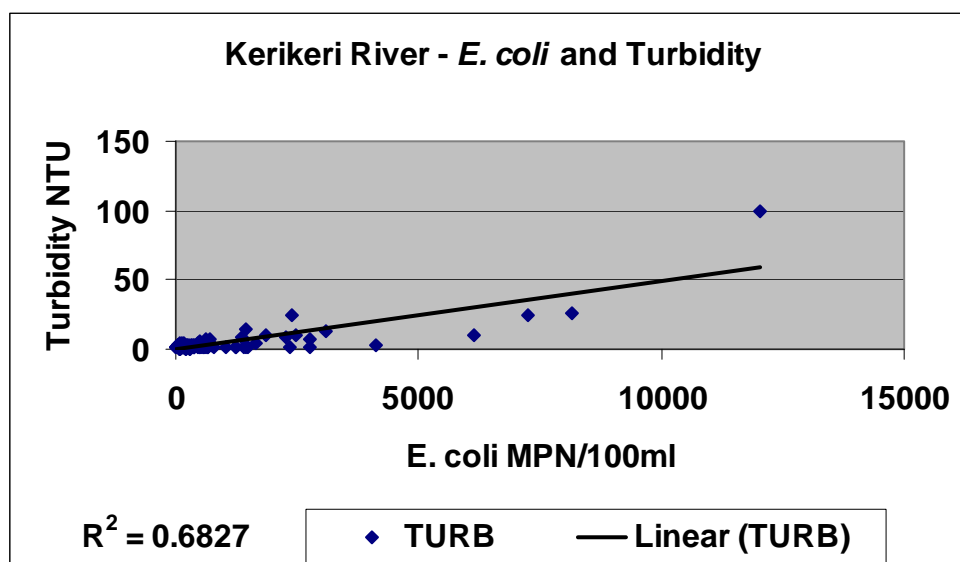
Graph 2: Turbidity and *E. coli* data for the Kaihu River

Results from faecal source tracking at this site in 2010-11 indicate that the sources of contamination at this site are ruminants and wildfowl. The upstream catchment is a mix of pastoral, horticulture, urban and native bush. It is likely that contamination after rainfall is as a result of rainfall runoff from the land. However, there is also a direct source of contamination at the site, as 13 ‘Action’ results are not related to rainfall. This is likely to be contamination from wildfowl in the water.
