23 Taupo Bay

Coastal Erosion Hazard Assessment

NORTHLAND REGIONAL COUNCIL
Coastal Erosion Hazard Assessment
Taupo Bay
Site: 23

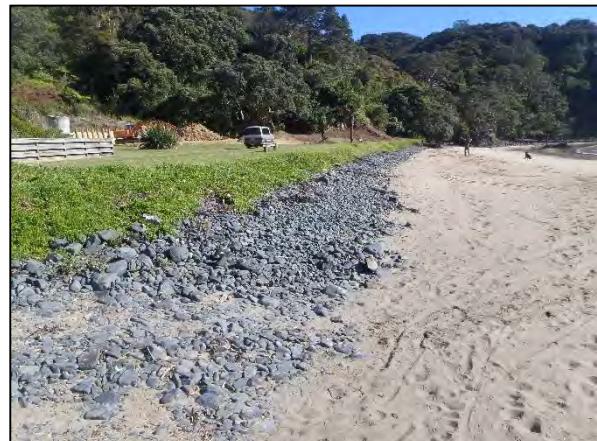
Site Photograph A (north)

The site has a sandy beach comprising fine to medium sand. The beach has a minimal berm width in the north and the berm increases toward the south to approximately 10 m above the high tide line. The berm area above the high tide line along the northern 100 m of the site comprises large pebble sediment sourced from the adjacent cliff shoreline (refer to Site Photograph A).

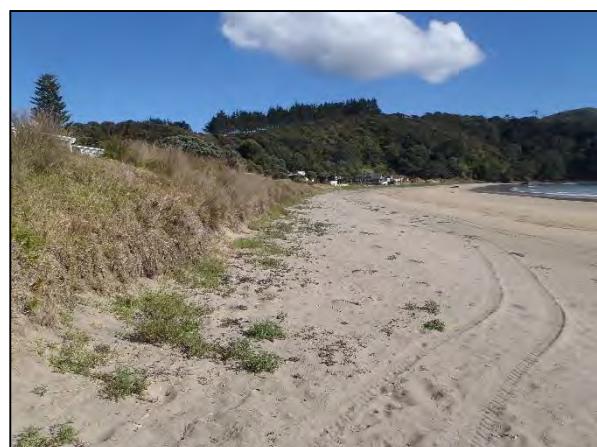
Site Photograph B (centre)

The dune vegetation is sparse over the northern half of the site. The back shore is relatively low and a recent erosion scarp exists. The dune is well vegetated at the southern end with spinifex and a foredune is developing. The dune heights range from approximately RL 4 to 7 m along the site. The backshore is developed with some houses situated only 5 m landward of the dune toe.

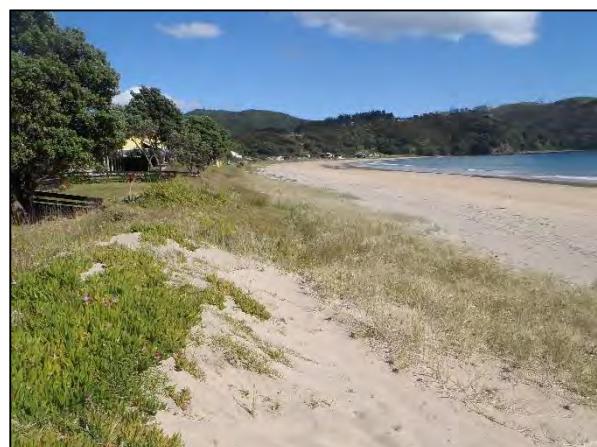
Site Photograph C (south)

The Taupo Creek mouth is located at the southern end of the site. A relatively large intertidal spit has formed at this end of the beach, which forces the stream flow north along the base of the Castle Peak headland. Some recent erosion is evident on the inside of the spit shoreline.

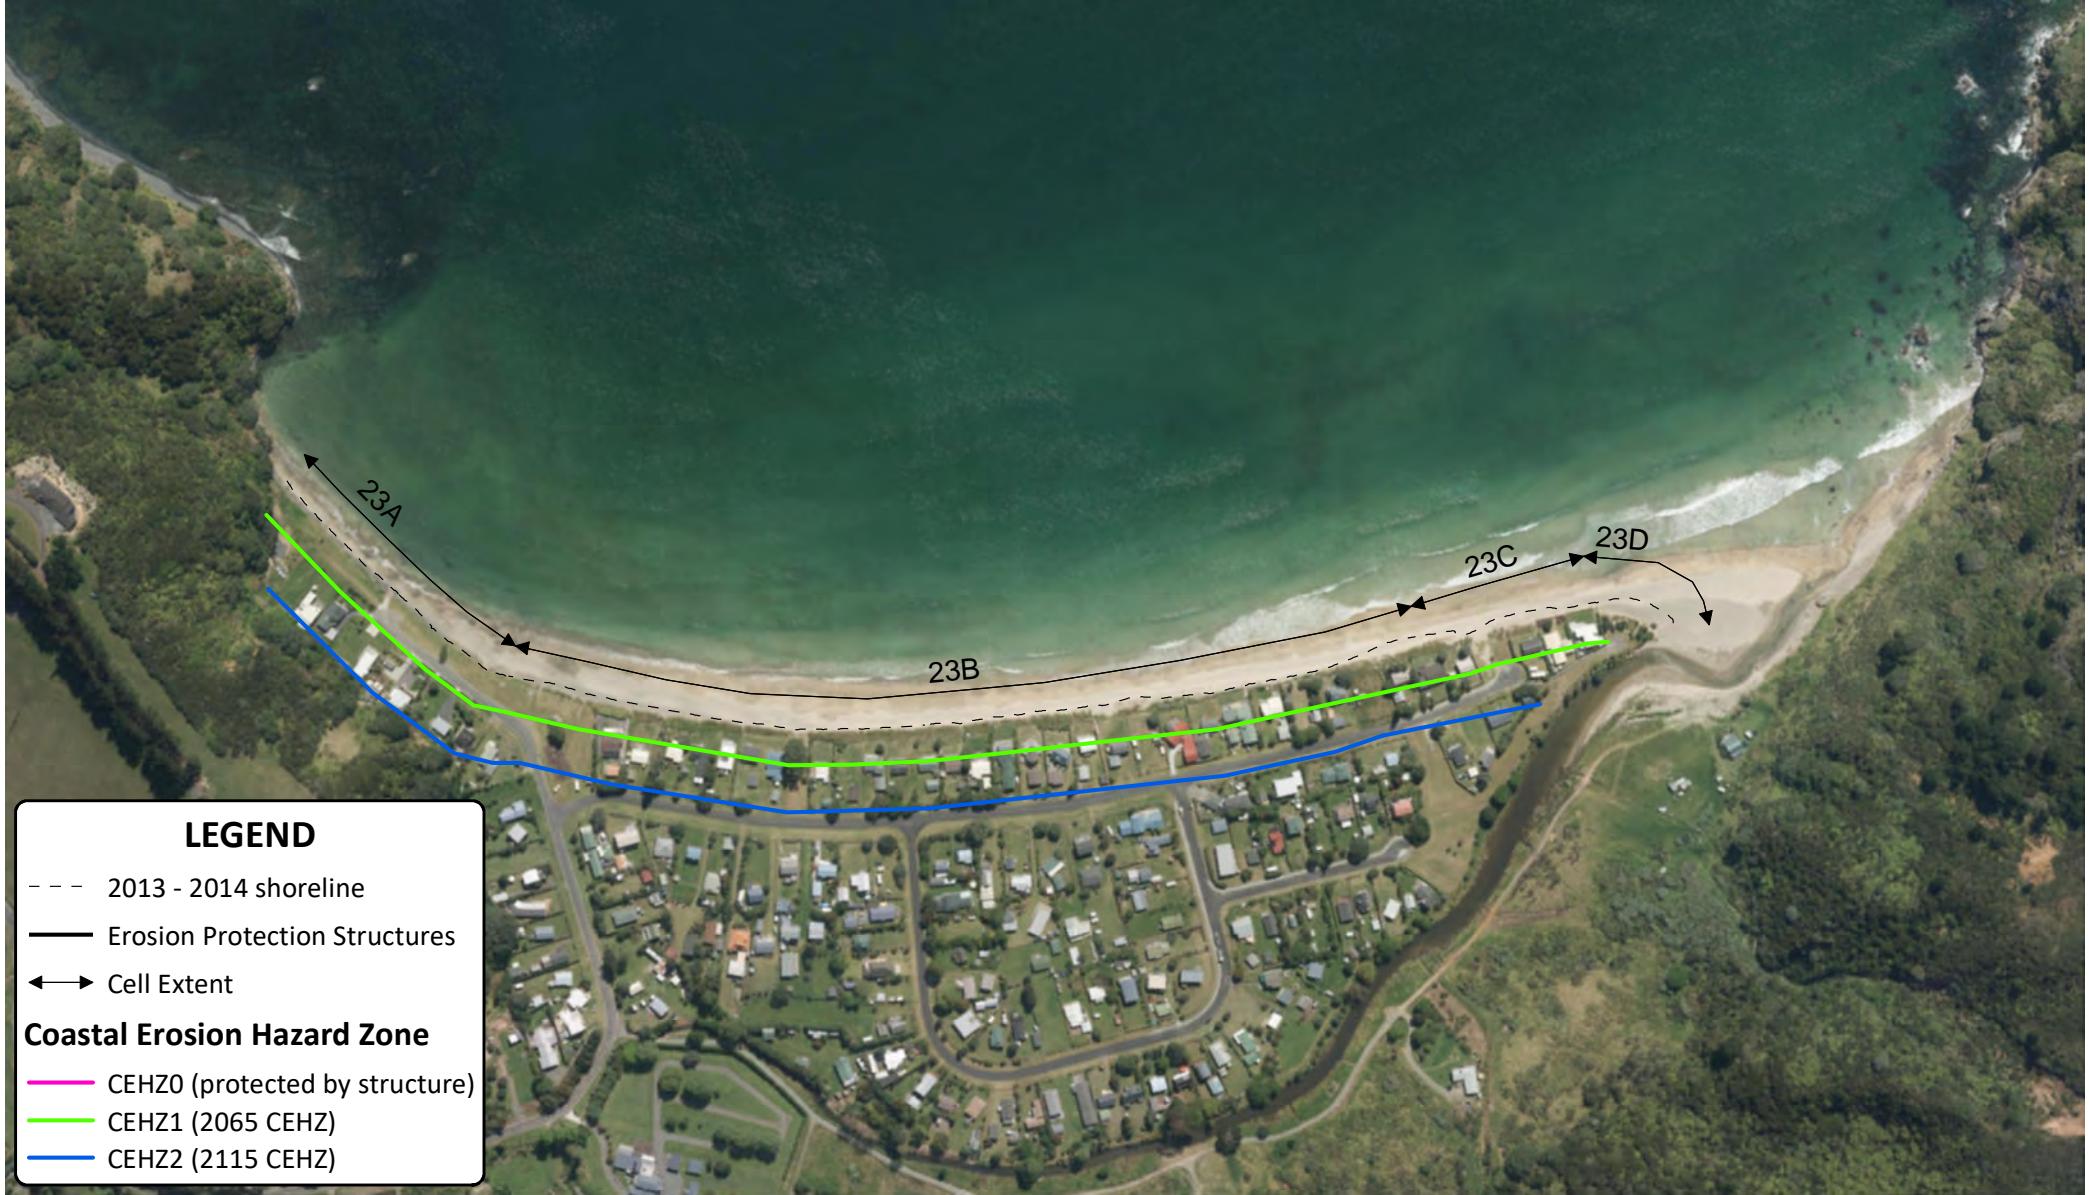
FIGURE No.
Figure 23-5

Coastal Erosion Hazard Zone widths are presented within Table 23-2 and Figure 23-5. CEHZ1 values range from 24 to 26 m and CEHZ2 values from 55 to 69 m. CEHZ's have been mapped in agreement with the calculated values.

Notes: Dashed CEHZ indicates greater uncertainty around stream mouths and backshore topography.
Northland 0.1m Rural Aerial Photos (2014-2015).

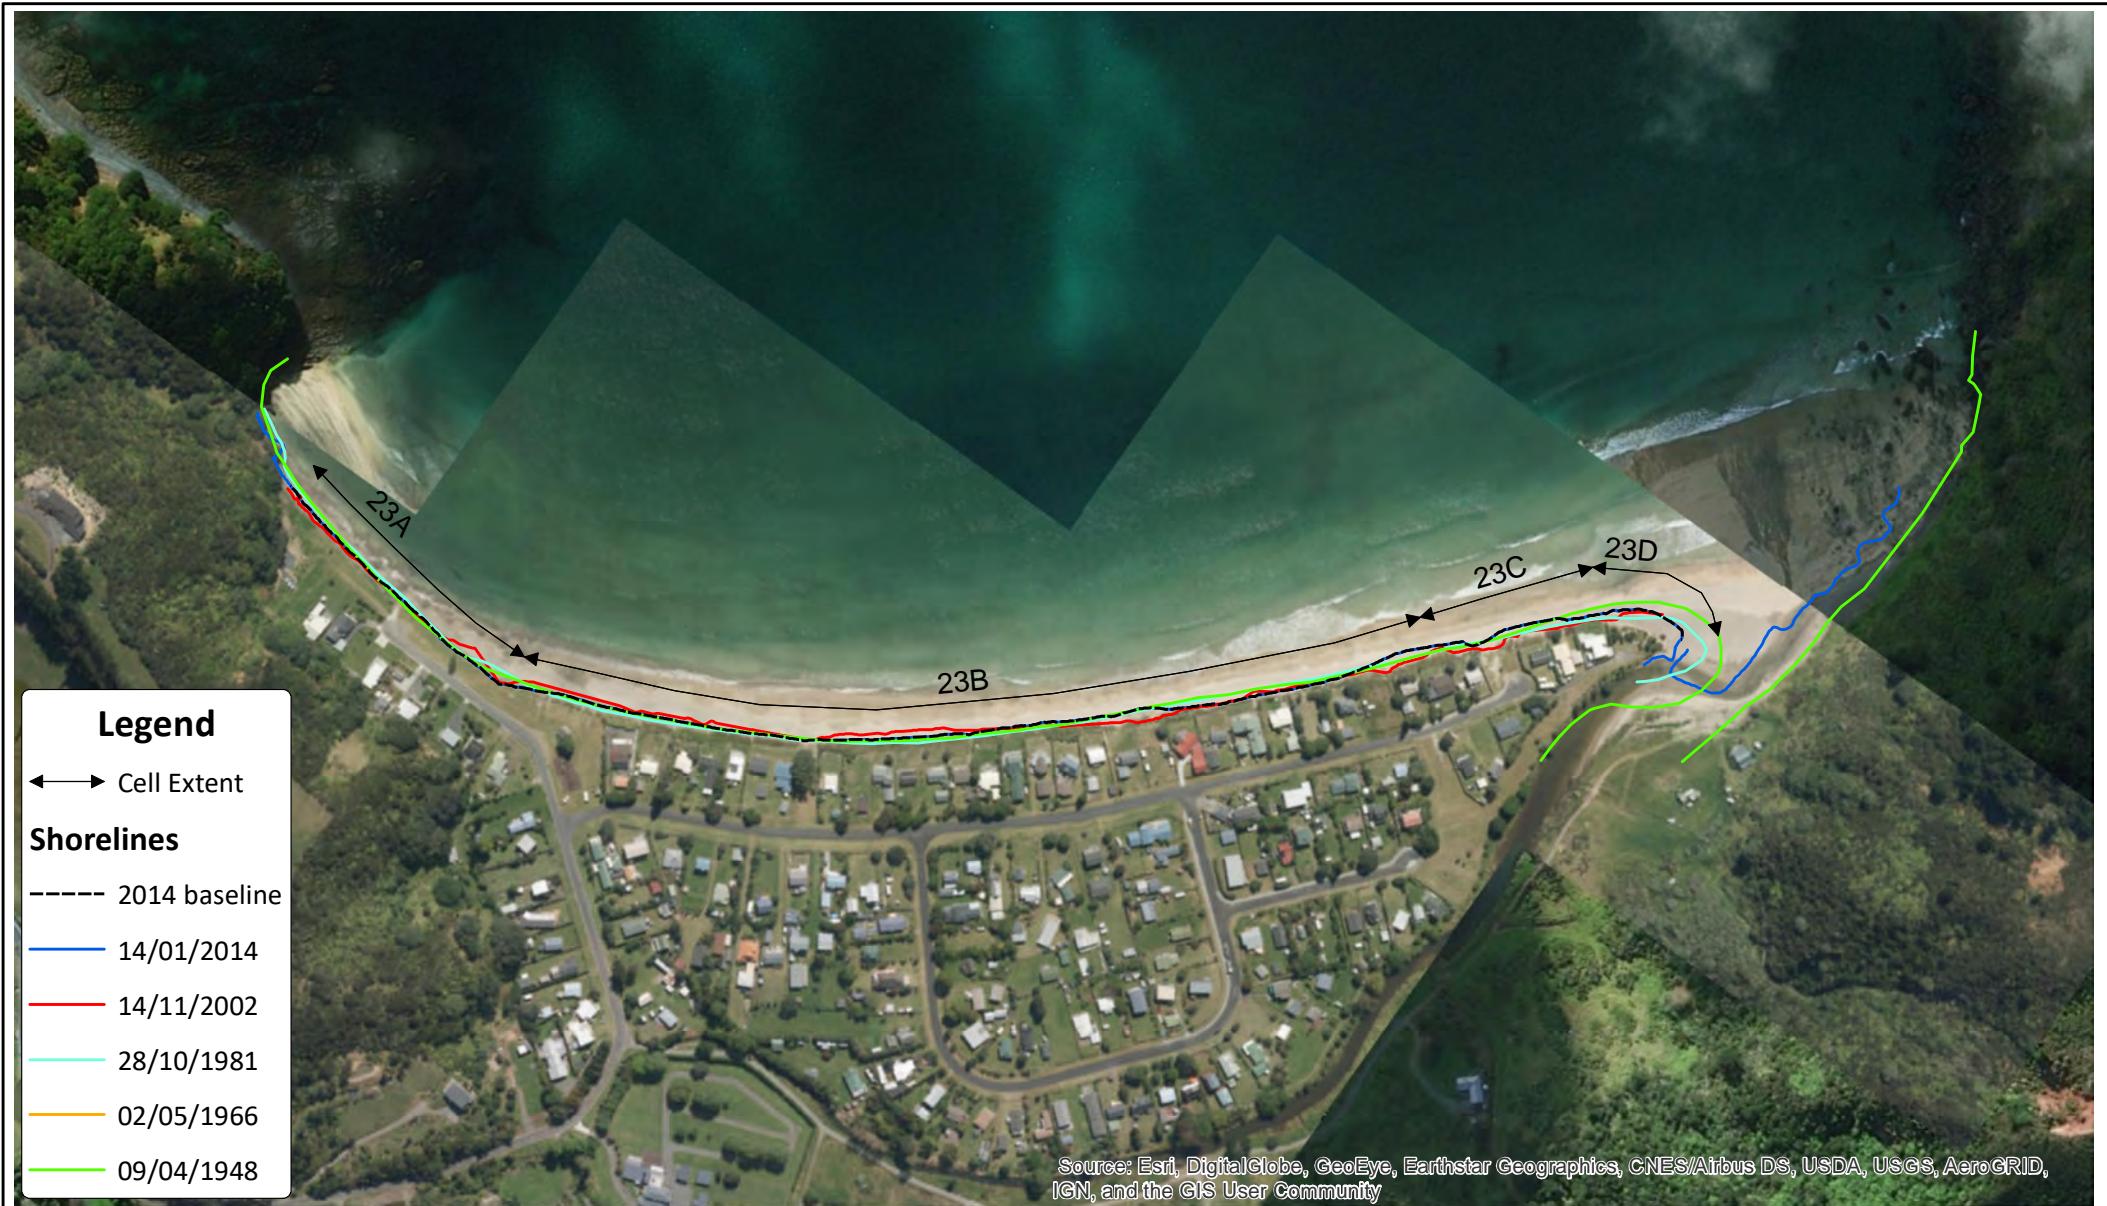
FIGURE No.
Figure 23-6

Figure 23-6 shows the available historic shorelines for Taupo Bay.

NORTHLAND REGIONAL COUNCIL
Historic shorelines
Taupo Bay
Site: 23
