Te Hiku

Lake Waipara / Dead Lake (Aupouri), NRC Lake No. 25

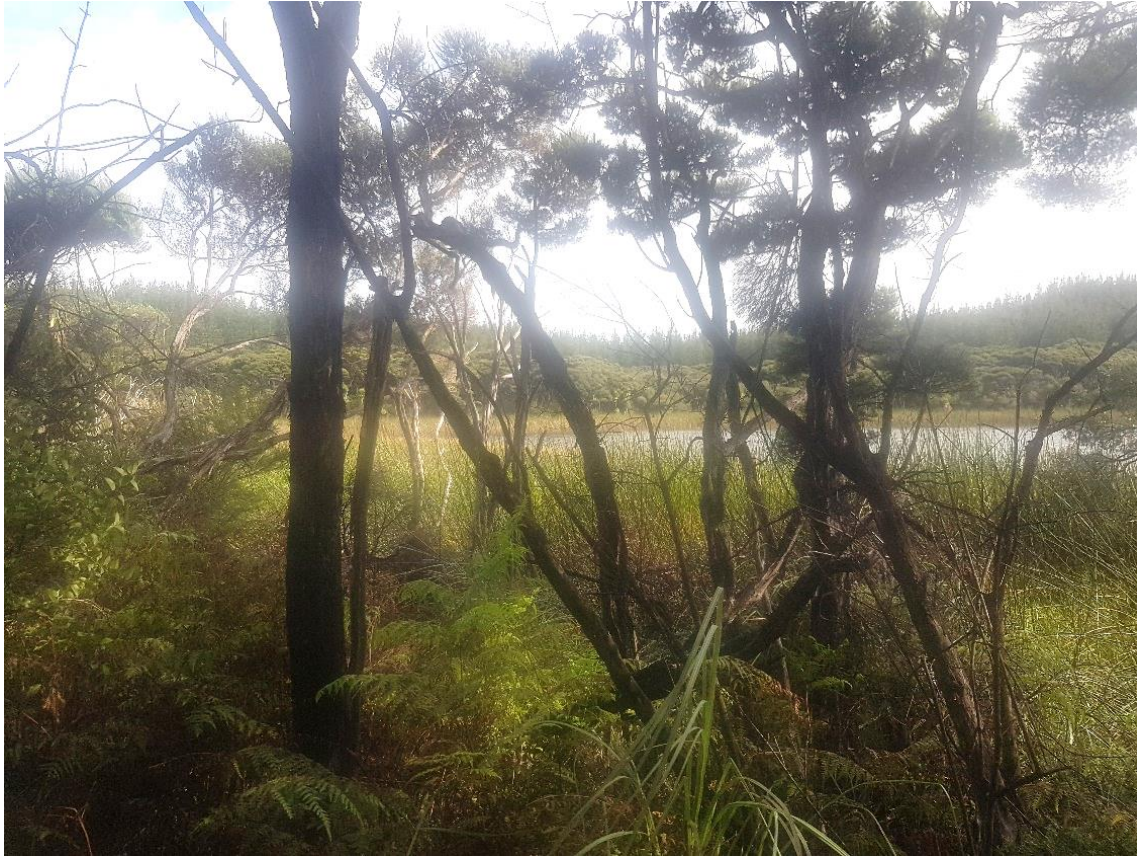
Lake Waipara from the southern margin of scrub vegetation which now surrounds the entire lake with a contiguous emergent zone (2023, Paul Champion).
