6 One Tree Point

Coastal Erosion Hazard Assessment

NORTHLAND REGIONAL COUNCIL
 Coastal Erosion Hazard Assessment
 One Tree Point
 Site: 6

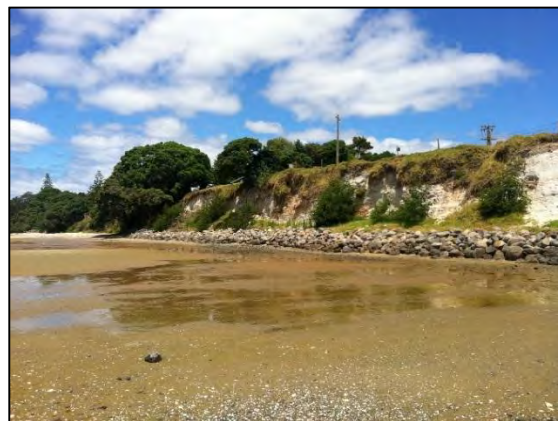
Site Photograph A (east facing shoreline)

Areas of slumping and landslides are apparent along the site, where coastal processes are undercutting the cliff toe causing instability over time. A sandy beach comprising fine to medium sand exists along the cliff toe from One Tree Point to Marsden Cove. There is a minimal berm above high tide and no dune system has developed.

Erosion protection structures exist along the majority of the toe of the cliff. The structures range from loose rock revetments to timber seawalls. There are also a number of stormwater outlets located at the base on the cliff. These type of structures can lower the adjacent foreshore level resulting in more wave induced erosion at the toe of the cliff. A boat ramp is situated at One Tree Point.

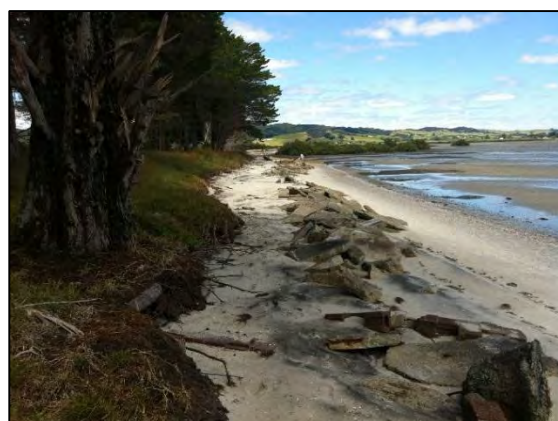
Site Photograph C (western spit shoreline)

The barrier spit located at the western end of the site has a relatively low backshore elevation and is experiencing erosion over the southern half of its extent. A sandy beach comprising fine sand exists along the spit shoreline, which transitions to intertidal mud flats approximately 10 m offshore.

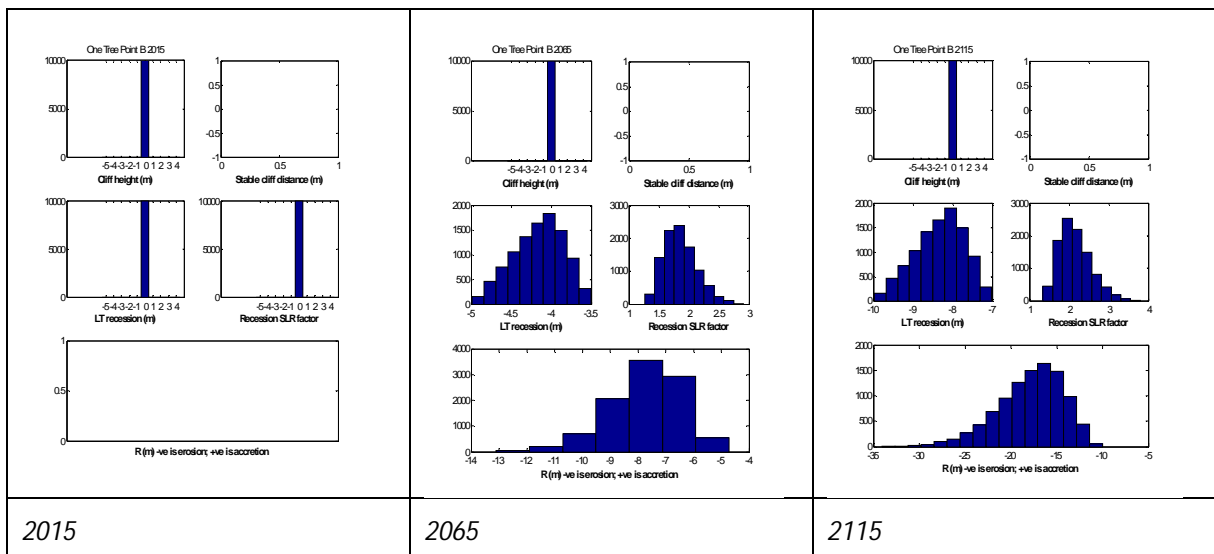
Figure 6-2 Histograms of parameter samples and the resultant shoreline distances for 2015, 2065 and 2115 timeframes for cell 6B

For cell 6B to cell 6D the cliff projection method has been adopted with future shoreline distances shown in Figure 6-2 to Figure 6-5 and Table 6-2 instead of CEHZ distances. The future shoreline (cliff toe) distances range from 3 to 7 m to 2065 and 14 to 25 m to 2115.

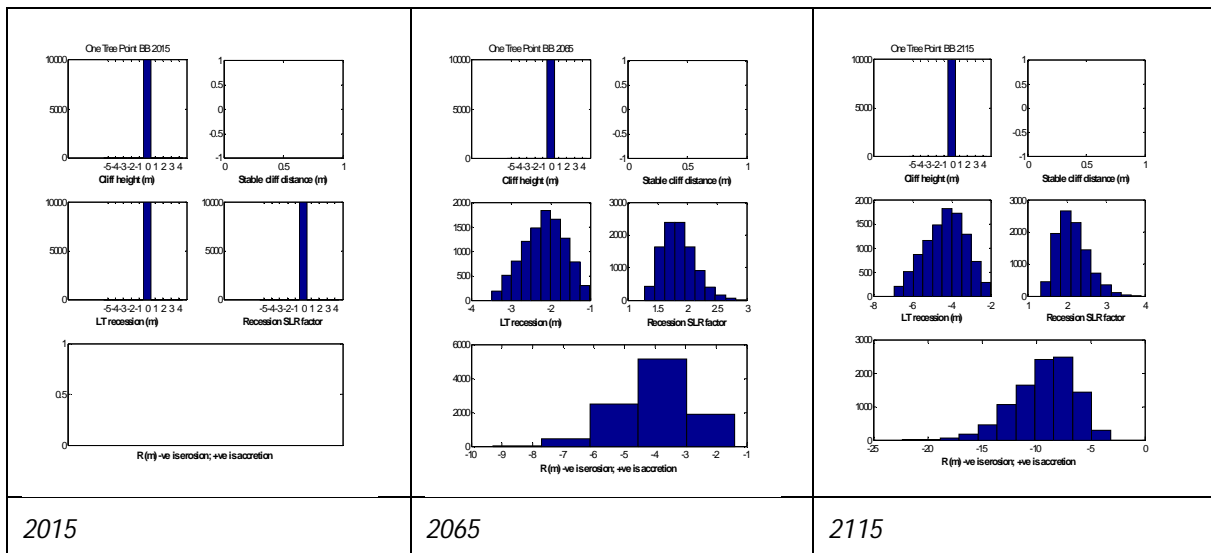
Figure 6-3 Histograms of parameter samples and the resultant shoreline distances for 2015, 2065 and 2115 timeframes for cell 6BB

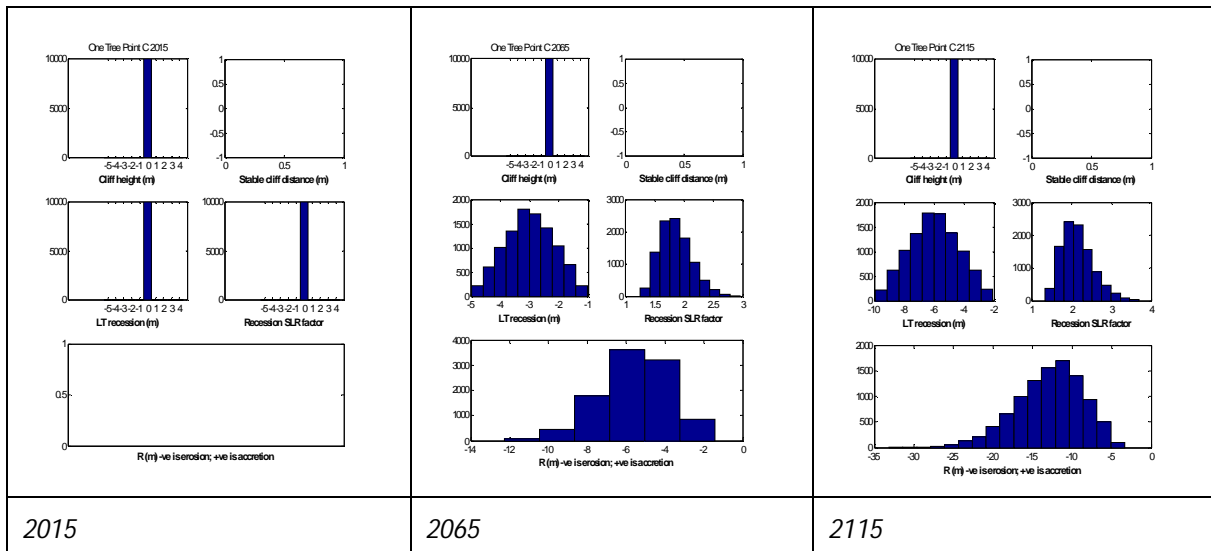
Figure 6-4 Histograms of parameter samples and the resultant shoreline distances for 2015, 2065 and 2115 timeframes for cell 6C

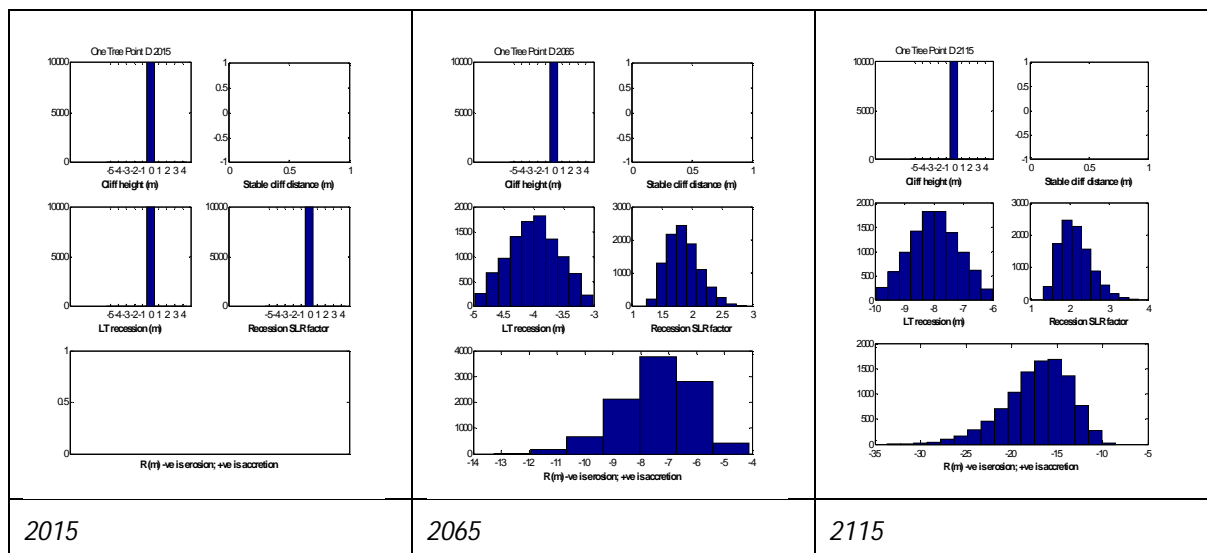
Figure 6-5 Histograms of parameter samples and the resultant shoreline distances for 2015, 2065 and 2115 timeframes for cell 6D

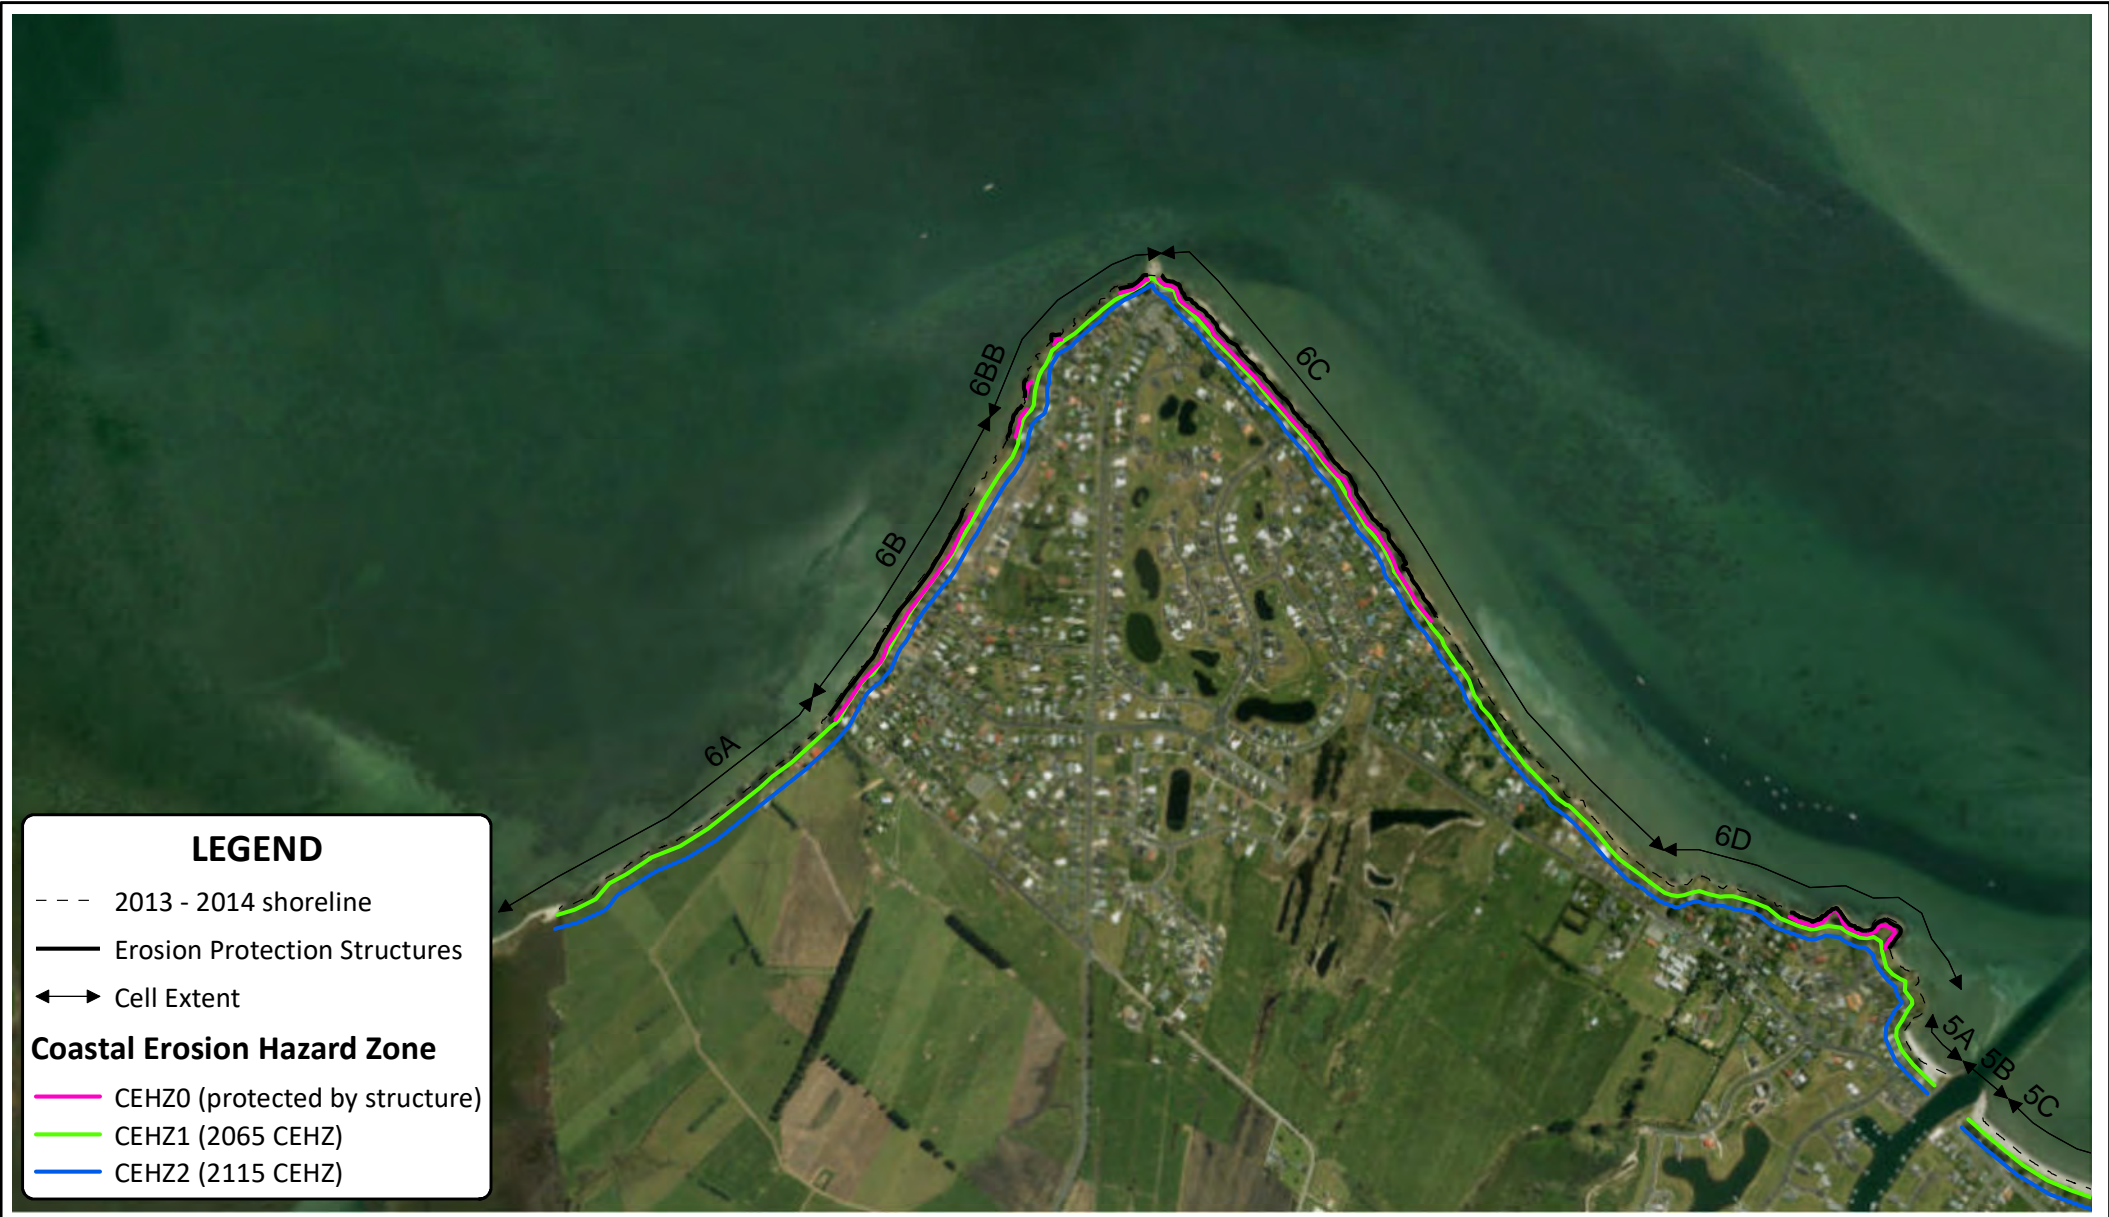
Notes: Dashed CEHZ indicates greater uncertainty around stream mouths and backshore topography. Northland 0.1m Rural Aerial Photos (2014-2015).

Histograms of individual components and resultant CEHZ distances using a Monte Carlo technique are shown in Figure 6-1. Coastal Erosion Hazard Zone widths are presented within Table 6-2 and Figure 6-6. CEHZ1 for cell A is 12 m and CEHZ2 is 41 m. CEHZ's have been

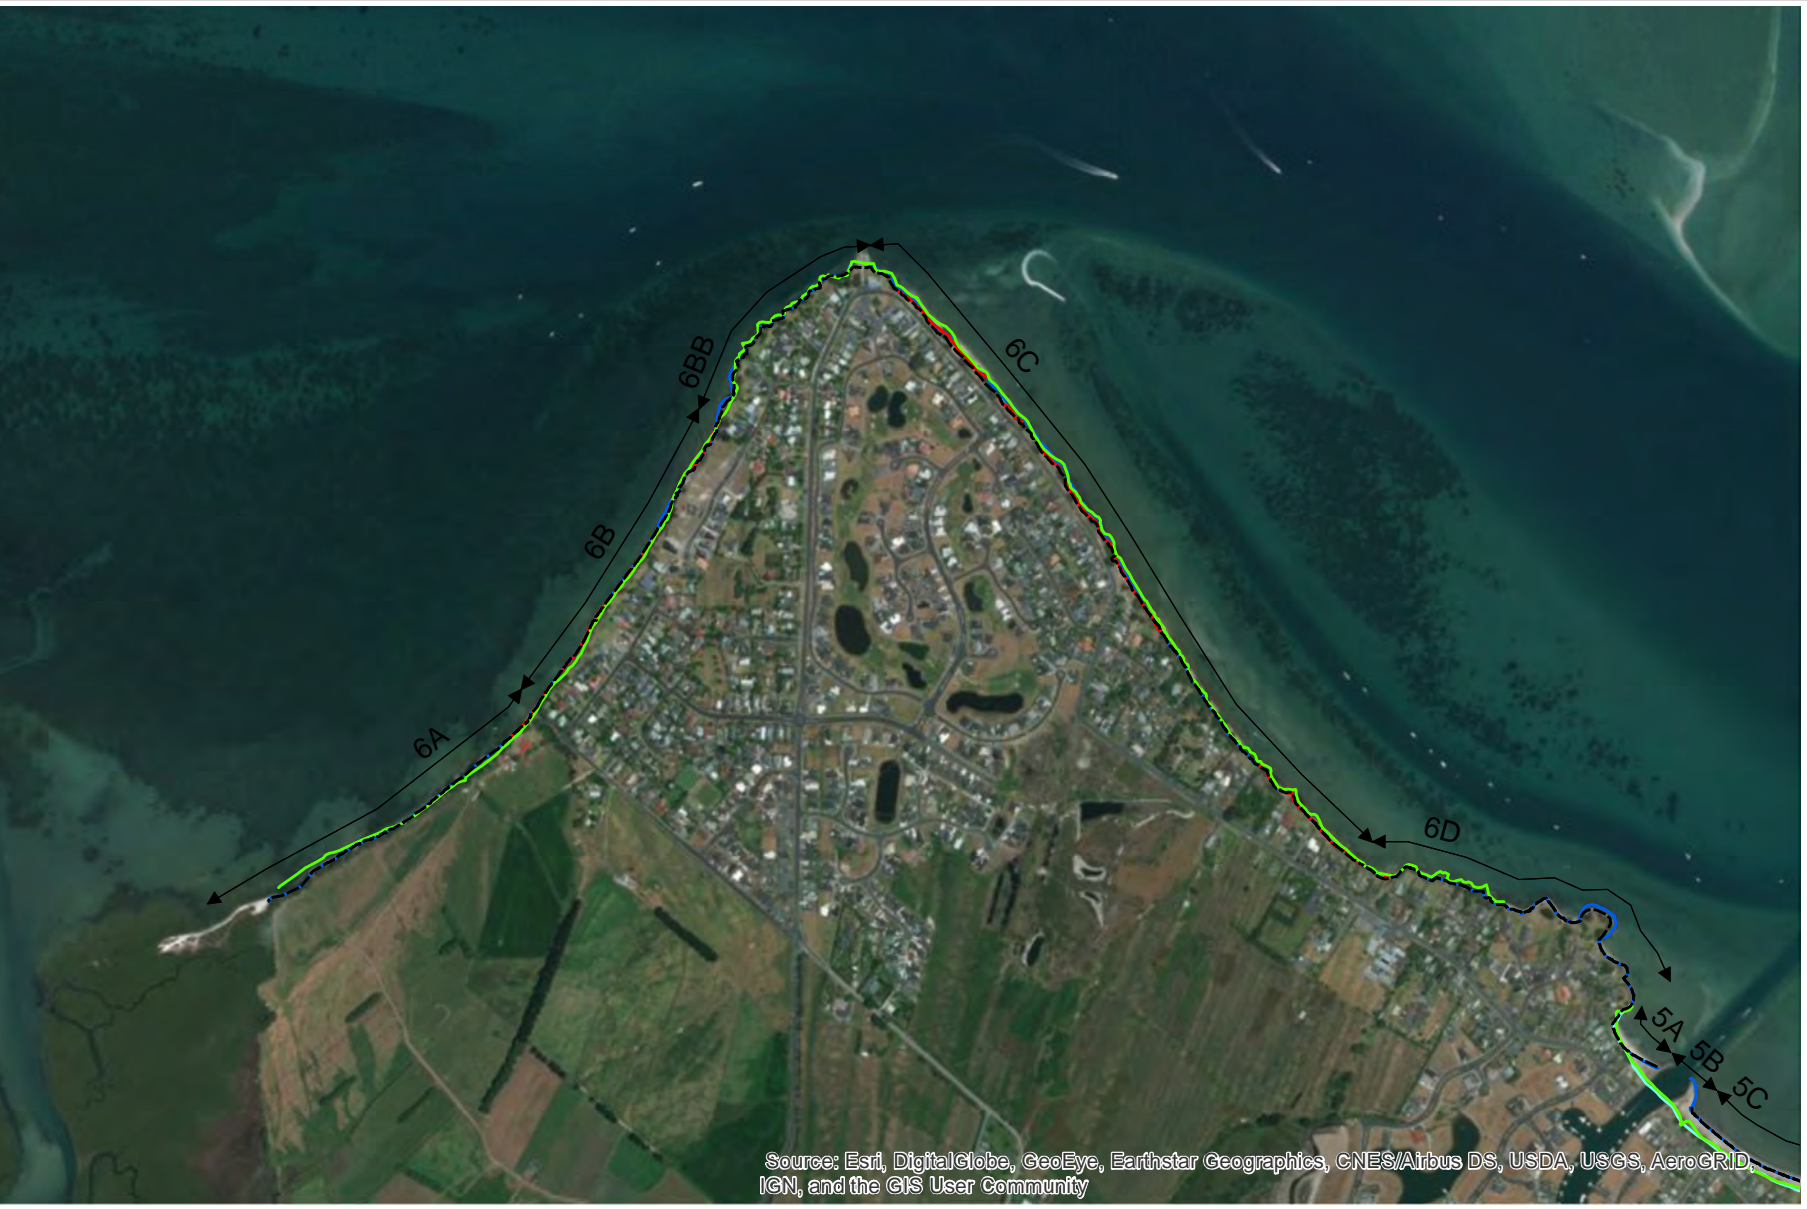
Historic shorelines
One Tree Point
Site: 6

Figure 6-7 shows the available historic shorelines for One Tree Point.
