## North of Dargaville

Black Lake (Kai Iwi Lakes), NRC Lake No. 226.

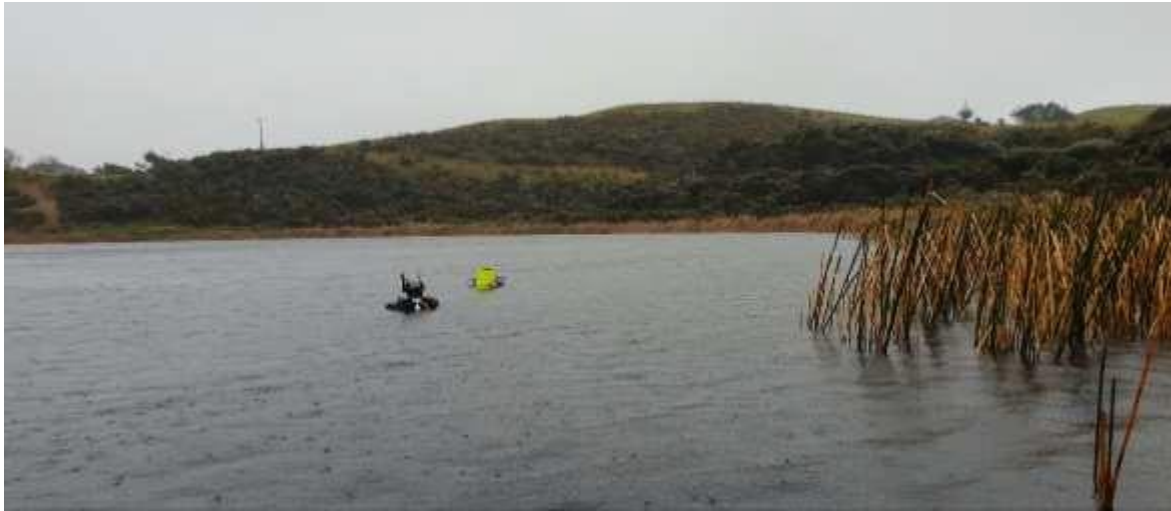
**Black Lake.** Divers record submerged and emergent vegetation data in Black Lake, with regenerating forest seen in the catchment. (Photo: Susie Elcock, September 2018).

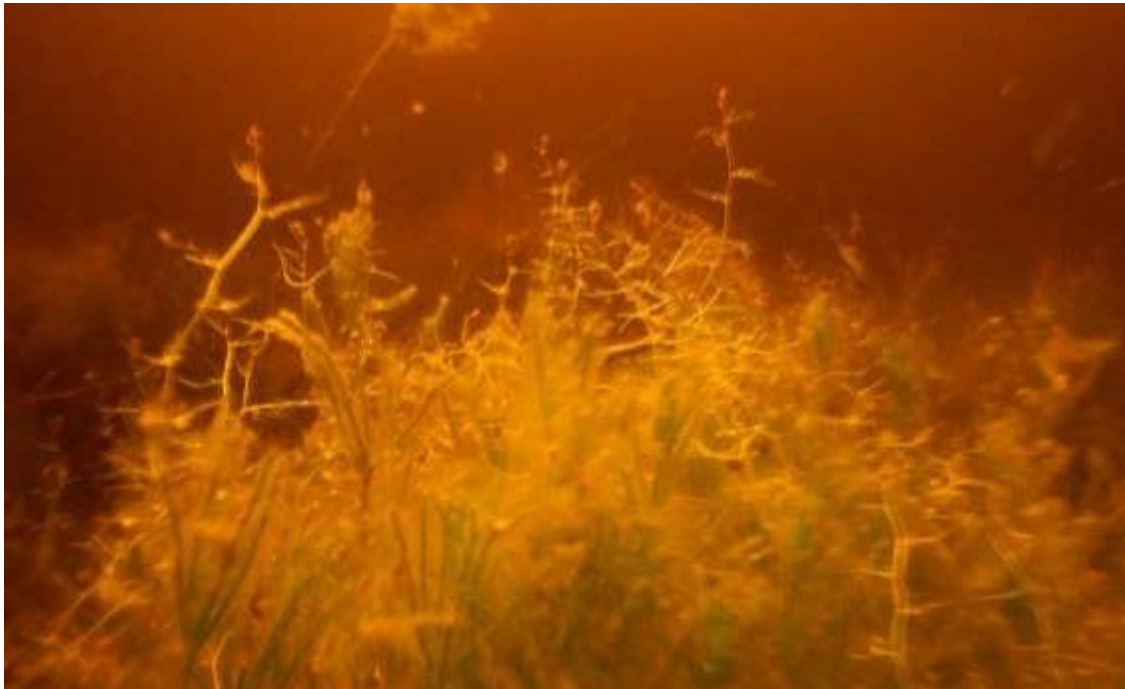
A small (1.5 ha) lake (1656385E, 6038510N), with a maximum depth of 19.8 m. The water was heavily stained orange/brown resulting from the dense wetland marginal vegetation, with a marked thermocline at 3 m depth. The lake was surrounded by a recently fenced wetland (0.86 ha), with over 2 ha of regenerating forest in the catchment, the remainder is grazed by cattle. Access is across private farmland, with no boat access to the lake.

**Figure 3-2: Black Lake.** Photo showing the brown-stained water, with submerged *Chara australis* and *Utricularia gibba*. (Photo: Tracey Burton 18 September 2018).

The submerged vegetation was dominated by *Chara australis* and *Nitella* sp. aff. *cristata*, both forming high covers from 1.0 to a maximum depth of 4.9 and 6.7 m respectively. *Potamogeton ochreatus* was common in the submerged vegetation, with *P. cheesemanii* also found on one profile. The invasive *Utricularia gibba* was common attached to raupo roots and sprawling over the other submerged species to a maximum depth of 3.9 m.
