Review of water quality information for Otiria Stream, Moerewa

August 2008
Northland Regional Council
Private Bag 9021
Whangarei
Ph: 0800 002 004

Introduction

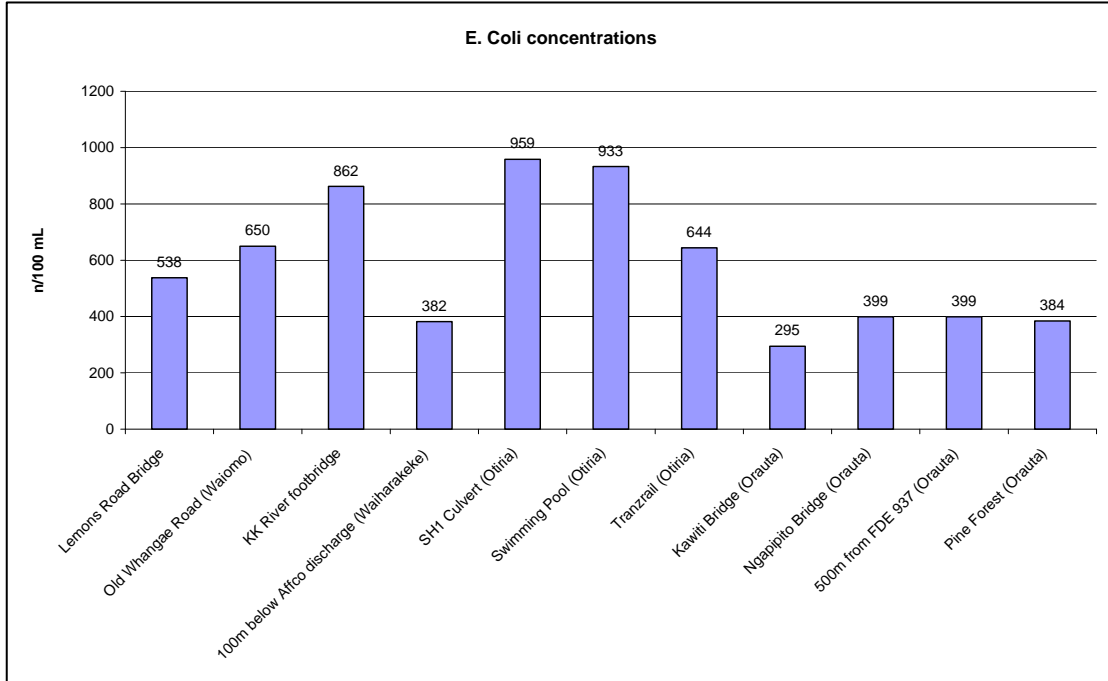
E-coli concentrations at selected sites (sampled 03/04/02).

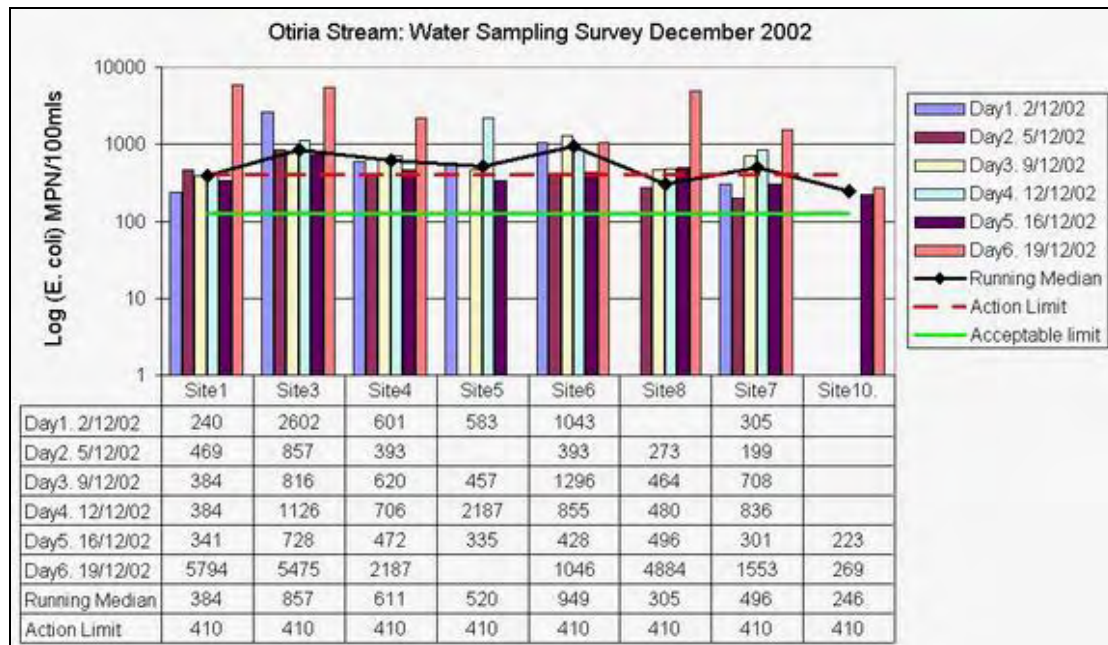
Table showing *E. coli* (MPN/100mls) results for some Otiria Stream sites

Exceedingly high sample results for all sites except site 1 are a bit unusual in comparison to results of other days.

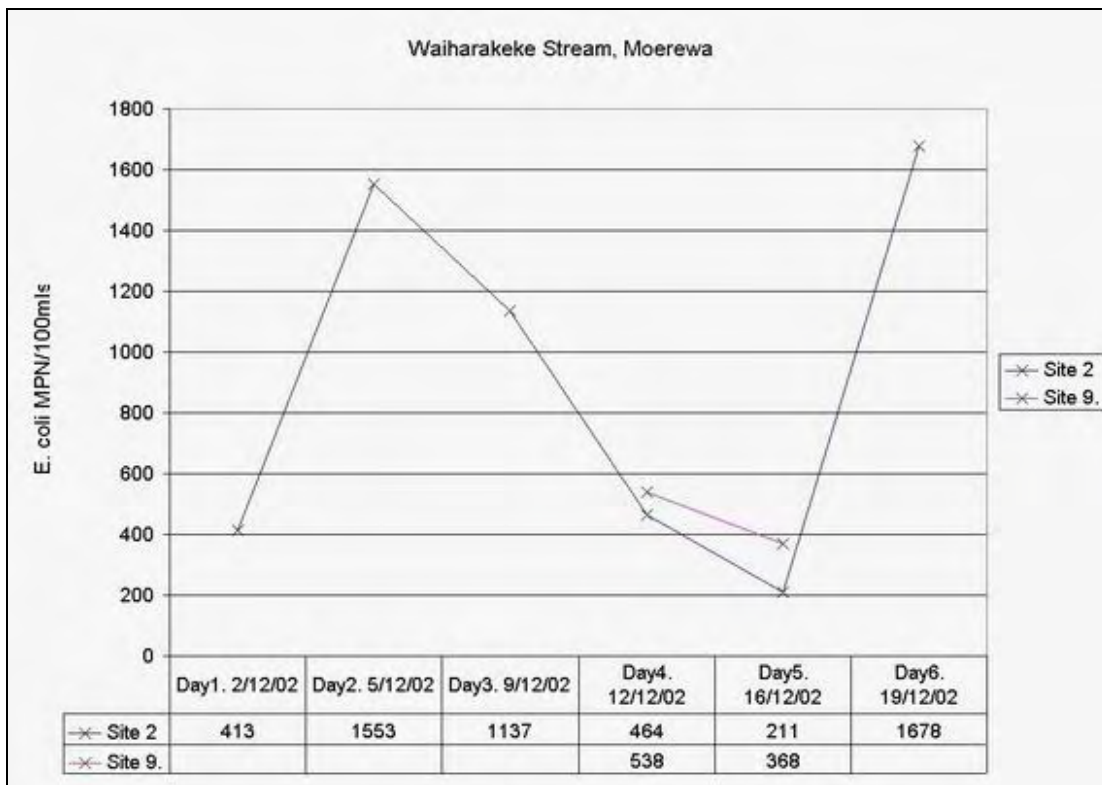
Results for this stream are all elevated, Tuna Town swimming hole appears 'bacteriologically unsafe' to bathe at. However, further sampling is required to determine bathing water quality at the swimming holes sites above 'Affco' (site 2).

Table showing *E. coli* (MPN/100mls) for two sites on Waiharakeke Stream
