Water quality and ecology

State of water quality in Doubtless Bay / Oruru River catchment

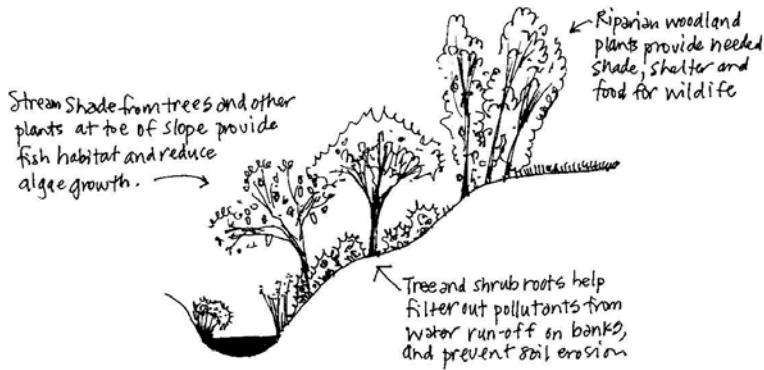
Where there is a diverse habitat available with a variety of flow types (runs riffles and pools) and good quality riparian vegetation, there tends to be high ecological health.

The habitat at the Oruru River site is described as MARGINAL based on NRC's habitat survey programme. The land use is forest and scrub (53%) in the upper catchment and mainly pasture (43%) in the lower catchment. Livestock have access to the river and there is very little vegetation cover. The river banks are relatively unstable and the river shows evidence of high sediment loads.

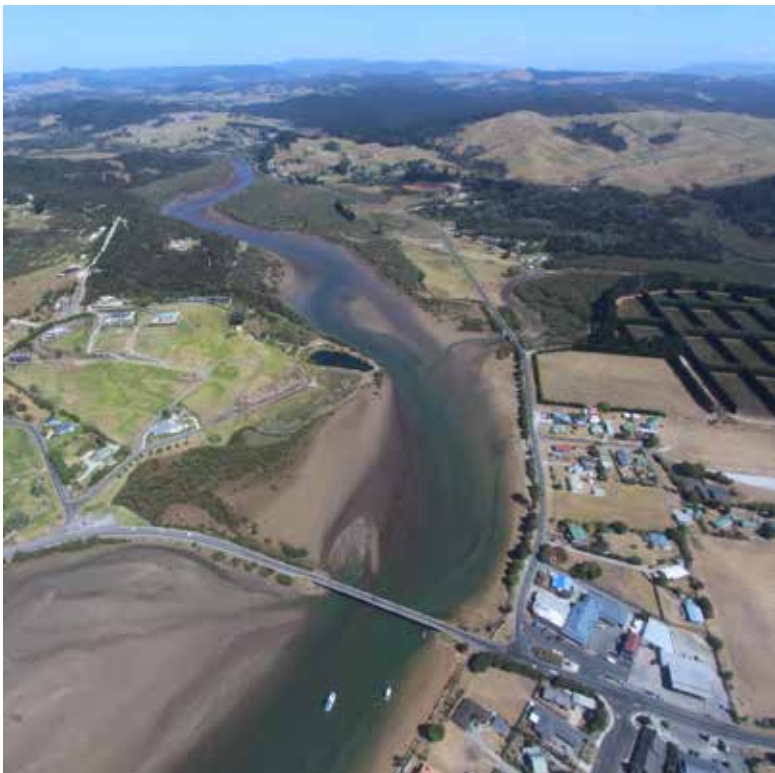
The effect of inappropriate land management on soil erosion in this catchment is exacerbated by the fact that 33% of the catchment's substrate is composed of highly erodible sediment/sand which can create high turbidity (TURB) levels.

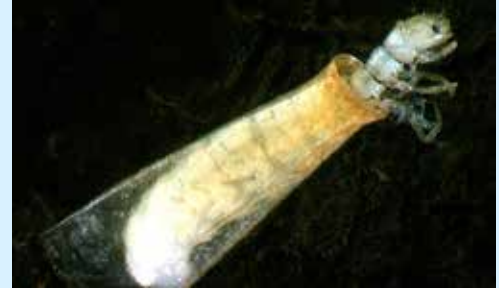
Oxyethira larva (credit Landcare Research)

The fair water and marginal habitat quality at the Oruru River site is reflected in a degraded invertebrate community, dominated by pollution-tolerant species such as snails and the pollution-tolerant caddisfly *Oxyethira*.
