Poutō Peninsula

Lake Kanono Pond 1 'Egg' (Poutō), NRC Lake No. 377A

Summary

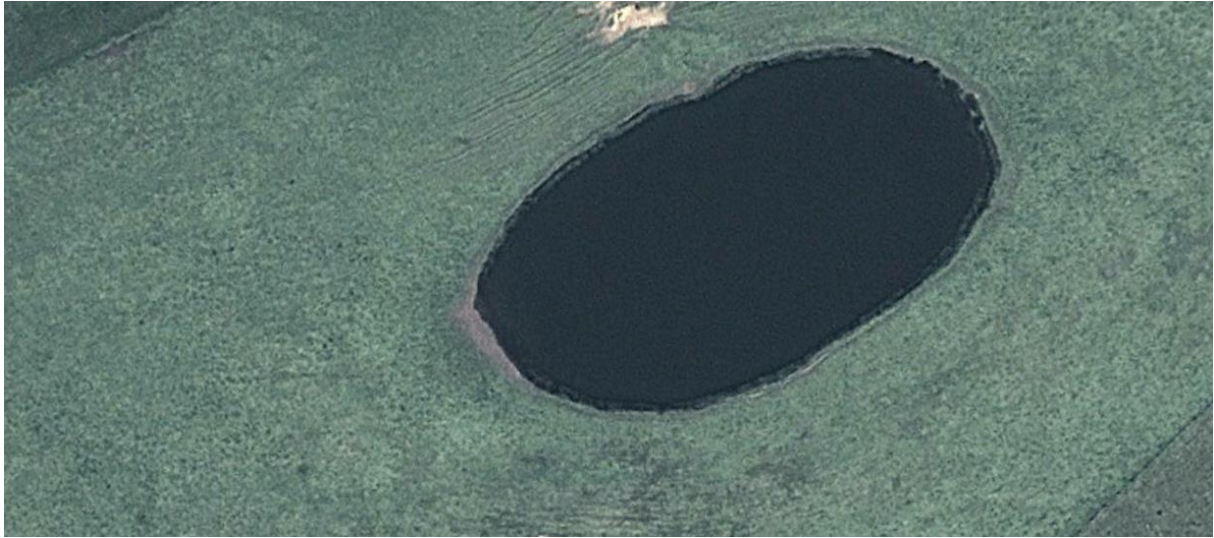
Lake Kanono Pond 1 'Egg', showing the unfenced pond margin (image from Google Earth 2012).

Low: Shallow pond in pasture, with no emergent or submerged vegetation.

Highly impacted by livestock access, unlikely to be further impacted.

Lake Kanono Pond 1 'Egg' (1703280E, 5975265N) occupies an area of c. 1 ha and was shallow, up to 50 cm deep. The catchment is in pasture and livestock currently have unimpeded access to the waterbody. There are no inlets or outlets. Access is through private farmland by permission only.

No monitoring.
