COASTS

SUMMARY 2007-08

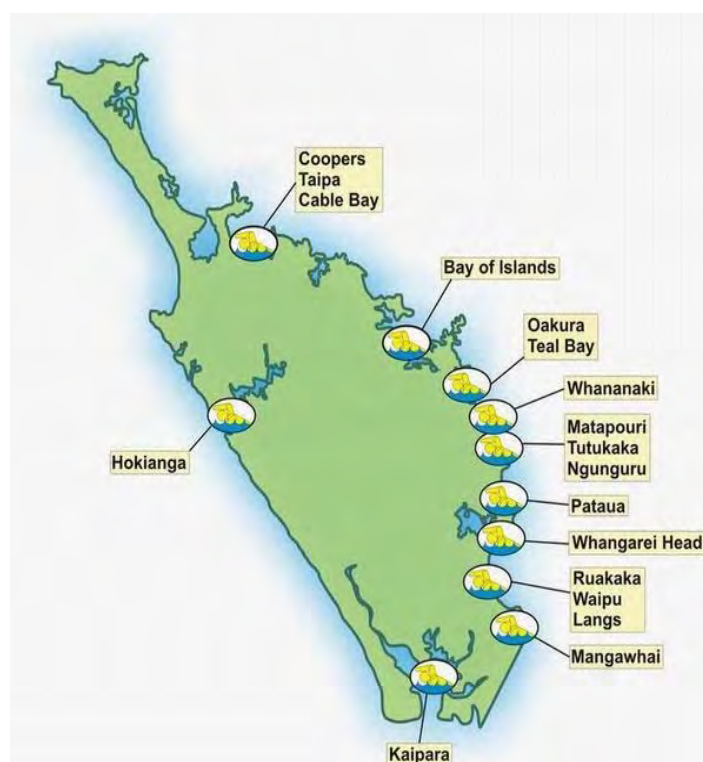
Map: Recreational Bathing Water Quality Programme – Coastal Sites

During the 2007-08 summer season, 44 coastal swimming sites around Northland were monitored. Samples were collected from each site on a weekly basis and analysed for *Enterococci* bacteria. These bacteria indicate faecal contamination of water from warm-blooded animals, which in turn indicates the likely presence of pathogens which can affect human health.

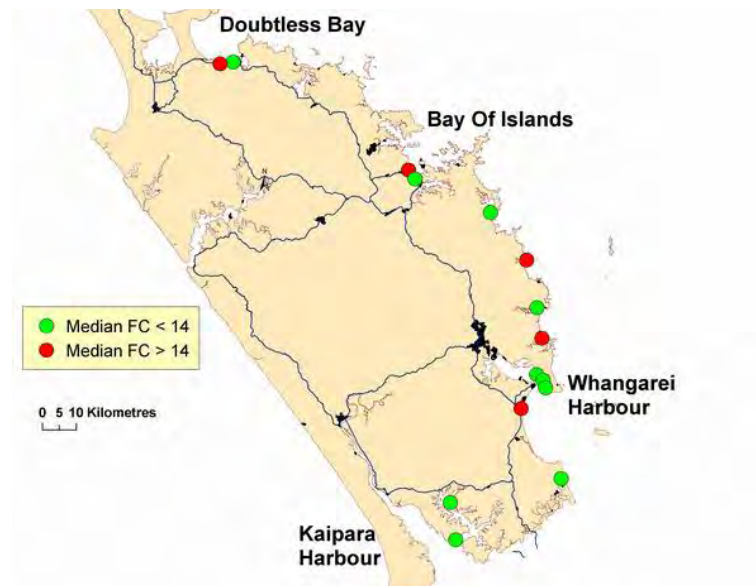
Map: Sites monitored for recreational shellfish gathering water quality and whether they complied with the median faecal coliform standard in 2007-08

- Of the 15 sites sampled in 2007-08, the median faecal coliform result for five sites exceeded the limit of 14 per 100 millilitres of seawater.
- Of the 15 sites sampled in 2007-08, 14 had more than 10% of samples that exceeded a *faecal coliform* count of 43 per 100 millilitres.
- Only one site, Tinopai in the Kaipara Harbour, met both water quality standards for safe recreational shellfish gathering in 2007-08.

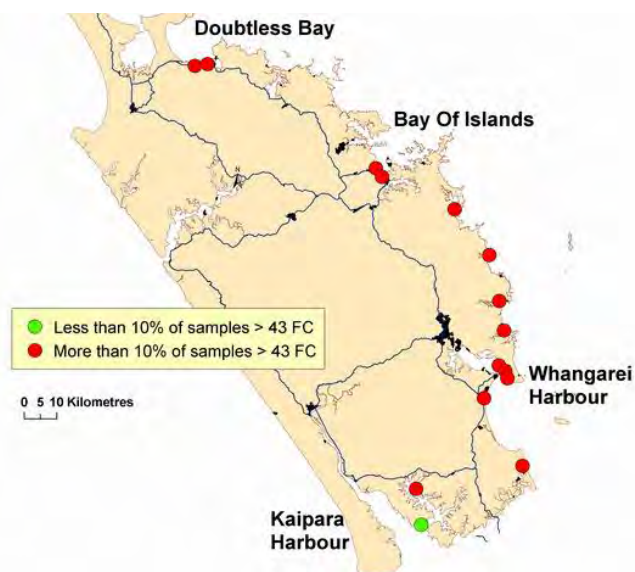
Map: Sites monitored for recreational shellfish gathering water quality and whether they complied with the standard of no more than 10% of samples exceeding 43 faecal coliforms per 100 ml in 2007-08

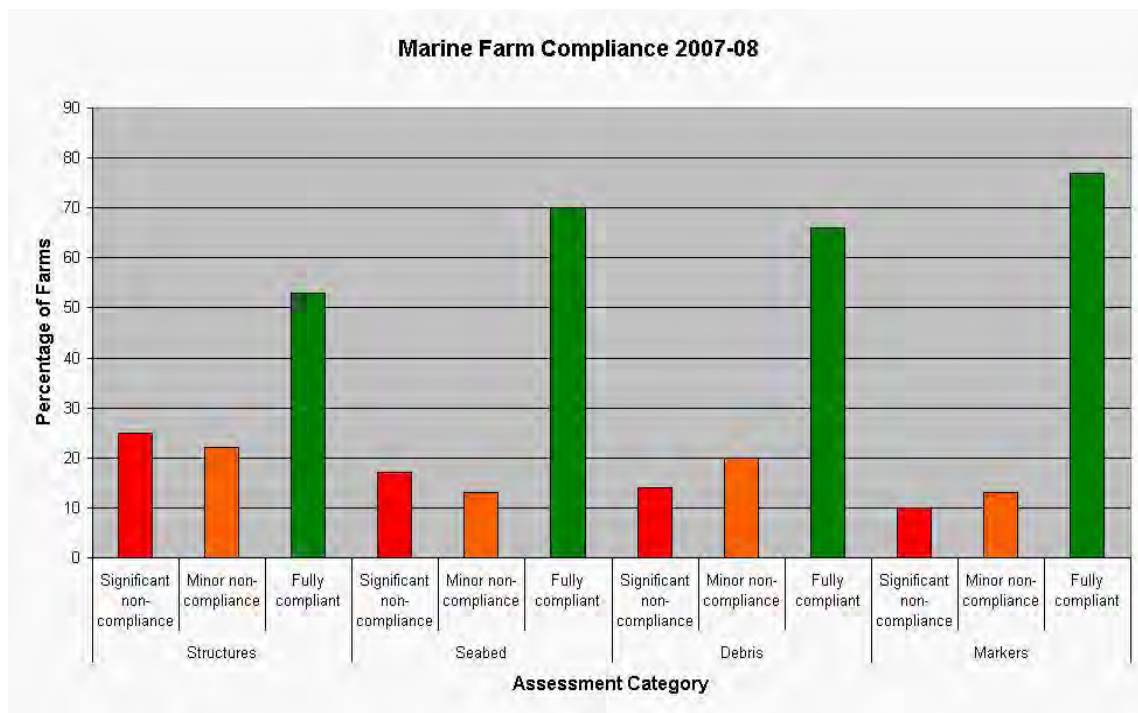
Depending on the results of the assessment, each farm is given a compliance grade - fully compliant, minor non-compliance or significant non-compliance. The graph below summarises the results from the 2007-08 survey season.

Farms that were found to have minor non-compliance in any of the assessment categories were requested to undertake remedial action. Abatement notices were issued to 25 farmers with significant non-compliance, requiring them to undertake actions to ensure compliance by the next inspection in mid-2009.

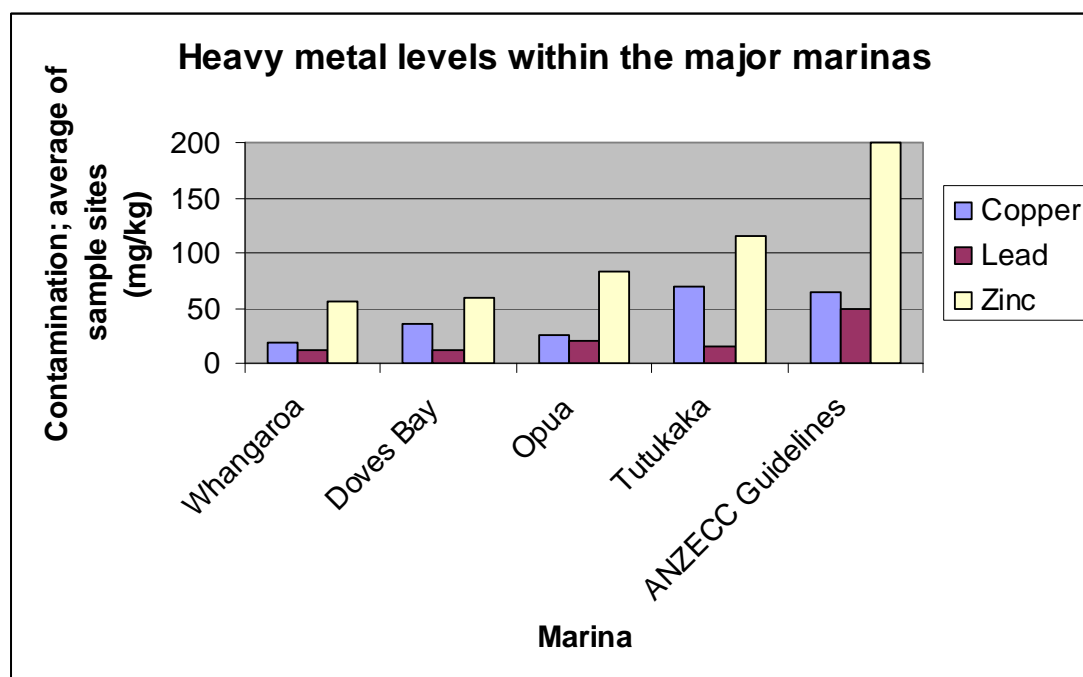
Results from heavy metal analysis undertaken in 2007-08 show general compliance across most marinas in Northland. However, levels of Copper within Tutukaka marina were found to be elevated above ANZECC guidelines. Further sampling is proposed for 2008-09 in this marina.

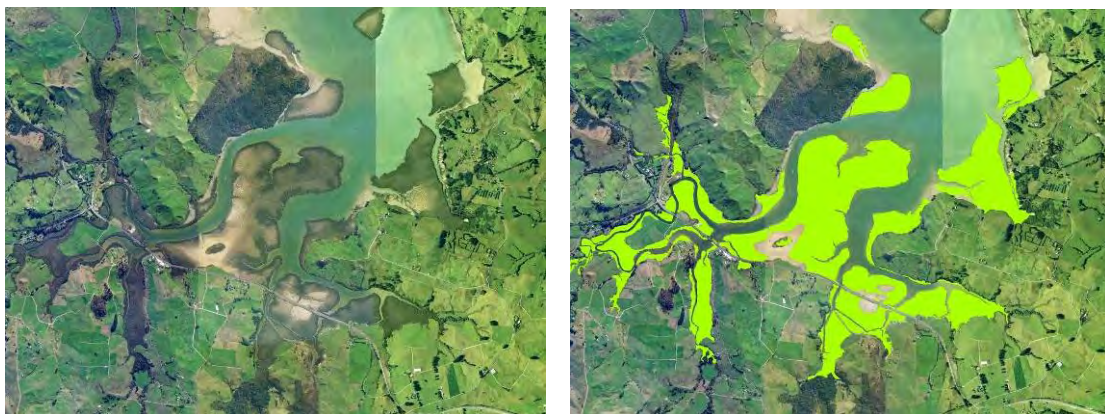
Photos: Digitalisation of mangrove habitat in the Mangapai River, Whangarei Harbour

Habitat assessment involves mapping key habitats, such as mangrove forest, sea grass beds and saltmarsh habitats, using both aerial photographs and field based surveys. This information is used to monitor changes in the distribution and extent of key habitats over time.

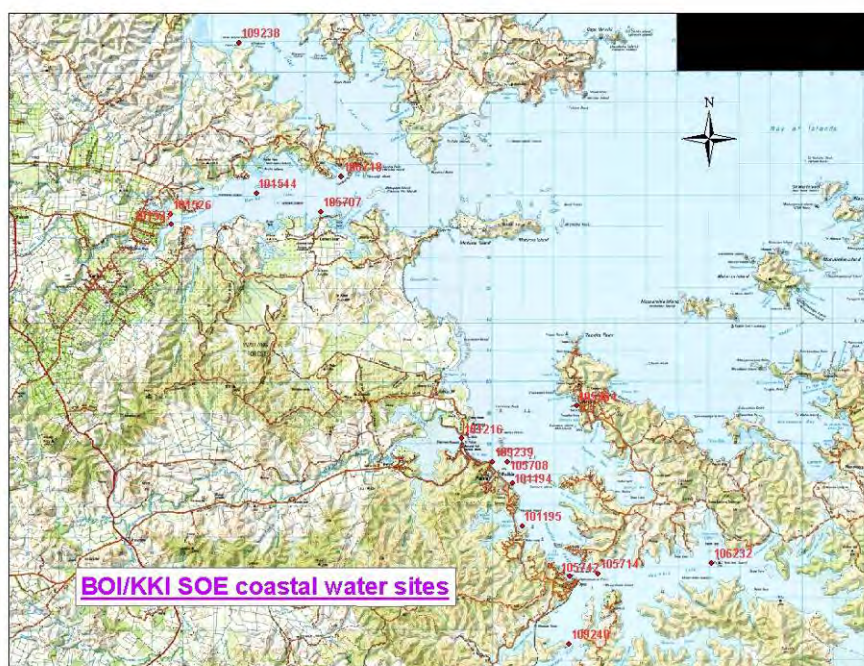
Map: Water and sediment quality monitoring sites in the Bay of Islands

The programme requires external laboratory analysis of water and sediment samples. The programme is being implemented in stages in accordance with the available budget. The water sampling programme for 2007-08 involved monitoring 32 sites, 16 in the Whangarei harbour and 16 in the BOI.

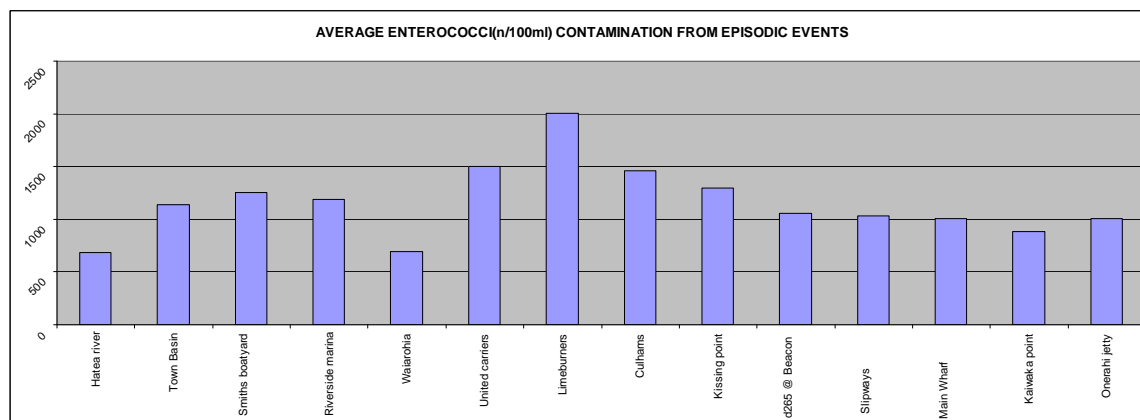
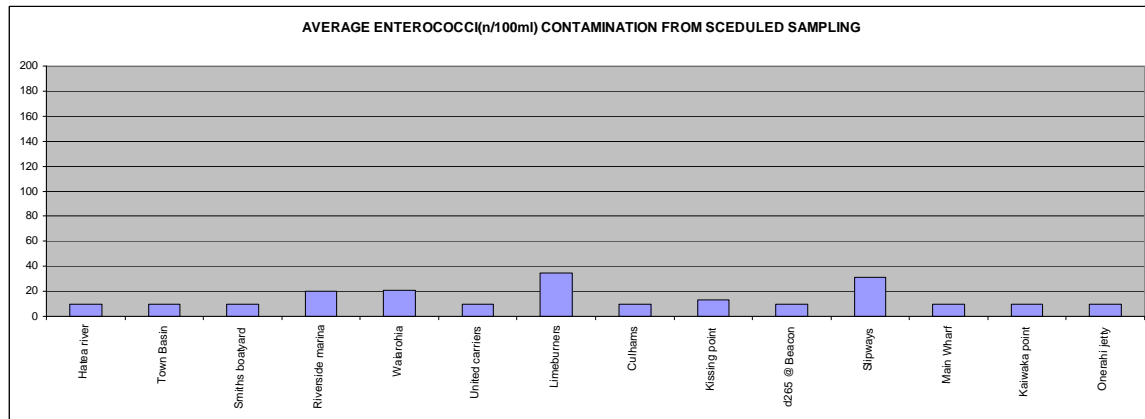
During 2007-08, a number of episodic sampling runs were undertaken in the Whangarei harbour, following heavy rainfall events. Results from this sampling show significant microbial contamination in the upper harbour after heavy rain. The graphs below give the results from episodic and scheduled sampling for the Whangarei Harbour for 2007-08.

According to the MfE *Microbiological Water Quality Guidelines*, a median result of greater than 277 *Enterococci* per 100ml of sea water means the water is unsafe for recreational contact. In order to minimise the potential for adverse human health impacts, it may be necessary to classify these waters as 'unsafe' for contact recreation after heavy rainfall events.

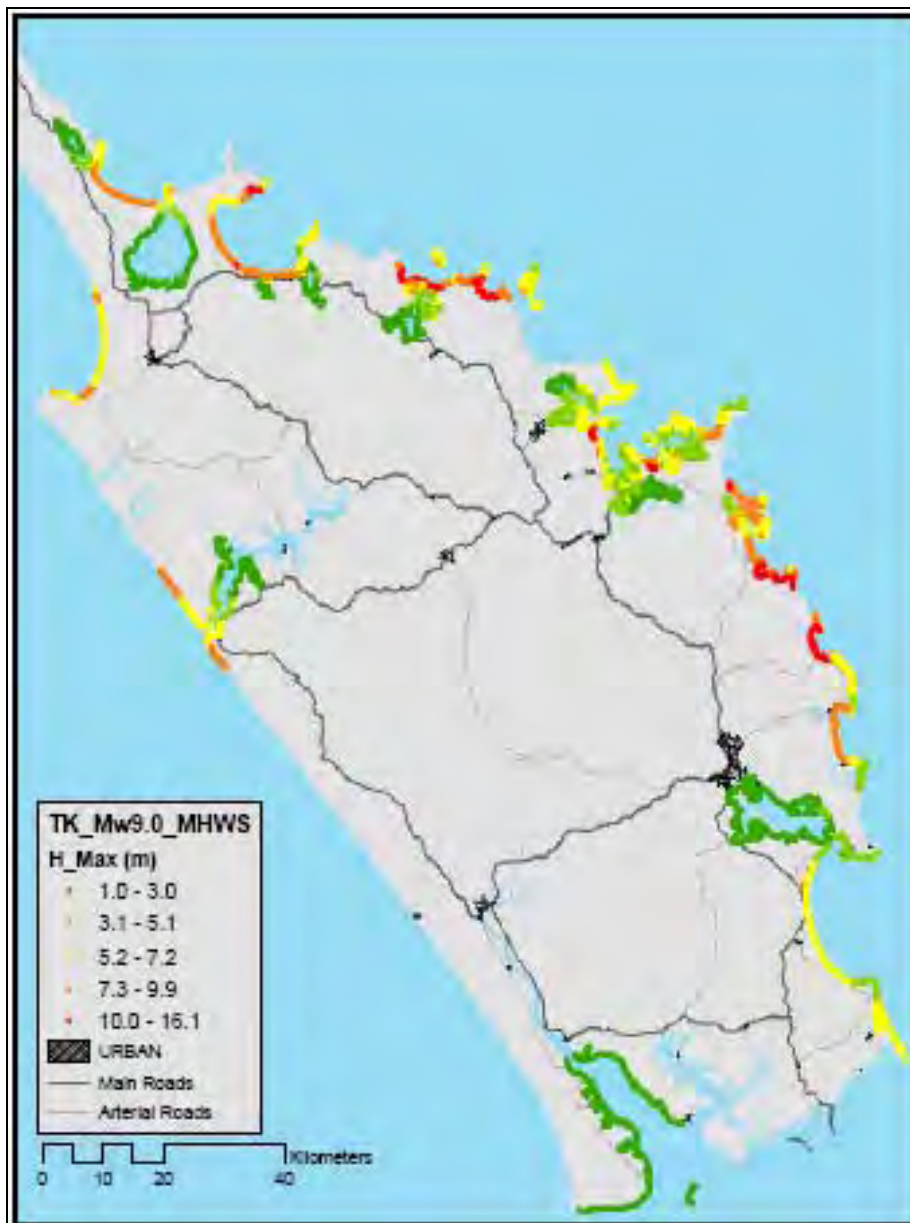
Map: Maximum wave height at shoreline for the Mw9.0 Tonga-Kermadec subduction zone scenario at MHWS. Areas of shoreline with no colour were not included in the model output.

The following maps give an indication of the likely wave heights at each of the study sites for both the distant and regional sources.

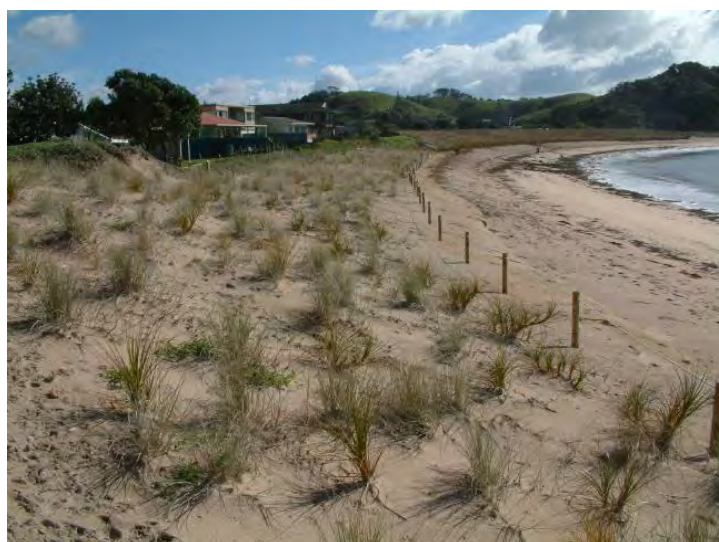
Photo: Beach nourishment at Matapouri

During 2007-08, the beach at Matapouri underwent beach nourishment and so the beach is still finding its natural state. The foreshore at Omapere was subject to significant erosion during the year and rockwork was required to stabilise a house located on the beach front. The beach at Pouto, a highly dynamic system, was cut back extensively to the east of the cliffs.

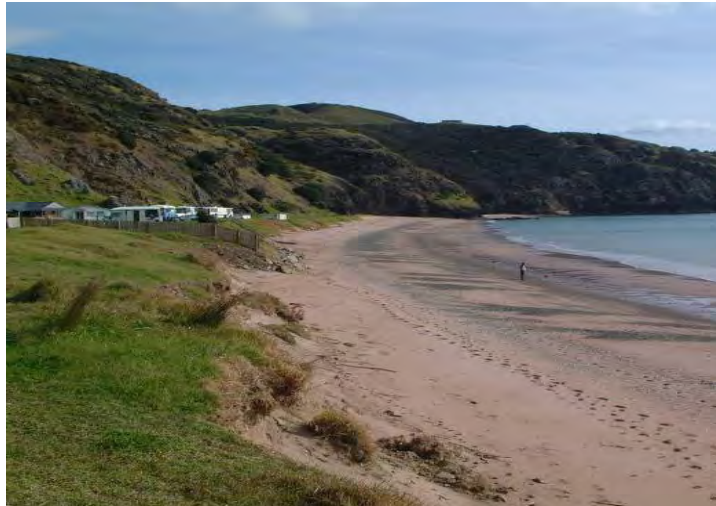
Photo: Dunes at Tauranga Bay before restoration work (August 2002)

Tauranga Bay is a typical example of a Northland east coast modified dune system. The beach frontage is designated as a District Council Coastal Reserve and a private campground is located on the frontage. The dunes themselves have been flattened in the past and native vegetation replaced with kikuyu.

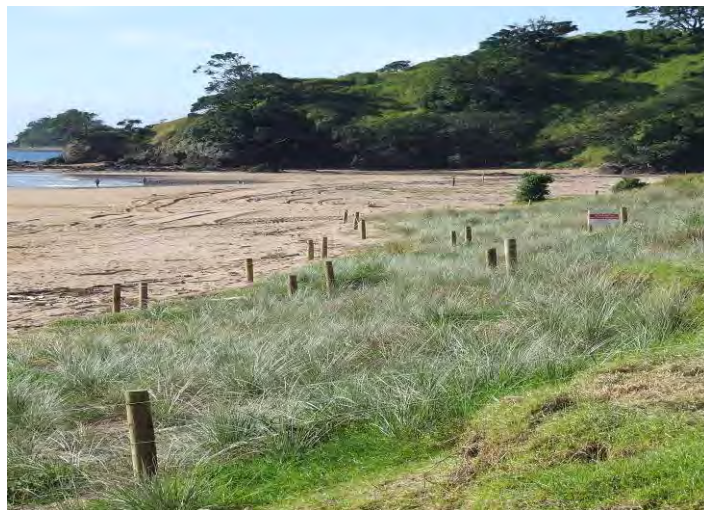
Photo: Dunes at Tauranga Bay after restoration (June 2008)

The plants thrived and sent out long runners (stolons) and although a severe storm swell in the winter of 2008 killed a number of plants, the new planting helped to bind the banks of the dunes and reduce erosion damage (see pictures below). The stolons left trailing over the steep face caused by the erosion will be able to take root and trap wind blown sand, in time restoring the dune profile.

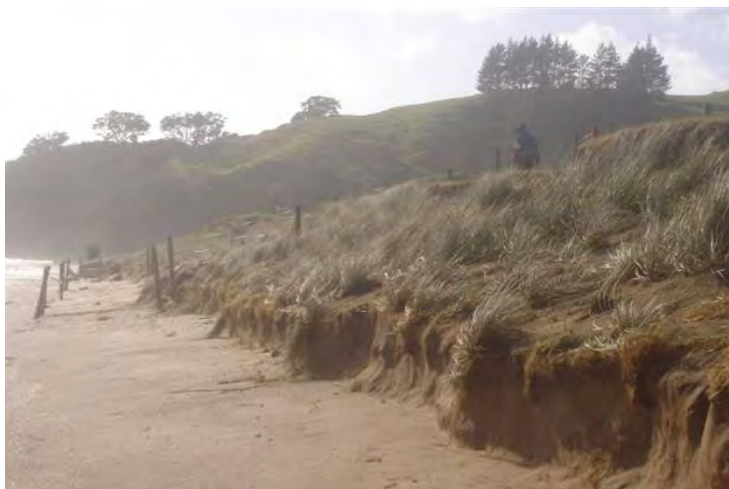
Photo: Erosion damage to dunes after storm (winter 2008)
