## North of Dargaville

### Waipuna Lake (Hokianga) NRC Lake No. 197a

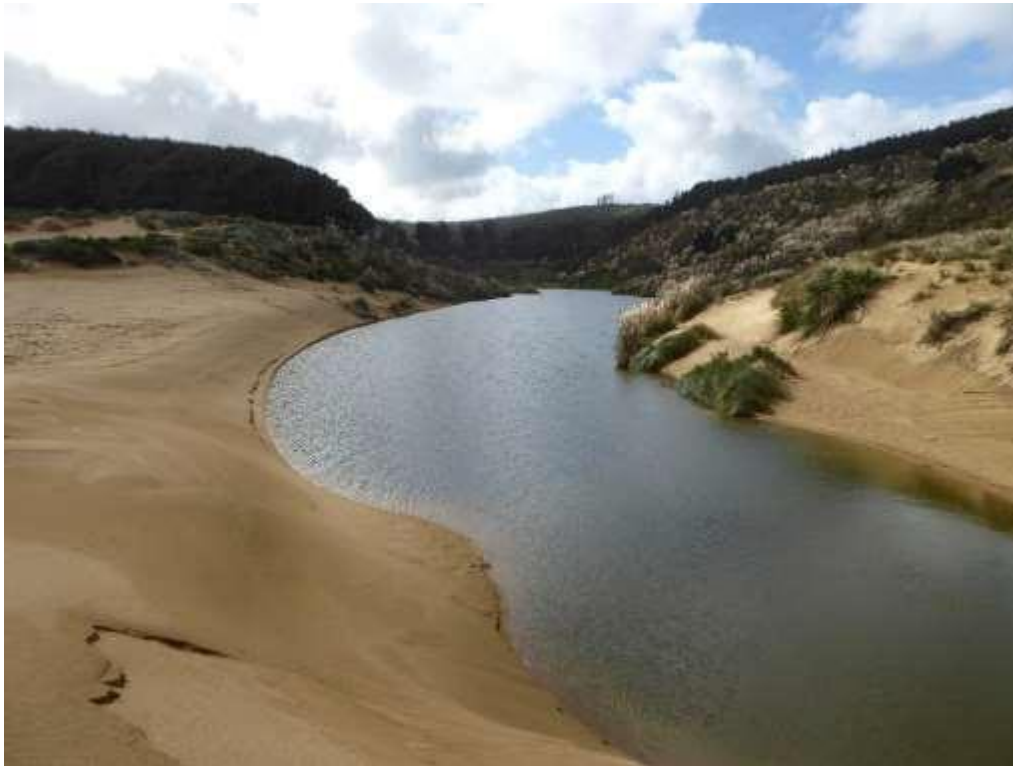
**Waipuna Lake.** Viewed from the west, note mobile dunes at the western end and scrub vegetation further east (Photo: Paul Champion 1 May 2018).
