Appendix: Background Information for Former Wharf Paihia

Elizabeth Clark. 17 March 2017. Historical Background Research: Former Wharf, Seawall and Road Stockyard Point, Paihia. Report for Northland Regional Council.

Former Wharf, Seawall and Road Stockyard Point, Paihia 1918 - 1924

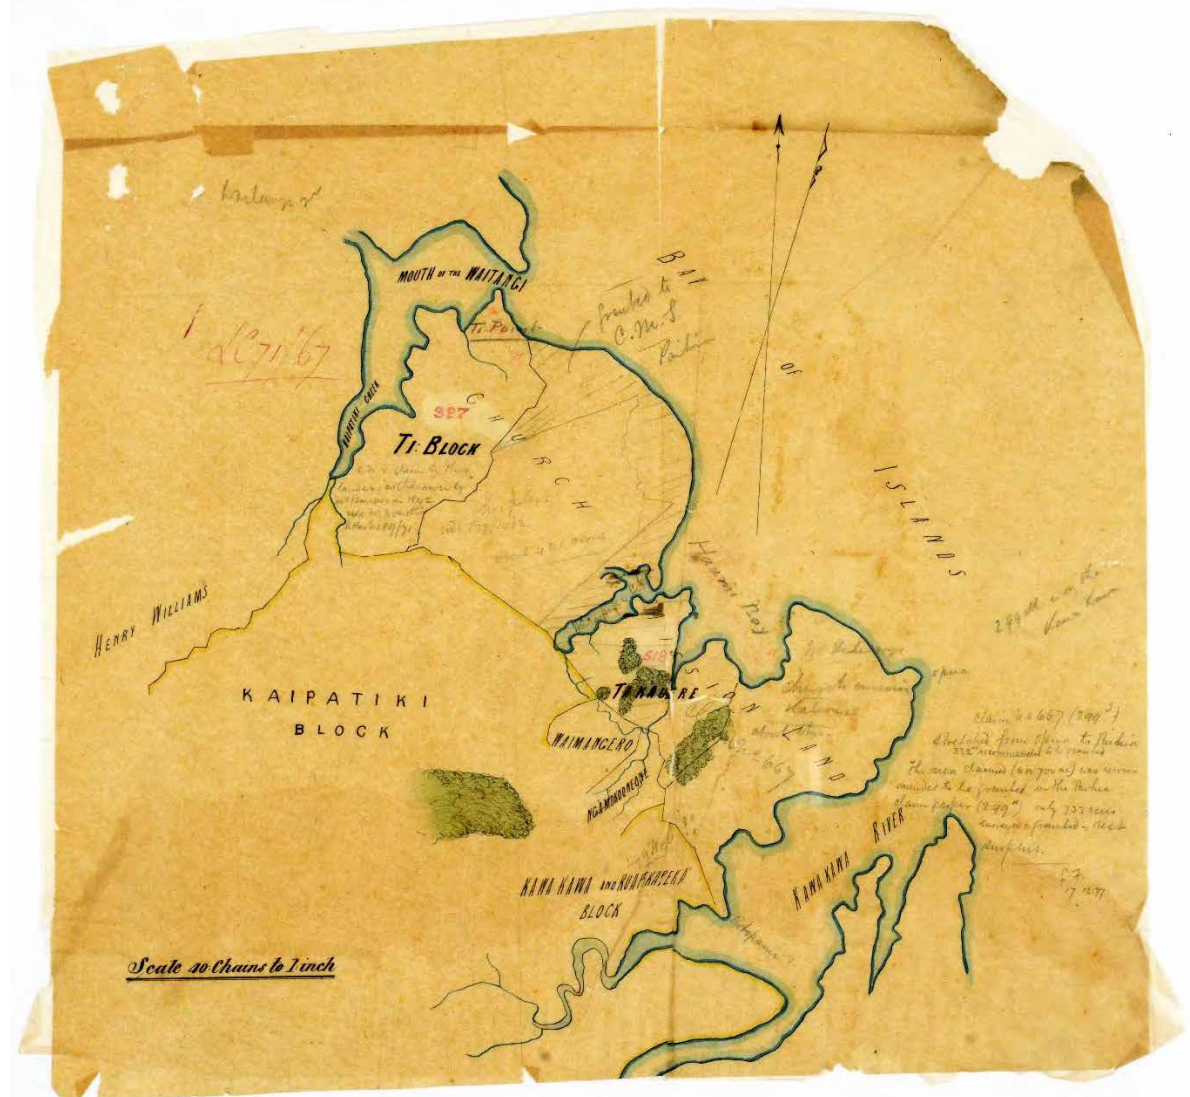
Paihia Old Land Claims Commission Tracing "The investigation of land sales before 1840 were conducted by the Old Land Claims Commission, and these are held by Archives New Zealand. This tracing comes from one investigation into the land owned by Williams and the Mission Society at Paihia, and shows its considerable size. 'Ti Point', at the mouth of the Waitangi River, marks the site of Te Tii Marae." (Archives New Zealand Reference: OLC Box 34/) Archives New Zealand Flickr Photostream URL:

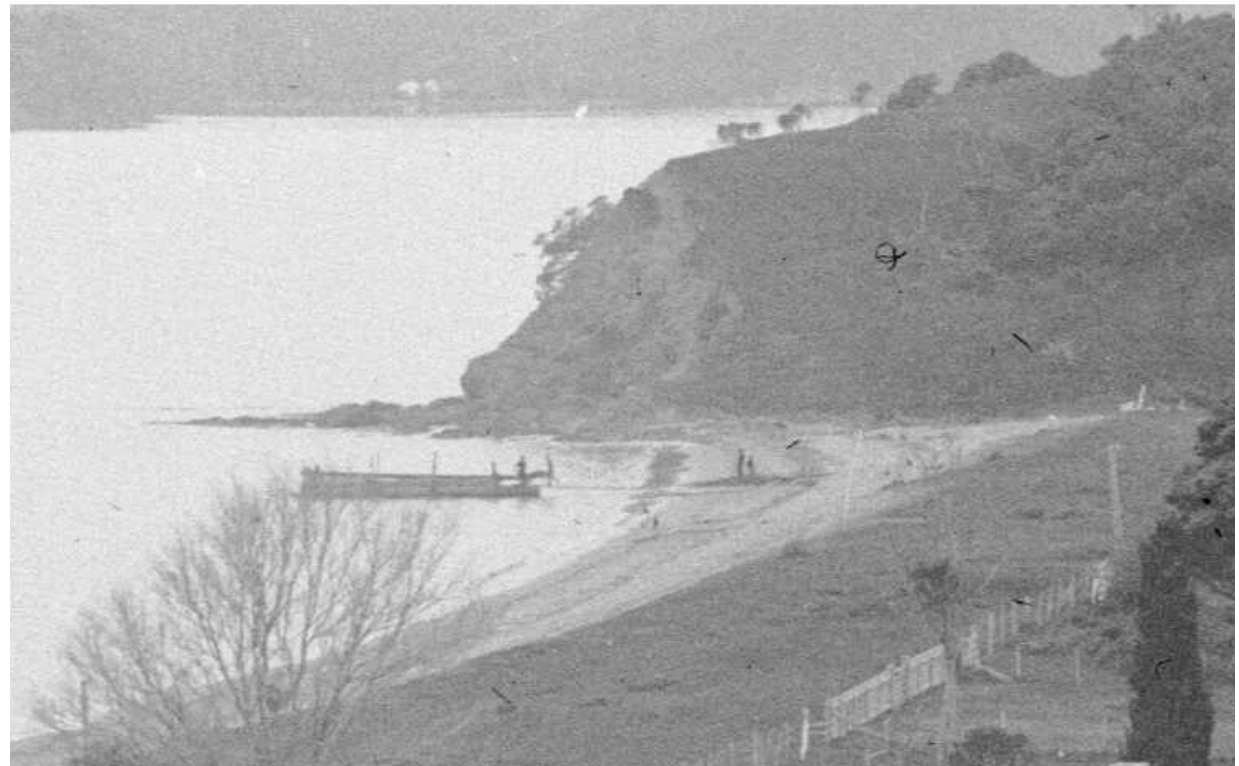
Detail Snip showing Stockyard Point without the wharf structure. Note the cattle race constructed on the foreshore. Taken from Paihia, Bay of Islands, circa 1915, photographed by F G Radcliffe. View overlooks houses by shoreline and includes the ruins of a dwelling which earlier housed Colenso's printing press. Source of descriptive information - Notes on file print. Dated from Radcliffe post card index compiled by Stan R Goodwin.
(Paihia, Bay of Islands. Radcliffe, Frederick George, 1863-1923 : New Zealand post card negatives. Ref: 1/2-003178-G. Alexander Turnbull Library, Wellington, New Zealand. [/records/23009427](#))

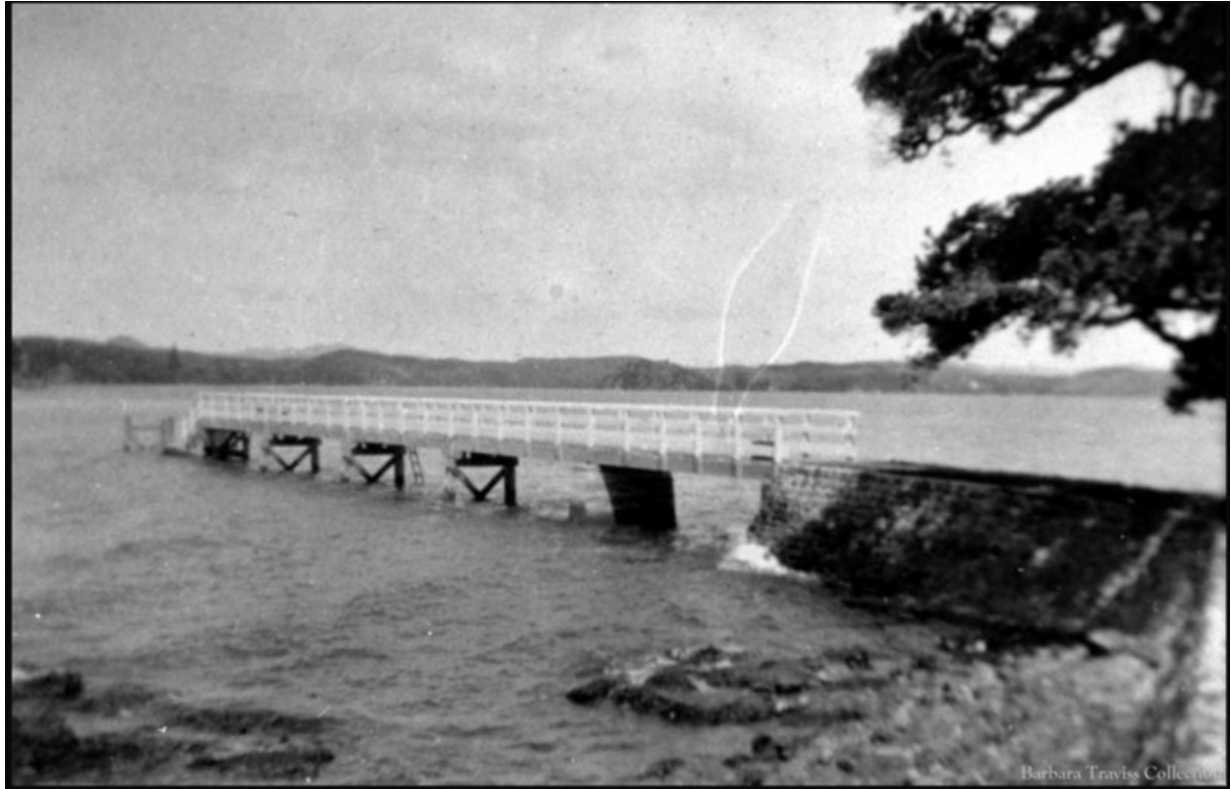
Paihia wharf (ca.1920 – January 1924) shows the wharf as it was constructed. Barbara Traviis Collection. Unknown photographer (Scan by Peter Honey: 20 May 2007: Barbara Traviss Collection Flickr URL: <https://www.flickr.com/photos/68087257@N04/7285673770/in/dateposted/>)

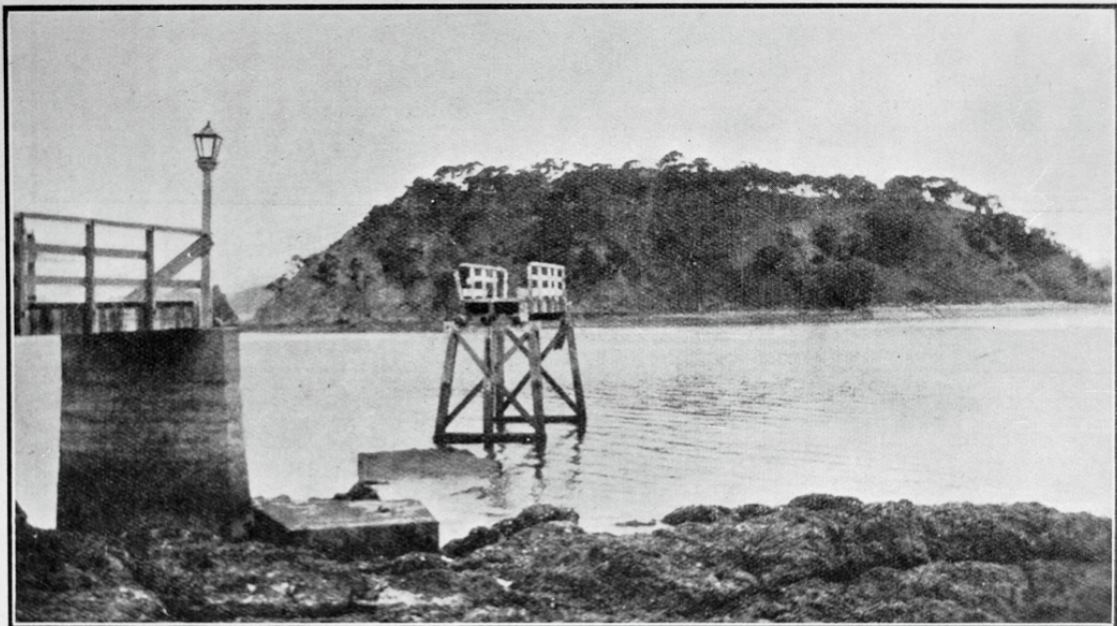
THE WHARF AT PAIHIA, BAY OF ISLANDS, NORTH AUCKLAND, SHOWING DAMAGE DONE BY A RECENT NORTH-EAST GALE. —A. Hall.

The replacement wharf (1920) shown in May 1924 after a storm had caused its destruction. Note the image was not published in the Auckland Weekly News until March 1926 almost 2 years after the event.

"The Wharf at Paihia, Bay of Islands, North Auckland, Showing Damage Done by a recent North-East Gale." Auckland Weekly News. March 1926. Hall A, ca.1924 (Sir George Grey Special Collections, Auckland Libraries, 7-A6698 URL:

The wharf remained standing until May 1924, when it was almost completely destroyed by a violent storm.

*"The violent south-easterly gale yesterday changed during the night to the north-east, and blew with hurricane force this morning, carrying away nearly all of the Paihia wharf, including two concrete piles."*²¹

During, October there had been some discussion regarding relocating the replacement wharf to more suitable site. The memorandum authored by marine engineer J J Wilson advised the district engineer at the Public Works Department in Whangarei of the concrete piers C and D had proved a failure and such type of construction was unsuitable and should be avoided in the future. A map was also provided for two new possible locations. The first located where the present day wharf currently stands and another location further south of the Stockman's Point were considered as options.²²

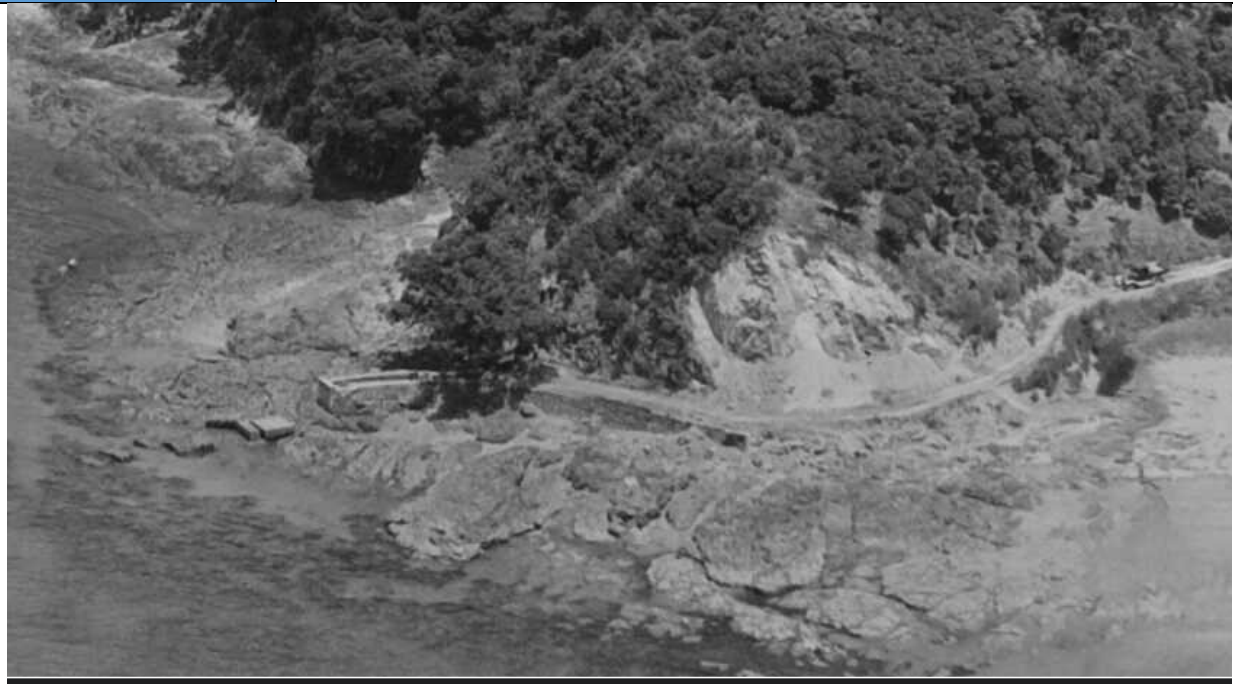
Detail snip: The wharf at low tide January 1953, showing the remains of the concrete piers in the intertidal zone. The surviving pier is visible against the seawall and road construction. Whites Aviation image. (Paihia, Bay of Islands, Northland. Whites Aviation Ltd : Photographs. Ref: WA-32147-F. Alexander Turnbull Library, Wellington, New Zealand. [/records/23506156](#))

It is important to note, there are two parts to the site that form the wharf overall. The first part of the structure is the former road constructed over the rocks on the coastal side that has been protected by a sea wall constructed of stone. The road dates from 1918, when the first wharf was constructed. It is possible it may have been altered during the construction of the second wharf at the same site. The Public Works Department files for the 1918 structure are currently held in the Wellington Office of Archives New Zealand and have not been sighted by the writer. The second part of the structure is the 1920 structure that replaced the first original 1918 wharf. The concrete piers are still in situ. One is still intact against the former road formation, the remaining piers extending into the water line only have the bases remaining, the rest presumably having been eroded away by tidal action.

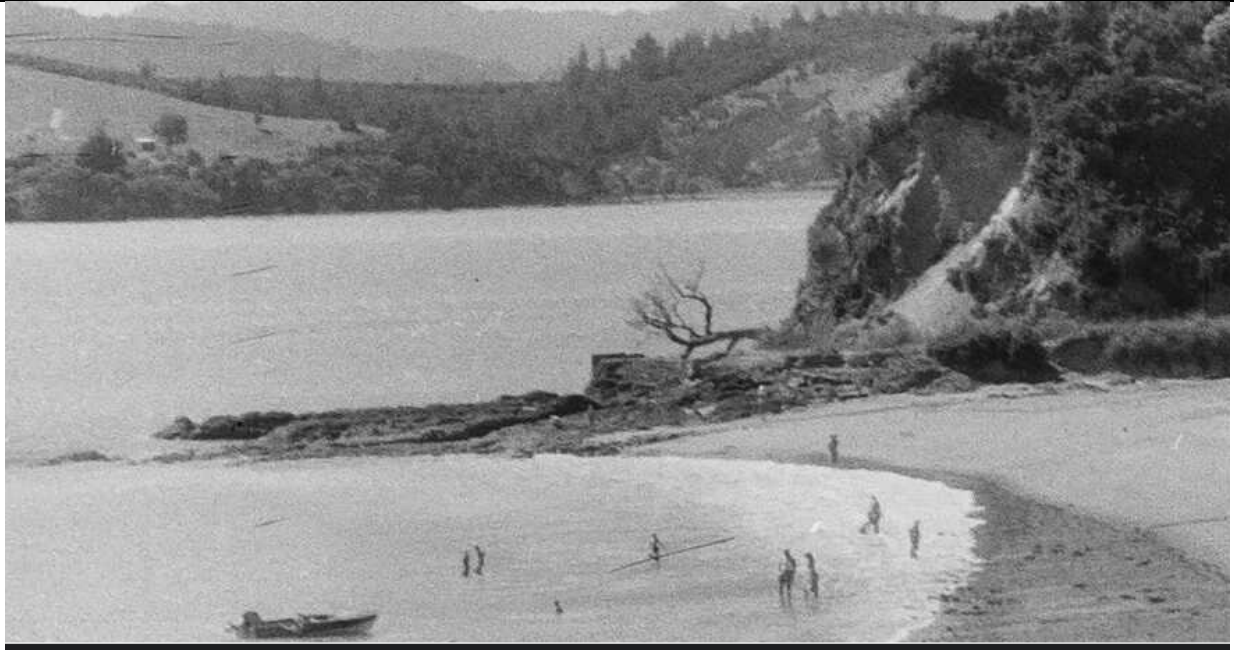
Detail snip: Showing a view of the former wharf road and seawall structure facing south-east dated 26 January 1957, Whites Aviation. (Paihia, Far North District, Northland. Ref: WA-42989. Alexander Turnbull Library, Wellington, New Zealand. [/records/32051357](#))

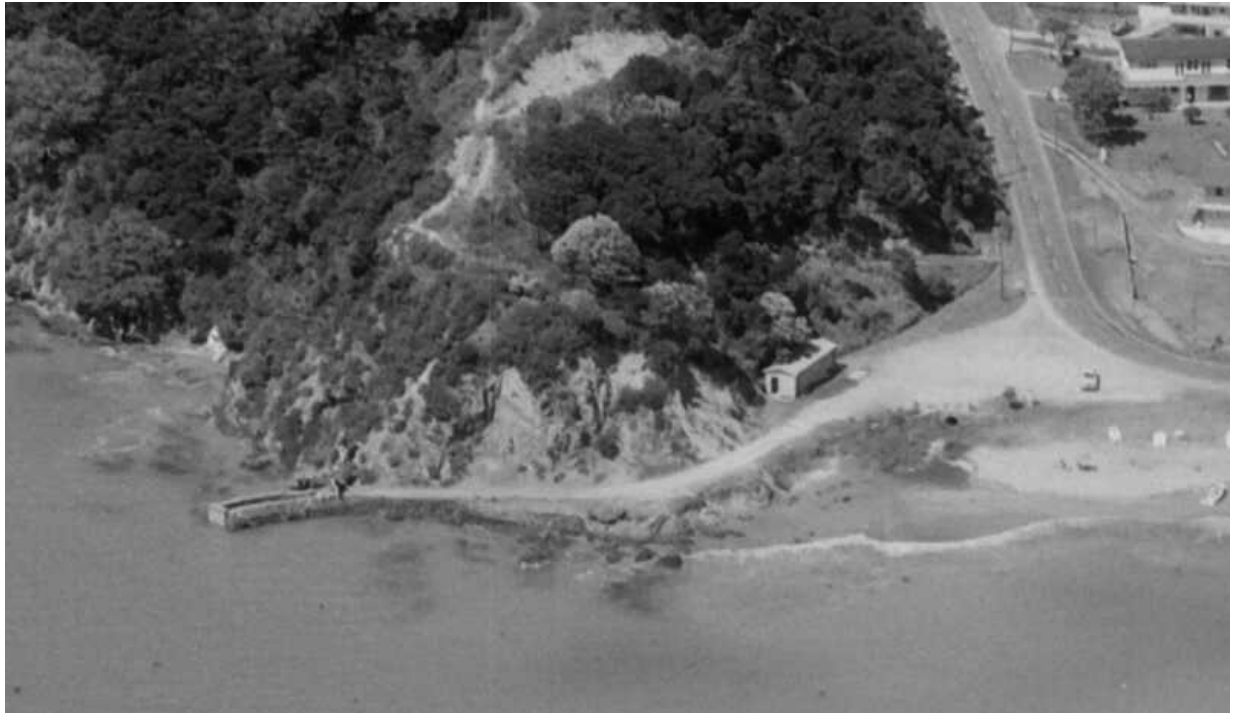
Detail Snip: Showing a view of the concrete pier abutment against the seawall and road structure 8 February 1966. Whites Aviation image. (Paihia, Bay of Islands, Northland. Whites Aviation Ltd :Photographs. Ref: WA-65610-F. Alexander Turnbull Library, Wellington, New Zealand. [/records/22343311](#))

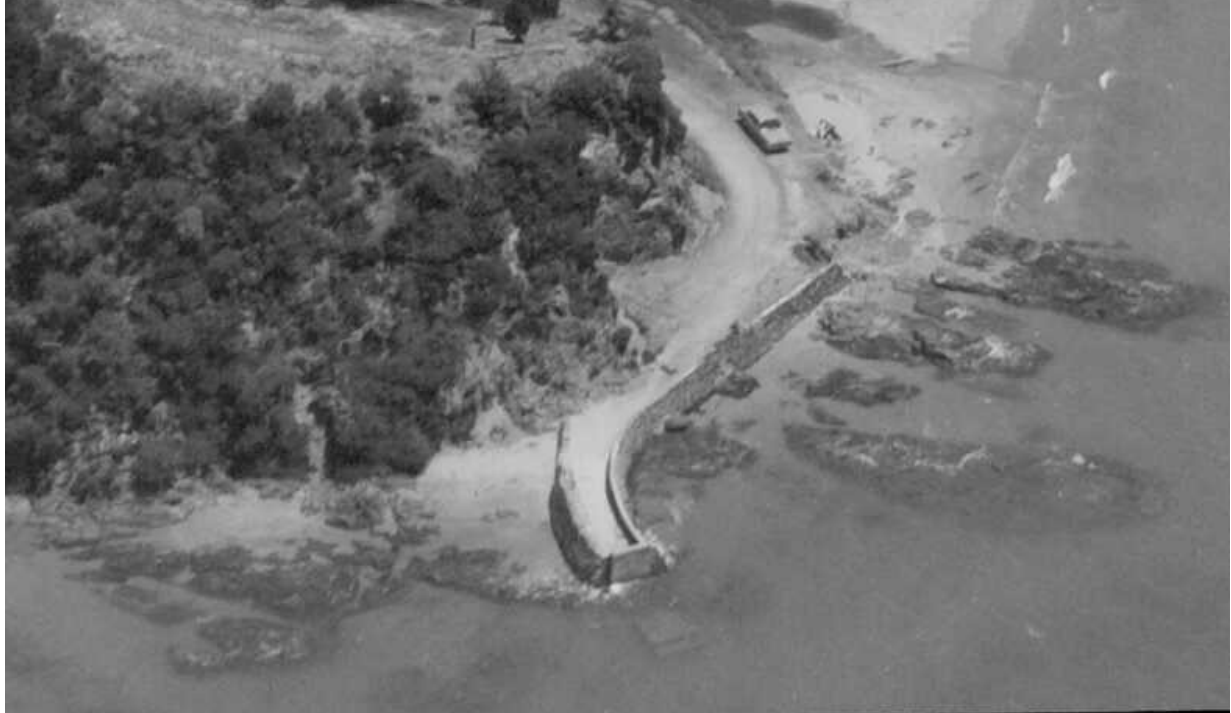
Detail Snip: The remains of the pier casements are visible in the intertidal zone. The seawall and road structure continue remain intact 25 January 1973. Whites Aviation image. (Paihia, Northland. Whites Aviation Ltd :Photographs. Ref: WA-71117-F. Alexander Turnbull Library, Wellington, New Zealand. [/records/22905646](#))

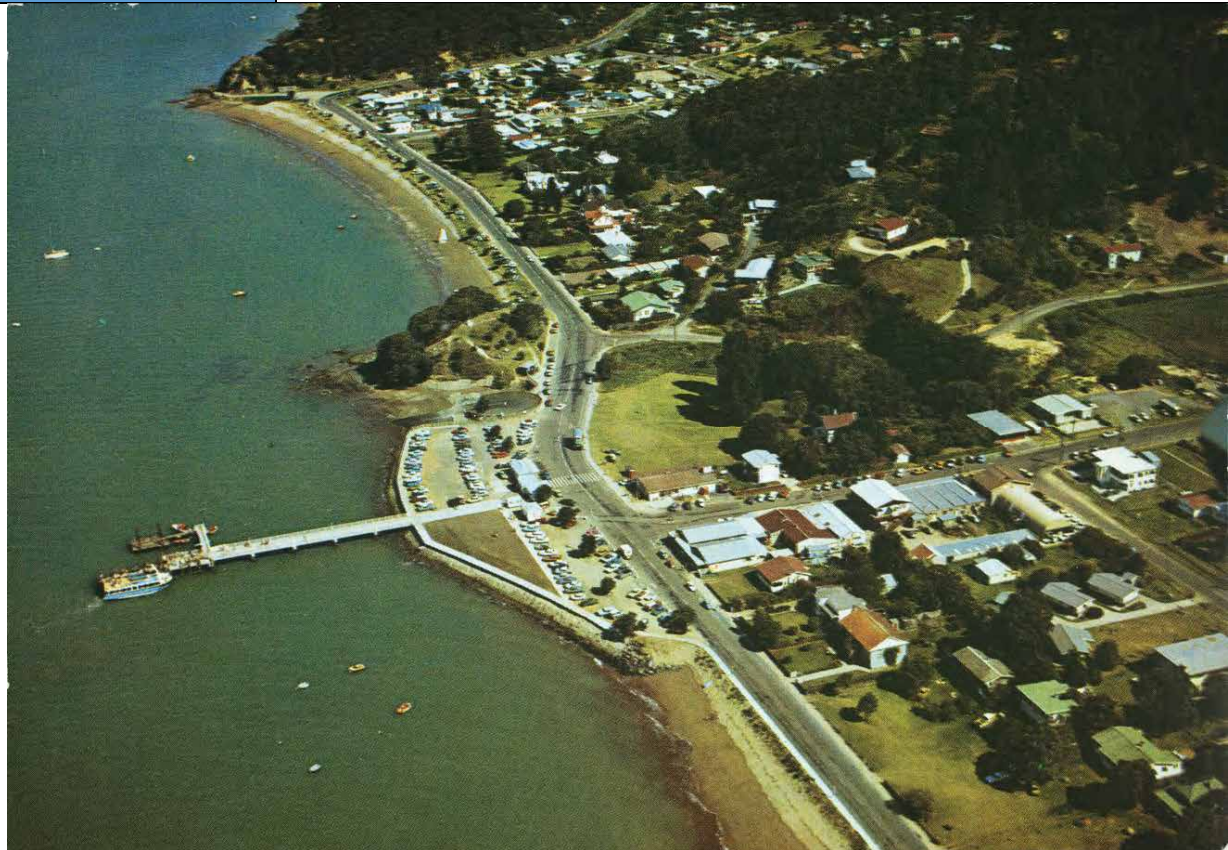
Aerial postcard view of Pahia showing the former wharf at Stockyard Point at the far left rear of the image. Gladys M Goodall, ca. 1970-79 (Goodall, Gladys M: Date Period: 1970 – 1979 "Aerial view of Paihia with wharf in centre: Postcard: Ref: Sir George Grey Special Collections, Auckland Libraries, 369-52 URL: http://www.aucklandcity.govt.nz/dbtw-wpd/exec/dbtwpub.dll?BU=http%3A%2F%2Fwww.aucklandcity.govt.nz%2Fdbtw-wpd%2FHeritageImages%2Findex.htm&AC=QBE_QUERY&TN=heritageimages&

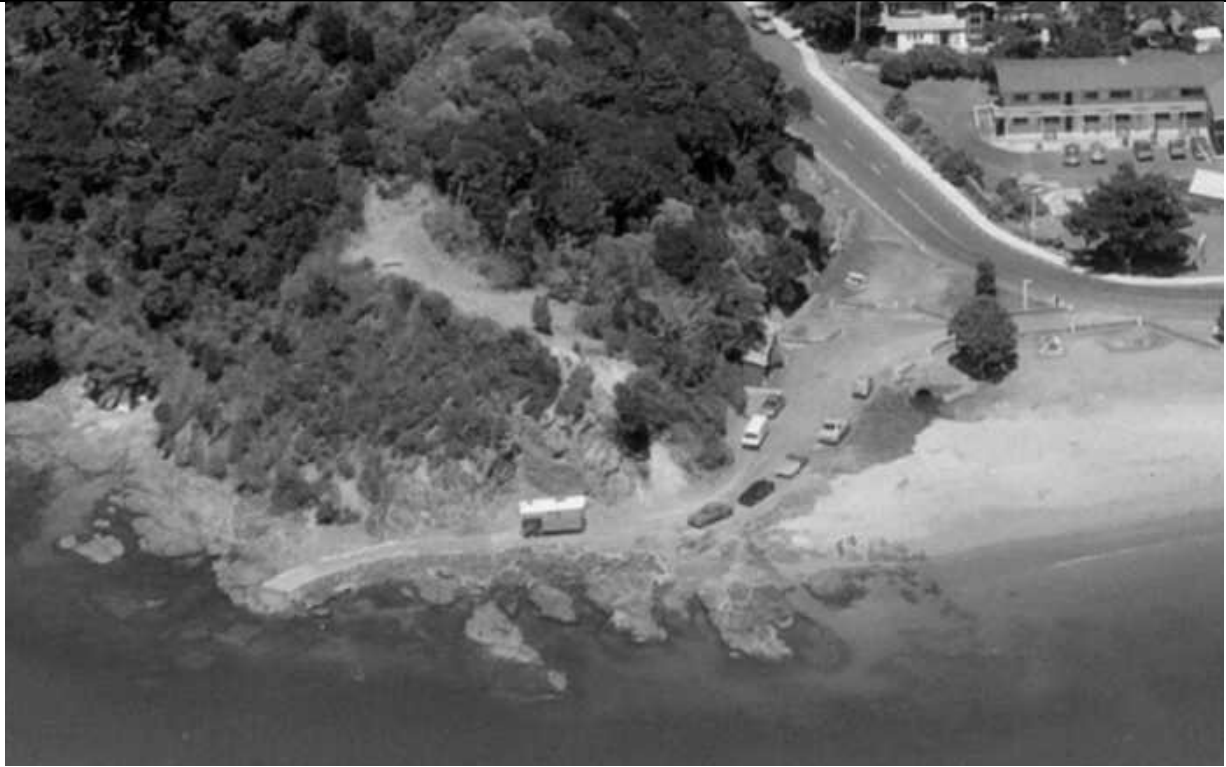
Detail Snip: Showing the wharf pier remains still visible in the intertidal zone. The seawall and road structure also remain unchanged, 21 February 1987. Whites Aviation image. (Paihia, Bay of Islands County, Northland. Whites Aviation Ltd :Photographs. Ref: WA-79316-F. Alexander Turnbull Library, Wellington, New Zealand. [/records/23139067](#))

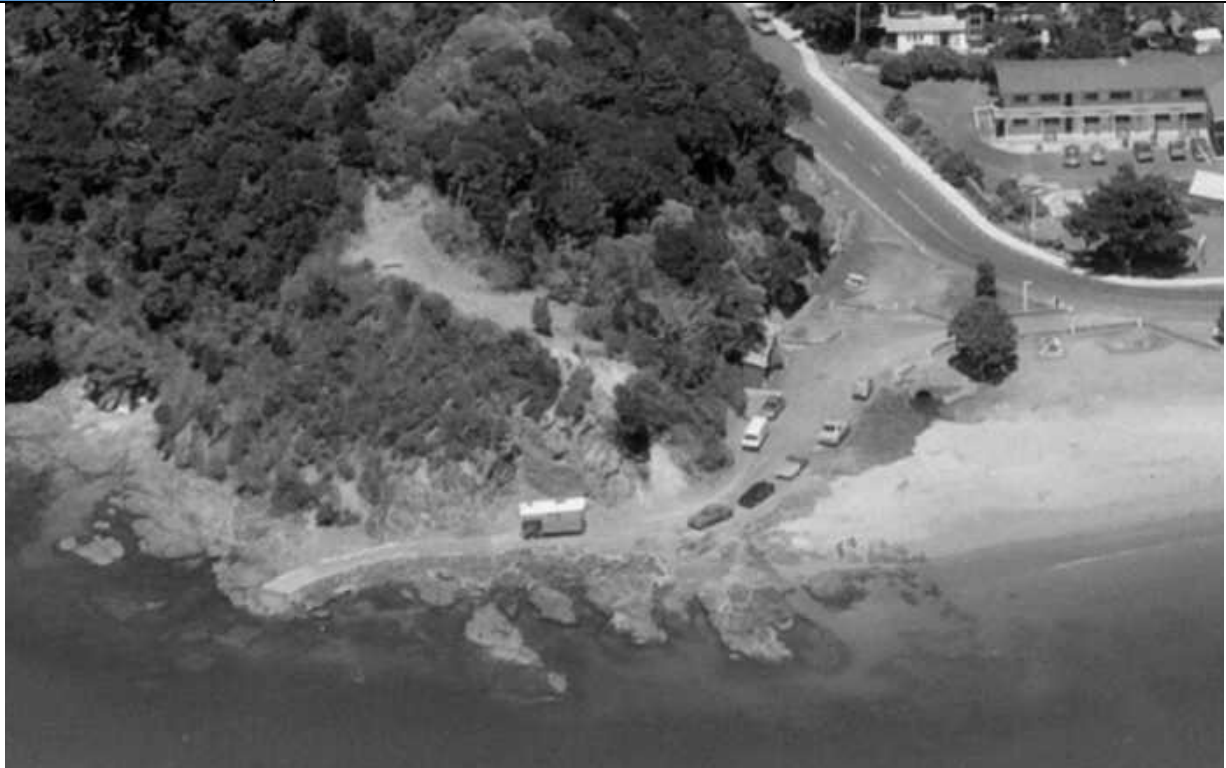
Detail Snip: Showing the wharf pier remains still visible in the intertidal zone. The seawall and road structure also remain unchanged, 21 February 1987. Whites Aviation image. (Paihia, Bay of Islands County, Northland. Whites Aviation Ltd :Photographs. Ref: WA-79316-F. Alexander Turnbull Library, Wellington, New Zealand. [/records/23139067](#))
