6. Pouto Peninsula

6.1 Grevilles Lagoon, the lake north of Kapoai (Pouto), NRC Lake No. 295; surveyed in 2005

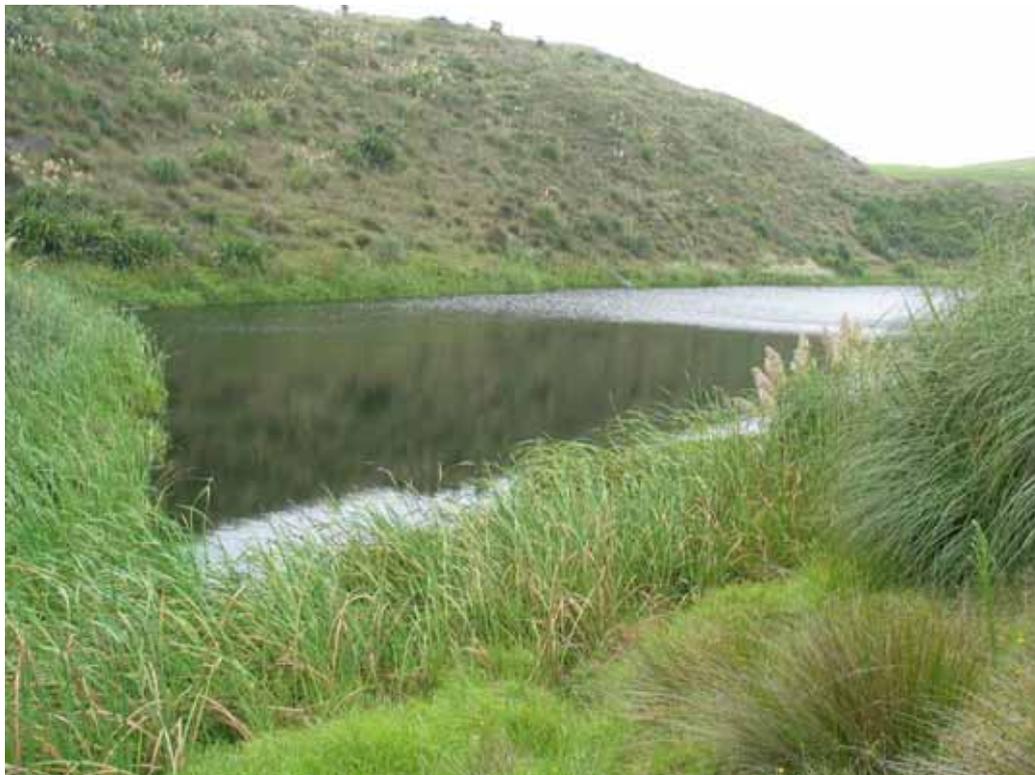
Plate: Grevilles Lagoon, set in a pastoral catchment, with margins retired.

Moderate: Fully fenced with native submerged vegetation, but emergent zone impacted by the weed *Alternanthera philoxeroides*.

Typha orientalis dominated emergent vegetation, 5 – 10 m wide, growing to 0.5 m deep, rings the lake. Scattered plants of *Schoenoplectus tabernaemontani* were also present. The pest plant alligator weed (*Alternanthera philoxeroides*) was abundant at the sample point, at the western end of the lake, forming floating mats amongst *T. orientalis*.

The margins have recently been retired from grazing and planting has been undertaken. Alligator weed is well established at this site. No monitoring is recommended.

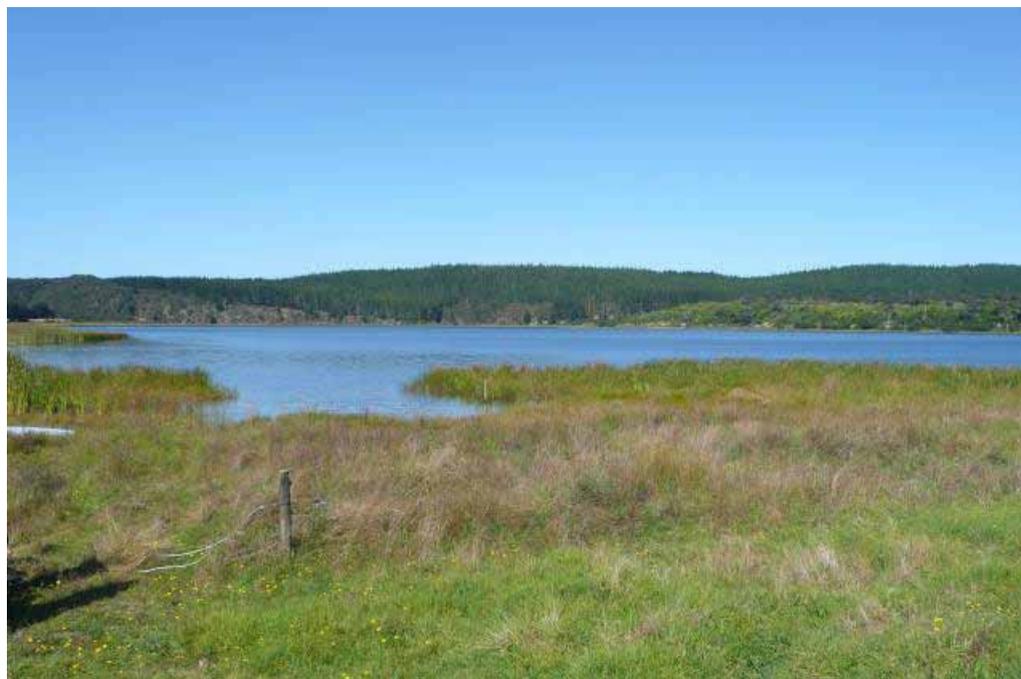
Plate: Lake Humuhumu showing pastoral catchment in foreground, pine forest in background and the large island (centre right) which divides the lake.

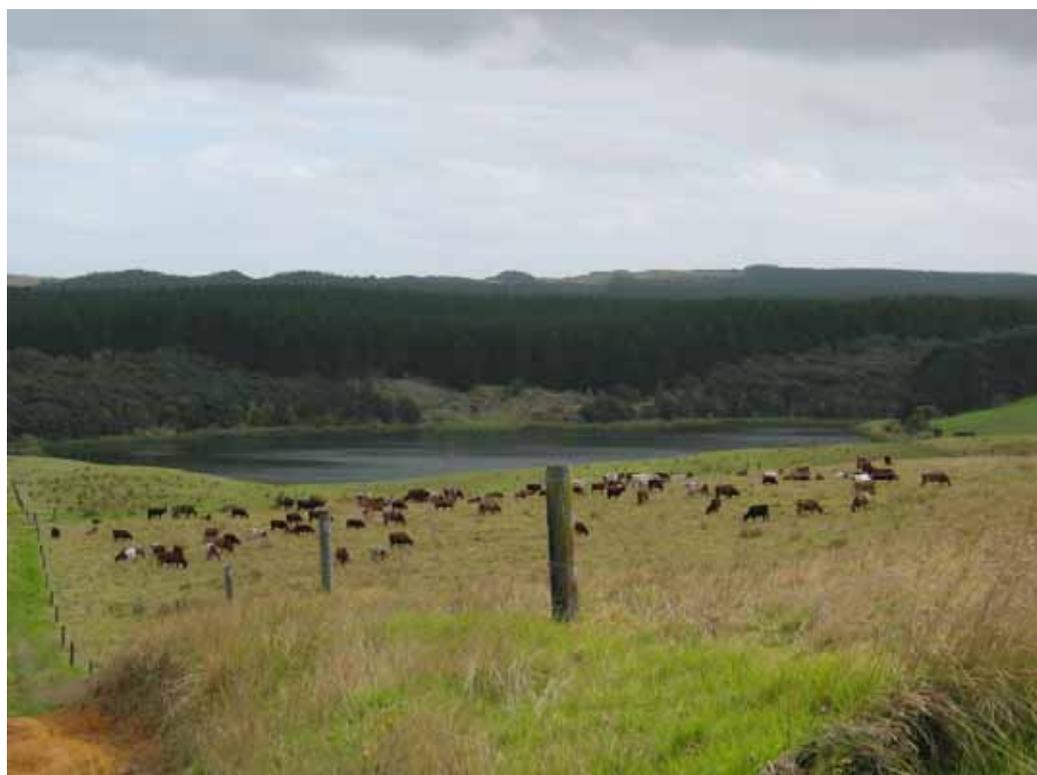
Plate: Lake Kahuparere showing pasture foreground, and pine forest on sand dunes to the rear.

High: Medium sized lake with native vegetation, but nutrient enriched with livestock access to margins.

The relatively poor visibility and presence of filamentous algae covering the submerged vegetation indicated nutrient enrichment. Cattle access to the east shoreline not only has damaged the marginal vegetation through grazing and trampling, but can also lead to direct addition of nutrients to the lake by defecation and urine. Fencing of

Maintain the awareness of the threats posed by introduced weeds and their mode of introduction on contaminated fishing nets to the owner. Fencing of the lake margin has occurred.

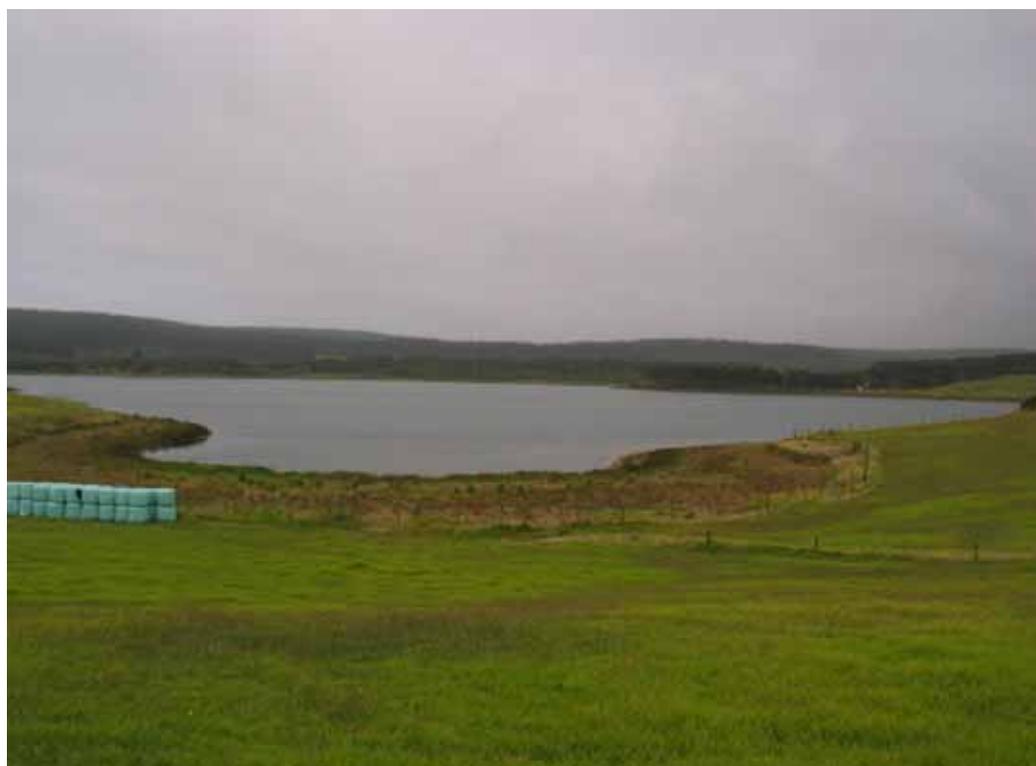
Plate: Lake Kanono showing the fenced margin and an access point in the foreground.

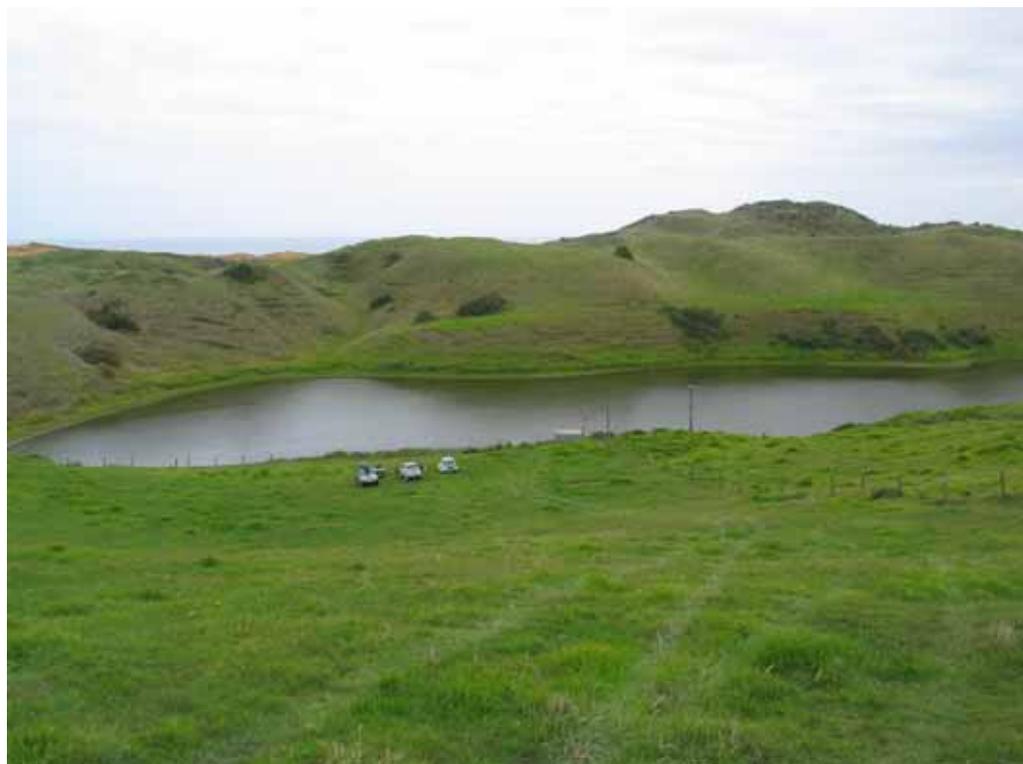
Plate: Lake Kapoai set in a pastoral catchment.

Low-moderate: No submerged vegetation and marginal vegetation sparse. Fencing of lake margin almost complete, water quality may improve over time.

Much of the lake margin has recently been retired from grazing. Fencing the remainder of the lake margin is advocated.

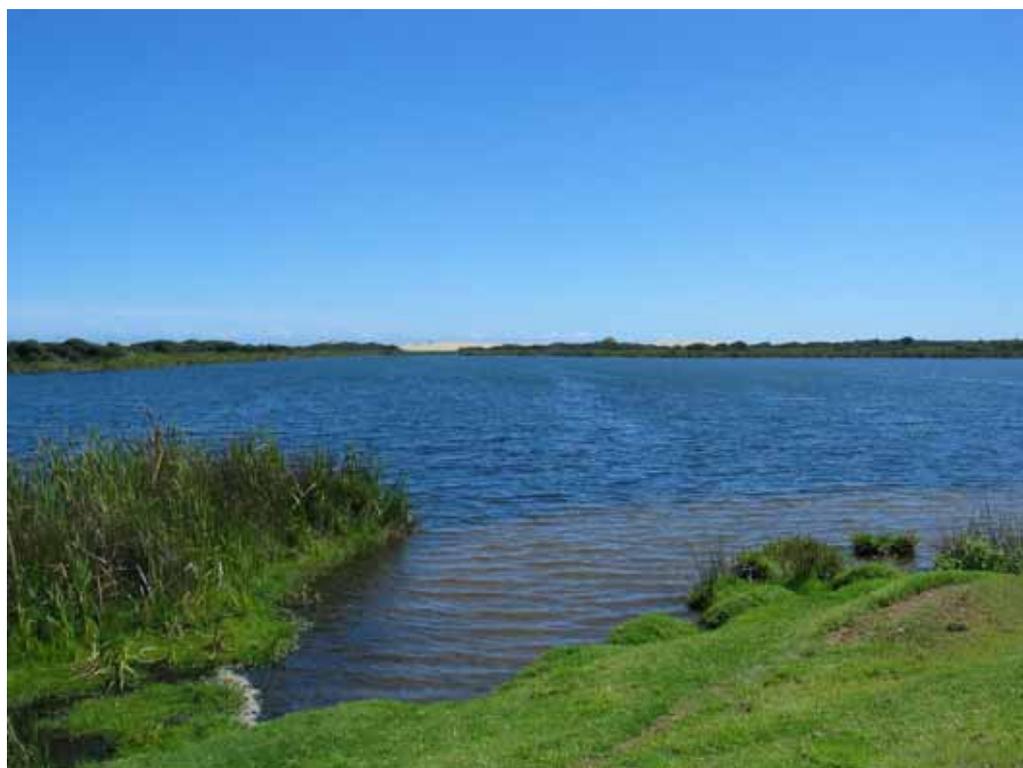
Plate: Lake Karaka viewed from the access point showing pasture to the lake edge. The remainder of the lake margin is wetland.

Emergent species encircle most of the lake, except the margin bordered by pasture and open to cattle grazing. *Typha orientalis* and *Baumea articulata* dominated. These extended over a 20 m wide band in most areas growing to depths of up to 2 m. Common amongst the emergent vegetation were plants of the nationally threatened fern *Thelypteris confluens*. Other emergent species seen in 2007 included *Apodasmia similis*, *Baumea arthrophylla*, *Baumea juncea*, *Carex maorica*, *Carex secta*, *Cyperus ustulatus*, *Eleocharis acuta*, *Isachne globosa*, *Isolepis prolifer*, *Juncus pallidus*, *Schoenoplectus tabernaemontani*, flax and cabbage trees.

Advocate fencing off the eastern shoreline to prevent cattle access to the lake.

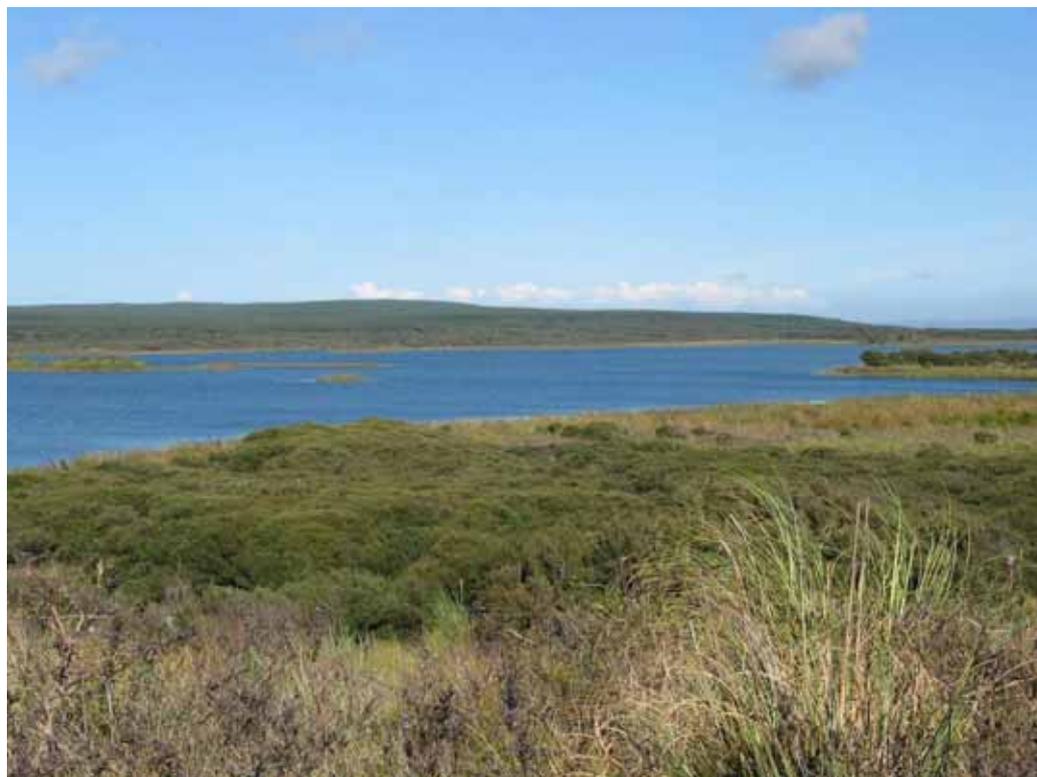
Plate: Lake Mokeno surrounded by wetland and indigenous scrub vegetation.

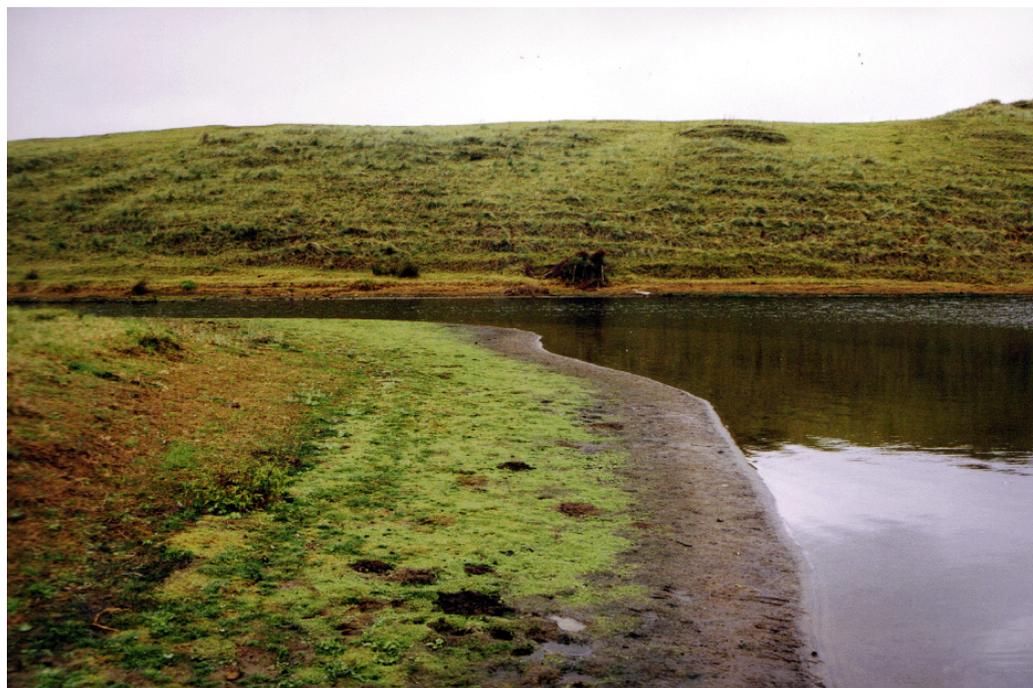
Plate: Southern end of Lake Parawanui showing the pasture catchment and grazed margin with an exposed turf community.

Low: A degraded lake, with poor water quality, grazed lake margins, sparse submerged vegetation and pest fish present.

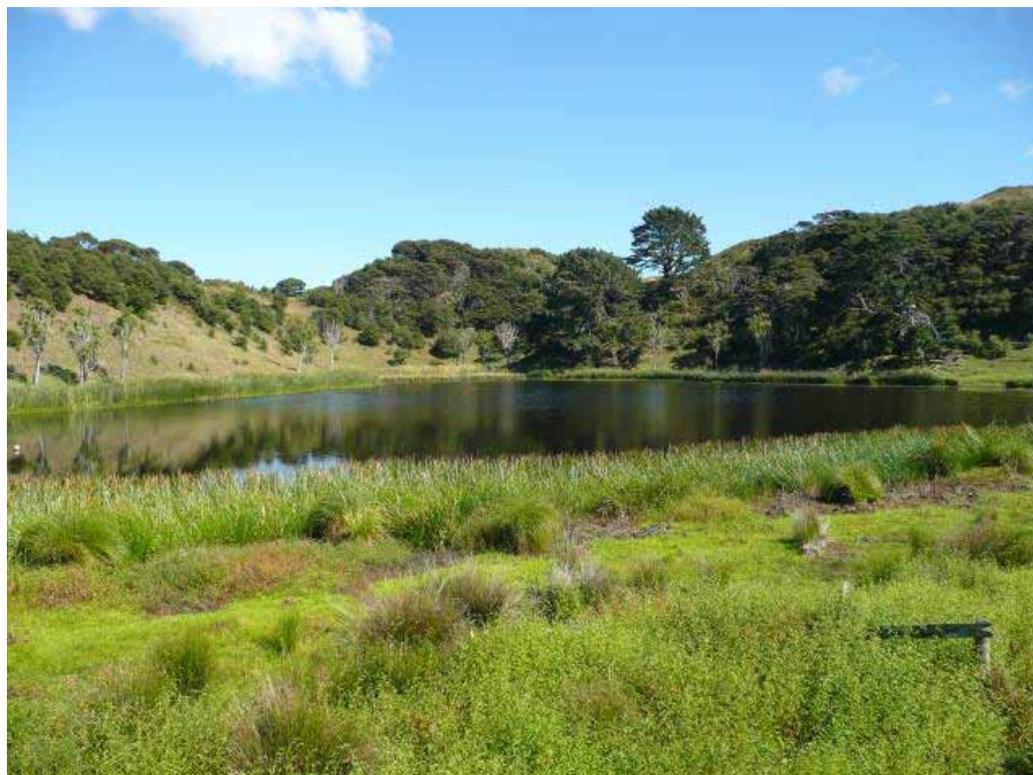
Plate: Phoebe's Lake with a dense margin of *Eleocharis sphacelata*.

Lagarosiphon major was the dominant species in shallow water forming dense surface-reaching beds extending to 2.6 m water depth. Below this, 1.5 m tall beds of *Potamogeton ochreatus* with occasional plants of *Nitella* aff. *cristata* were found to a maximum depth of 3.6 m. *Utricularia gibba* was common in shallow areas, sprawling over *L. minor*.

Consider management of *L. major*. Currently no monitoring recommended.
