Mangere Catchment Group Mangere River stream health investigation Field Trip

**Collated and narrated by
Kim Jones – Whitebait
Connection.
Photos by Susan Karels
from NRC - Enviroschools**

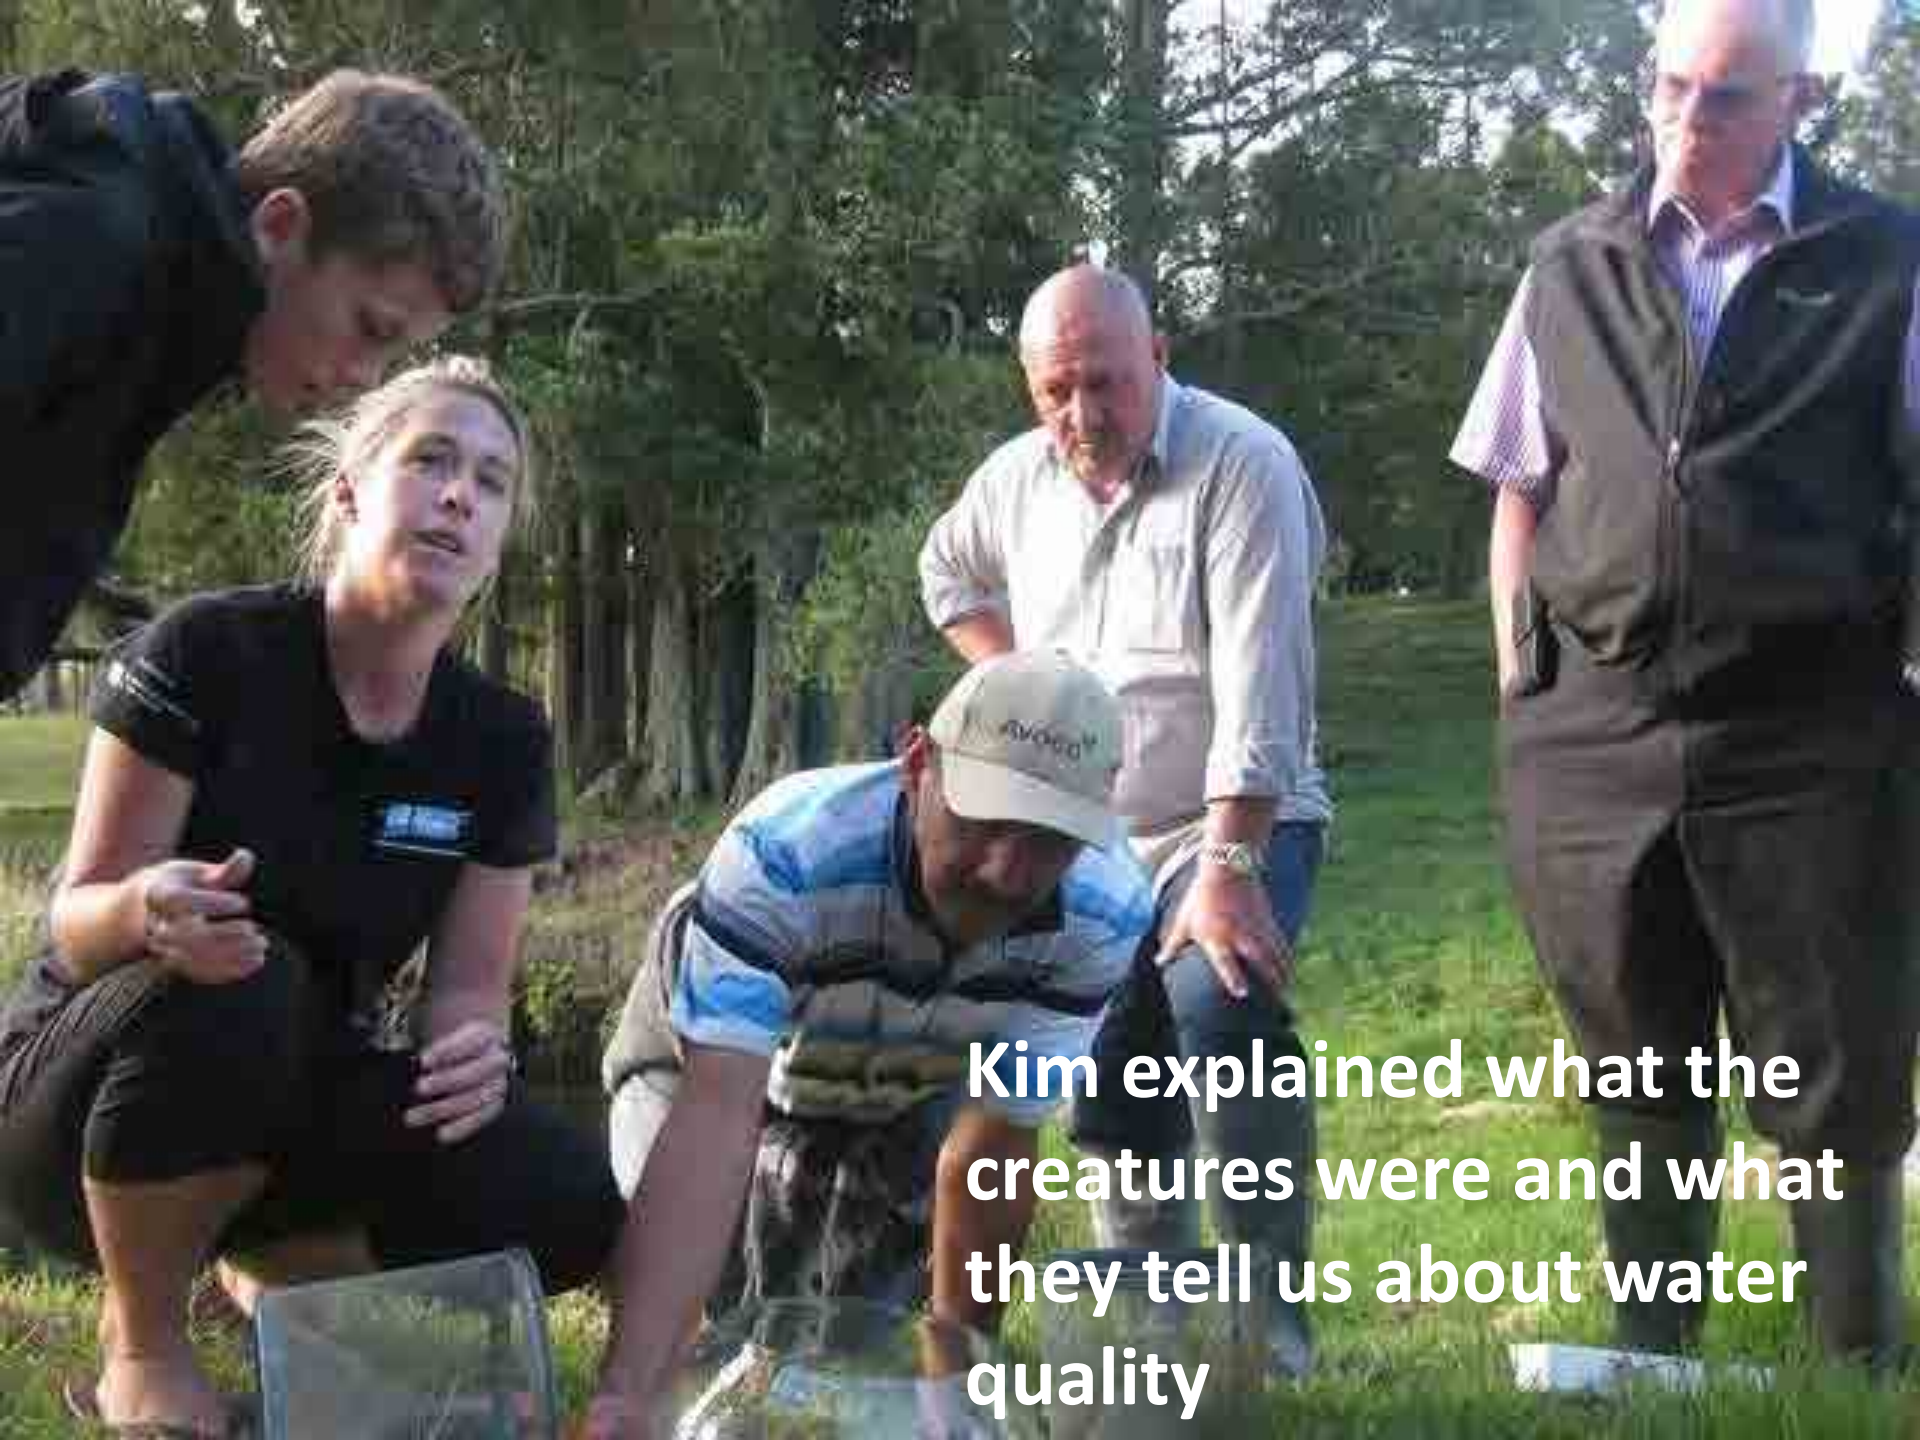
A Kewai / Freshwater
Crayfish and a Common
Bully

Kim explained what the creatures were and what they tell us about water quality

Bully are found throughout the catchment as they don't need to go to the sea to complete their lifecycle (so barriers such as dams don't cause an issue for them). Finding freshwater fish like this is good as it tells us that the habitat is fairly good – fish need food, oxygen, cool temperature and fairly good water quality to live in

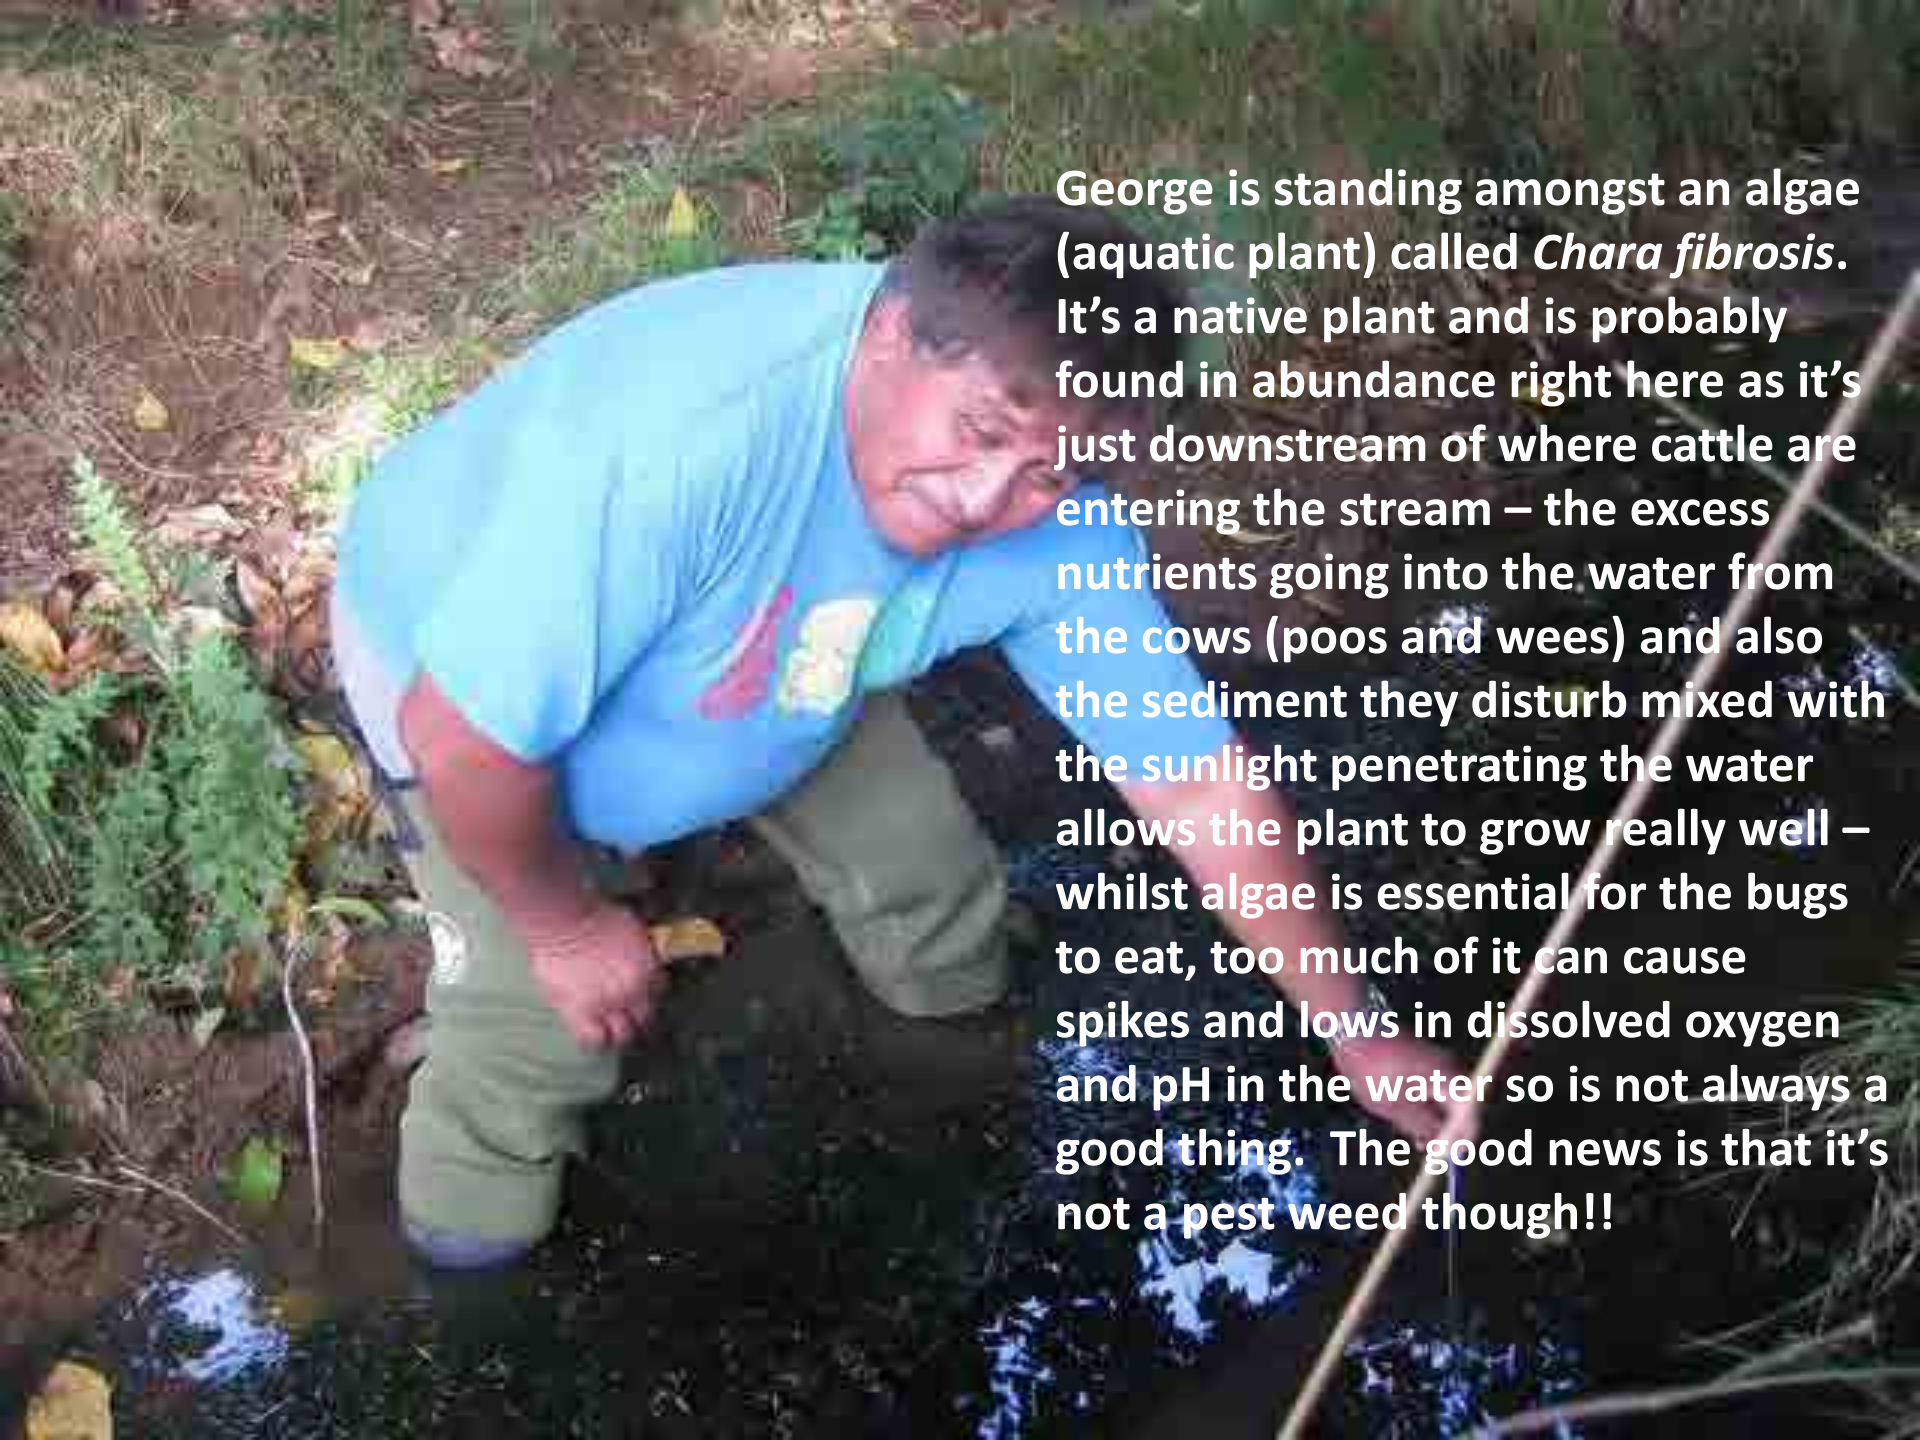
A man with dark hair, wearing a light blue t-shirt and green waders, is standing in a shallow stream. He is leaning forward, looking down at the water. The stream is filled with a dense growth of green, leafy aquatic plants, identified as Chara fibrosis. The background shows a grassy bank with some fallen leaves. The text is overlaid on the right side of the image.

George is standing amongst an algae (aquatic plant) called *Chara fibrosis*. It's a native plant and is probably found in abundance right here as it's just downstream of where cattle are entering the stream – the excess nutrients going into the water from the cows (poos and wees) and also the sediment they disturb mixed with the sunlight penetrating the water allows the plant to grow really well – whilst algae is essential for the bugs to eat, too much of it can cause spikes and lows in dissolved oxygen and pH in the water so is not always a good thing. The good news is that it's not a pest weed though!!

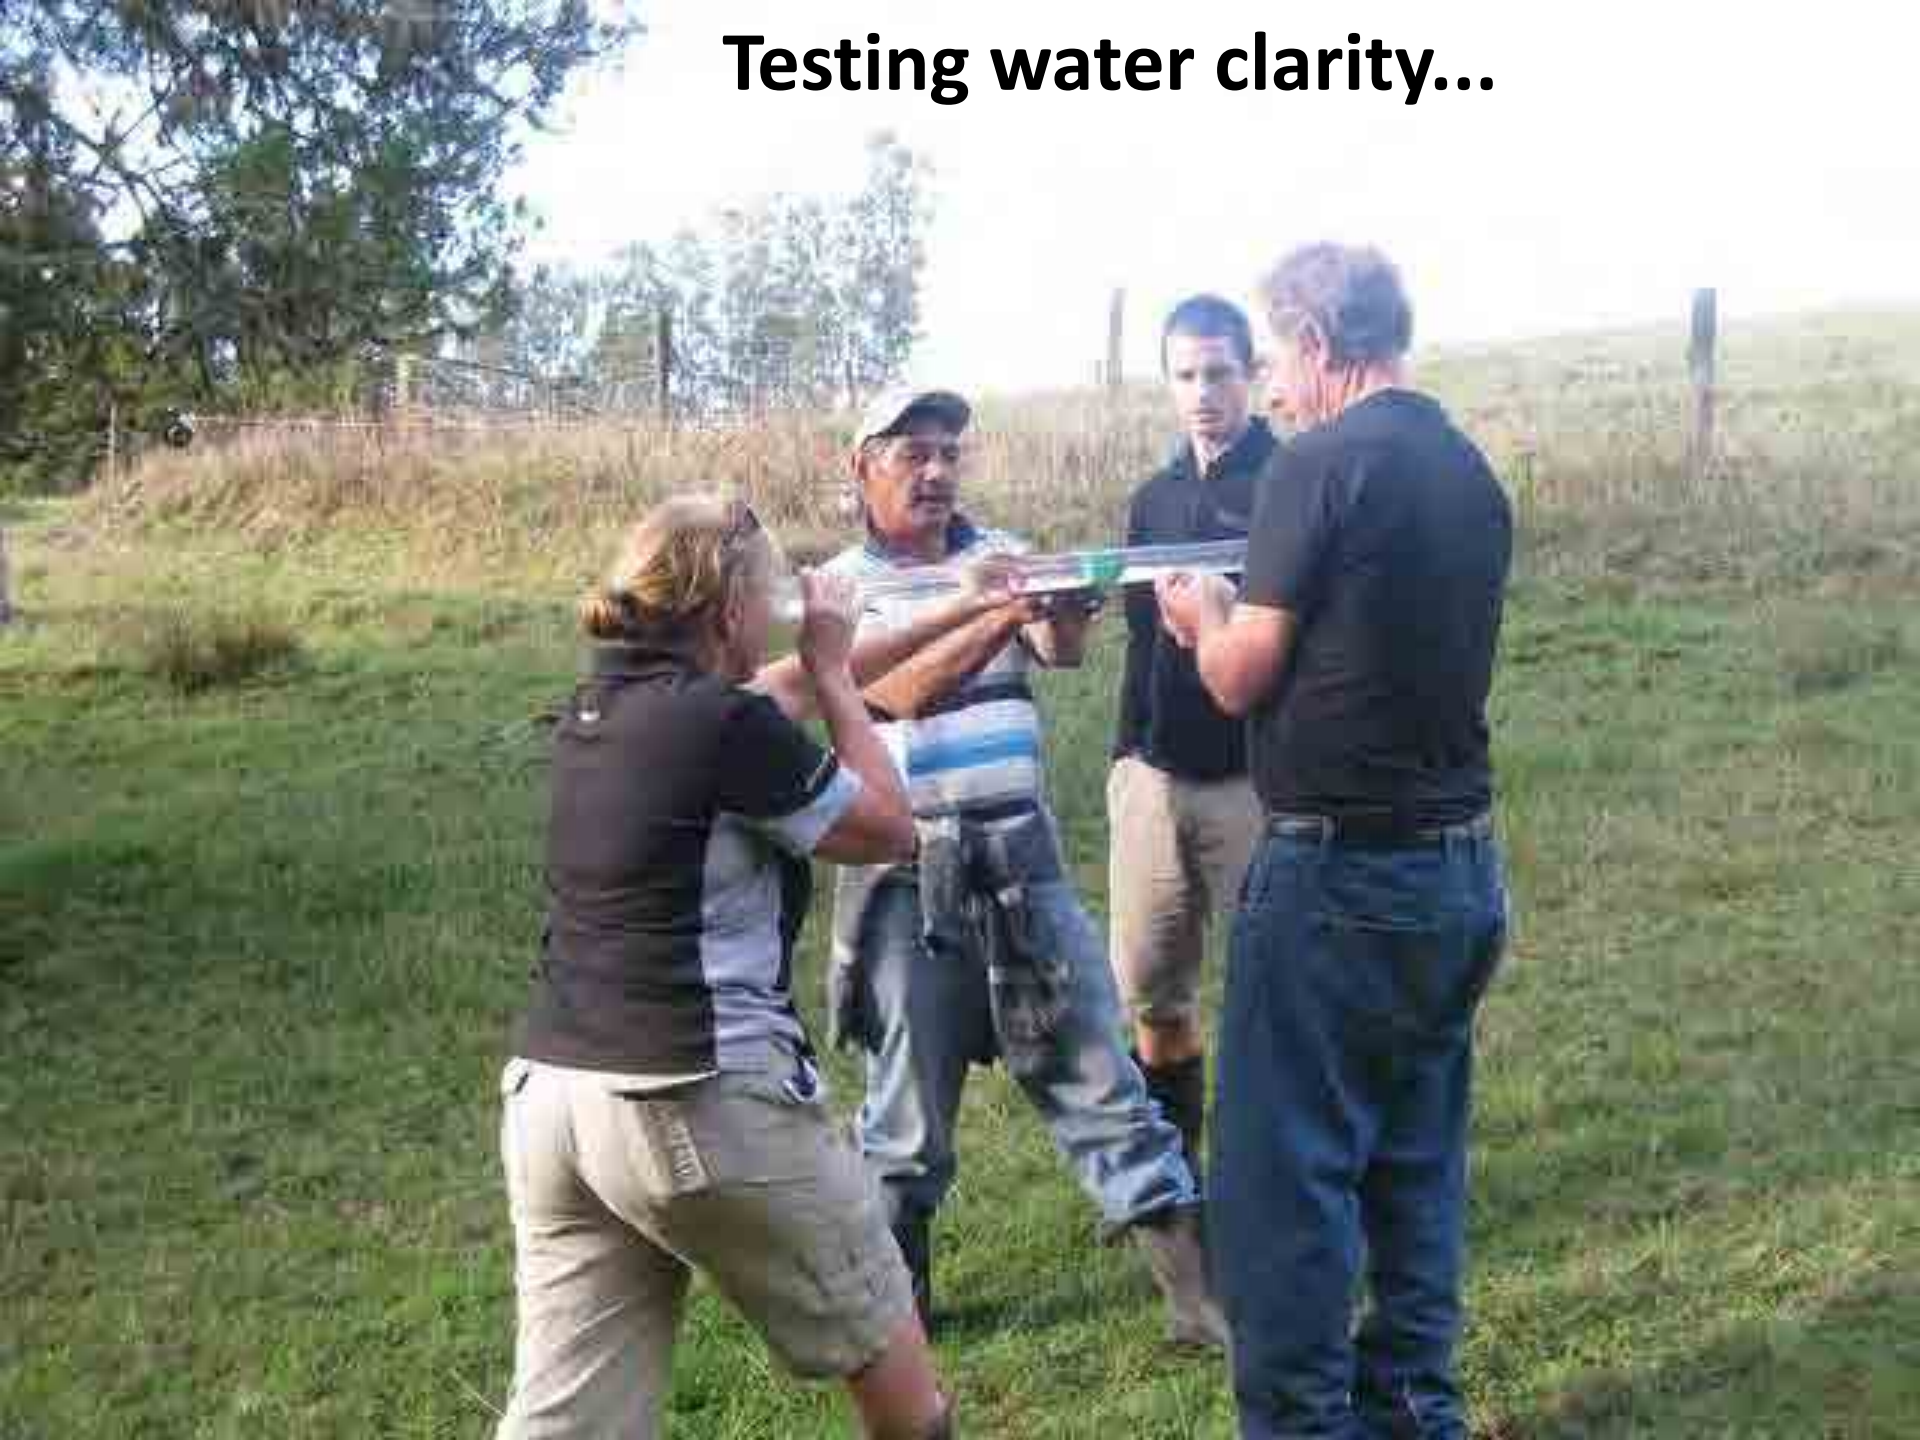
Testing water clarity...

...we got 91cm at this site – that's fantastic!

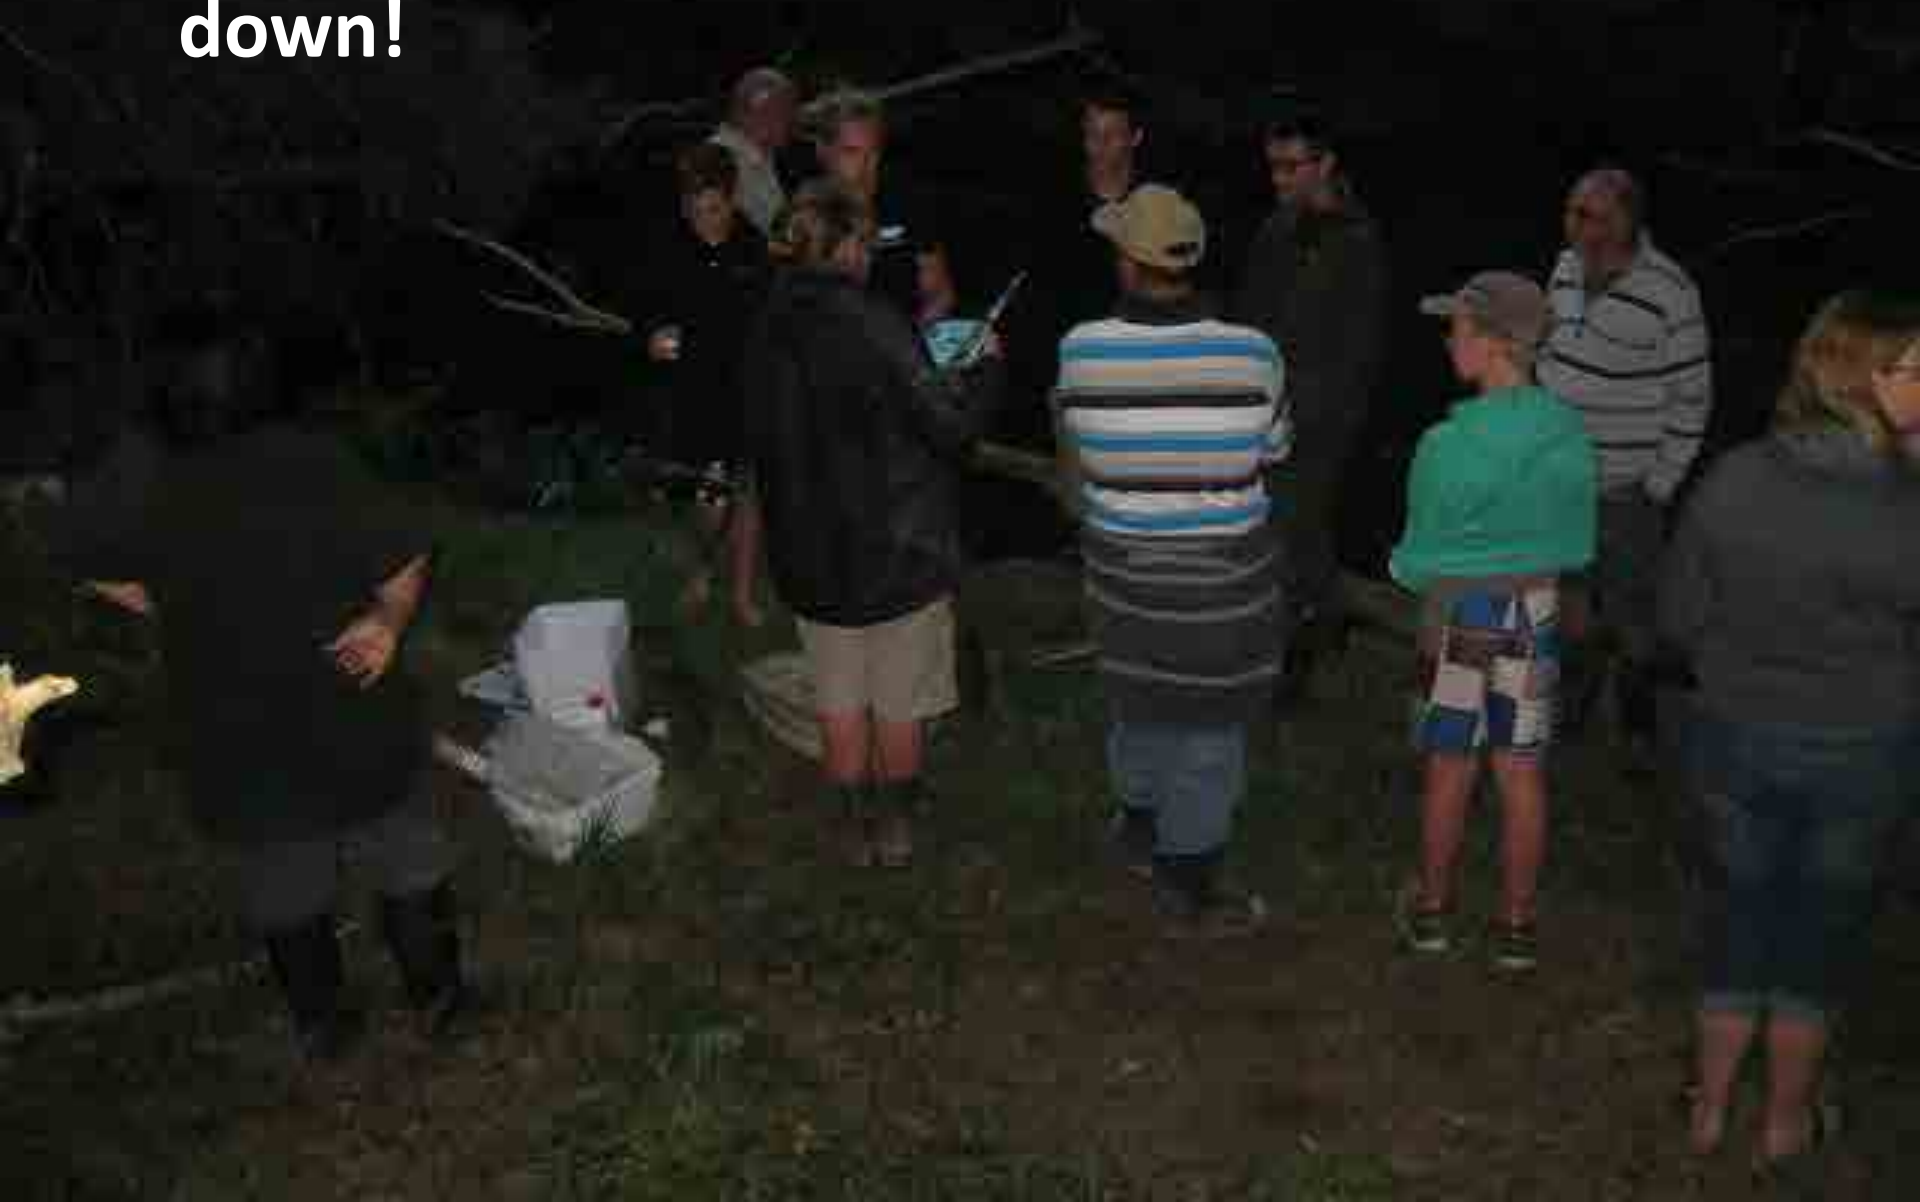
**Some quick testing
before the sun went
down!**

At this site we found that the water quality was more degraded despite the surrounding and instream habitat being very similar

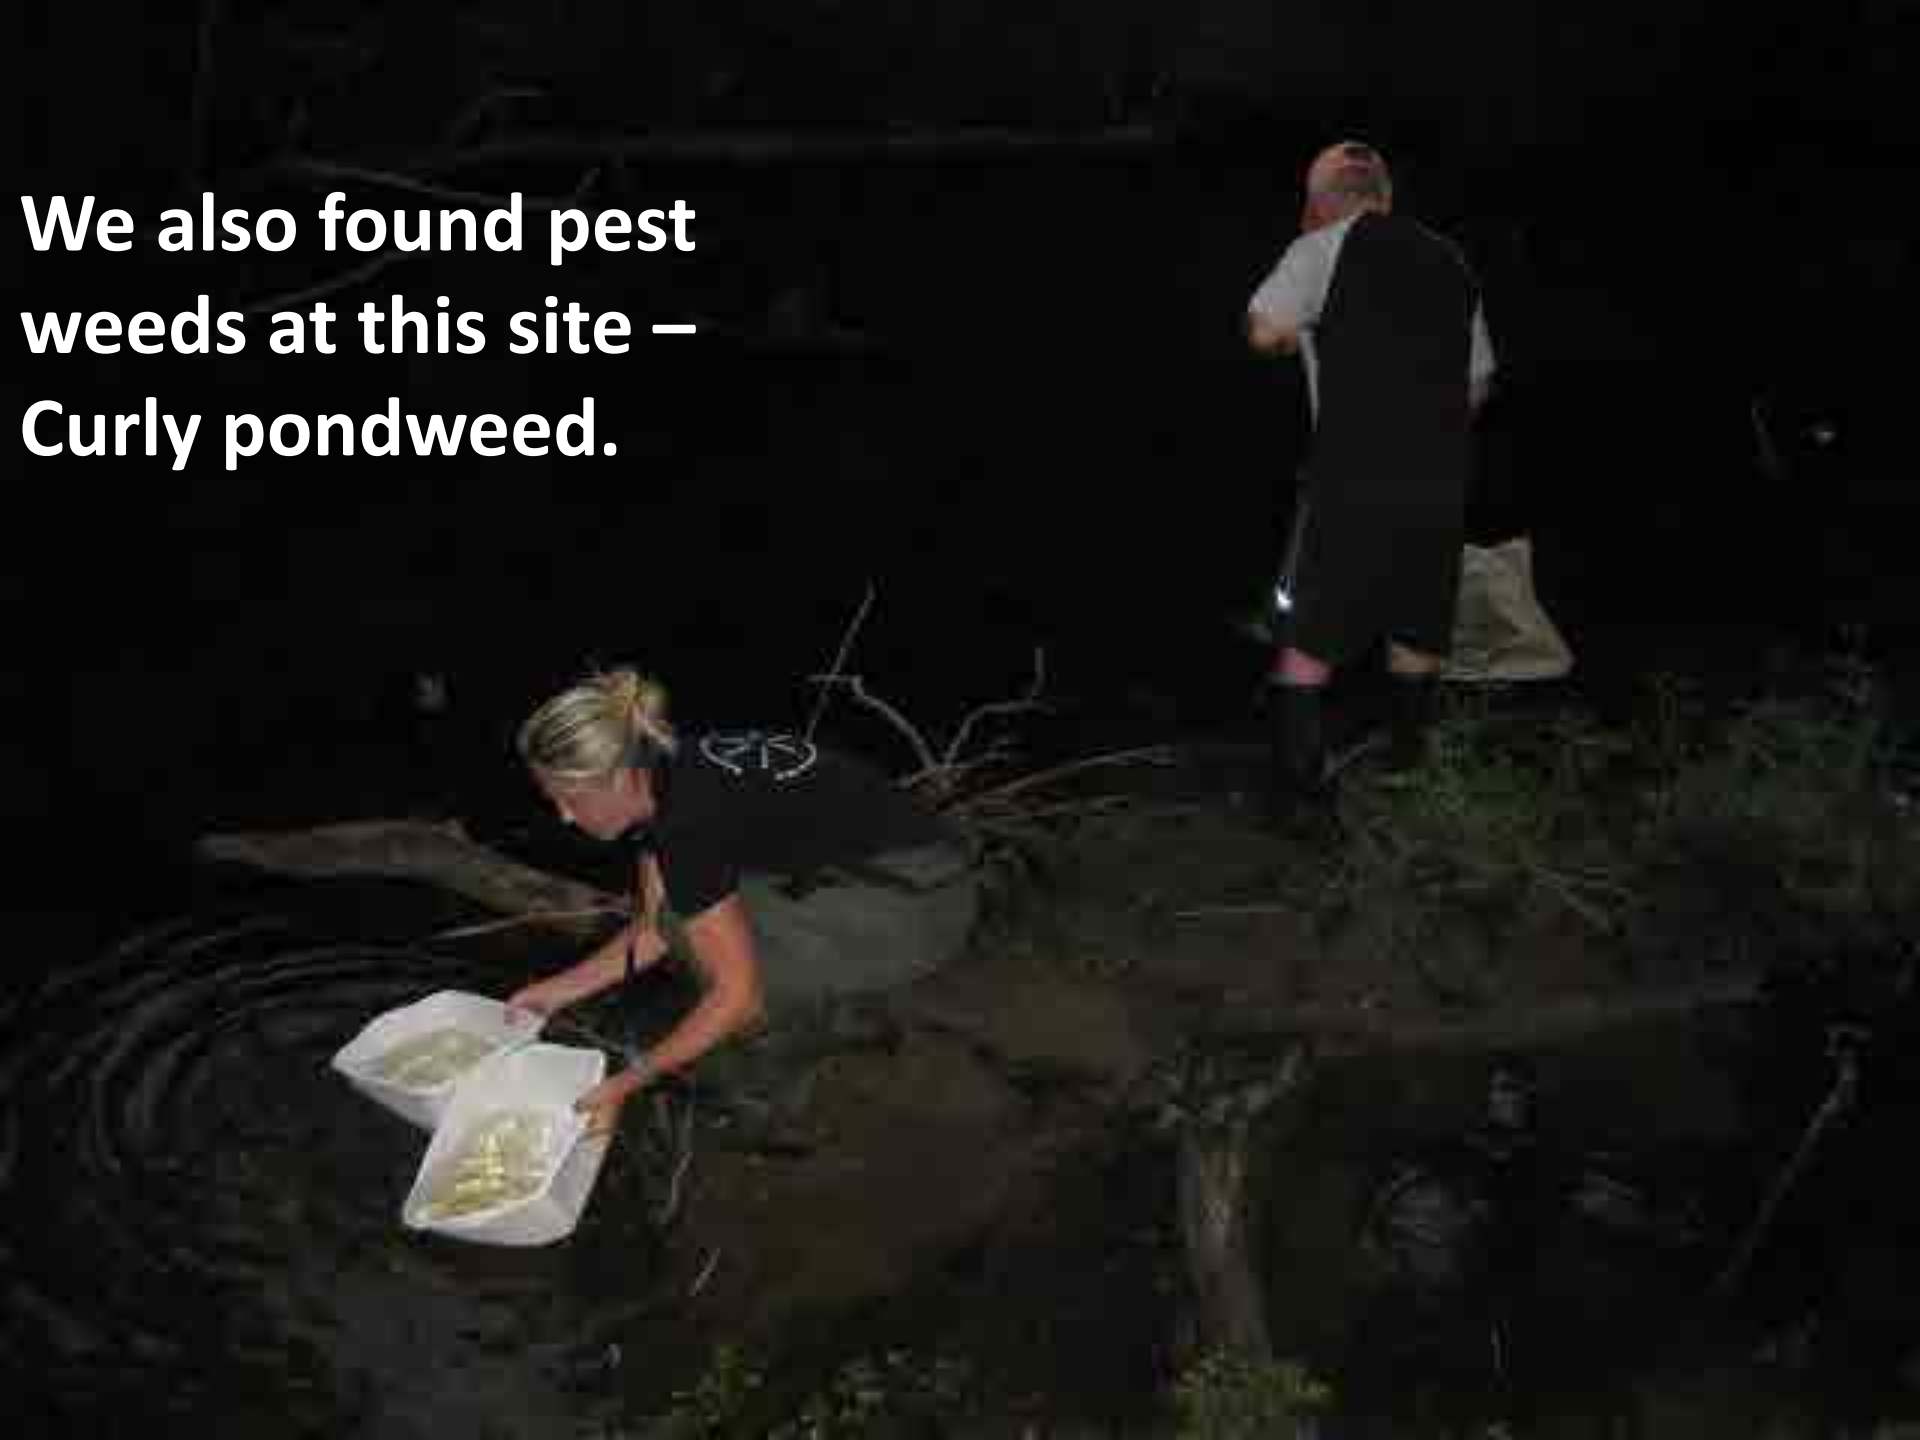
**We also found pest
weeds at this site –
Curly pondweed.**
